**LANGTOFT HALL, LANGTOFT,  
LINCOLNSHIRE:**

## **AN ARCHAEOLOGICAL WATCHING BRIEF**

May 1996

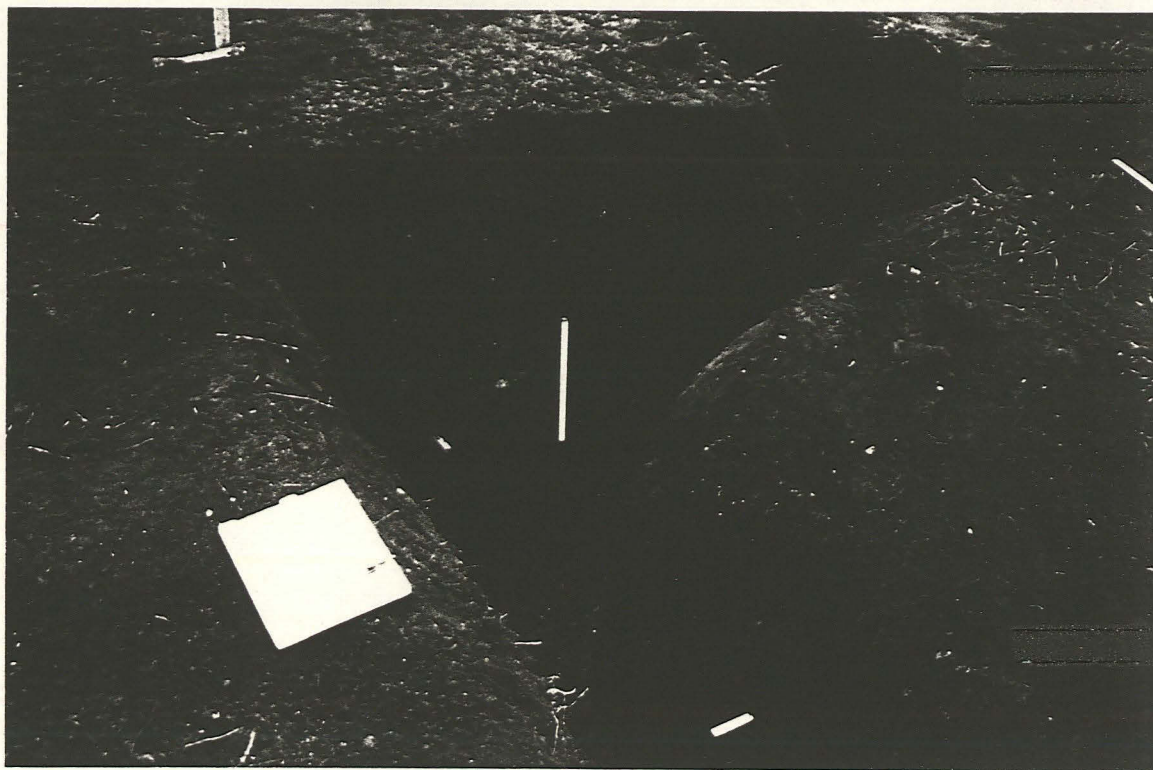
*An undated linear feature [9001] was observed running north-east / south-west across Plot 9. Although no dating evidence was recovered from this feature, the nature of its fills and profile were closely comparable to a linear feature recorded by Wessex Archaeology in their Trench 1 (feature 102) and Trench 10 (feature 1011), which they identified as a continuation of the medieval moat that can be seen as an earthwork feature to the north-east of the site.*

37. Feature [9001], looking south-west.
