LINDSEY ARCHAEOLOGICAL SERVICES

**Land adjacent to Walnut House
Lilly's Road, Lincoln
Archaeological Watching Brief**

Planning Application: **LC03/0147/94**

September 1996

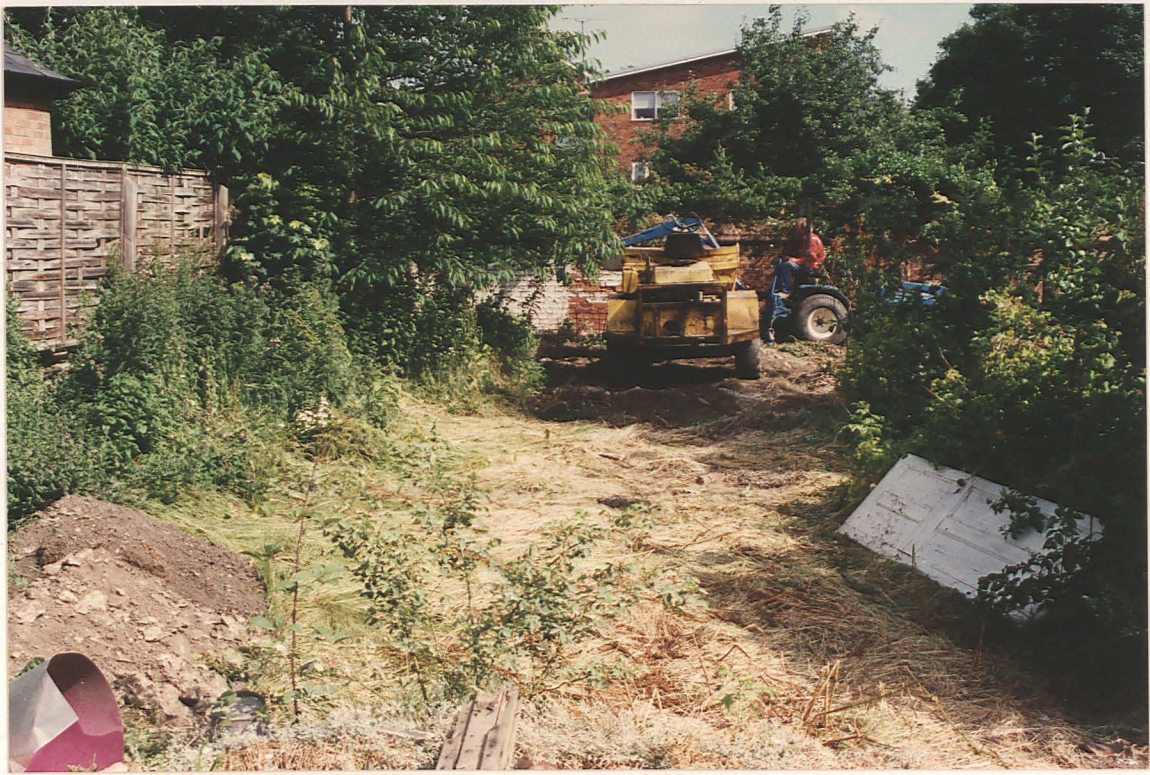
Pl. 1. Location of proposed outbuilding, looking north.

A workshop measuring 13.75 x 6m was to be built at the north end of the garden (Pl. 1). The north, west and east trenches were located c.750mm from existing boundary walls. Excavation began in the NW corner along the north foundation, followed by the east, west and south trenches to a depth of 1.20m below the modern ground level (63.67m OD). The trenches were dug through garden soil, except in the NE corner where the concrete floor base of a greenhouse was removed.

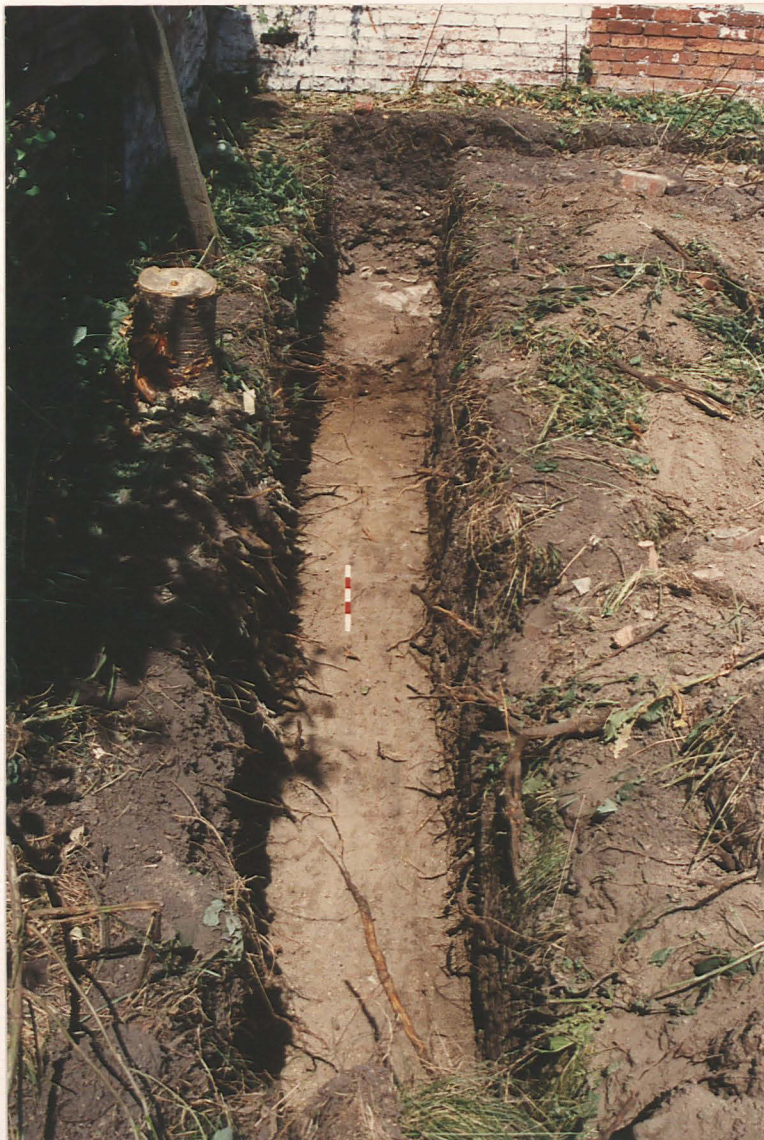
Pl. 2. Outbuilding west trench, layer 16, possible pit 34 foreground, looking west. Scale 0.50m.

Layer 16 was cut by feature 34 which appeared only in the SW corner of the foundation trench (Pl. 2). The similarity between its fill, 17, and layer 16 indicates a rapid backfilling of this feature. The mortar and limestone fragments imply building material contamination. One sherd of Roman pottery, early 2nd-4th century was found.

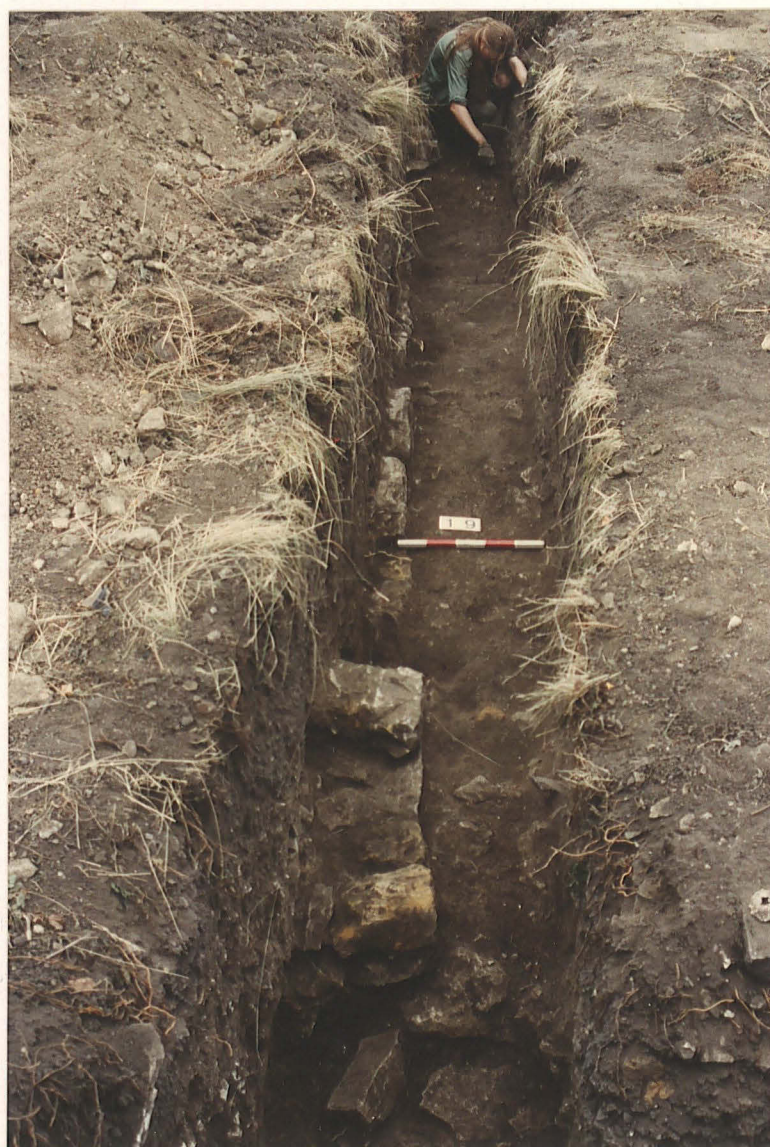
Pl. 3. South wall 19, with return wall 22 in foreground, looking west.
Scale 0.50m.

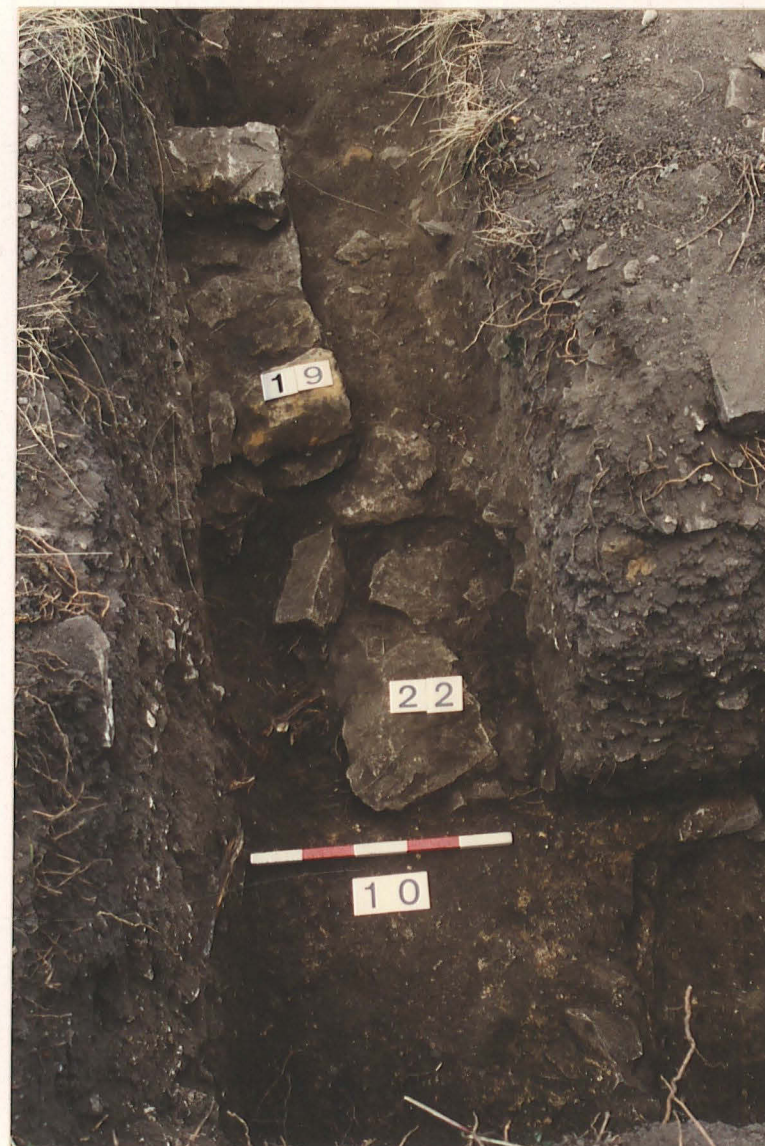
Pl. 4. Wall 19 with return wall 22. External surface 10 in foreground,
looking west. Scale 0.50m.

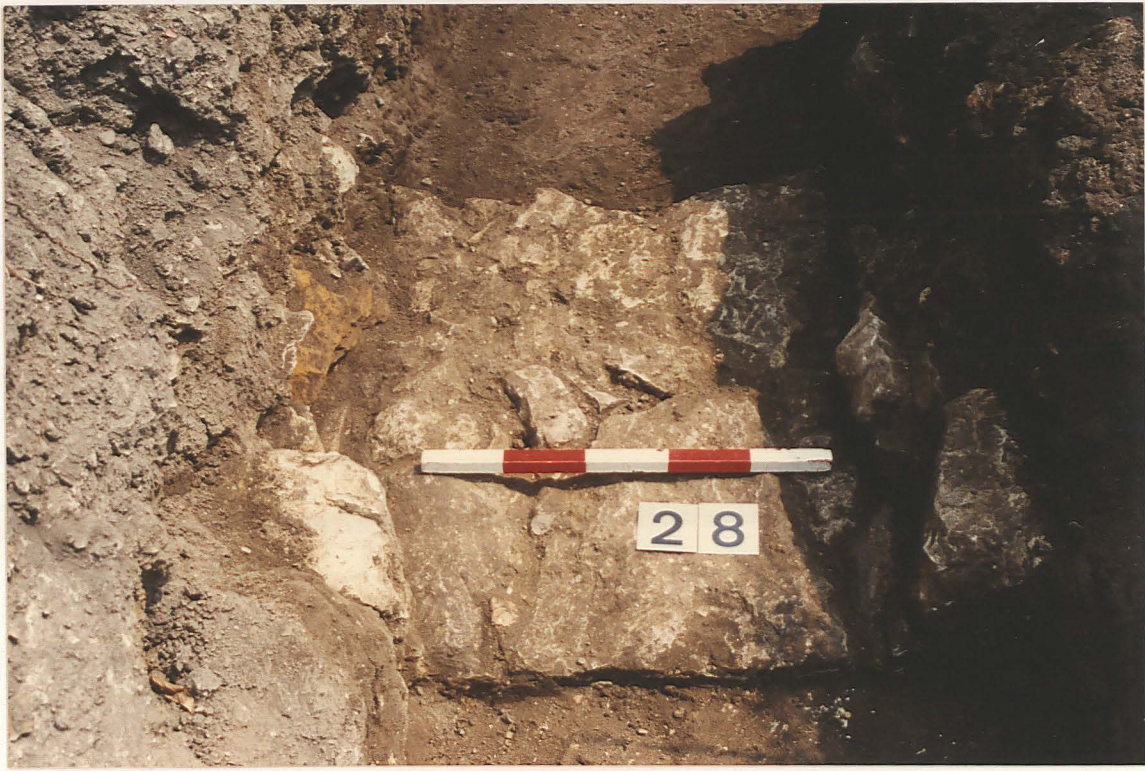
PI. 5. NNW-SSE wall 28, the continuation of wall 22, looking east. Scale 0.50m.

Wall **22** was recorded as **28** in the northern trench, situated 1.50m from the eastern trench edge (Pl. 5.). The return wall **4** (Pl. 6.) extended along the northern foundation trench parallel to wall **19** but its junction with wall **28** lay north of the trench limits. It was recorded for c.10.60m giving a minimum length for the building as 13m. Four courses of stonework were revealed, the highest course being 64.12m OD. An associated construction trench (**5**) was visible in the trench base at a depth of 63.67m OD. Its fill was a dark brown sandy soil, with occasional mortar fragments, similar in nature to the wall bonding of **4**. A single piece of Roman pottery dating to the mid/late 2nd century and a piece of cattle bone were found in the foundation trench.

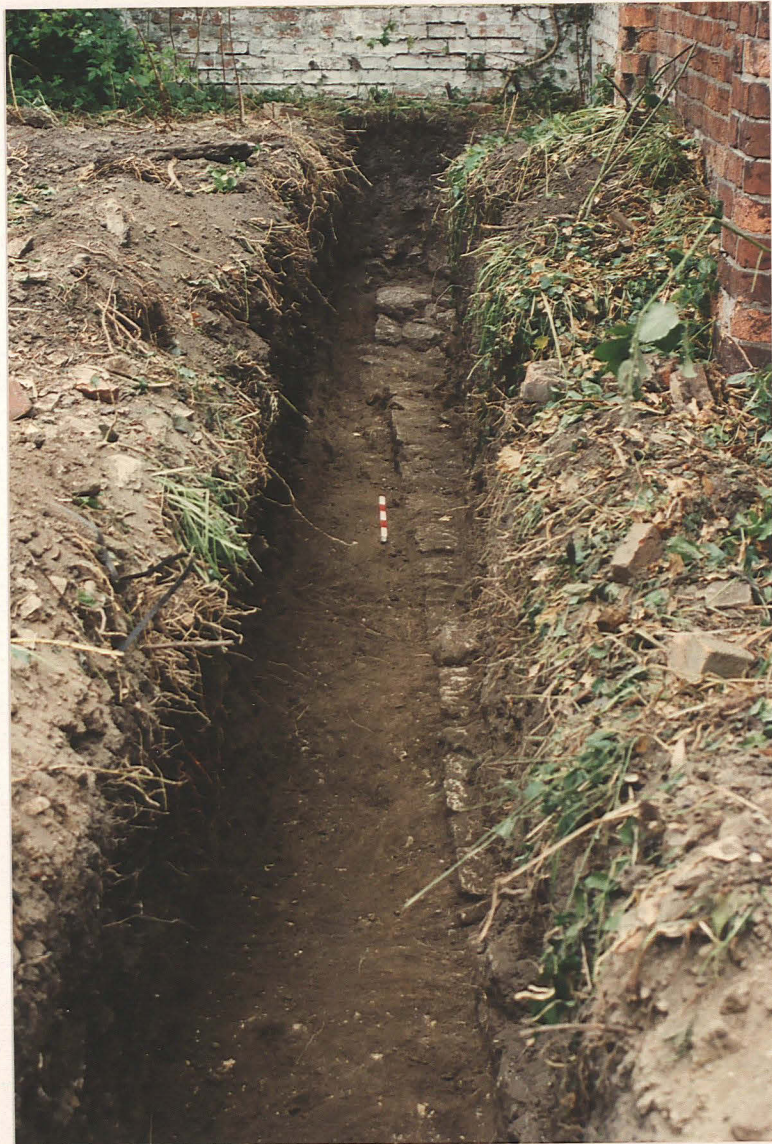
PI. 6. North trench. ENE-WSW wall 4, looking west. Scale 0.50m.

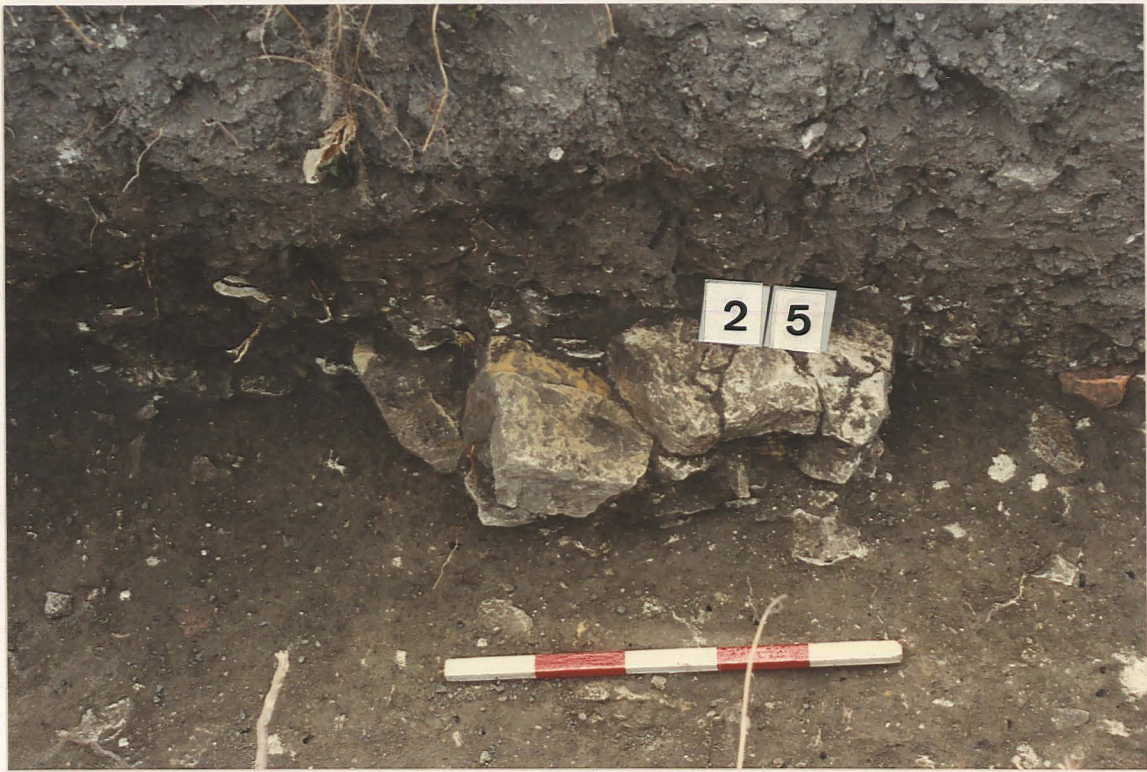
Pl. 7. Possible internal wall 25 in outbuilding south trench, looking south. Scale 0.50m.

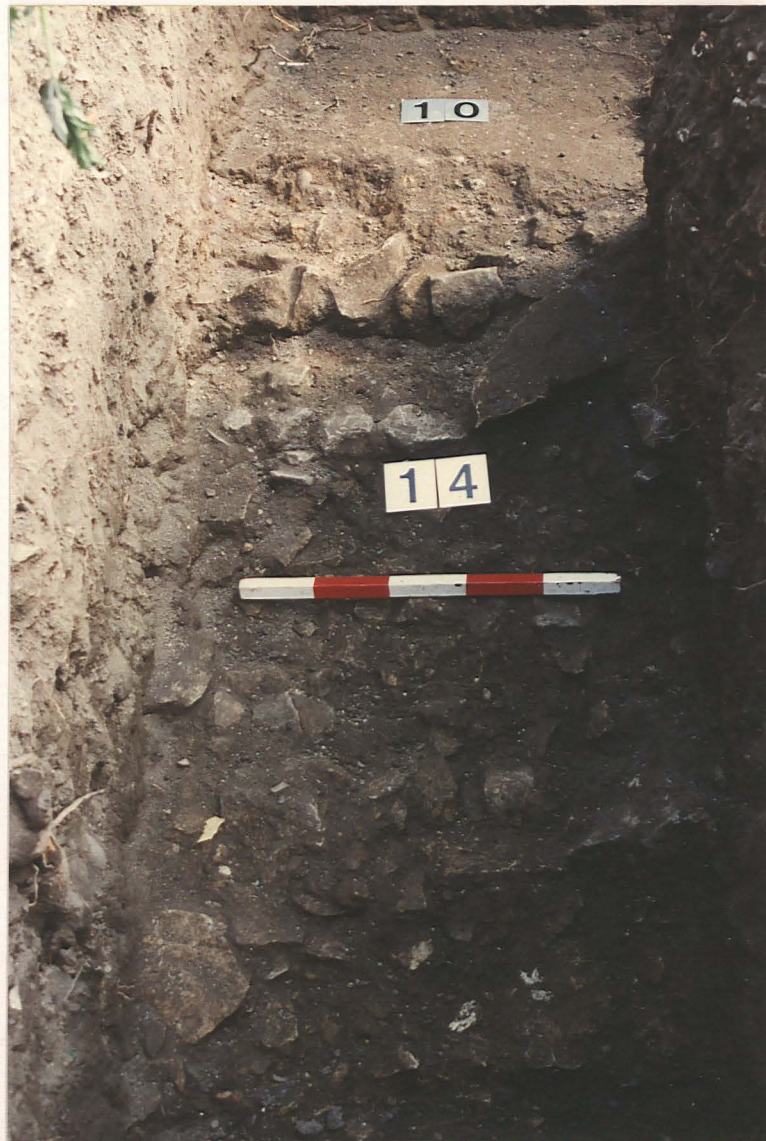
Pl. 8. Possible external surfaces 10 and 14, looking south. Scale 0.50m

East of wall **22** was **10**, a creamy orange mortar surface with limestone inclusions, extending 0.75m along the east trench (Pl. 8.). No associated dating evidence was recovered deposit, but it butted wall **22** and may have been contemporary with the building. Surface **10** overlay a make-up layer **13**, which comprised a grey brown sandy soil 0.05m thick and **31**, a crumbly creamy yellow mortar deposit. These two deposits also failed to produce finds. Layer **14** (Pl. 8) comprising limestone pieces within a light/mid brown clayey sand, lay below **31**. This surface extended a further 0.80m beyond **10**, and may represent an earlier floor associated with the building but no finds were recovered to date this deposit.

Layer 12, a dark brown sandy silt with mortar and limestone fragments (Pl. 8) was recorded in the eastern foundation trench, sealing Roman layer 11. It contained Roman tile and pottery, mixed with post-Roman pottery. A dark brown clayey layer 8, in turn sealed 12 (and 9 and 10 in the south east corner of the trench where 12 was not present. This humic layer butted walls 22 and 28 but extended no further westwards. Like 12, this layer produced a mixture of Roman and post-Roman pottery.

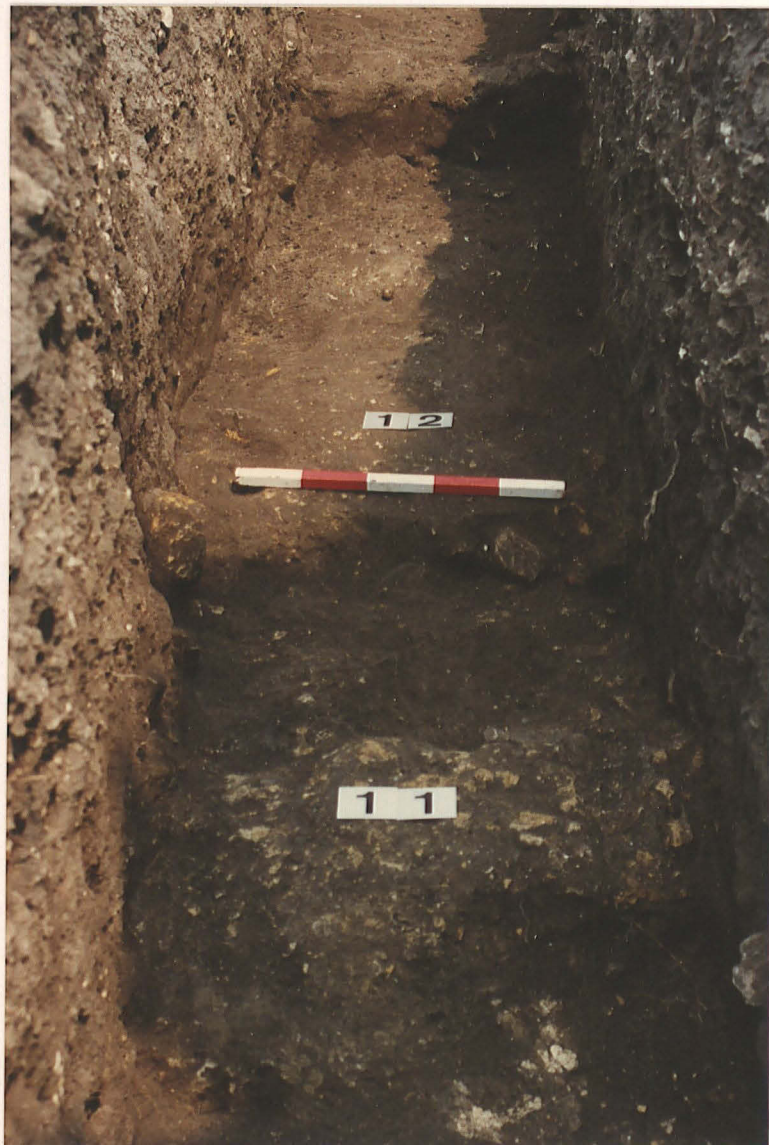
Pl. 9. Possible surface 11 with medieval sealing layer 12, looking north.
Scale 0.50m.

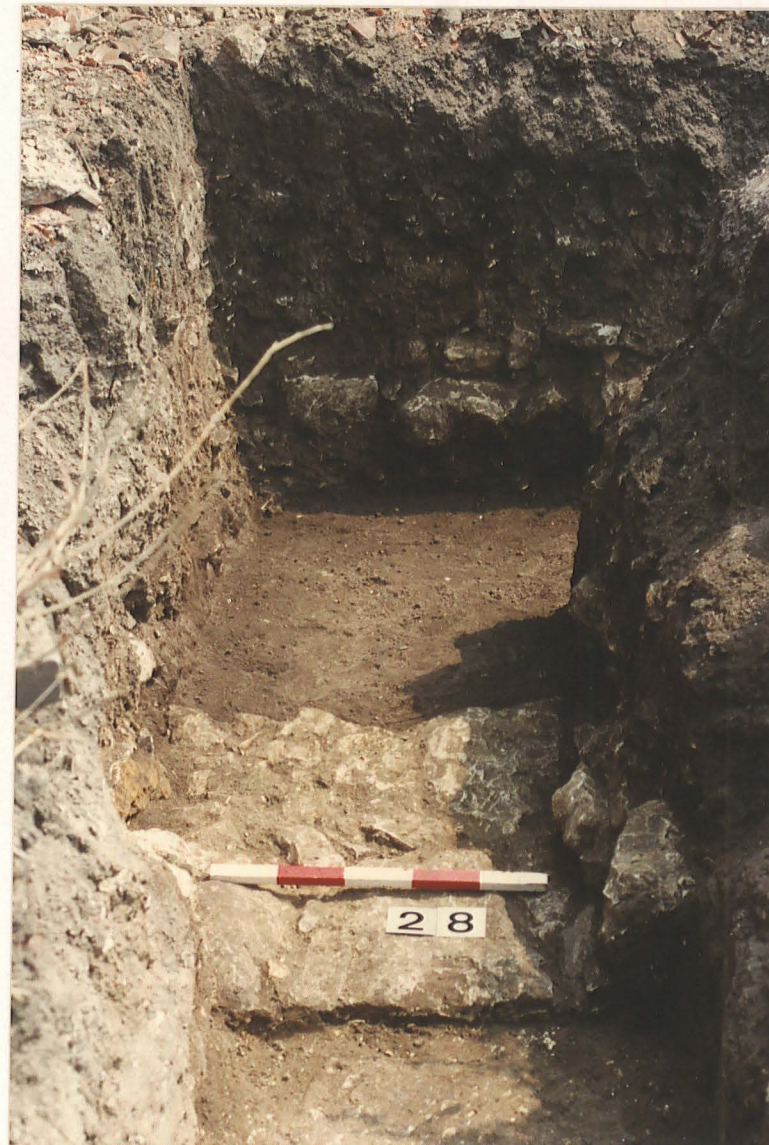
Pl. 10. Possible pit 33 with limestone blocks 32 at base. Wall 28 in
foreground, looking east. Scale 0.50m.

A possible pit of indeterminate function, 33, was dug into deposit 2, at the NE corner of the modern foundation trench. Not seen during machining, this feature was visible in section and was a minimum of 1.40m wide and 0.65m deep. Its upper fill, 35, was a dark brown sandy silt with green blue clay. Lower fill 32, contained large limestone fragments 0.06 - 0.30m in size which were within a mid/dark silty sand matrix. The size of the stones indicate that they may have come from a wall, or pit 33 itself may have been part of a robber trench. Deposits 2, 35 and 3/7/15 were sealed by 0.50m thick modern garden soil.

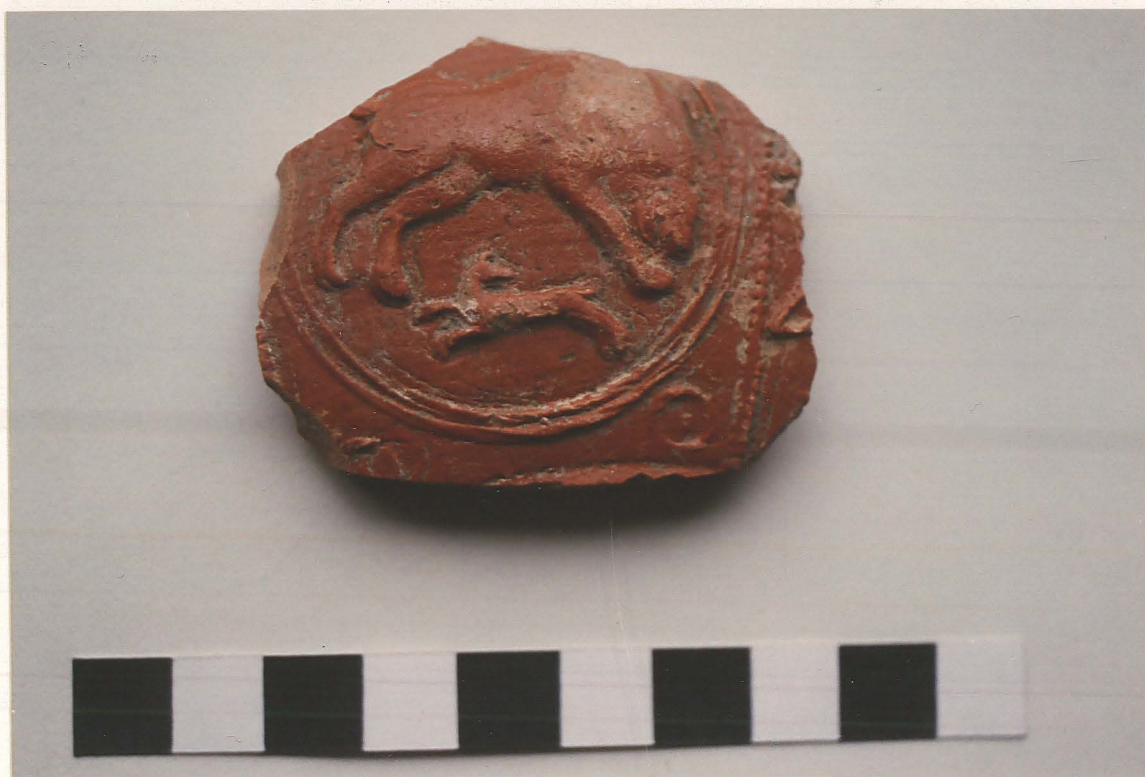
Pl. 11. Sherd of decorated Samian ware retrieved from fill 9.

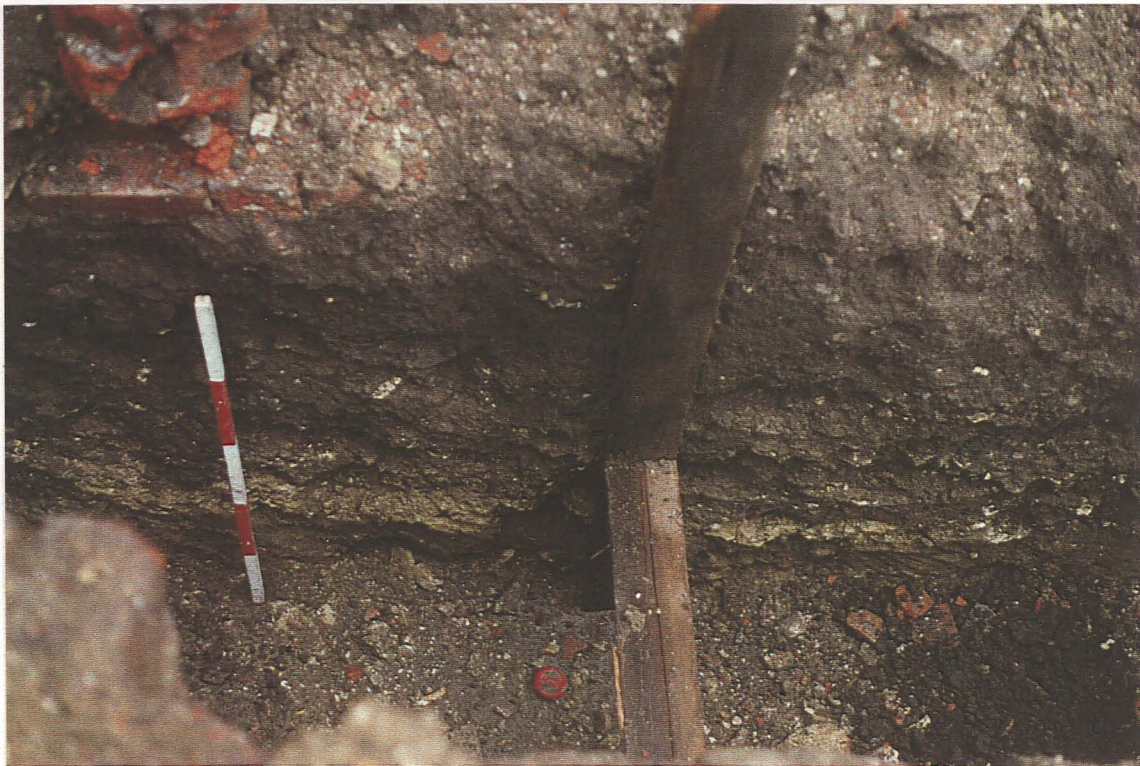
Pl. 13. West trench of house, bedrock at base of trench. Layer 53, immediately above, sealed by levelling material 49. Pit 66 (marked by 0.50m scale) and 70 (right) cuts surface 48. Looking west.

The requirements of the Building Inspector meant that the foundation trenches in this area had to be excavated down to undisturbed ground (i.e. bedrock) which was found at a depth of c.1.80m below existing ground level (63.26 OD). Bedrock **54** (Pl. 13) was a limestone brash.

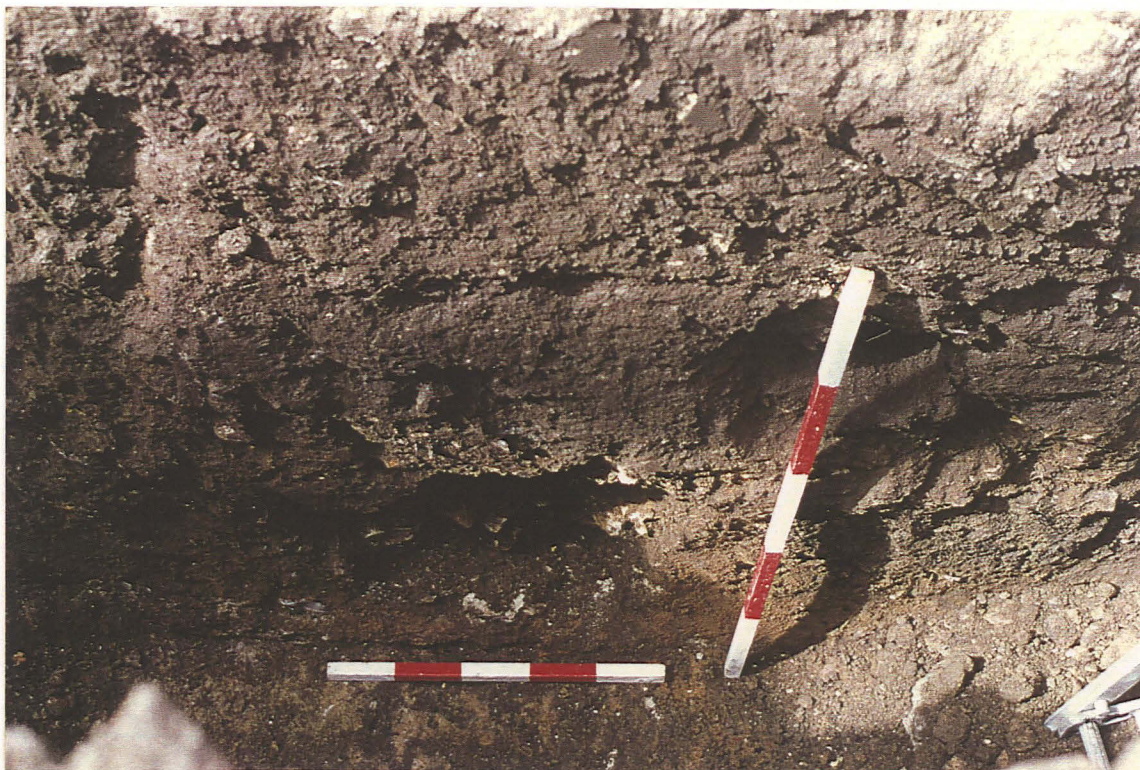
Pl. 14. Wall 64 (centre) with robber trench/pit 72 above, looking west. Vertical scale 1.0m.

Cutting through layer **53** was the construction trench, **65**, for wall **64**. It was 0.50m wide and contained loose limestone fragments up to 0.20m in size; no sign of facing stones or bonding was noted (Pl. 14). No pottery, tile or any other dating evidence was retrieved. A brownish white sandy clay surface **48/102/40** lay south of wall **64**. It may represent an internal floor surface associated with the wall but later intrusions had destroyed the relationship between the two (Pl. 13). Sealing **53**, below floor surface **48/102/40** was a red-brown clay with frequent charcoal flecks **49** (Pl. 13) which contained pieces of late 3rd - 4th century Roman pottery. This deposit is interpreted as a levelling layer for the floor surface and provides indirect dating evidence for the floor and wall.

Pit/trench **72** (Pl. 14) was located to the south of pit **74** situated directly above wall **64** suggesting that it may have been dug to rob stone from wall **64**. Whether feature **72** followed the wall as a linear trench or was a pit dug to remove only part of the wall could not be determined within the confines of a narrow foundation trench

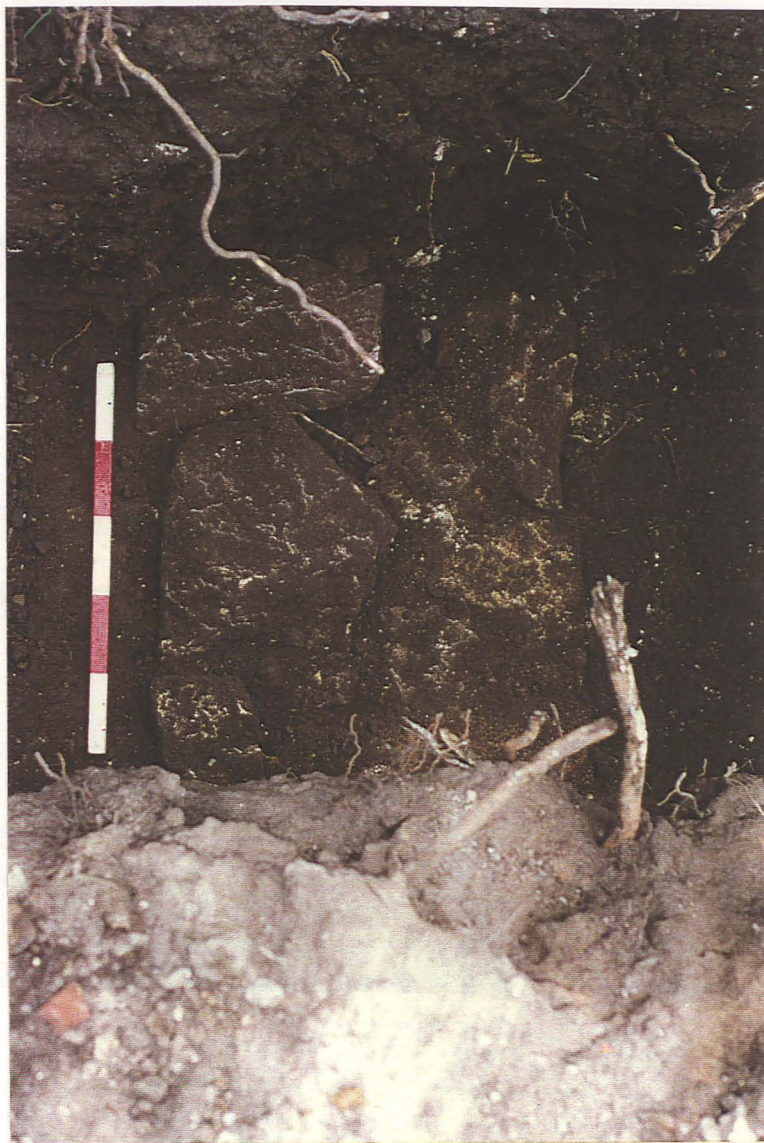
Pl. 15. East trench of house, wall 90 sealed by 108, from above. Scale 0.50m.

A similarly aligned wall **90**, (Pl. 15), the same width as **64** and three courses high, was noted in the east trench. It comprised limestone blocks up to 0.38m in size within a light brown sand bonding which contained pink mortar flecks. There were no associated finds. Surface **92**, a creamy white clay with occasional limestone fragments, possibly associated with **90**, also produced no finds.

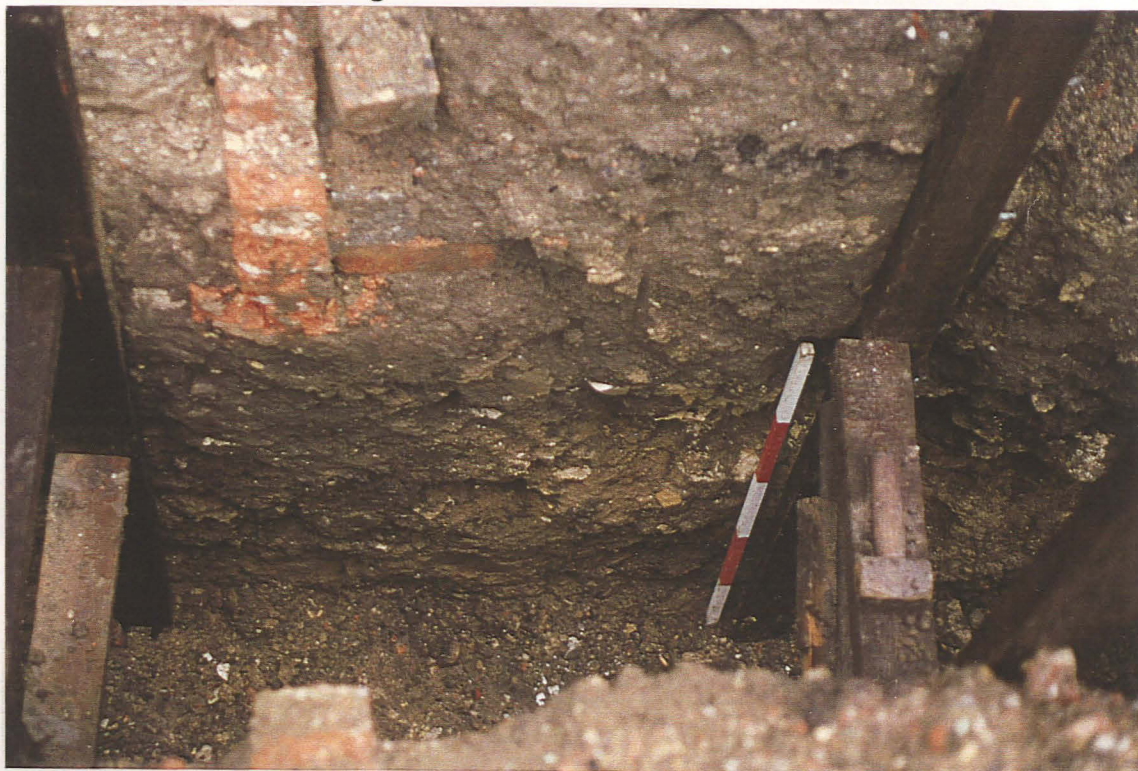
Pl. 16. West trench of house. Rubble 78 (light brown material) cut to the north (right) by pit 77, to the south by 74. Brick wall 55 also visible. Looking west. Scale 0.50m.

The western foundation trench contained a multiplicity of pits/gullies. The earliest of these features, pit **74** (Pl. 16), was situated c.1m from the northern trench edge. Its full dimensions could not be recorded because it was cut through by pit **77**, to the north, and robber pit/trench **72** to the south. Pit **72** was situated over demolition remains (**78**) and was probably a robber trench or pit. Human remains were retrieved from its rubble fill **73**, along with cattle, deer and sheep-sized animal bones. No pottery was present to date this pit but because fill **73** was very similar to that of layer **47** (indicating a possible quick refilling of the pit with material derived from **47**) a medieval date is likely, two pieces of Roman pottery probably being residual.

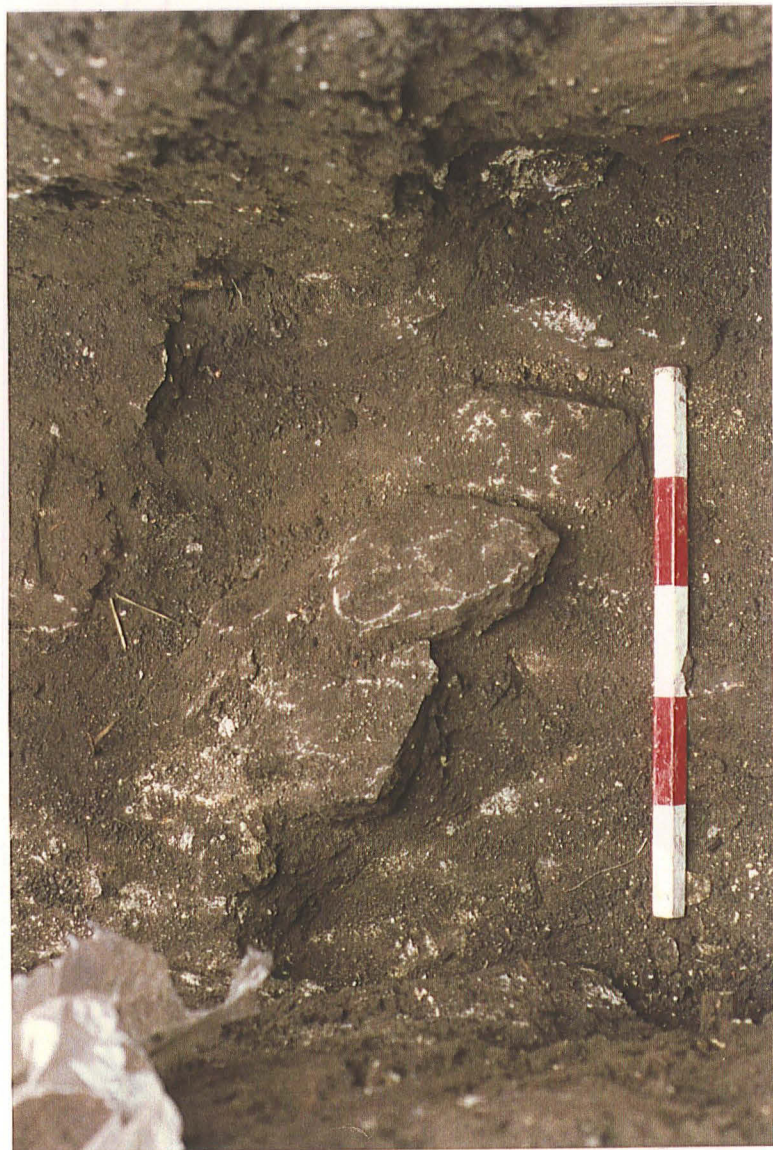
Pl. 17. North Trench of house. Possible wall 106, looking north. Scale 0.50m.

A possible wall, **106**, aligned NNE-SSW was noted in the northern foundation trench. It was 0.80m wide, one course only was visible comprising limestone blocks bonded in a light yellow sandy mortar (Pl. 17). It appeared to be cut to the west by pit **77**, and was sealed by **89**. No finds were retrieved to allow dating. However, the top of the wall course was at 64.20m OD, a similar level to the Roman wall foundations found in Area 1.

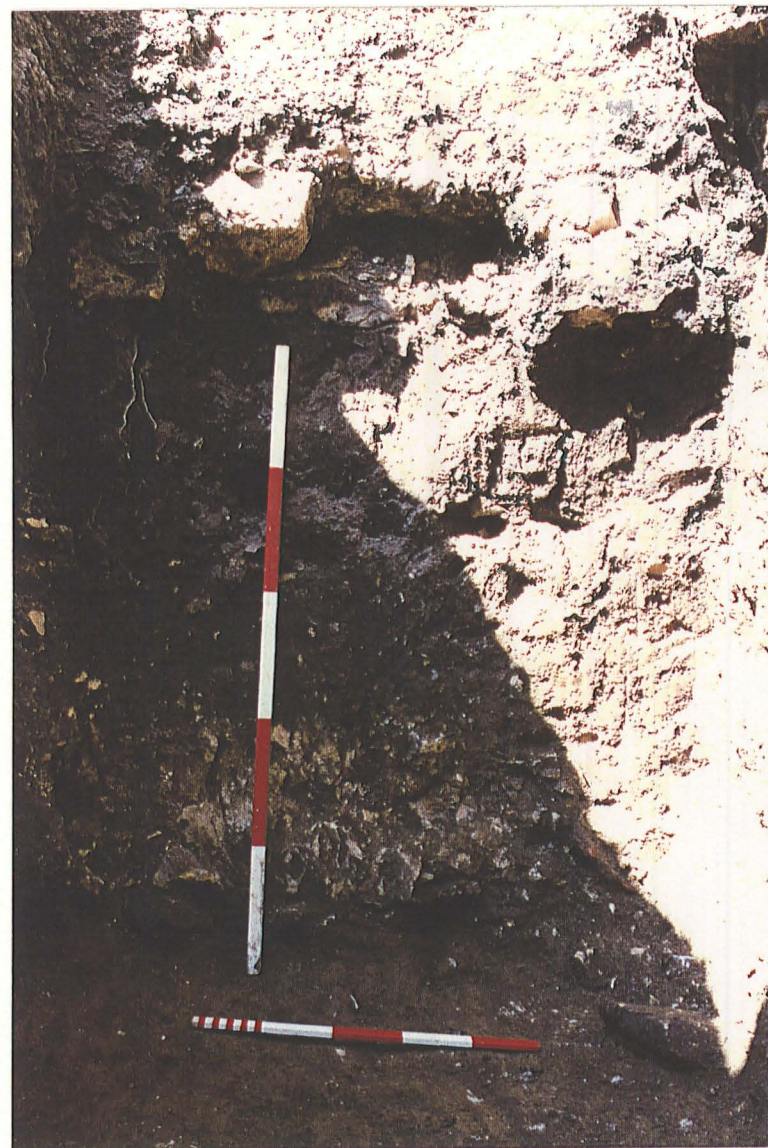
Pl. 18. East trench of house. Possible wall 111 sealed by layer 113 in turn sealed by 37, looking north. Vertical scale 1.0m, horizontal scale 0.50m.

Compact courses of pitched stone **111** (Pl. 18) apparently aligned NW-SE were observed in the eastern foundation trench, sealed by **113**. The new kitchen/conservatory wall foundation trench revealed stones **114** (Pl. 19) at its south end projecting approximately 0.50m into the trench. Full dimensions and true alignment could not be recorded as the trench was unsafe to enter because of recent heavy rain. Likewise, the western kitchen/conservatory trench was not entered when stones **115** (Pl. 20) aligned approximately NW-SE were noted 2.50m from the northern trench edge. However, a photographic record of the features was made. These three isolated features may be a continuous wall, with a return formed by the wall **106**.

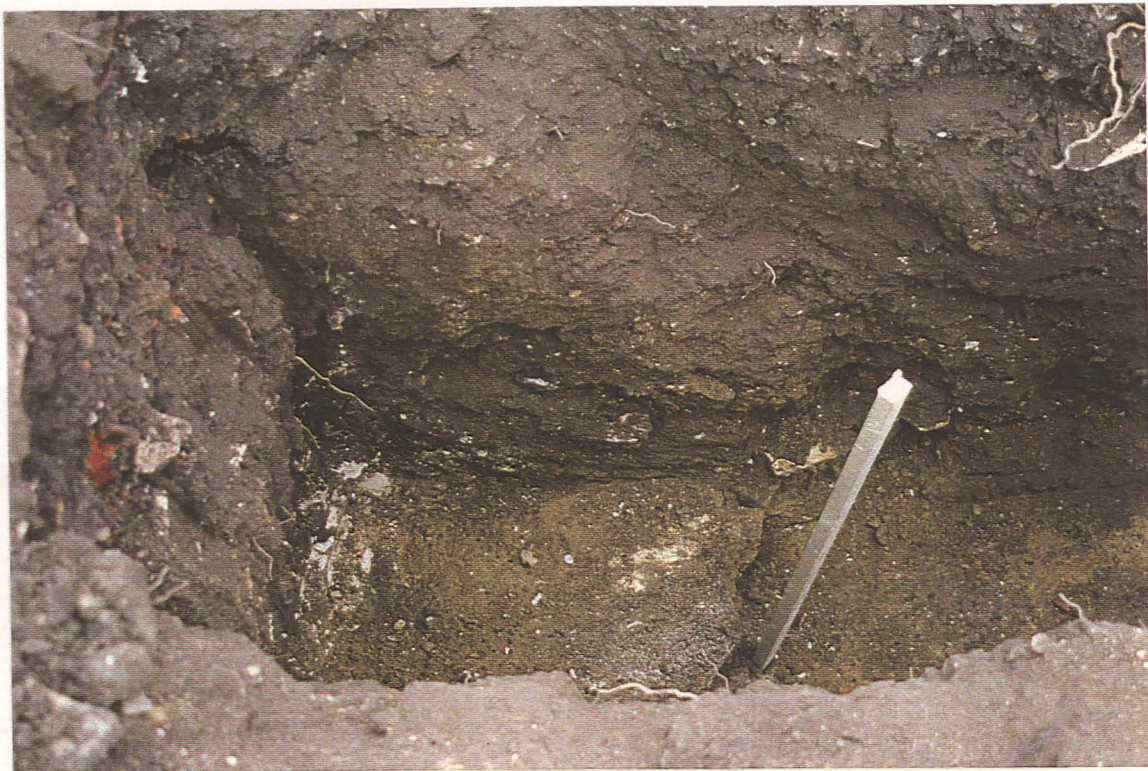
Pl. 19. Kitchen/conservatory (east) foundation trench. Possible wall 114, looking west.

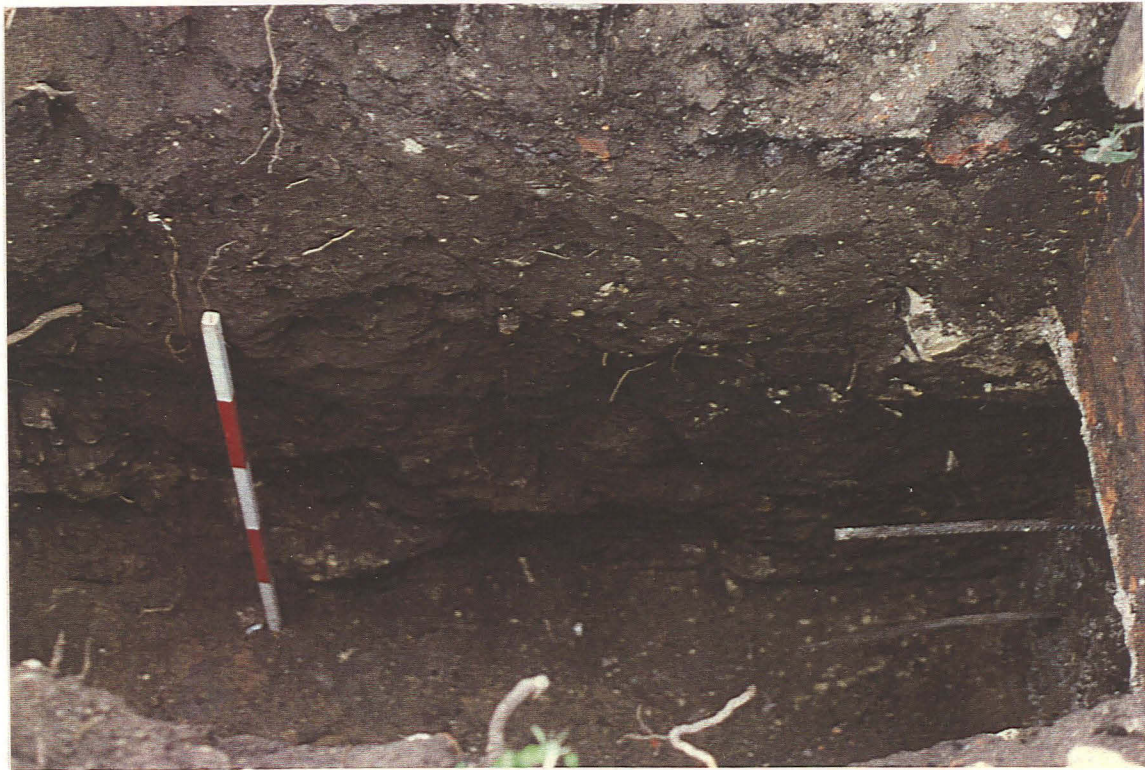
Pl. 21. East trench of house. Pits 86 (immediately right of scale) and 88, below tarmac 84, looking east. Scale 1.0m.

The east foundation trench cut across two pits. **88** (Pl. 21) was situated c.6m south of the northern trench edge and contained a single fill of dark grey silty clay with limestone rubble, **87**. It was cut 0.70m to the south by pit **86** (Pl. 21) which was backfilled with a dark grey silty clay **85**, later capped by tarmac and soil **84** (Pl. 21) which acted as a path for the Walnut House extension.

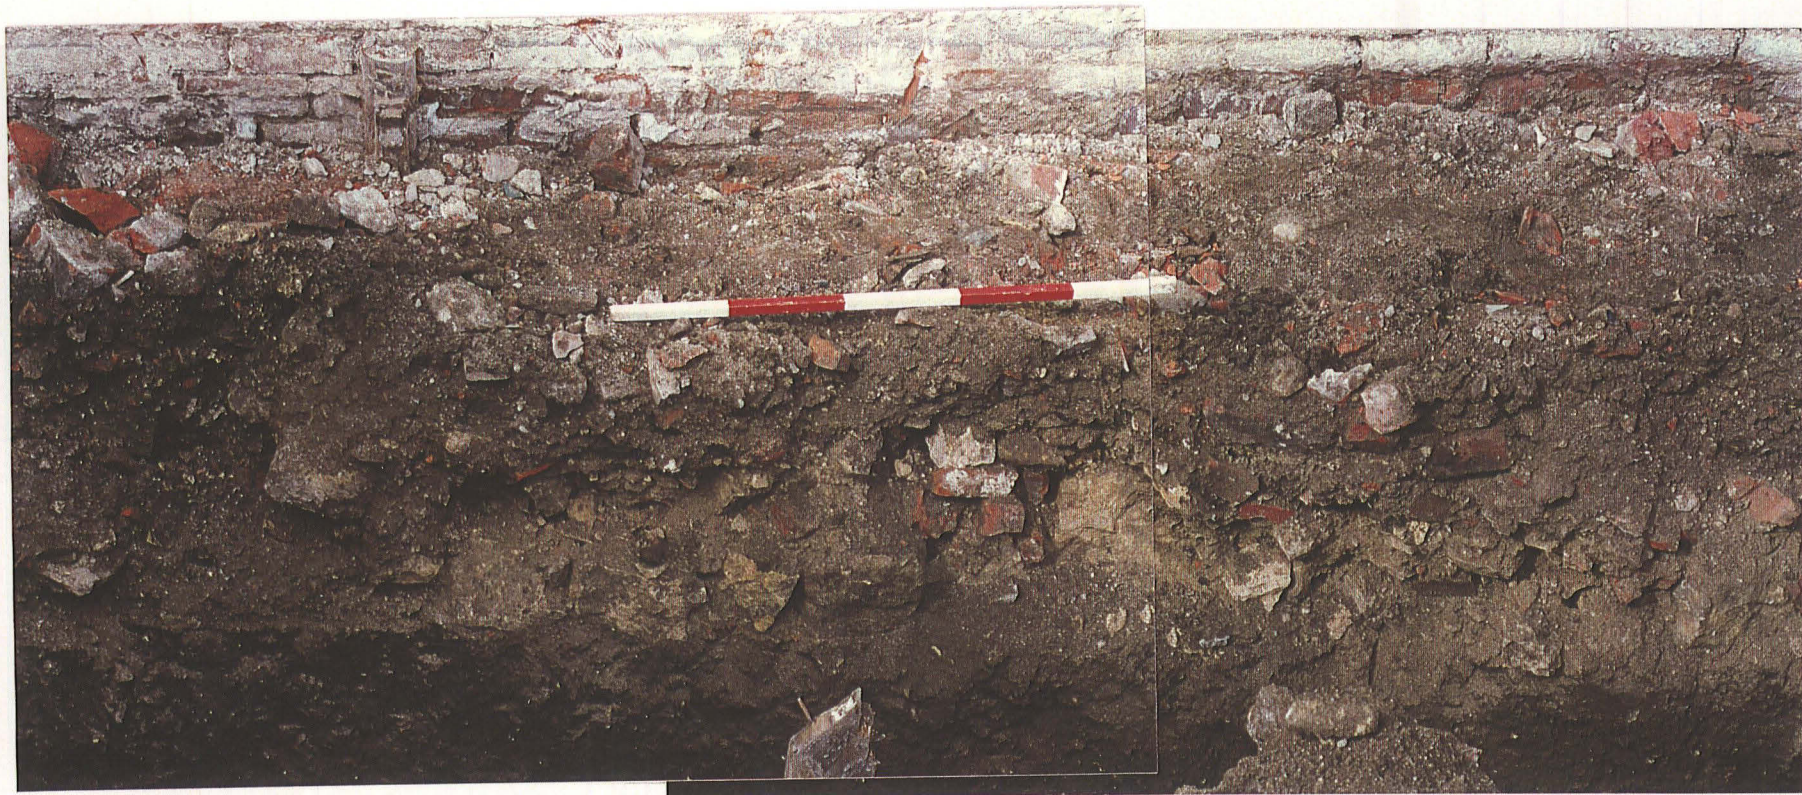
Pl. 22. West trench of house. Modern levelling and bedding deposits 60 - 63, looking west. Scale 1.0m.

The abbattoir walls 55, 80 and 97 aligned east-west cut through the medieval deposits, to a depth of between 0.26m and 0.50m. Between walls 55 and 80 were various levelling layers and bedding courses which may have truncated the medieval features (Pl. 22). A dark grey sand with demolition material 62, overlay 63, bands of dark grey clay and brick/limestone fragments butting up to wall 55. This deposit in turn sealed an extensive deposit, 61, containing large limestone fragments within a dark brown sandy silt. This same deposit was seen in the west face of the hall/living room foundation trench (numbered 96) but unlike 61, was sealed by loose limestone and brick fragments 95 c0.16m deep. Layer 61 sealed levelling deposit 60, a dark grey brown sandy silt situated immediately north of 63.

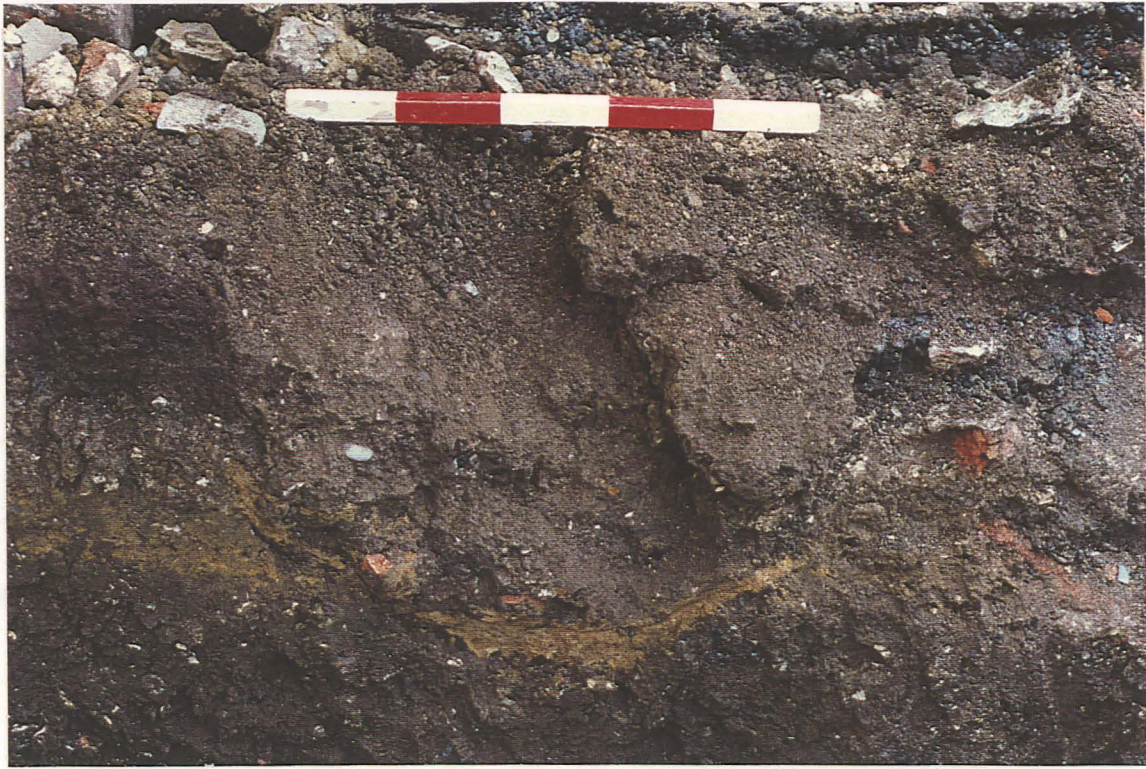
Pl. 23. West trench of house. Modern pit 52 cutting layer 45 and orange brown sand 46, looking west. Scale 0.50m.

South of wall 55 was 45 (Pl. 23), a 0.36m deep deposit of ash and sandy silt with burnt sand, limestone fragments and charcoal flecks, cut by pit 52 which contained two distinctive layers, 51 and 50 (Pl. 23). Drain 58 (Pl. 24), was noted close to wall 55, one of many late drains that criss-crossed the site eventually connecting to chamber 43 or 44 (Pl. 24). A brick floor 112, on bedding layer 62, sealed all the deposits inside the abbattoir building. 80 was the north wall of the abbattoir and in the garden beyond was construction layer 79, comprising tarmac, brick and limestone fragments within a mid/dark grey silty clay which butted up to 80. This deposit was sealed by 1/83 the modern topsoil. An ill-defined modern soakaway 105, 1.30 wide and 1.10m deep, with brick infill 104, was seen in the northern trench face, cutting 1/83.
