LINDSEY ARCHAEOLOGICAL SERVICES

**Land adjacent to Walnut House
Lilly's Road, Lincoln
Archaeological Watching Brief**

Planning Application: **LC03/0147/94**

September 1996

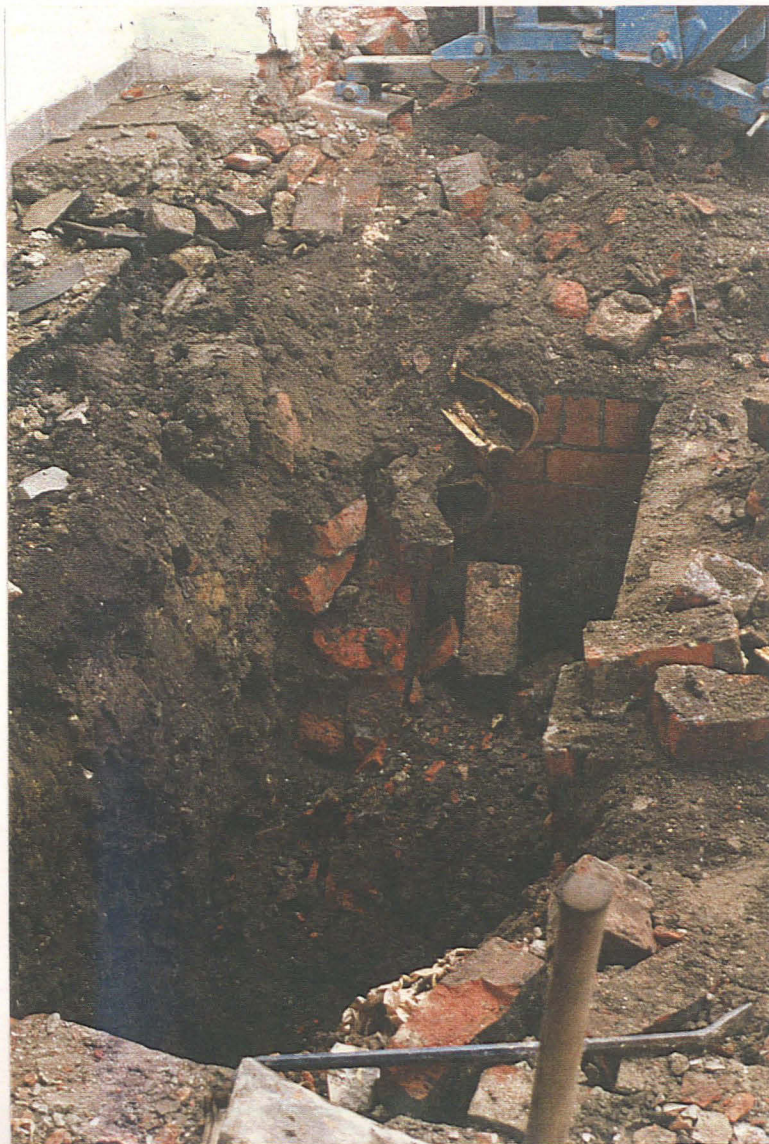
Pl. 24. West trench of house. Brick inspection chamber 44 with drain 58 visible amongst the rubble during excavation. Looking north.

South of wall 55 was 45 (Pl. 23), a 0.36m deep deposit of ash and sandy silt with burnt sand, limestone fragments and charcoal flecks, cut by pit 52 which contained two distinctive layers, 51 and 50 (Pl. 23). Drain 58 (Pl. 24), was noted close to wall 55, one of many late drains that criss-crossed the site eventually connecting to chamber 43 or 44 (Pl. 24). A brick floor 112, on bedding layer 62, sealed all the deposits inside the abbattoir building. 80 was the north wall of the abbattoir and in the garden beyond was construction layer 79, comprising tarmac, brick and limestone fragments within a mid/dark grey silty clay which butted up to 80. This deposit was sealed by 1/83 the modern topsoil. An ill-defined modern soakaway 105, 1.30 wide and 1.10m deep, with brick infill 104, was seen in the northern trench face, cutting 1/83.

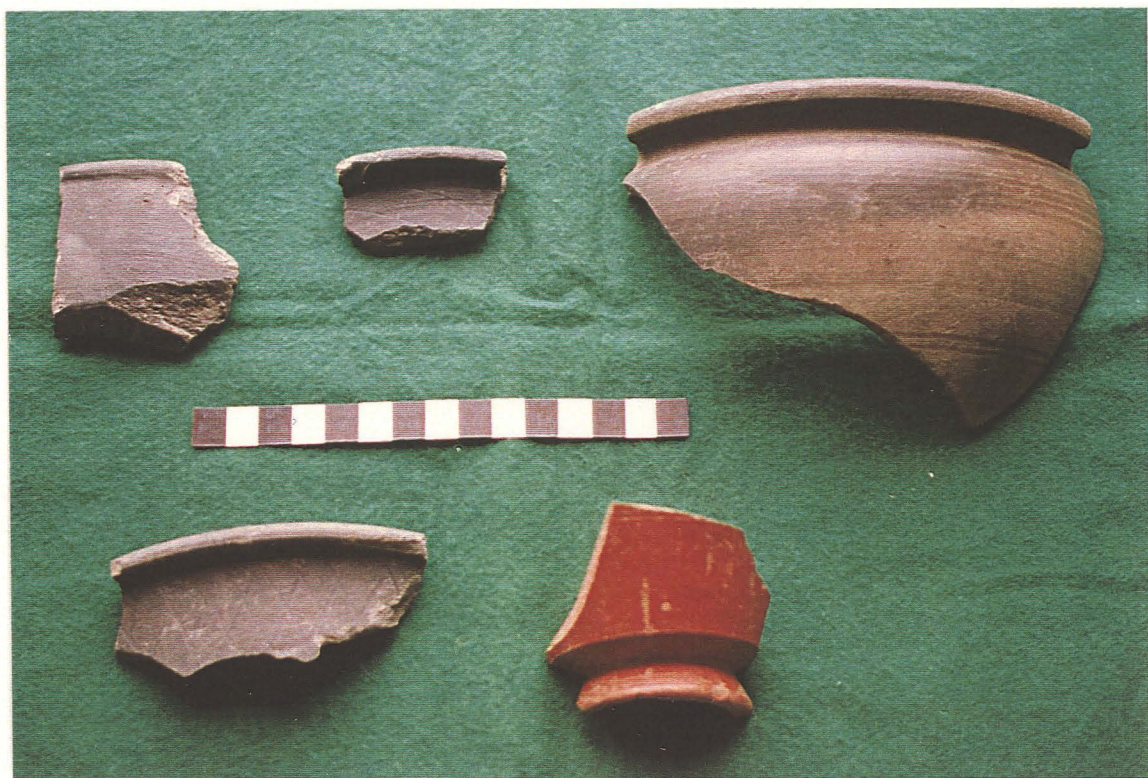
Pl. 25. Roman pottery finds from layer 100, which also contained human remains.

Human remains were retrieved from four contexts 68, 73, 75 and 100, under conditions set out in Home Office Licence no. 22588 issued on September 22nd 1995. All but those from 100 were retrieved from intercutting pits containing finds with a 12th -15th century date range (Pl. 25).
