**Land at New Park Farm, Tattershall Thorpe:**

**Archaeological Monitoring of Topsoil Stripping  
Phase 1b of the Tattershall Quarry Extension**

Report prepared for  
Butterley Aggregates Limited

**December 1996**

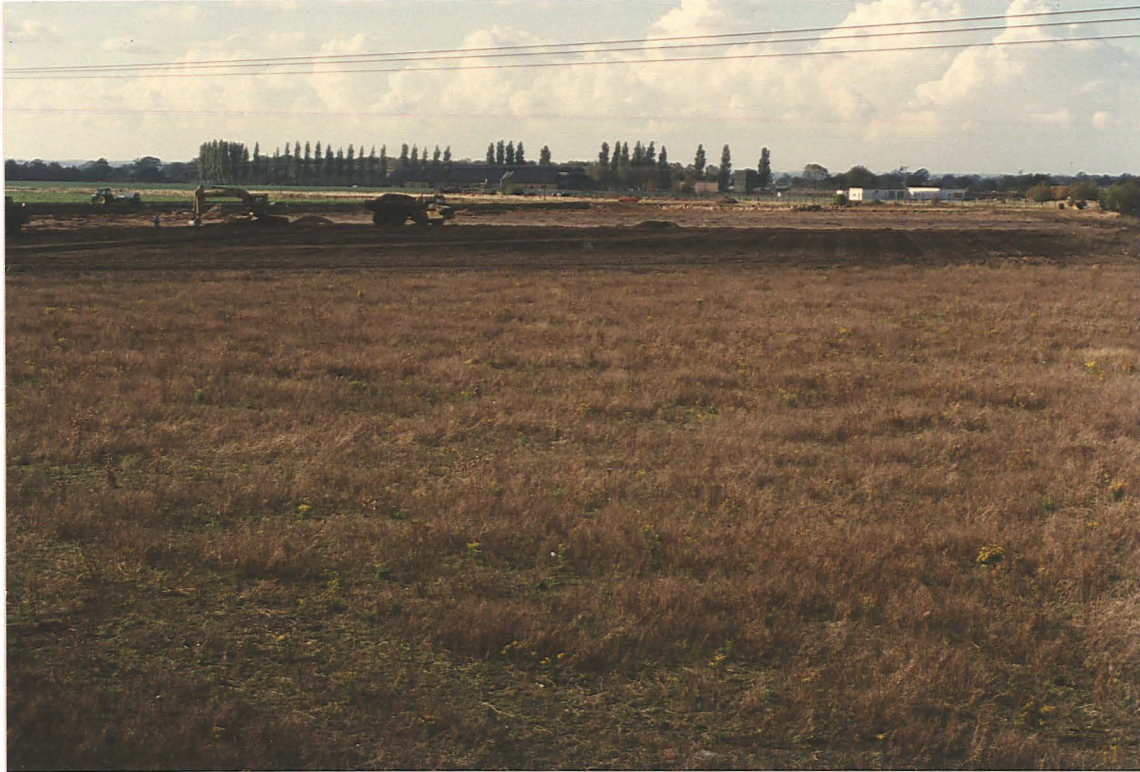
**Frontispiece: Topsoil stripping in progress in Area 1b (looking NW towards golf course and RAF Woodhall premises. The existing quarry is to the right).**

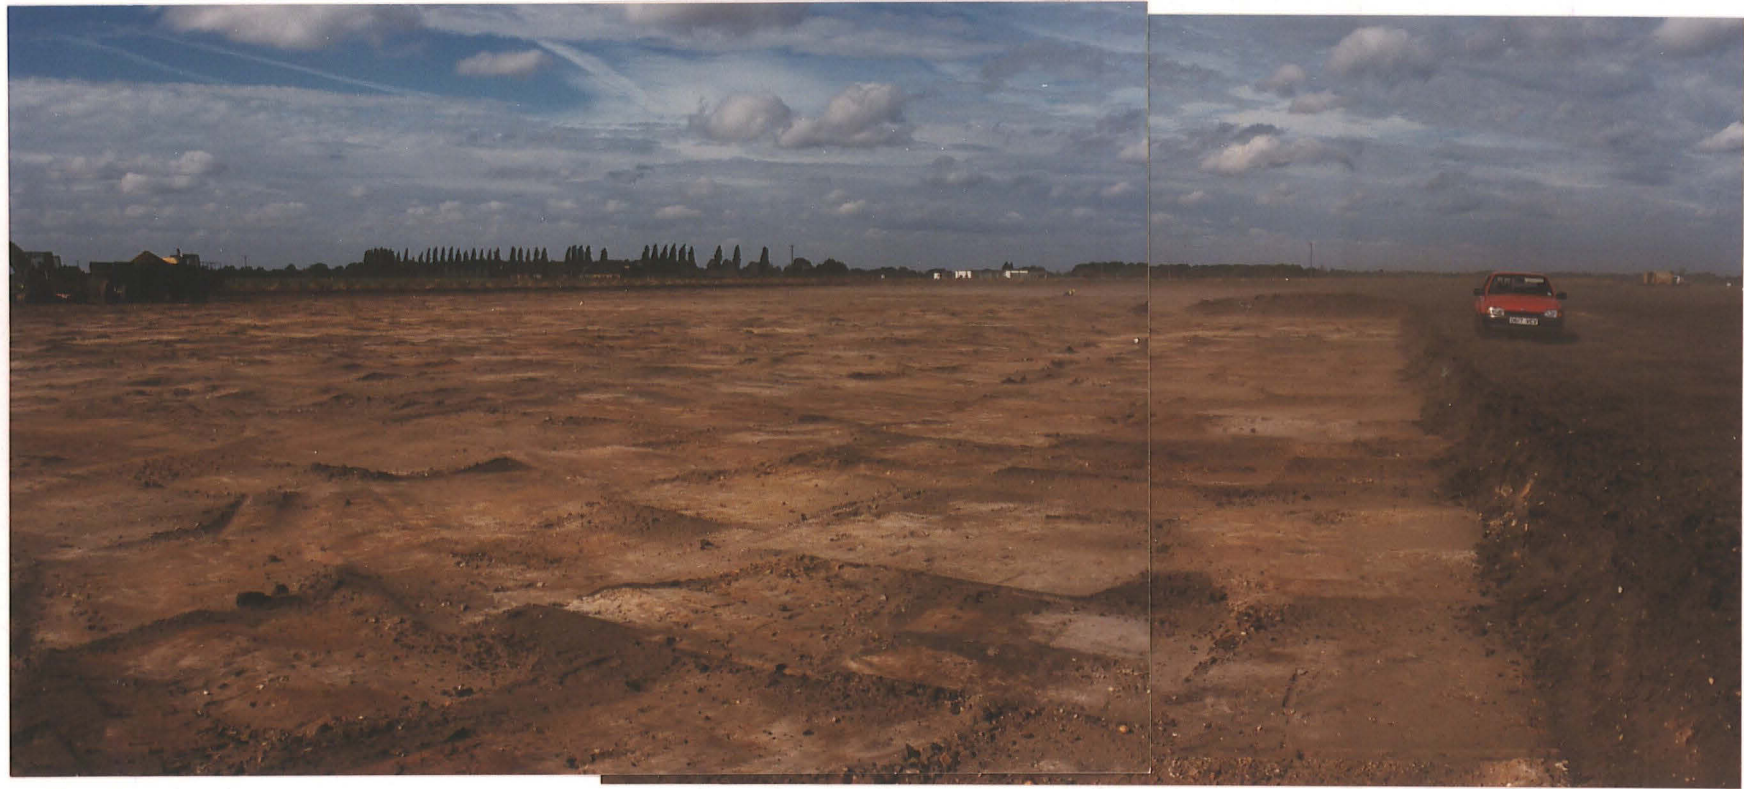
PI. 1 Composite view during the topsoil stripping of Phase 1b. In the foreground the stripped surface is visible, partly obscured by loose spoil left by the machine bucket; features could be distinguished in these conditions. Wind-borne sand (far distance) rapidly masked colour variations. The machine is removing sand and gravel from beneath the stripped surface (Looking SW).

Photographic recording was affected by the need to photograph features promptly despite prevailing light or wind conditions. Wind-borne sand presented a major problem for both monitoring and recording, with excavated features filling with sand within minutes of preparation for photography (Pls. 1 and 2).

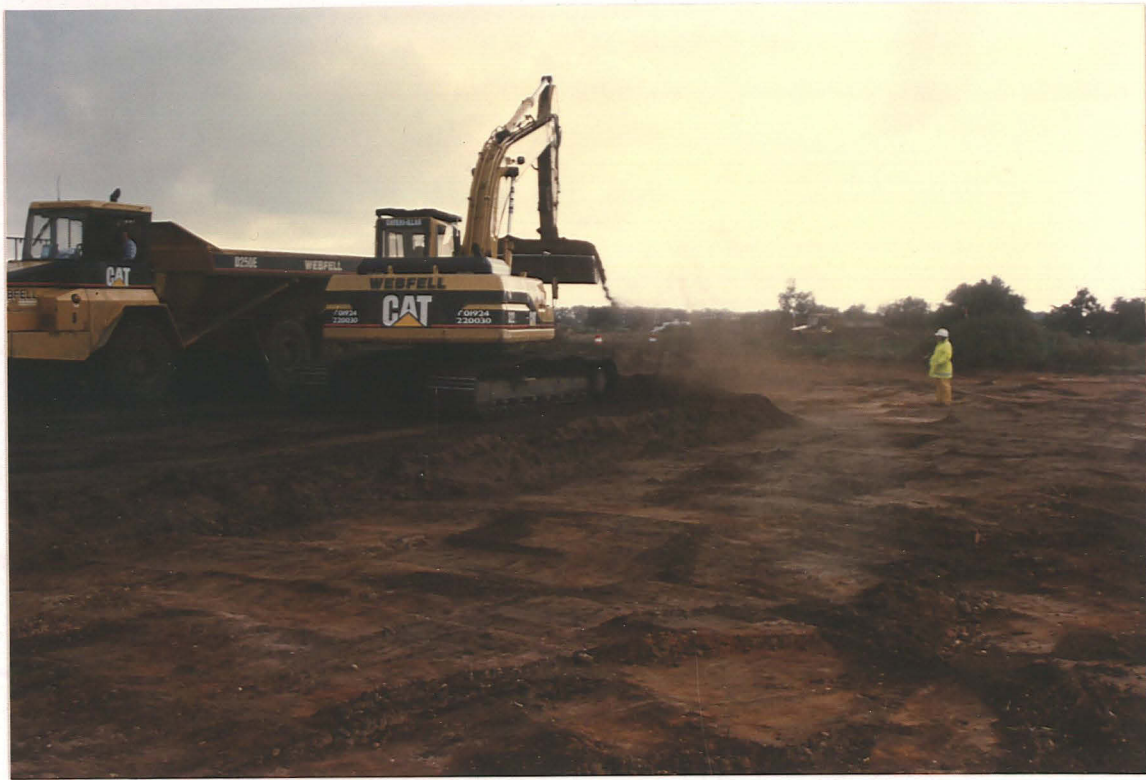
Pl. 2 The method used to remove topsoil, with archaeological monitoring in progress.

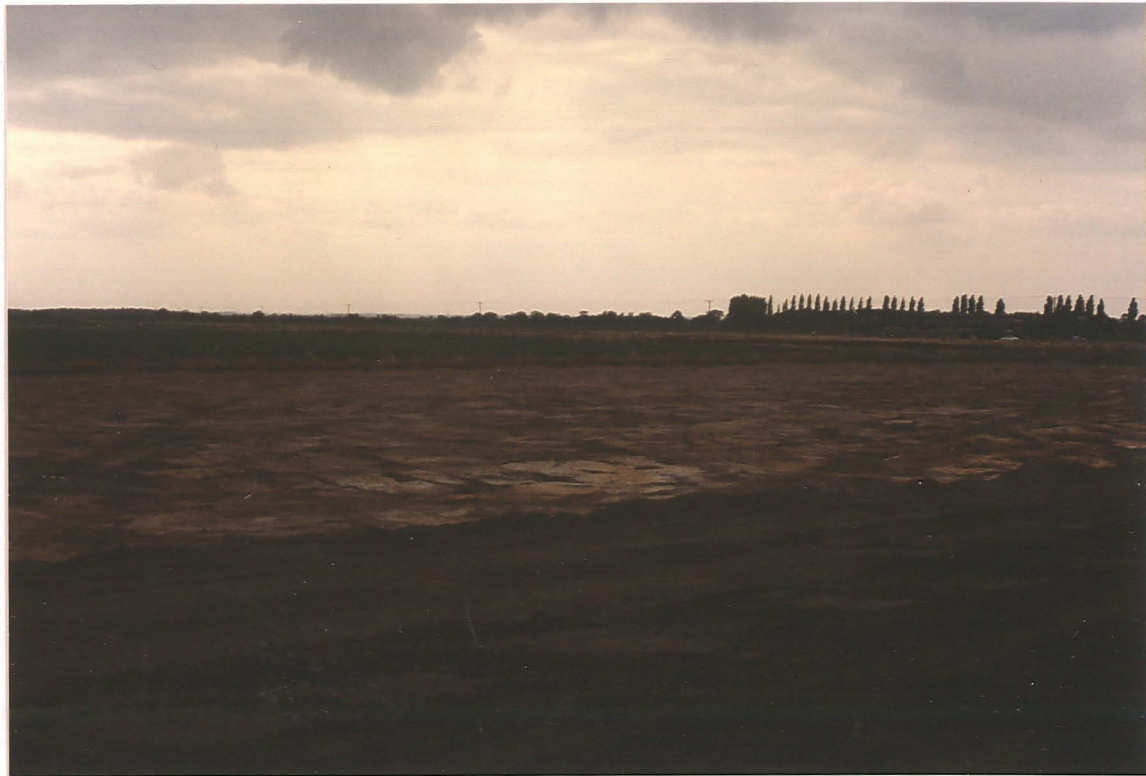
Pl. 3 Enclosure 1: The dark peaty fills of gullies 008 (centre right), 023 (left foreground), and 024 (left) are visible crossing the stripped surface (looking NW).

Three small field ditches, 008, 023 and 024, were revealed at the SW side of the area, forming the SE corner of an irregular shaped enclosure (Pl. 3). No entrance gap was found between the ditches but Ditch 008 had been excavated as a separate event to Ditch 023. There was no distinguishable difference between 023 and 024.

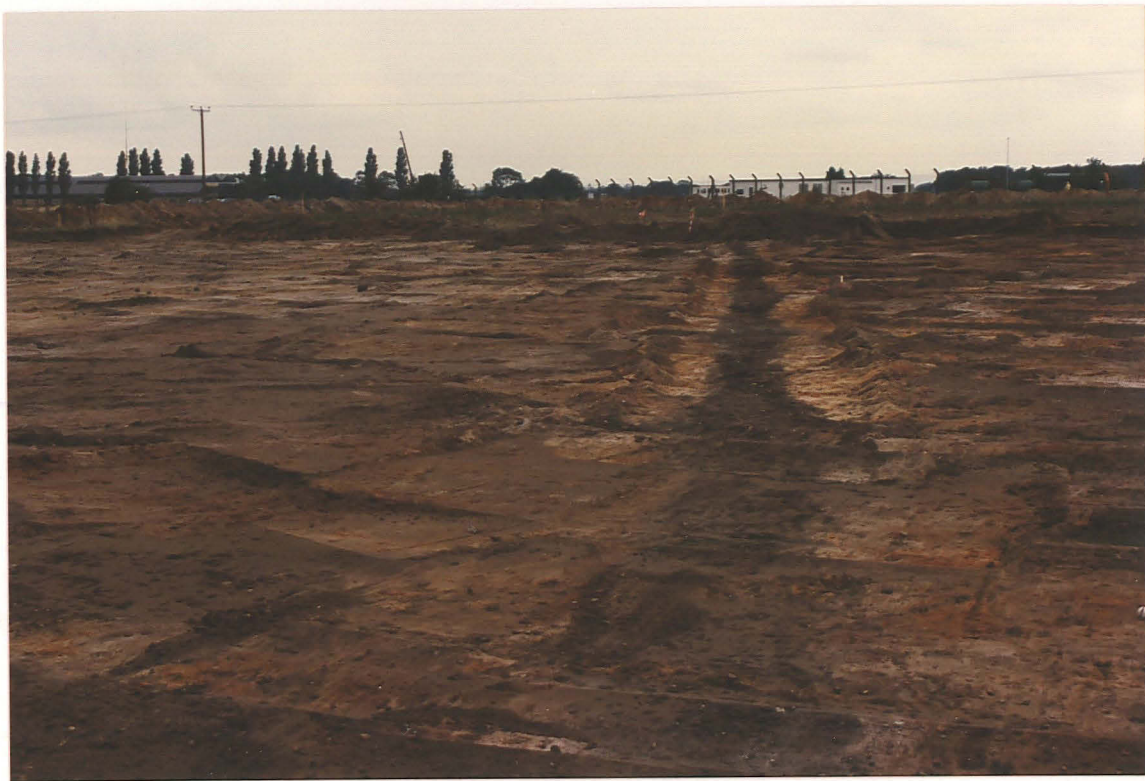
PI. 4 Gully 008, looking NW. A narrow band of sand has been cleaned to define it more precisely.

008 was a shallow V-shaped linear gully aligned SE-NW, 0.7m wide and 0.2m deep (Pls. 4 and 5; Fig. 4). Its fill 007 was dark brown sand with a dry peaty appearance (Pl. 6). No dateable finds were recovered from its fill. The gully stopped abruptly at the SE end for no obvious reason; it appeared to have been dug after 023 had filled (Pls. 7 and 8).

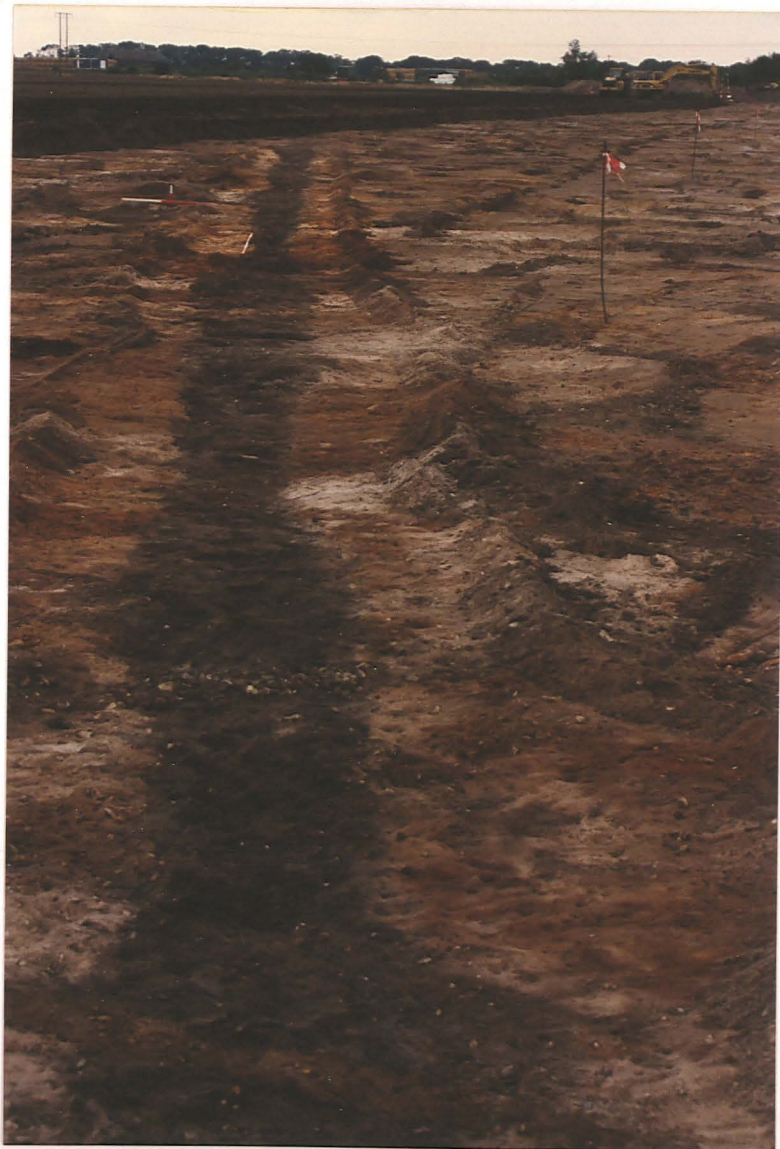
PI. 5 Gully 008, looking SE towards the outbuildings of New Park Farm.

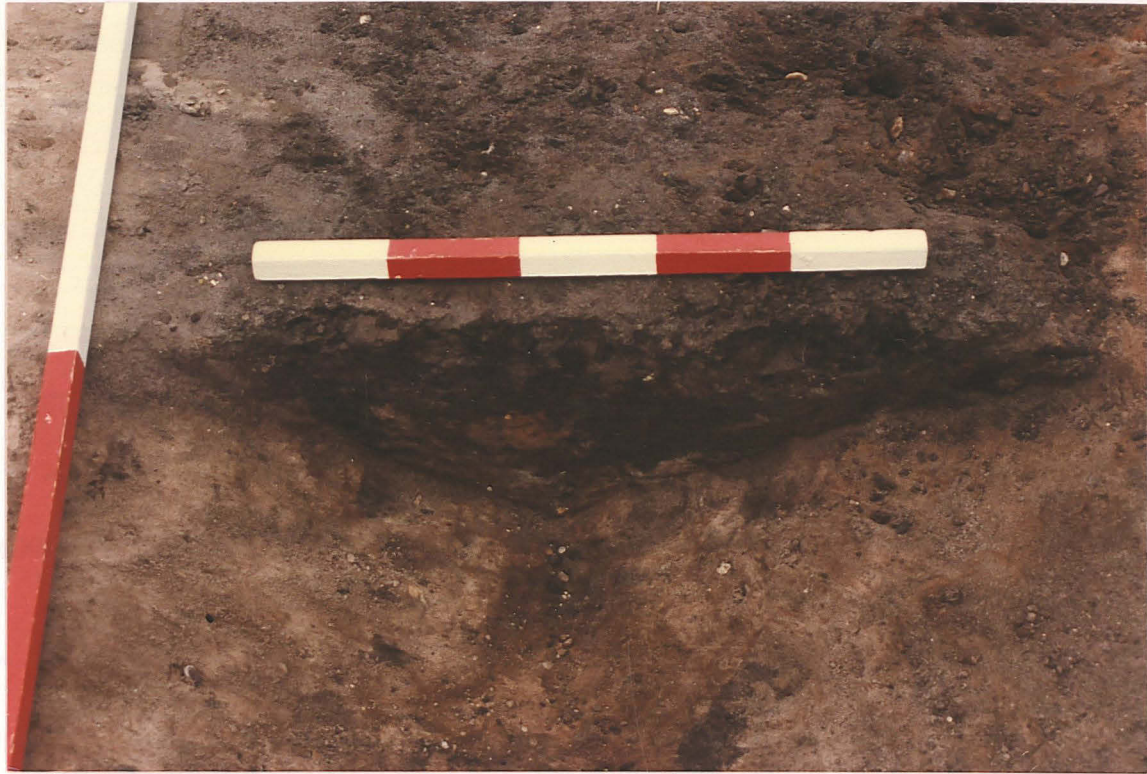
Pl. 6 Section through the fill of gully 008, showing desiccated organic material in the upper layer (central scale divisions 0.1m).

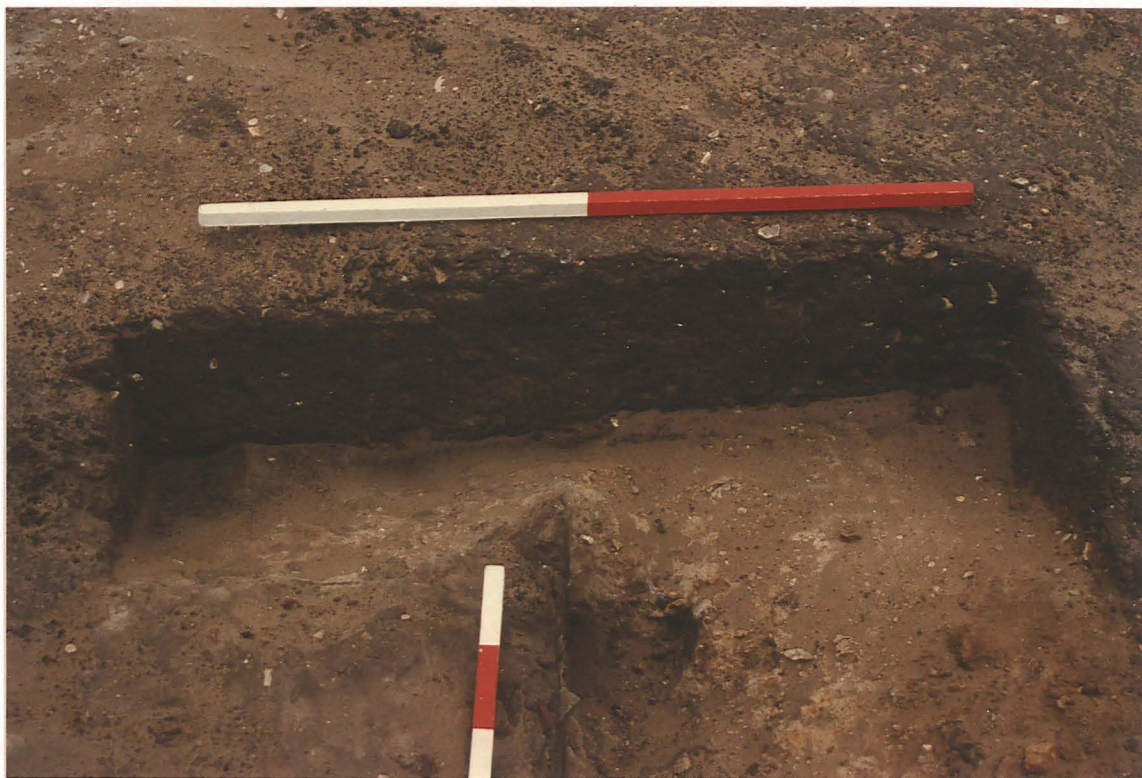
Pl. 7 Section across the intersection of gullies 008 and 023; the darker fill of 008 (far right) overlies the brown fill of 023 (looking NW).

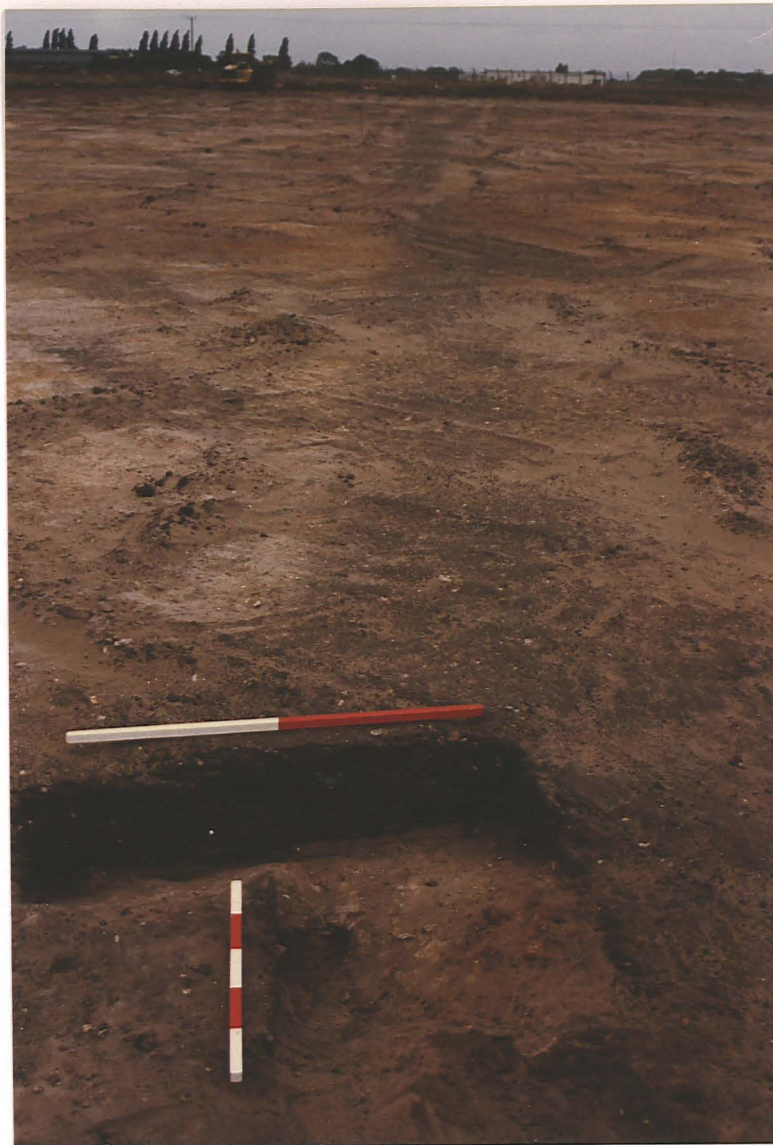
PI. 8 Position of section at corner of Enclosure 1, with gully 008 visible across the stripped surface (looking NW).

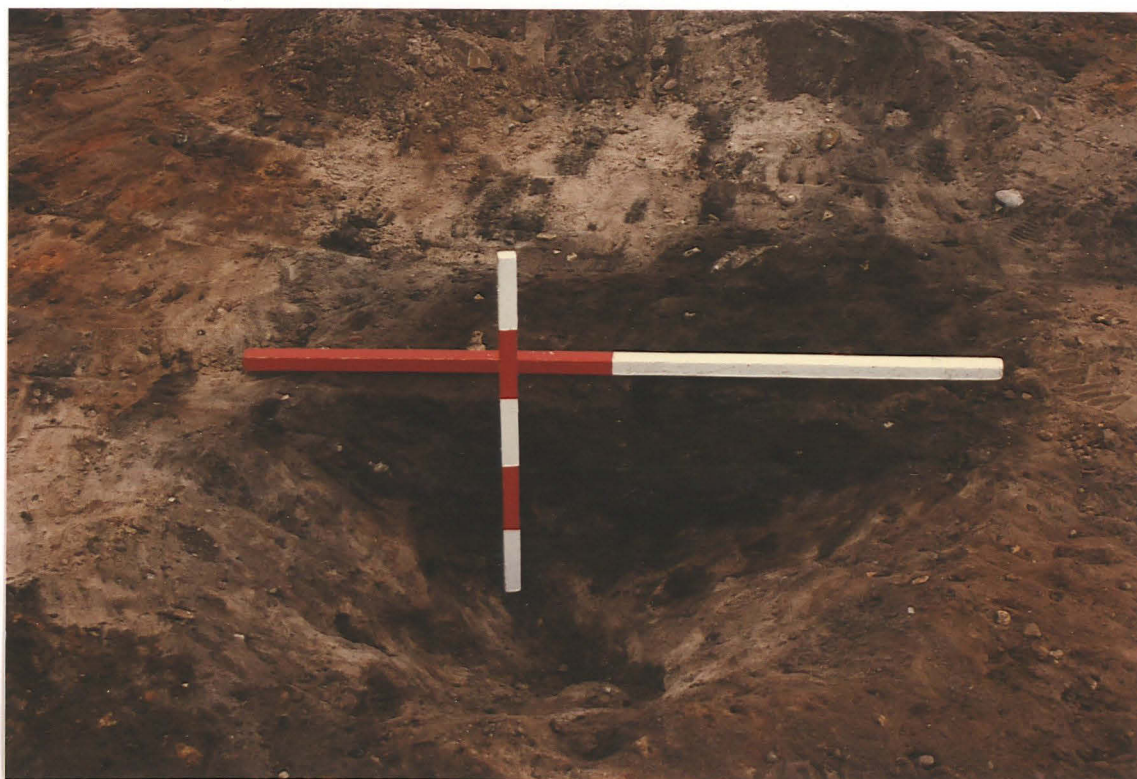
PI. 9 Natural feature 009, showing the dark sandy fill and the irregular base. Depth 0.3m, width 1m.

Several anomalous scoops in the sandy natural close to this enclosure were examined but interpreted as the result of small trees or bushes becoming uprooted (Pl. 9). Animal disturbances, possibly even rabbits, may sometimes have been responsible. It is unlikely that in these conditions evidence of a hedge contemporary with the enclosure ditches could have been identified.

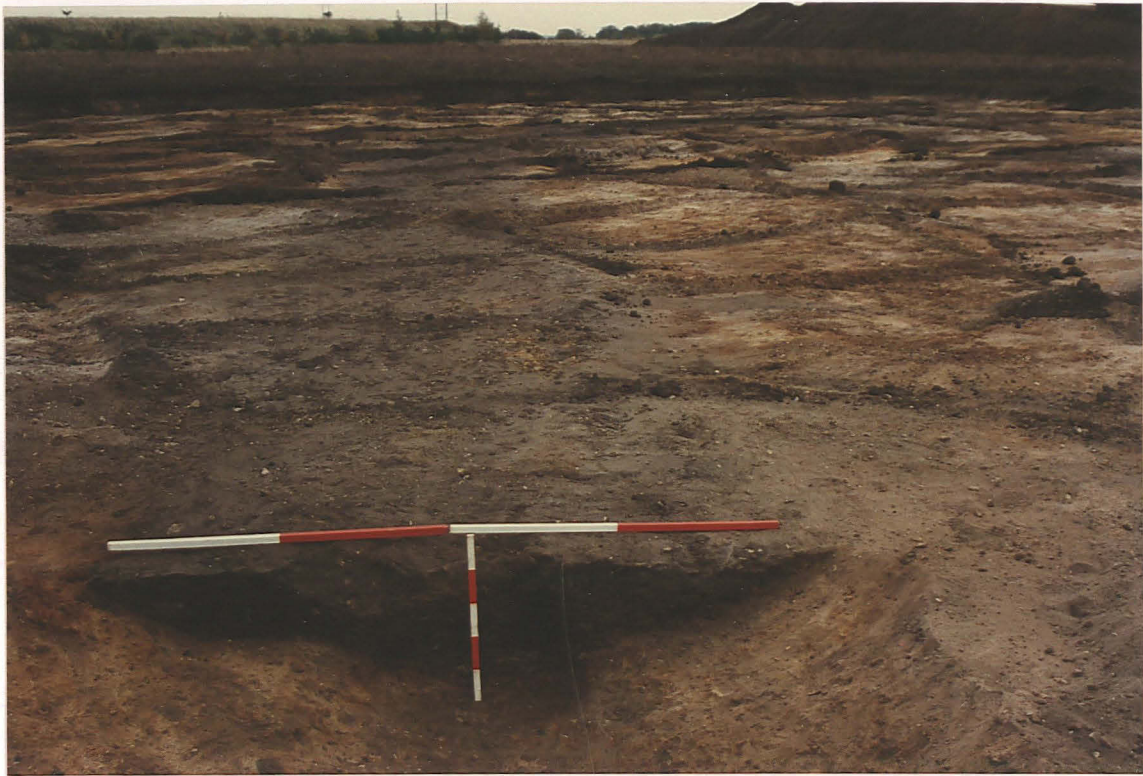
Pl. 10 Section across the fill of ditch 030 (looking east, scale divisions 0.5m and 0.1m).

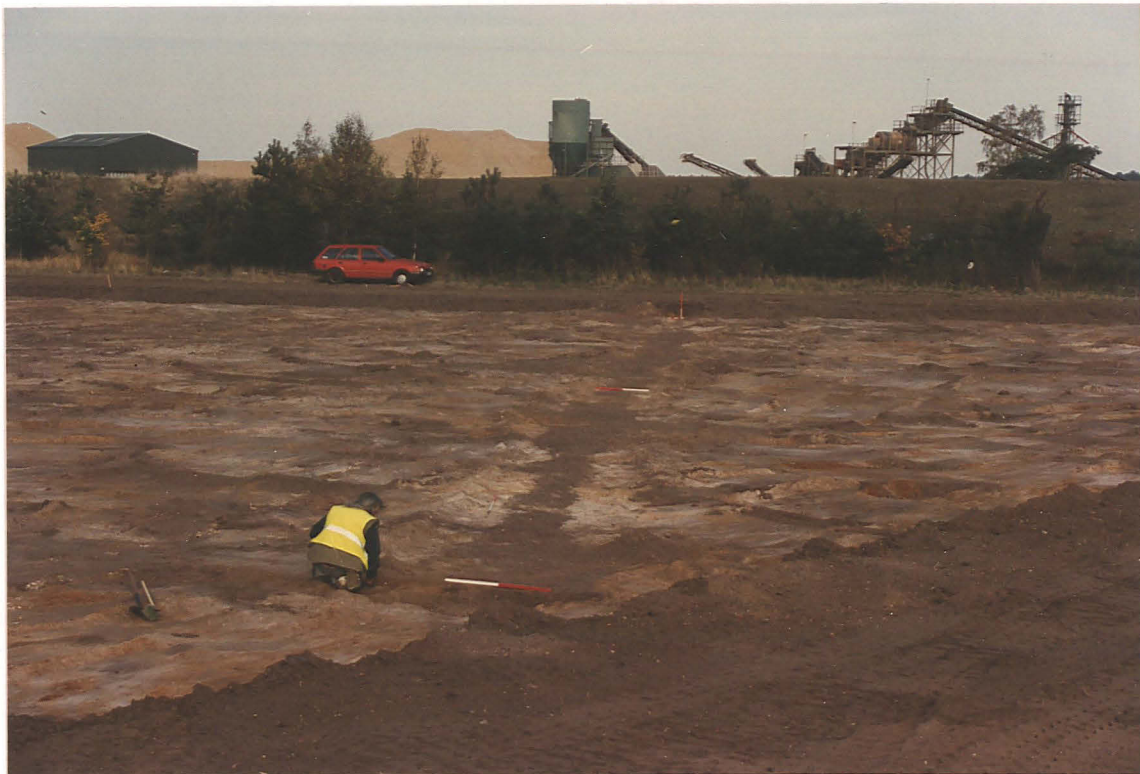
Pl. 11 Ditch 026 becoming exposed by topsoil stripping on the north side of the area (looking north). Scales: 1m.

One other ditch of probably post-medieval origin was found. 026 extended 50m into the stripped area from the northern edge, aligned NE-SW (Pl. 11). It was up to 1.5m wide and 0.3m deep (Pl. 12). The sides sloped to a narrow base. This ditch coincided with a mole drain which continued on the same alignment beyond the ditch terminal. This juxtaposition suggests that the ditch was filled but either visible or remembered when the 20th century mole drain was created.

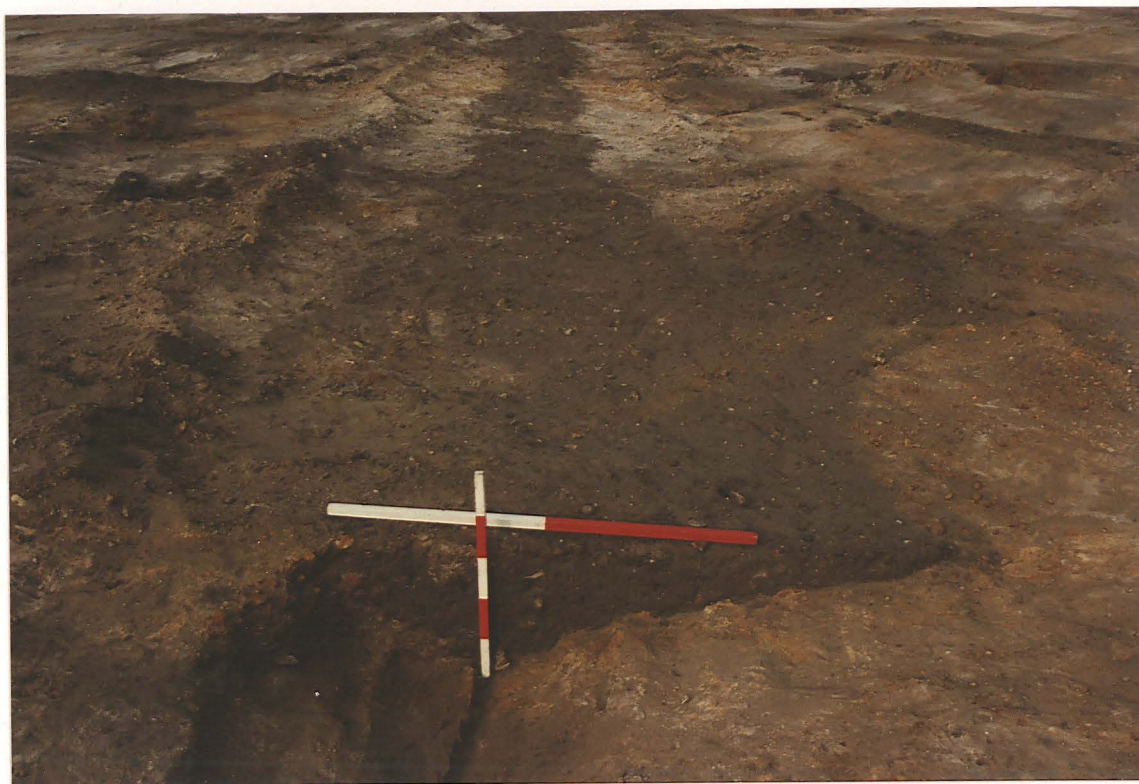
Pl. 12 Ditch 026, with mole drain obscuring left edge (looking north, scale divisions h 0.5m, v 0.1m).

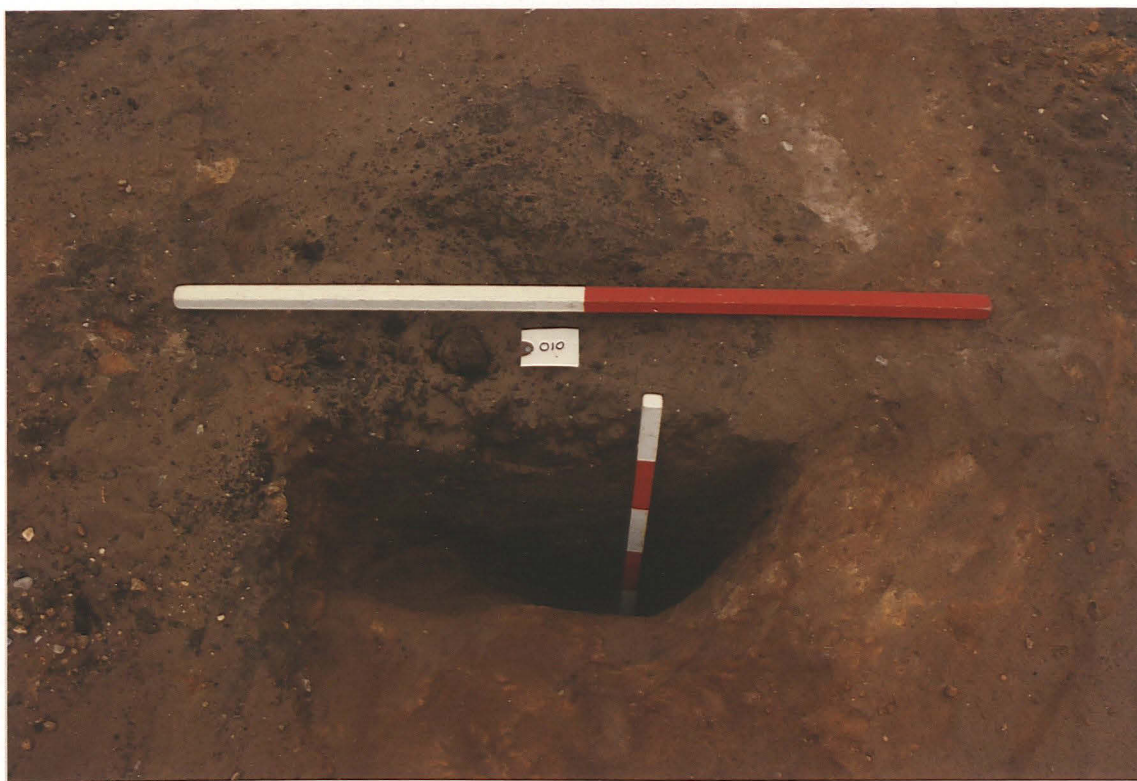
Pl. 13 Post-hole 010 with part of fill removed (scale divisions h 0.5m, v 0.1m).

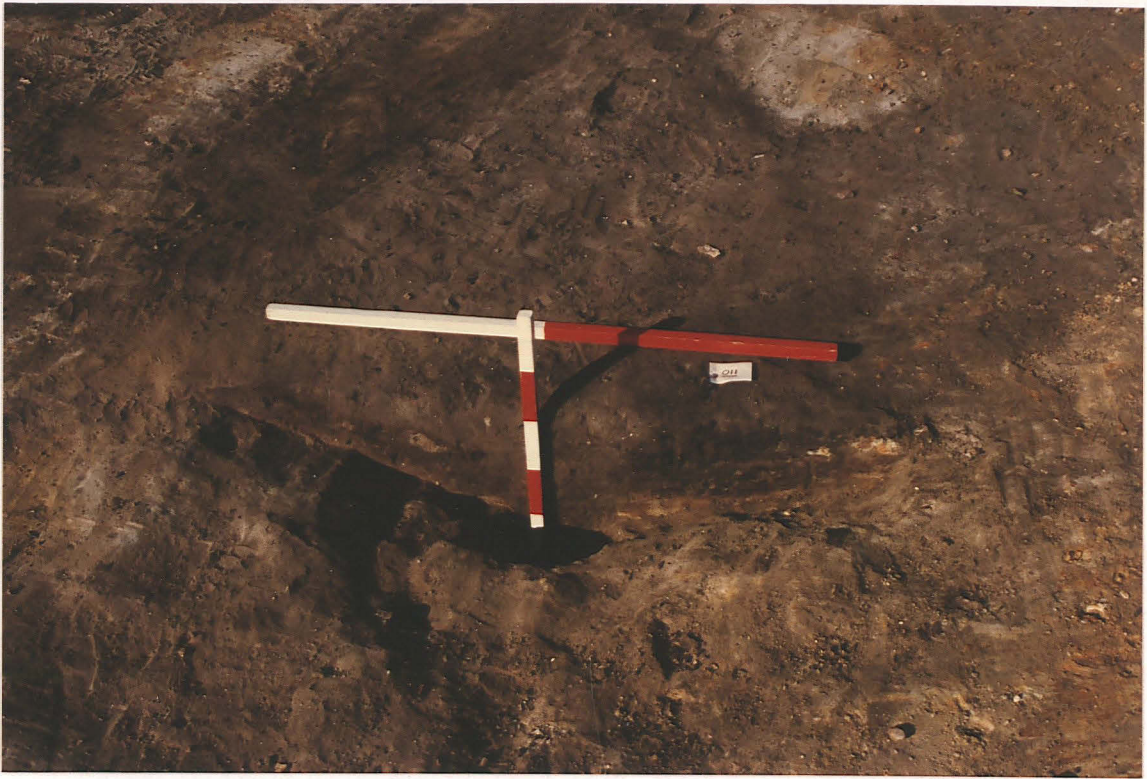
Pl. 14 Post-hole 011, cut through dark organic fill of natural feature (scale divisions h 0.5m, v 0.1m).

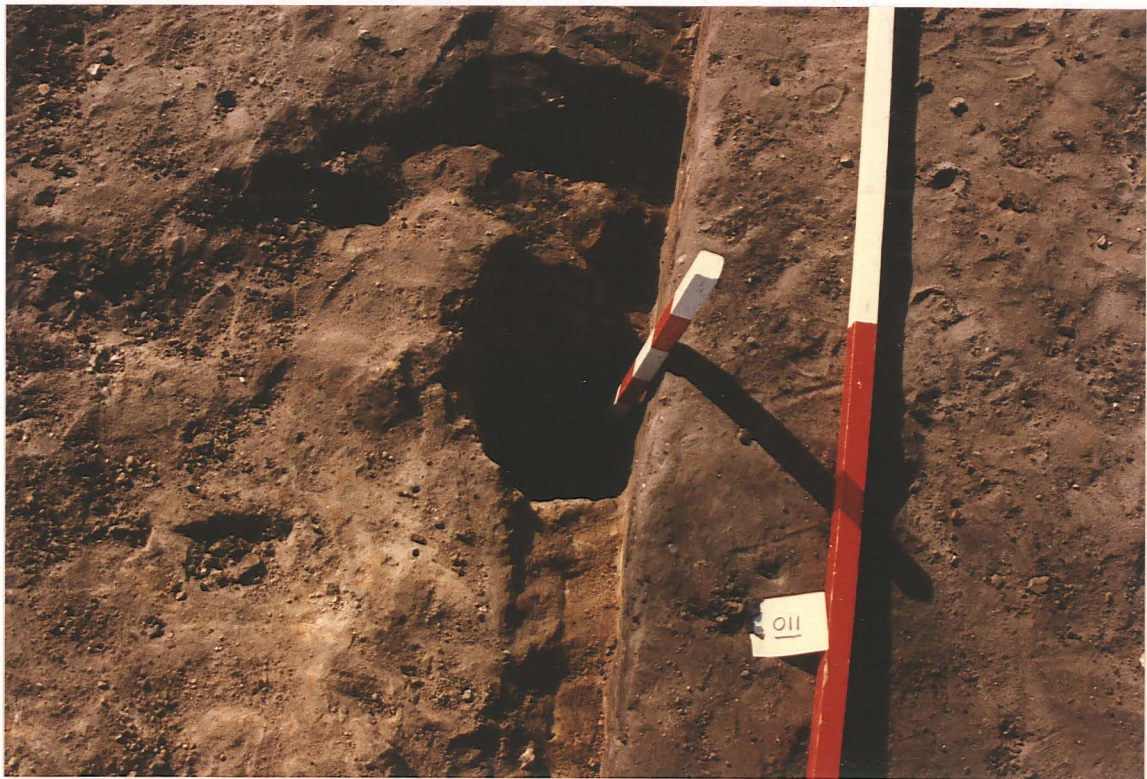
Pl. 15 Post-hole 011 (scale divisions h 0.5m, v 0.1m).

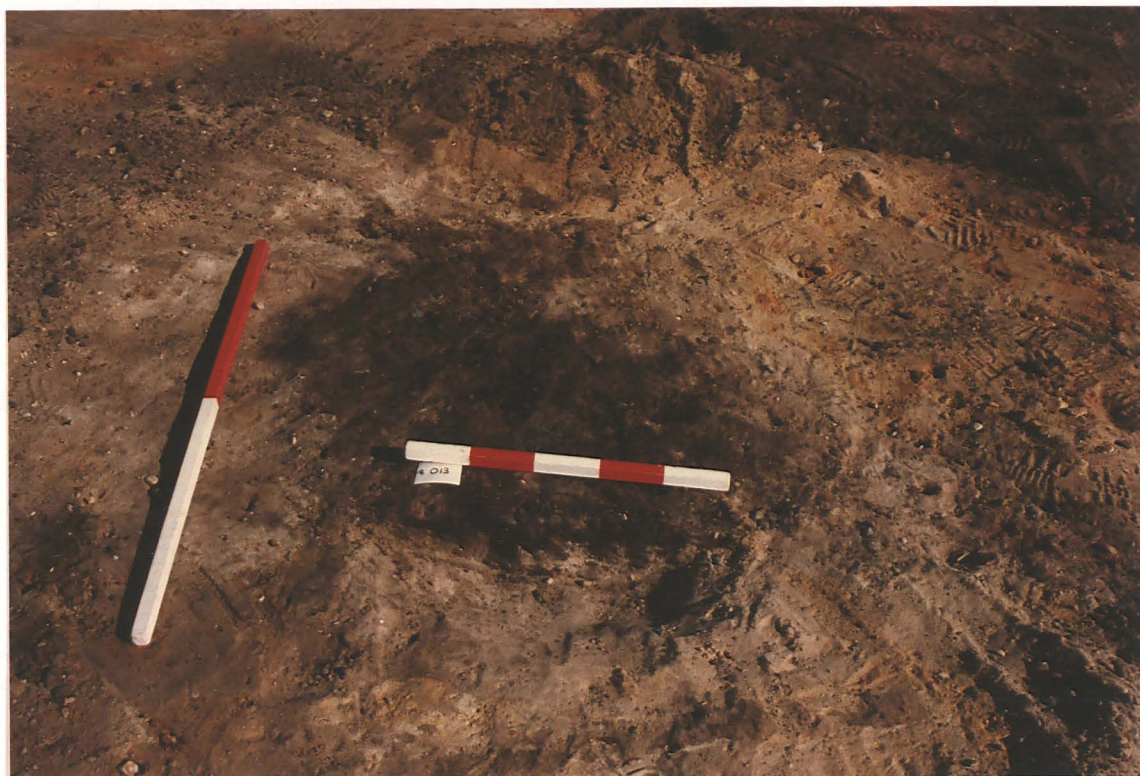
Pl. 16 Natural feature 013 (scale divisions 0.5m and 0.1m).

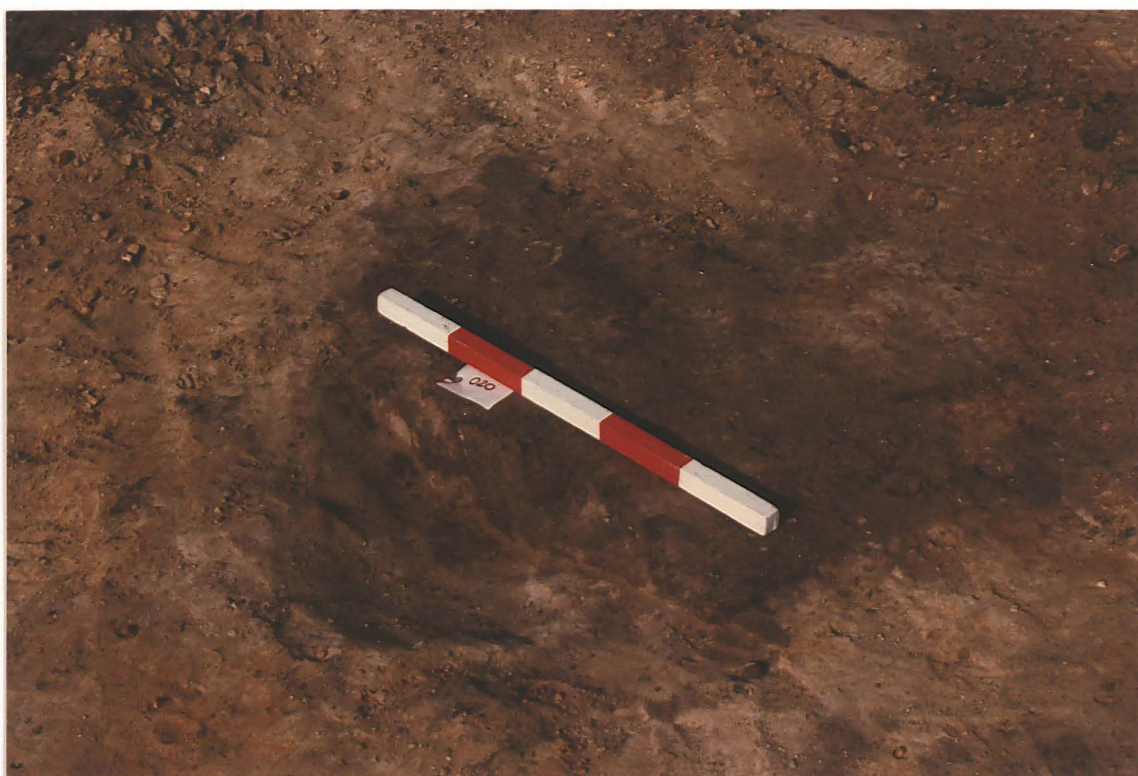
Pl. 17 Natural feature 020, partly excavated (scale divisions 0.1m).

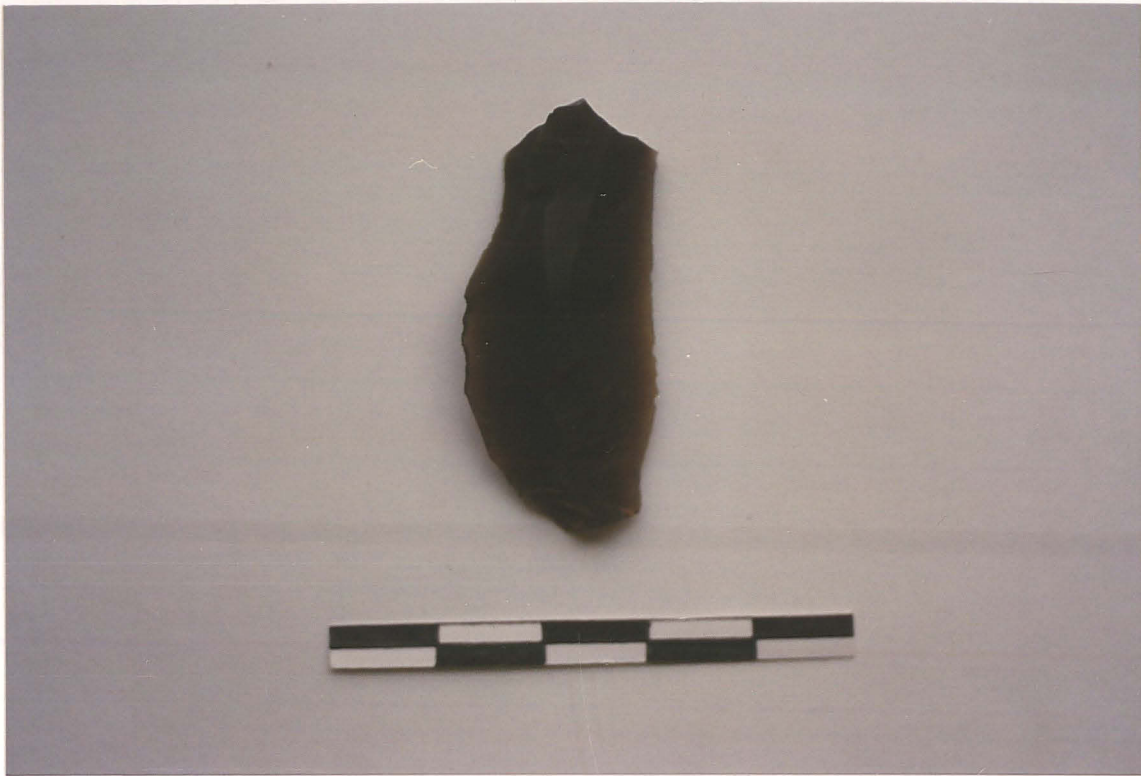
Pl. 18 Struck flint blade from natural feature 021; scale divisions 10mm.

The only prehistoric artefact retrieved from this phase of the watching brief was a worked flint blade tool found protruding from the exposed surface of 021 (Pl. 18). 021 was apparently a naturally formed feature, 1.7m x 4.2m and 0.26m deep. It was very irregular in shape with numerous small holes which were thought to be the result of animal or root disturbance. The scoop was filled with grey sand with a high gravel content (Pl. 19).

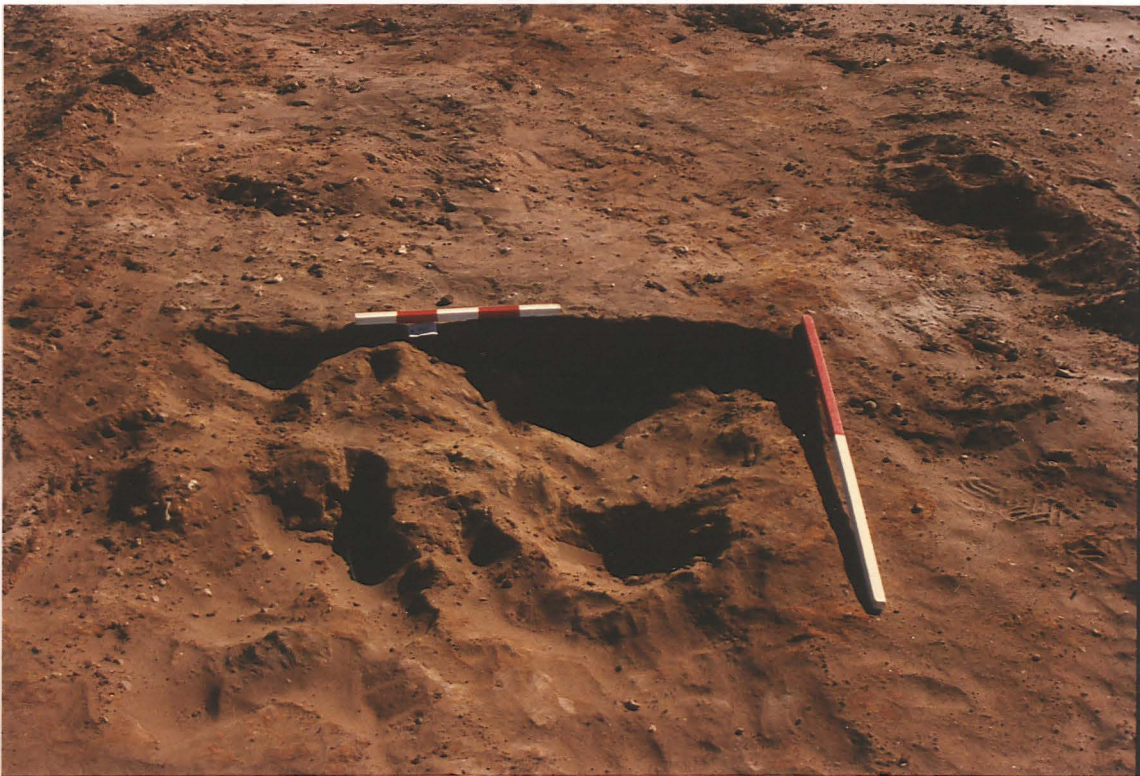
Pl. 19 Natural feature 021, partly excavated. The irregular base is evident. (Looking SE, scale divisions 0.1m and 0.5m).

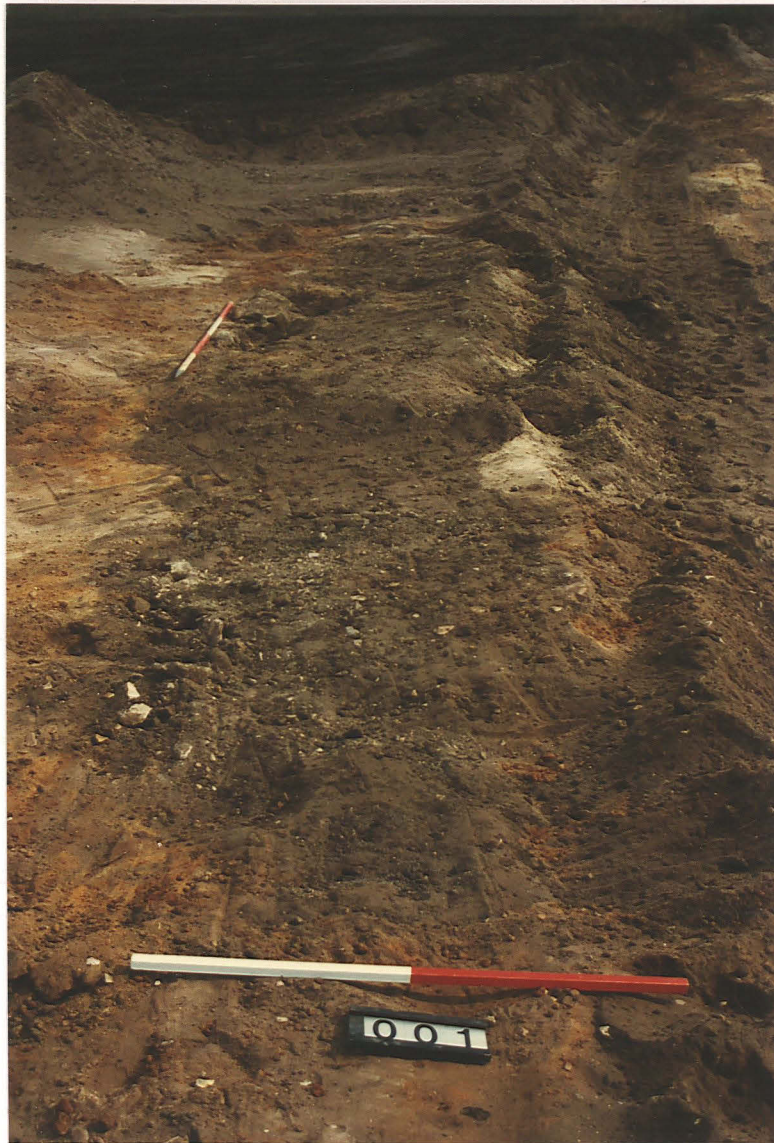
Pl. 20 Foundation trench 001 of airfield structure (looking SE, scale divisions 0.5m).

A narrow east-west linear feature 001 was exposed close to the SW corner of the stripped area and close to heaps of demolished brick and concrete rubble. The feature was 1.4m wide and 0.55m deep, with a very mixed fill incorporating 20th century brick fragments and chalk lumps (Pls 20 and 21). This was interpreted as the wall foundation of a demolished structure, probably associated with the former airfield. Another short stretch of chalk and concrete foundation was seen to the east but was not investigated (Pl. 22).

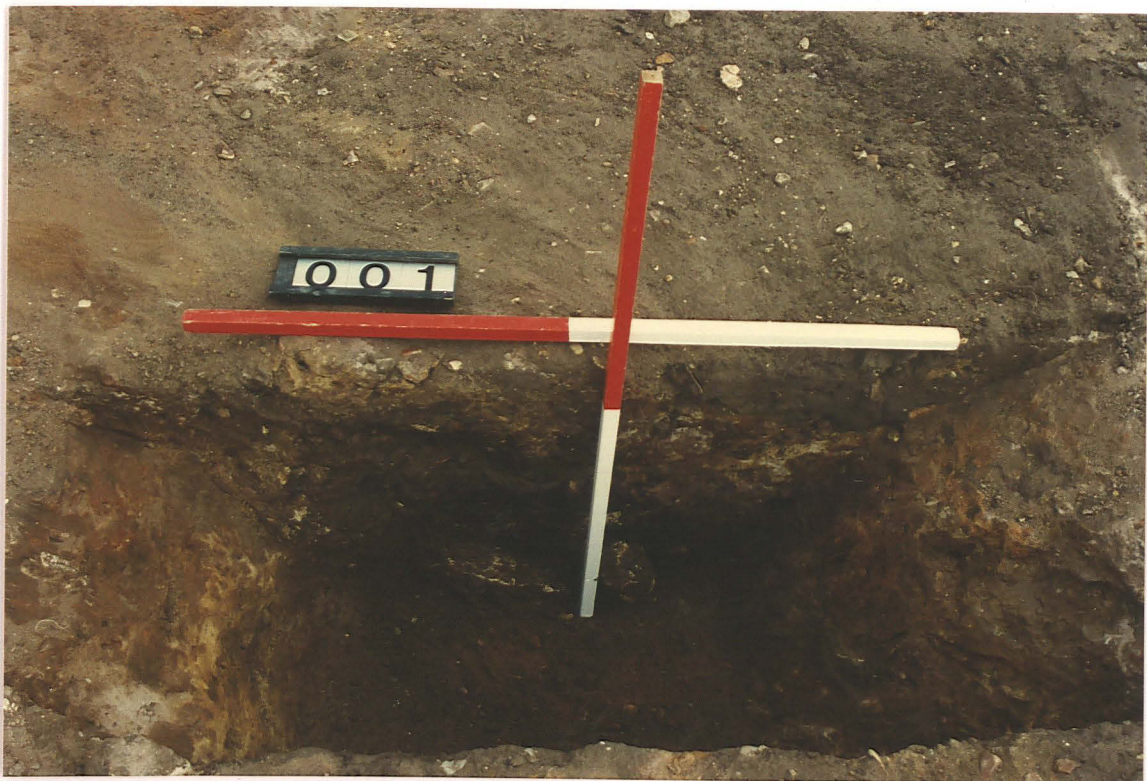
Pl. 21 Backfill of airfield structure foundation trench 001 (scale divisions 0.5m).

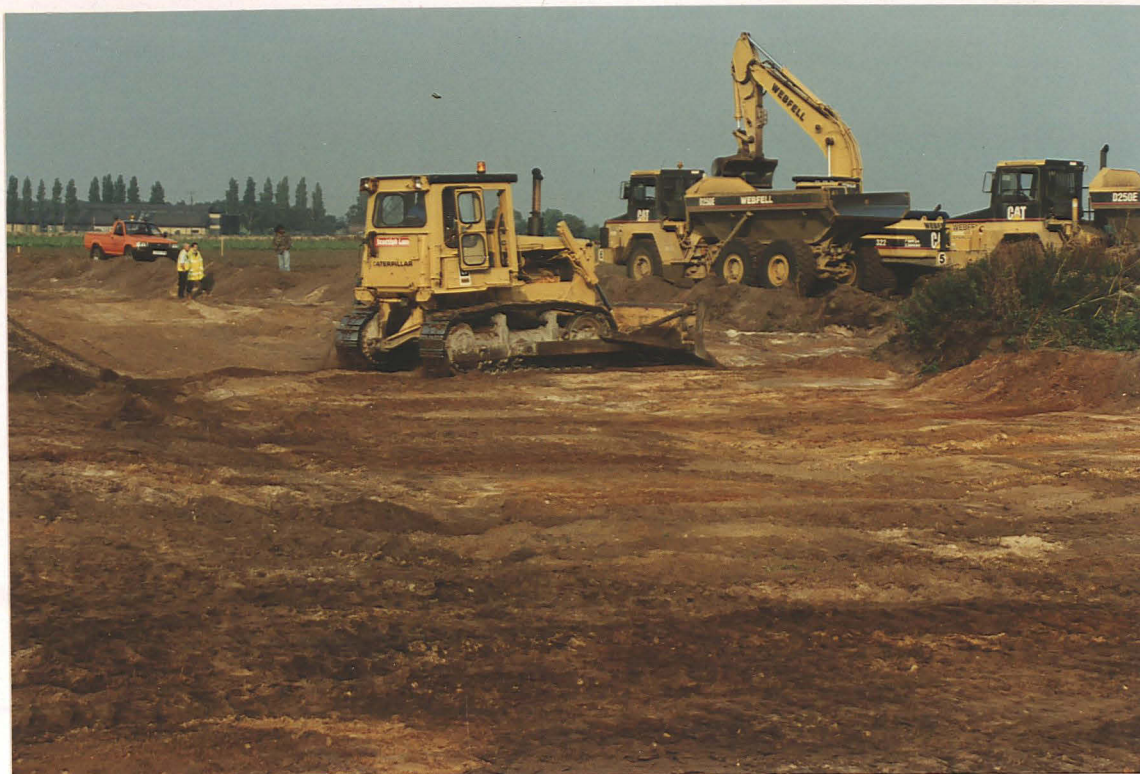
Pl. 22 Topsoil stripping at the southern part of the area, in the vicinity of concrete demolition rubble (far right) and a concrete wall foundation (in front of bulldozer). Looking NW.
