**Land at New Park Farm, Tattershall Thorpe:**

**Archaeological Monitoring of Topsoil Stripping  
Phase 1b of the Tattershall Quarry Extension**

Report prepared for  
Butterley Aggregates Limited

**December 1996**

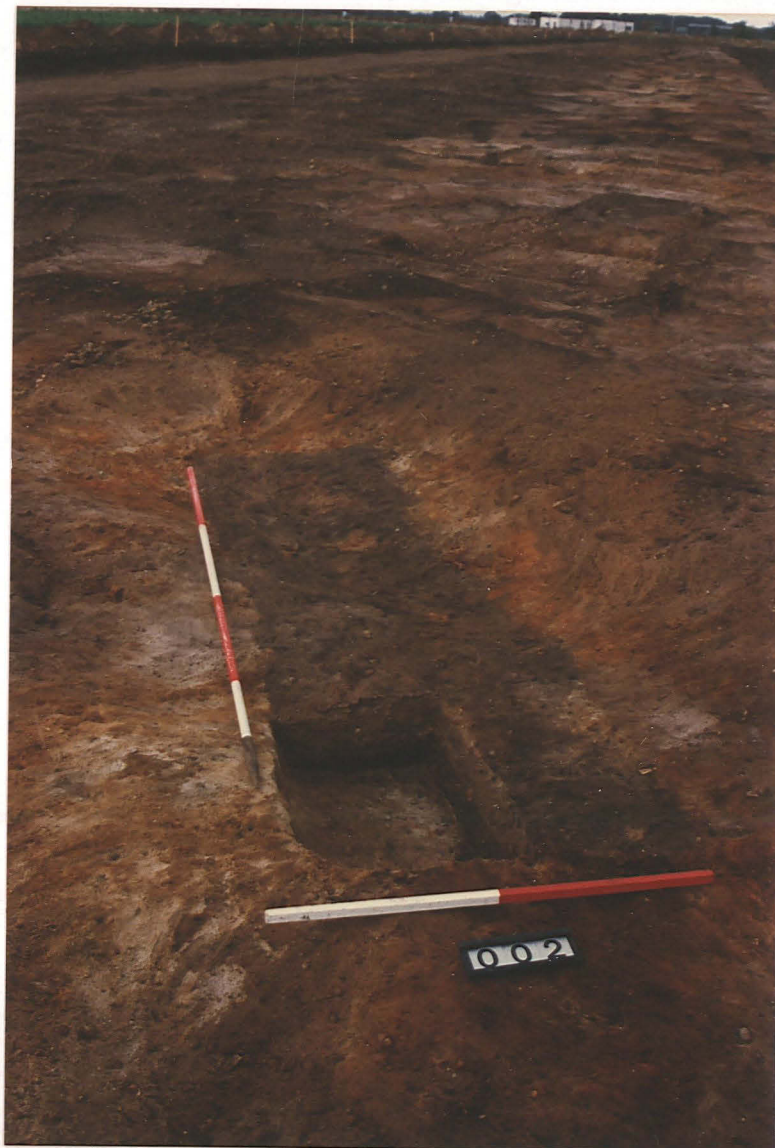
Pl. 23 Partly excavated airfield feature 002, looking NW (scale divisions 0.5m).

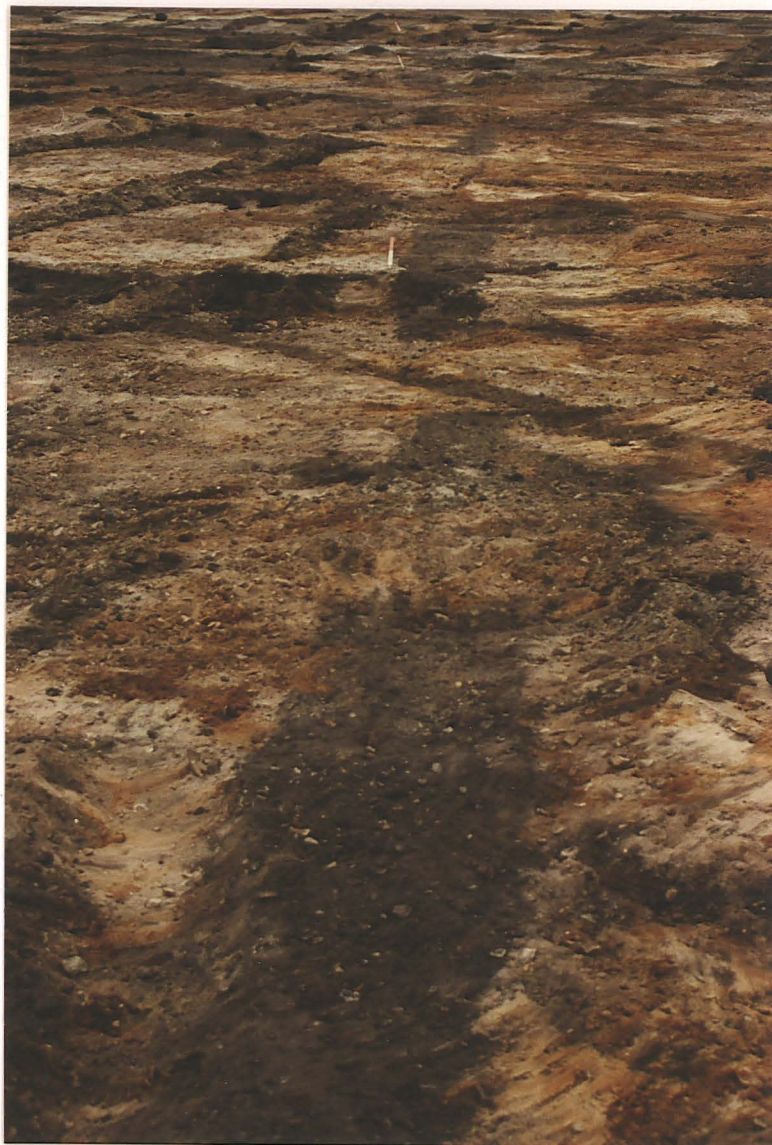
Pl. 24 Airfield feature 022 visible after topsoil removal (looking NW).

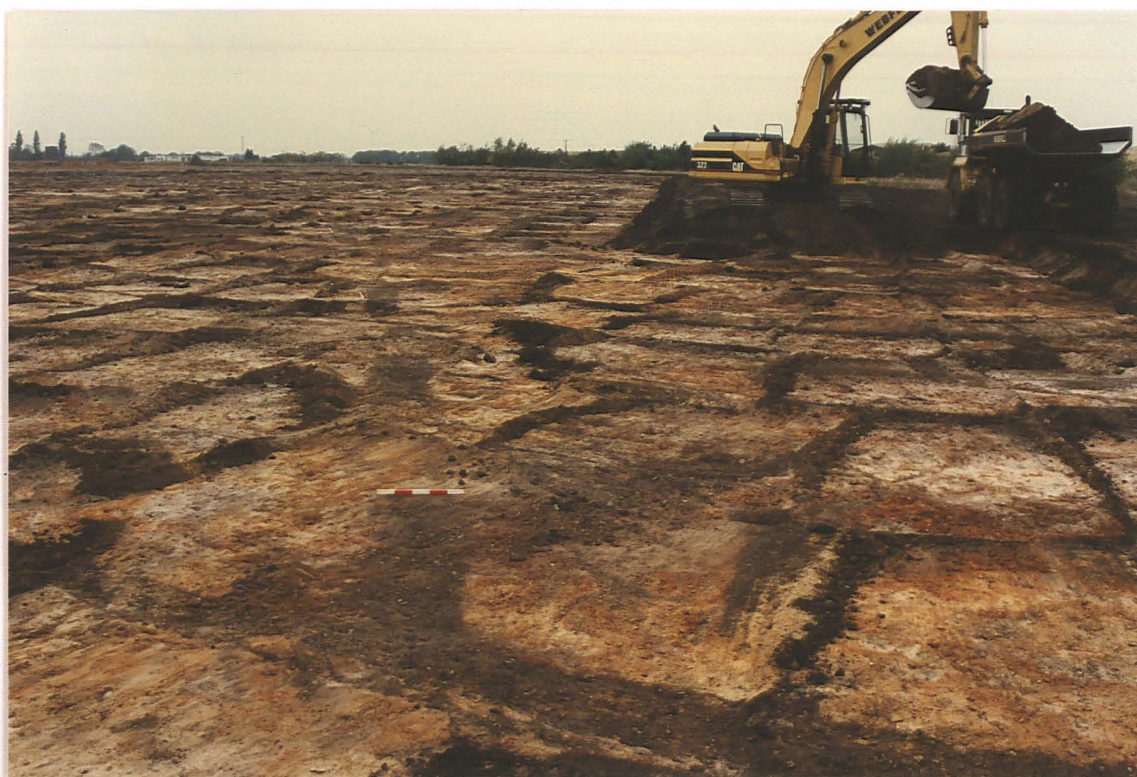
Pl. 25 The alignment of 022, a series of at least seven shallow machine-dug trenches similar to 002-006. They were interpreted as pits to contain fuel for ignition during poor visibility. (Looking NW).

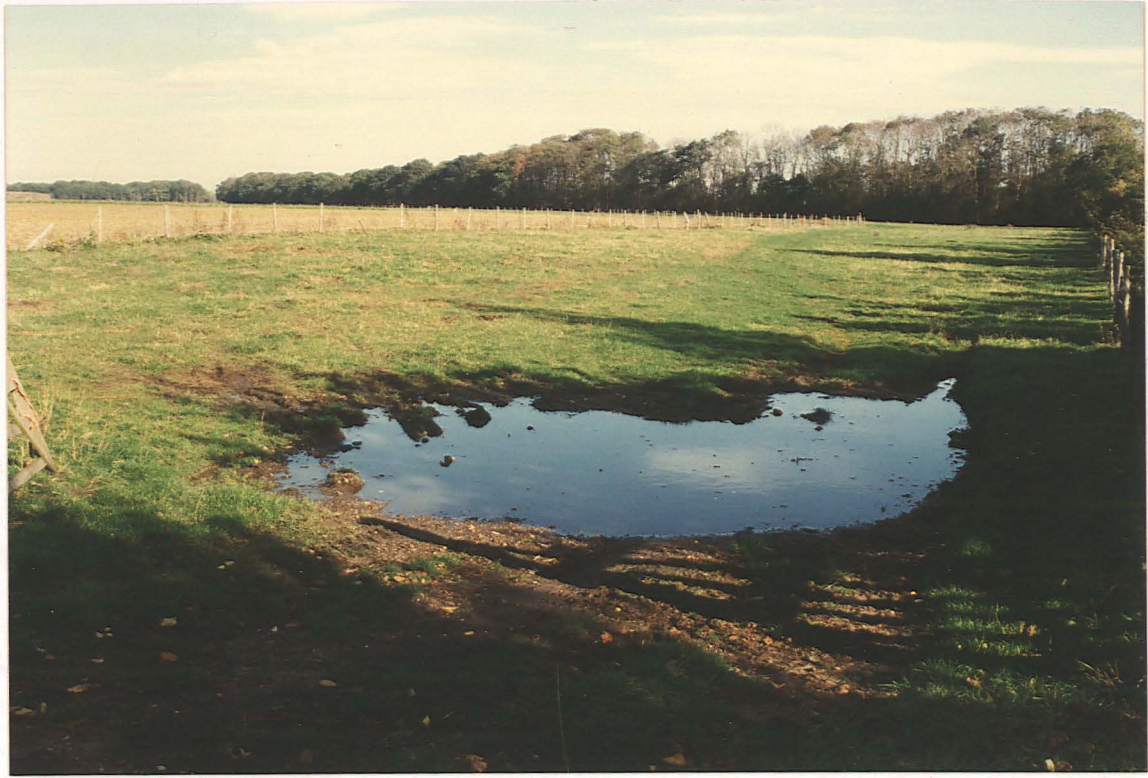
PI. 26 Pasture field at base of slope, south of New Park Farm. A stream flows beside the right boundary hedge. This field was topsoil stripped in preparation for a quarry perimeter soil bund (looking east from North Road).

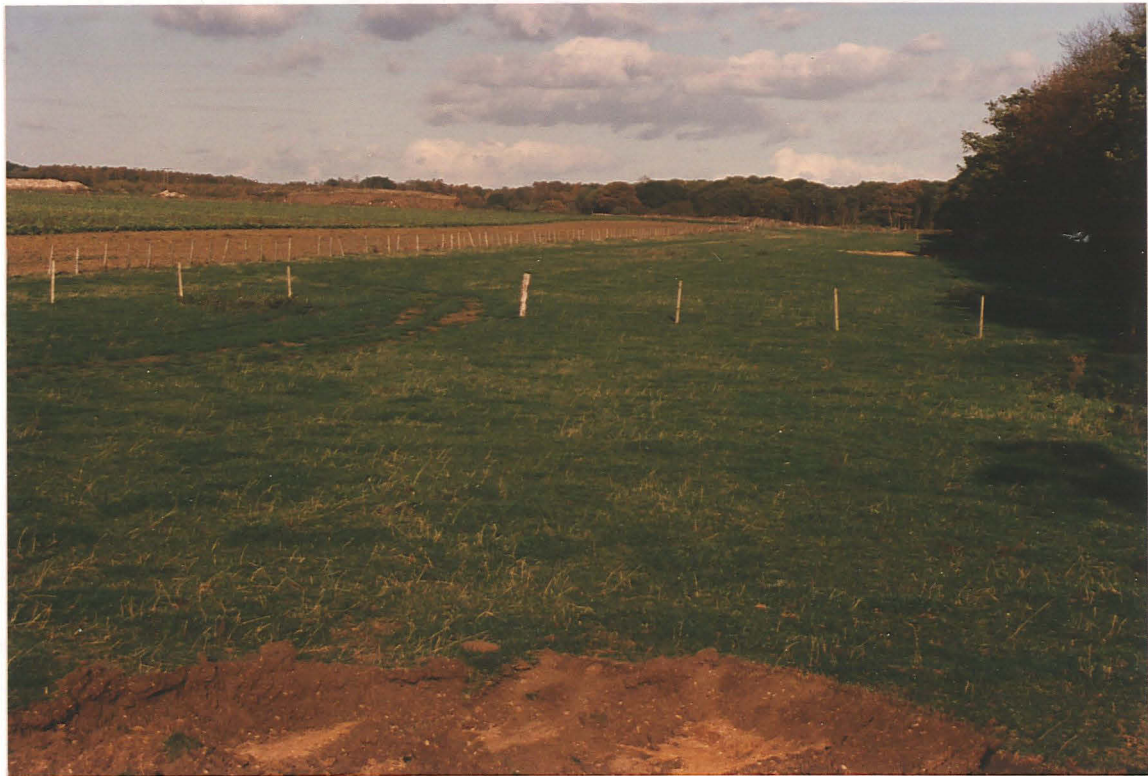
PI. 27 Pasture field to SW of Fox Covert. The soil bund was created beside the left fence (looking NE).

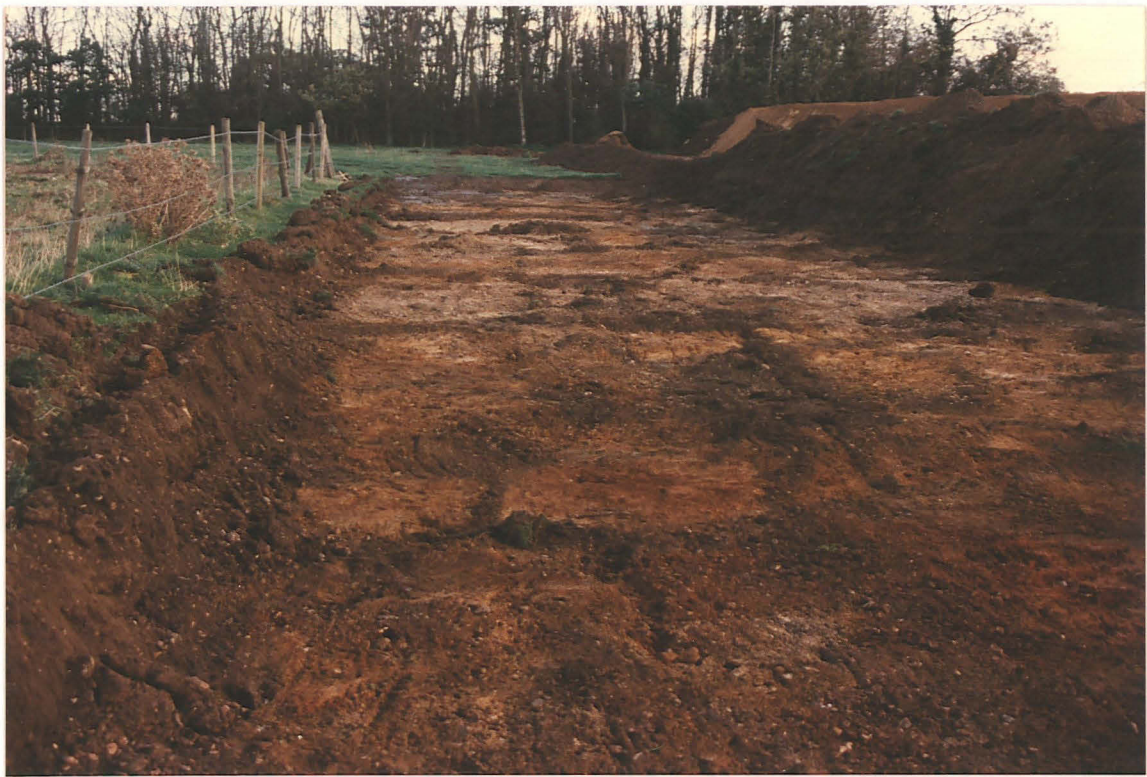
**Pl. 28** The stripped surface at the base of the slope by the stream was inspected but no archaeological remains were seen (looking east).

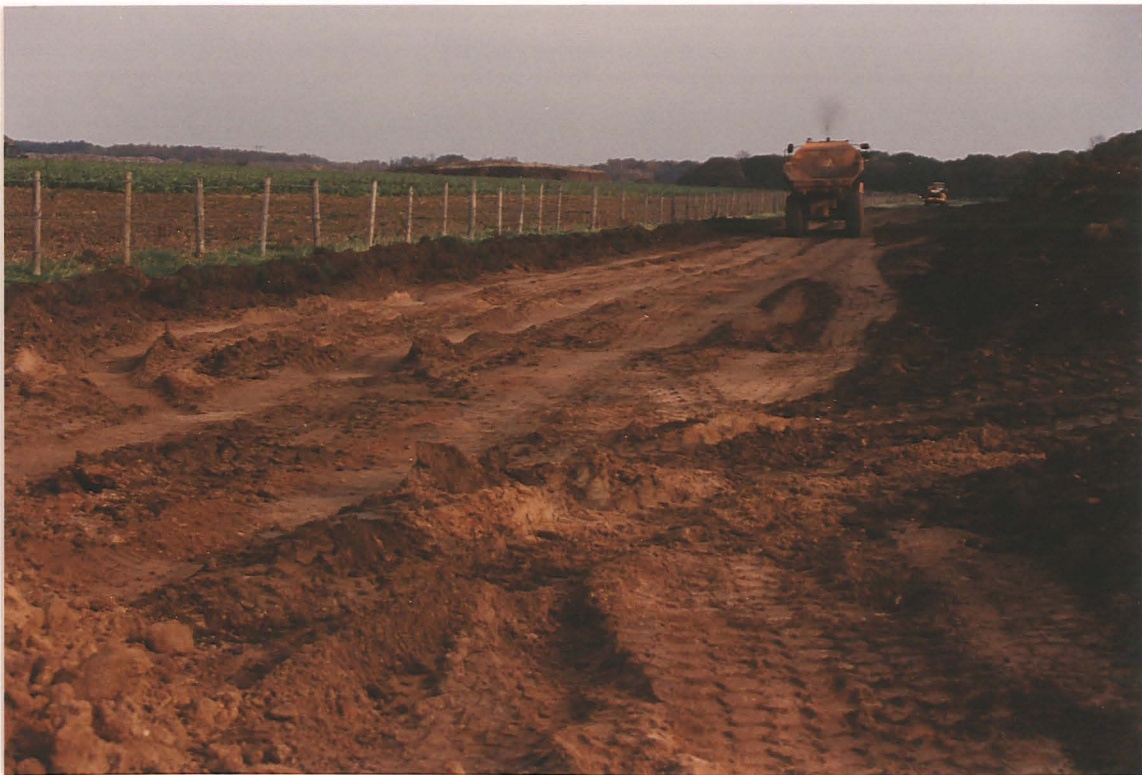
**Pl. 29** Machine trampling completely obscured the unmonitored soil horizon on the site of the perimeter bund (looking NE towards Fox Covert).

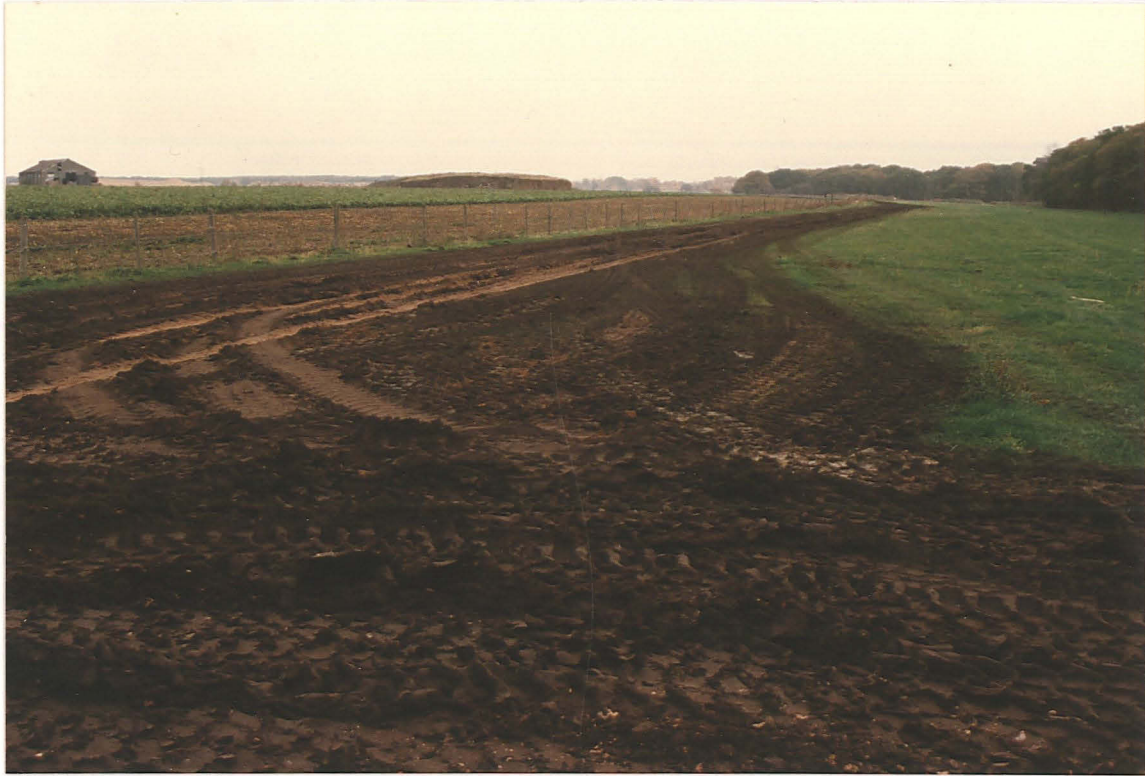
**PI. 30** This section of the bund location was not monitored as machine ruts had destroyed the surface before topsoil was removed (looking NE towards Fox Covert).
