**ARCHAEOLOGICAL WATCHING BRIEF
OF WATER MAINS REPLACEMENT AT
MARSTON,
LINCOLNSHIRE
(MVP96)**

Work Undertaken For
Anglian Water Services Ltd

November 1996

A.P.S. Report No. 53.96

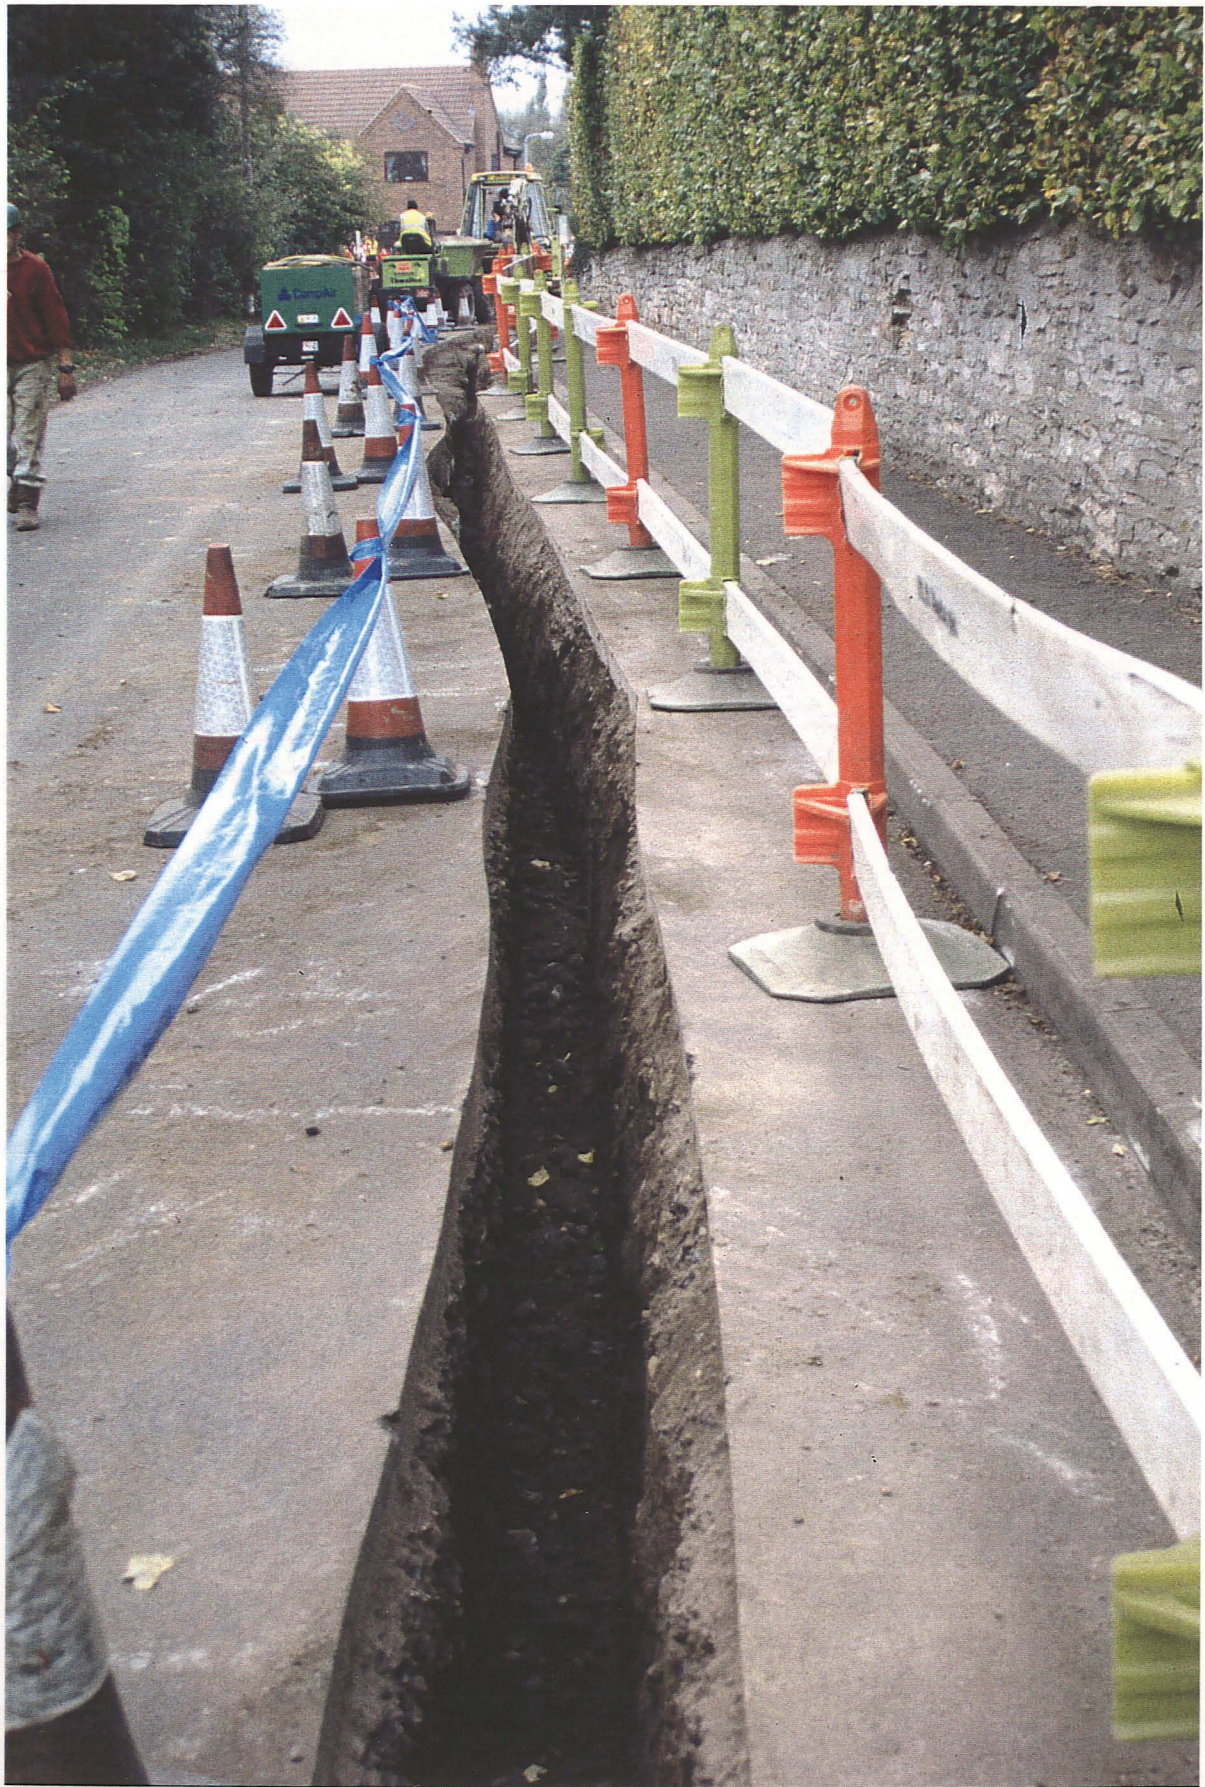
Plate 1 General View of Pipe Trench,
looking west alongside wall to grounds of Marston Hall

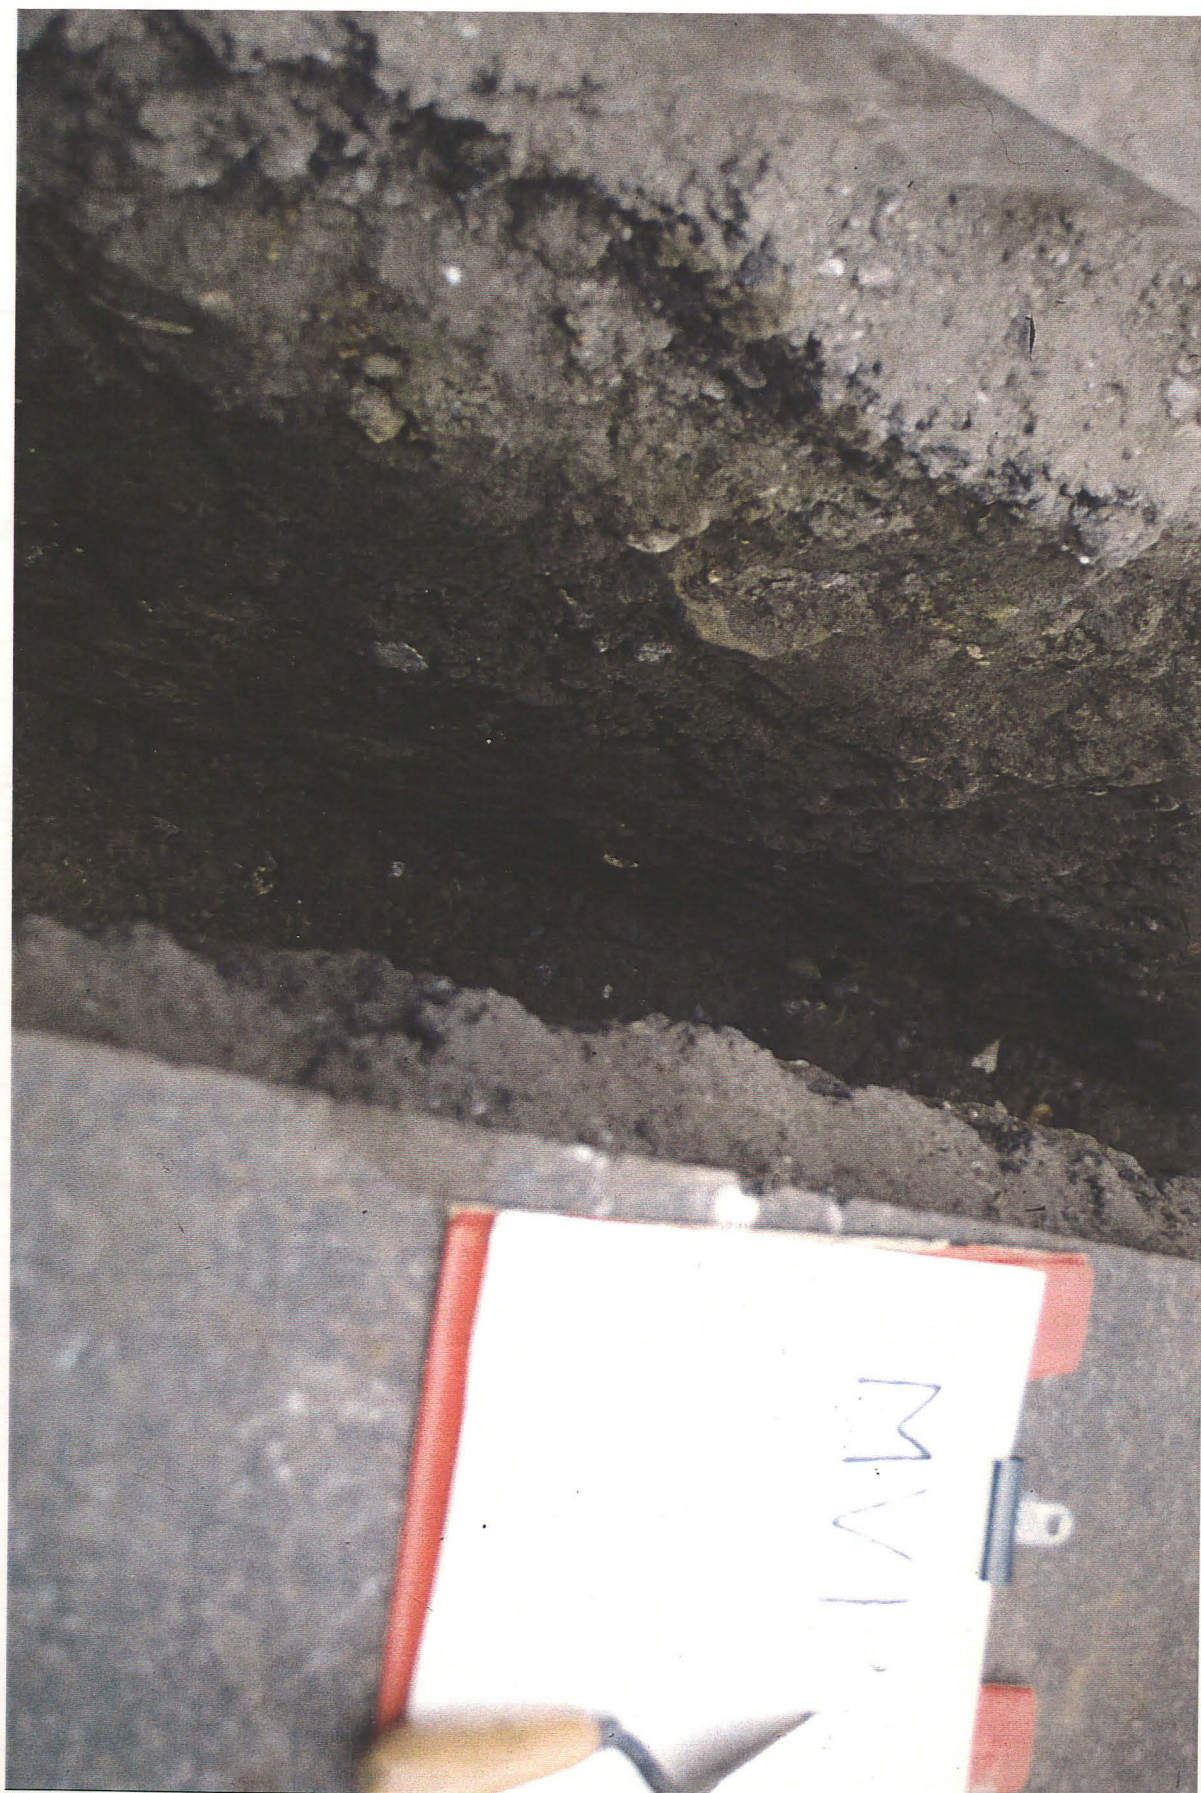
Above the brown natural sands were layers of grey or brownish-grey sand, (010) and (013), up to 0.40m thick. These possibly represent a former ground surface. Cutting the natural sand layers (007) and (008) was a shallow, concave feature (006), 0.8m wide and 0.22m deep. Interpreted as a possible gully or pit, it was filled with grey-brown silty sand (005).

Plate 2 Marston Village Pipeline, Section 2
