## Waddingham to Hamilton Hills (Lincs.)

Mains Replacement Scheme

### Archaeological Monitoring in Osgodby (near Park Farm, Usselby)

Site Code: OPF 96  
LCNCC Museum Accn. No. 175.96

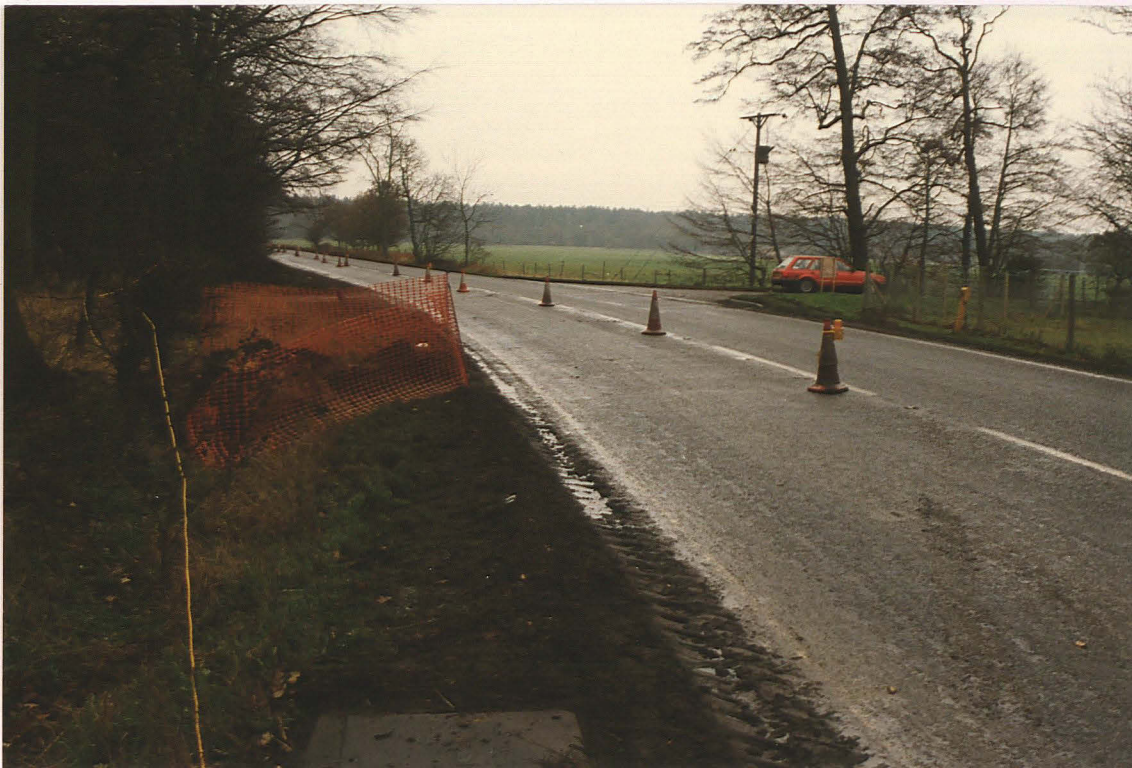
Pl. 1 Position of trench on the A46 verge, near tracks to Wood Cottage (left) and Park Farm (right). The fencing marks 1. Looking south.

1. A short length of trench was excavated in the A46 verge north of the track to Wood Cottage in order to locate existing services (Pl. 1). The trench was 0.9m wide and positioned between 1m and 1.5m from the edge of the main road, 20m north of the centre of the track to Wood Cottage and on the edge of the existing ditch. Brown loam containing twigs and other organic remains was visible in the SW and NE corners to a depth of 1.05m below the ground surface (Pl. 2). This deposit was interpreted as the comparatively recent backfill of a ditch closer to the road, mostly filled with detritus from the adjacent plantation. This ditch is unlikely to have been medieval or earlier.

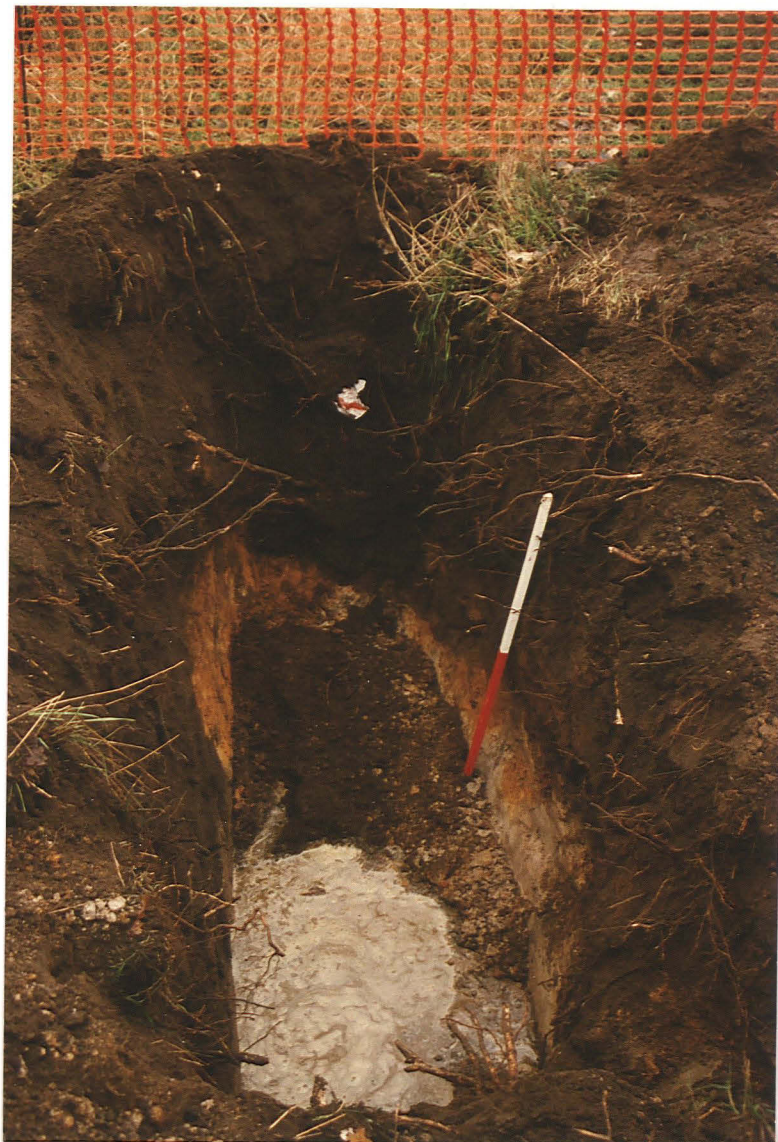
Pl. 2 Dark brown fill of woodside ditch 1 (left foreground, right background) north of track to Wood Cottage. Looking south, scale divisions 0.5m.

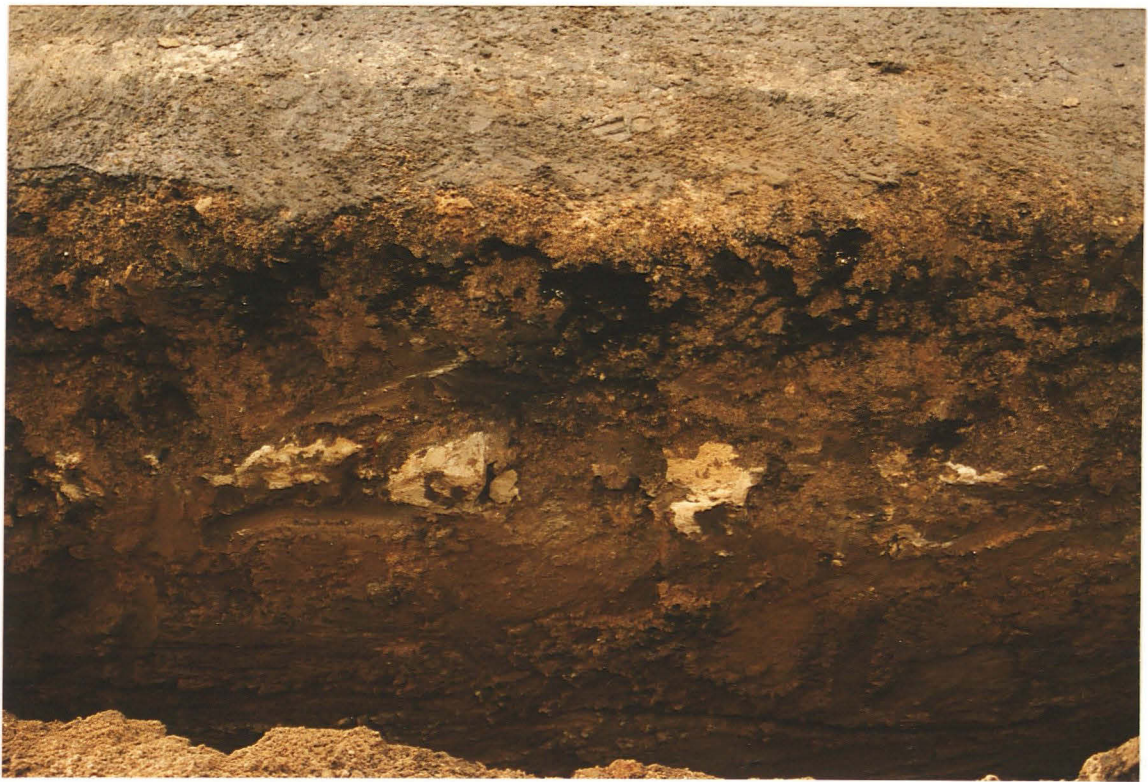
**Pl. 3** Chalk rubble blocks 3 of the post-medieval Caistor to Market Rasen road, visible beneath the modern A46.

2. The pipe trench was excavated to a width of 0.35m and a depth of 1.25m at the eastern edge of the main road north of the track. Part of this trench clipped the eastern edge of the foundation for the Caistor to Market Rasen road, a layer 0.2m thick of rough chalk blocks 0.3m below the modern tarmac surface (Pl. 3). This was only present on the western side of the trench.

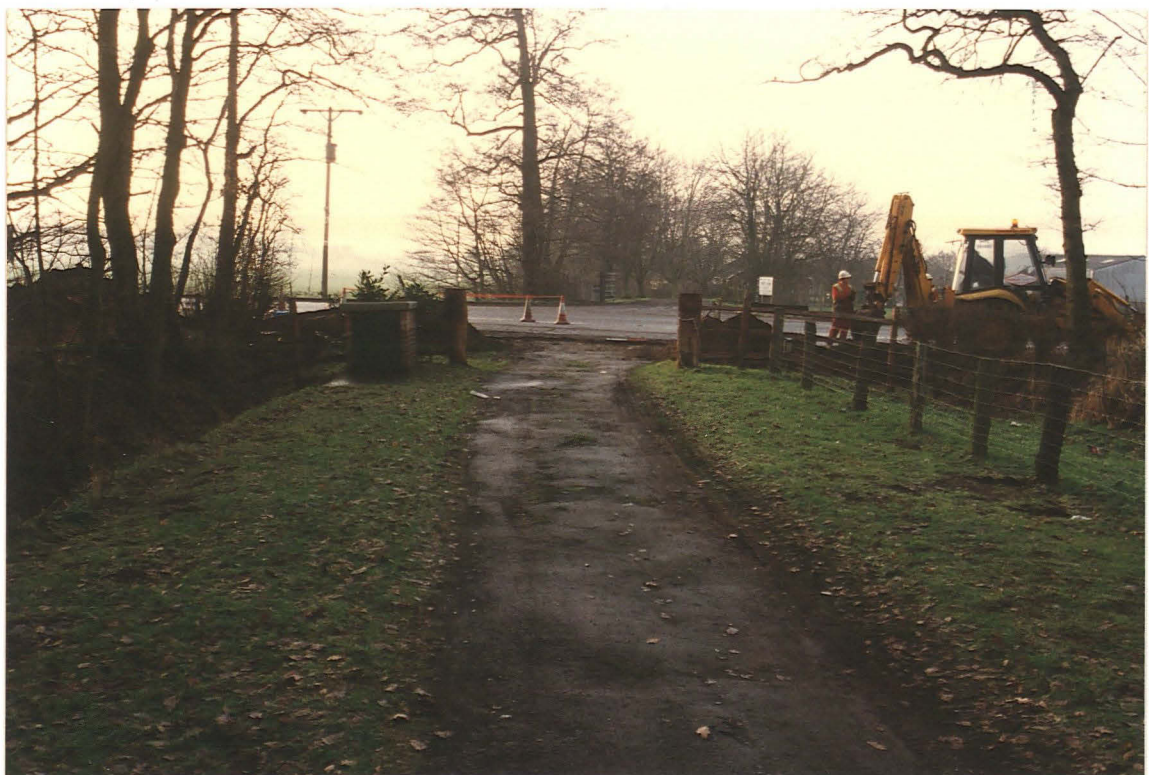
**Pl. 4** Junction of the main road with tracks to Wood Cottage and Park Farm (opposite). Looking west; the 1m horizontal scale marks the centre of 3.

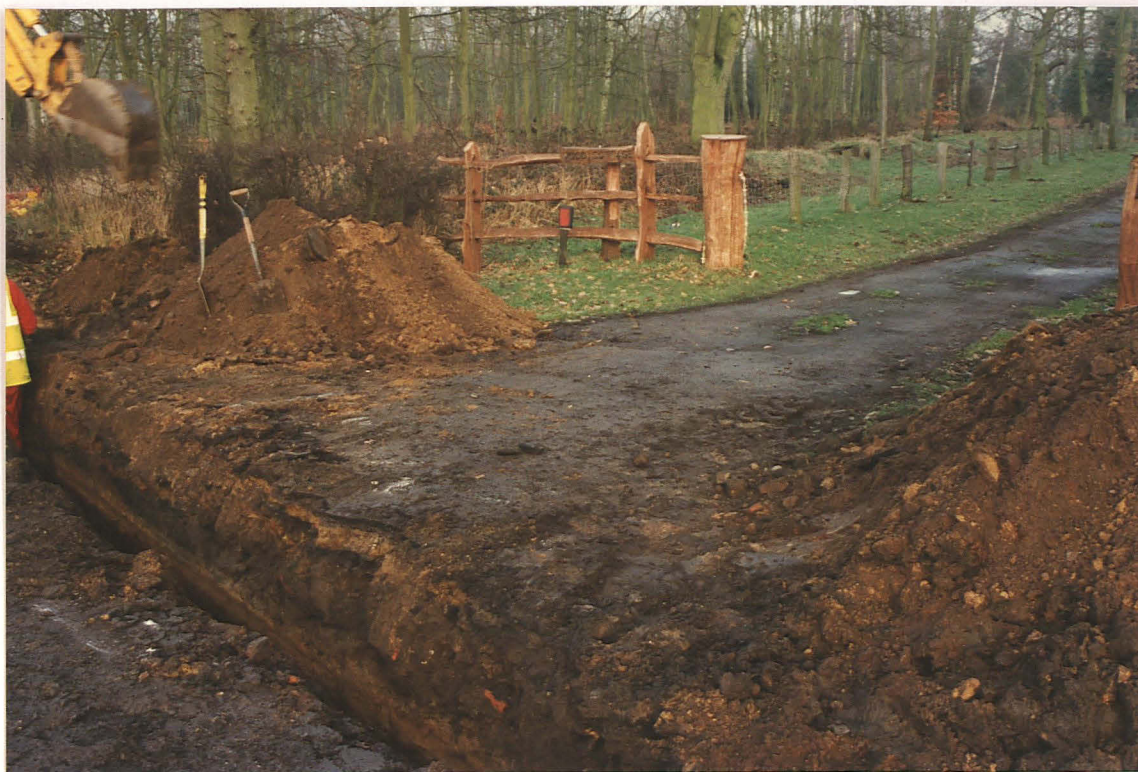
Pl. 5 The pipe trench across the Wood Cottage track, showing the thin upper lenses above a cambered rubble road 3 (looking NE).

3. The modern tarmac surface of the lane is 0.03m thick, overlying a black silty material 0.04m thick. This covers a thin layer of yellow sand 0.06m thick which is in turn above a similar depth of black soil (Pl. 5). These bands seem to have formed during a sustained period of minor use, either as re-surfacing or as wash of soil from adjacent land.

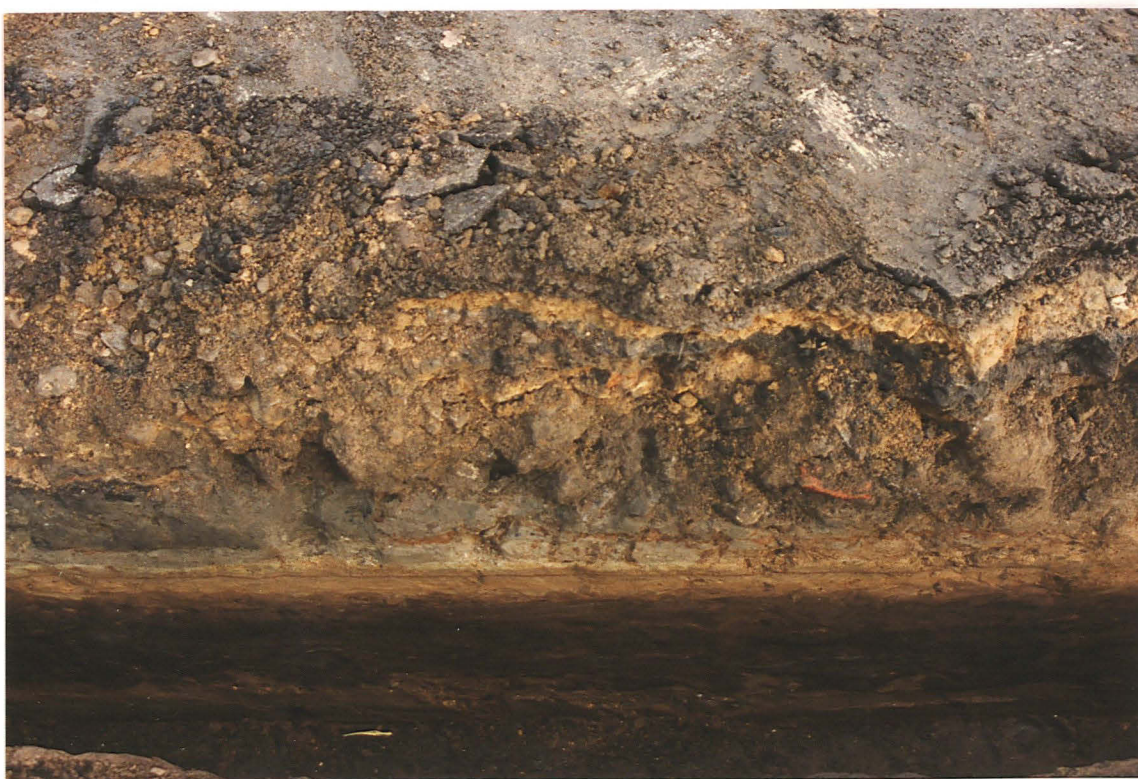
Pl. 6 Detail of the road construction and underlying deposits at 3.

Beneath these thin layers is at least one layer of deliberate road construction material, exhibiting a distinct camber about 3.5m wide (Pl. 6). The upper layer is 0.25m thick, comprised of post-medieval brick rubble, sand and small pieces of limestone or chalk. It overlies 0.12m of compact grey silt which may represent a buried ground surface; a fragment of a post-medieval brick was found stratified beneath this layer (Pl. 7). Below this are layers of light yellow sand, brown peaty sand and coarse sand seen in the trench to the north, probably the sequence of natural deposits. At 1.1m from the surface, another small piece of brick was seen in the trench face within the coarse sand layer. This was also post-medieval; it is suspected to have been moved from a higher layer and pressed into the soft material by the machine bucket.

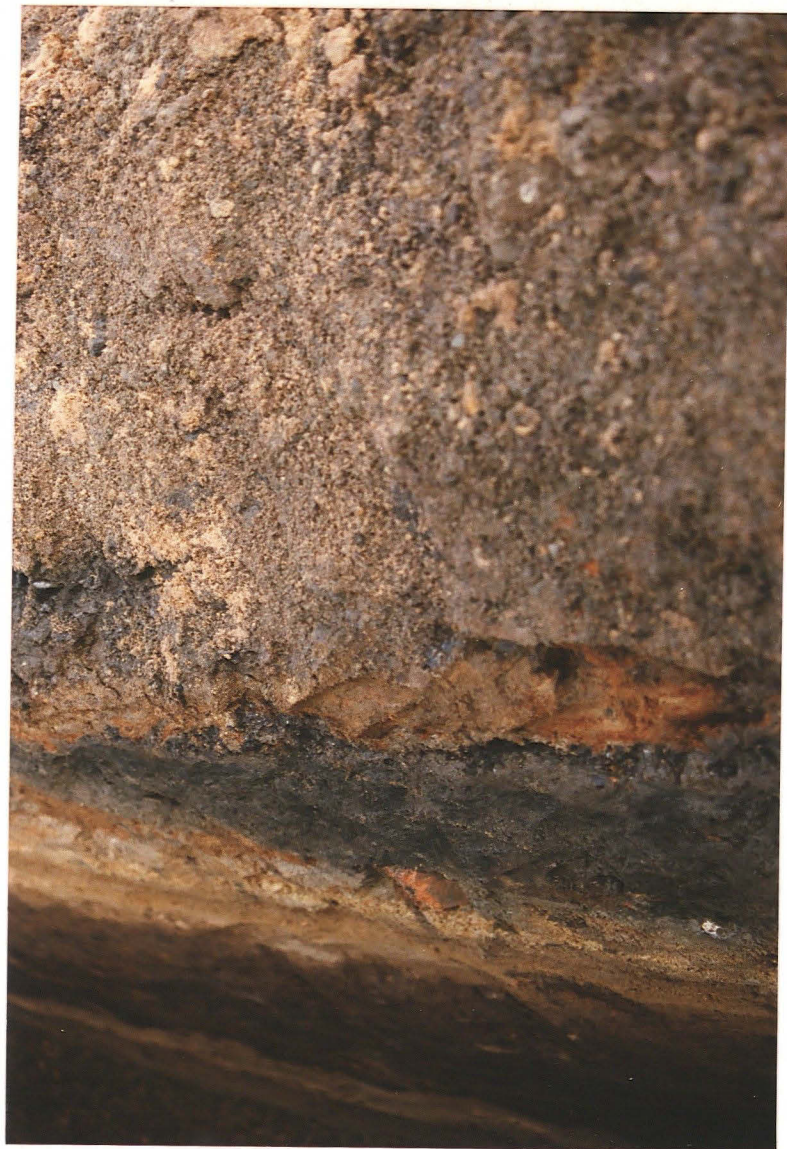
Pl. 7 Layer of compacted grey silt beneath road 3. Note the post-medieval brick fragment visible beneath the layer.

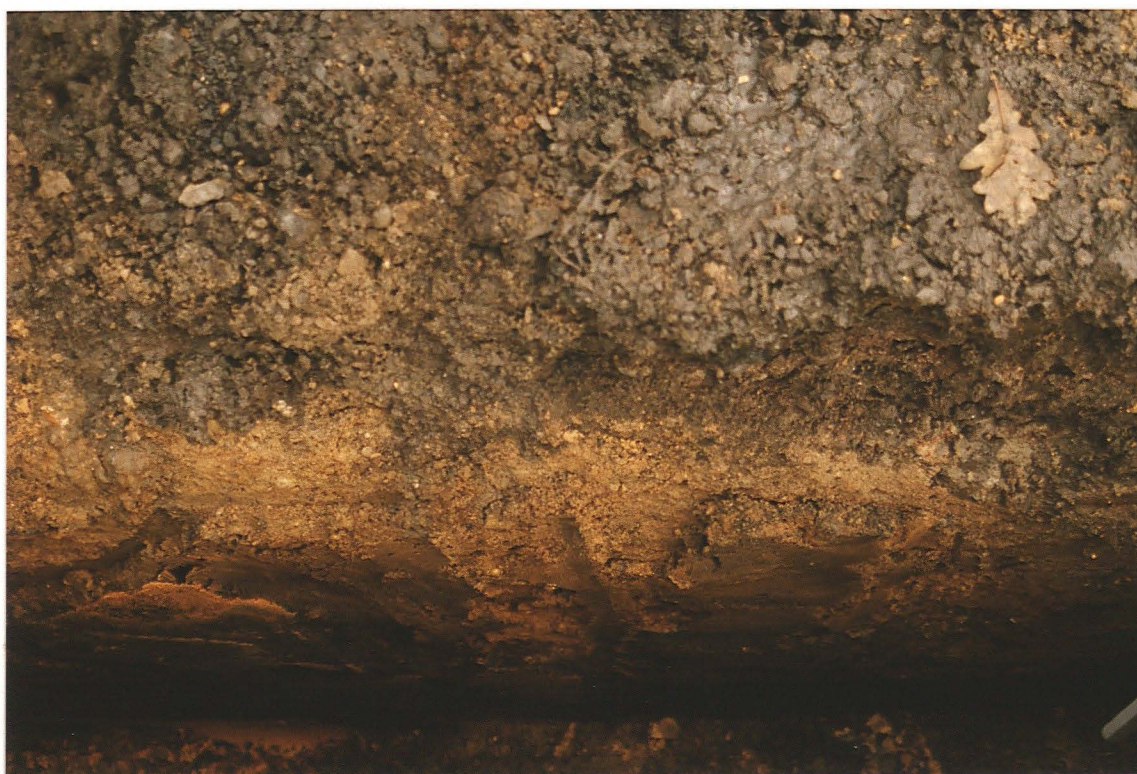
Pl. 8 Yellow sand deposits 4 in trench south of Wood Cottage track.

4. To the south of the lane the trench was cut into the verge. Here it cut through a thick yellow sand deposit beneath the topsoil (Pl. 8). The contractors reported similar ground to the south. Underneath the yellow sand was a brown sand which extended beneath the trench base.
