**ARCHAEOLOGICAL WATCHING BRIEF  
AT MAIN ROAD,  
STIXWOULD,  
LINCOLNSHIRE  
(SMR96)**

Work Undertaken For  
Mr N.B. Fisher

December 1996

A.P.S. Report No. 60/96

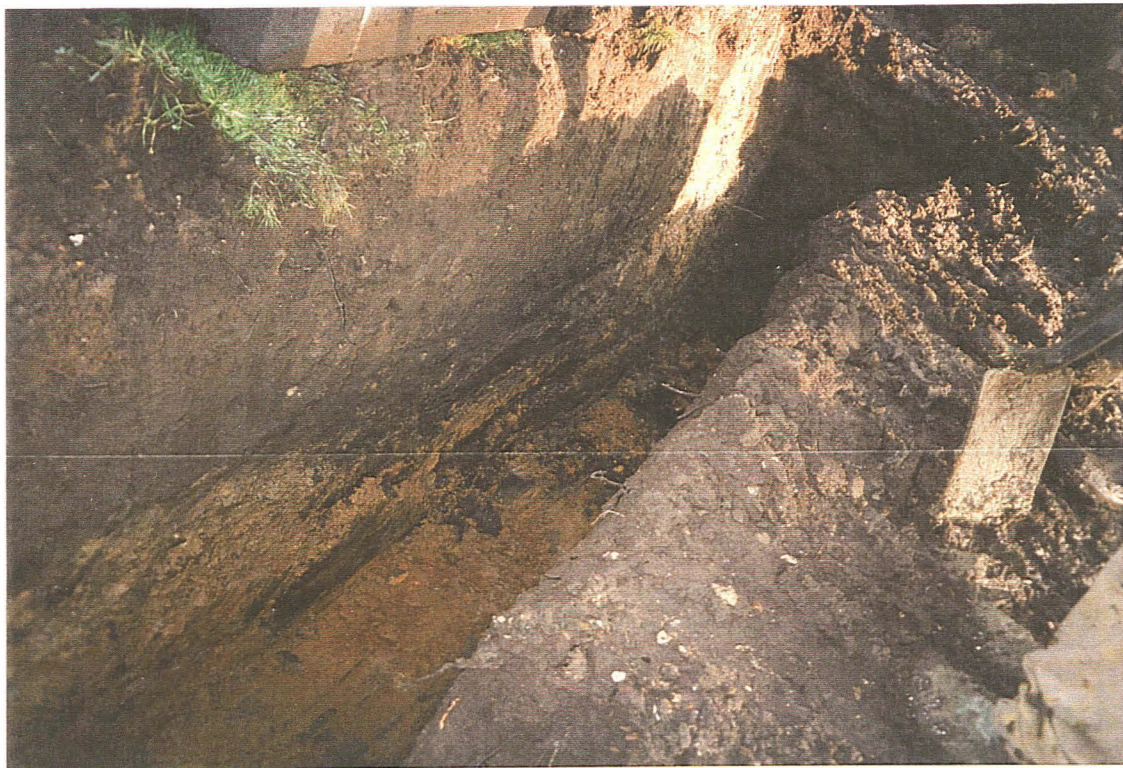
Plate 2: Section 2, showing ditch (012)

012 was a deep, gradual sided feature which was not exposed to its full extent (Fig. 4). The cut was at least 2.4m north-south by 3m east-west, 1.2m deep and filled with a mid-dark grey sandy silt with a high organic content (05). A fragment of a stoneware jar of 19th-20th century date was recovered from (05). Feature 012 was interpreted as a ditch.
