**74A Winn Street, Lincoln
Archaeological Watching Brief**

NGR: SK 9897 7133
Planning Appl. LE26/0514/96
Site Code: LWS 97
LCNCC Museum Accn No. 7.97

Report for

Quality Homes (Lincoln) Ltd

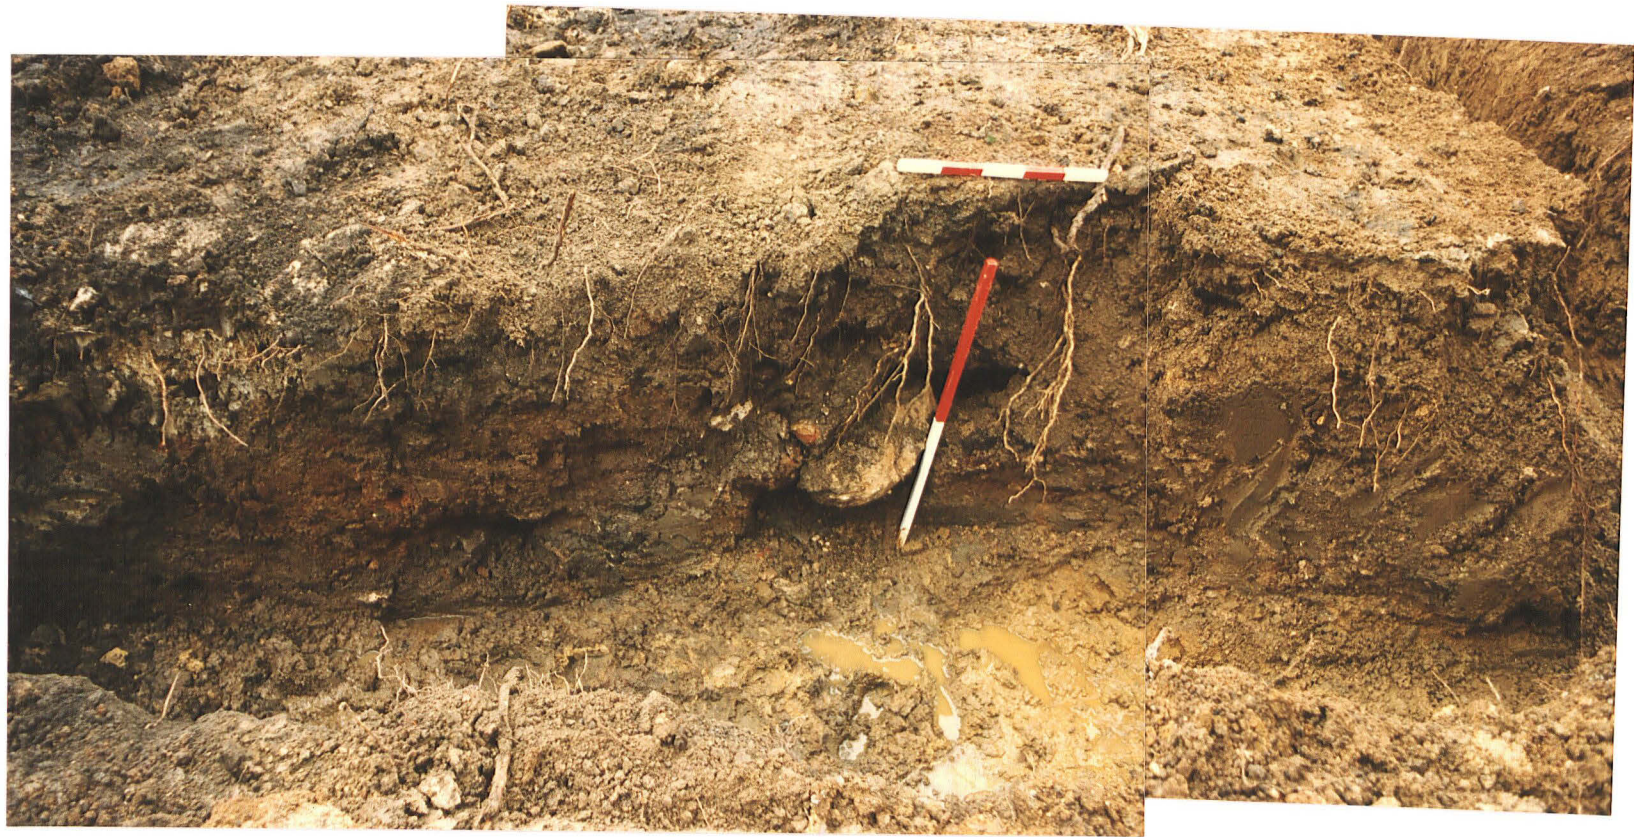
0.80m east of wall **3** was another, more substantial limestone wall **10**, of similar size blocks to those in **3** and bonded with a cream mortar bonding (Pl.3, Fig. 4C). It was 1.10m wide and aligned NNE-SSW. As this wall did not form a right angle to **3** it may not have been contemporary. Root disturbance was noted, accounting for fragments of wood seen in deposit **9**, a brown grey clay silt which infilled areas where stone was absent. The wall sat upon a blue grey clay base with limestone inclusions, **11**, 0.30m deep, 2m wide, which infilled the base of the wall's foundation trench, **14**.

A 1.60m wide x 0.50m deep robber trench **8** (Pl.3), was recorded c.0.40m east of the wall edge of **10**. The mid-grey brown clay silt fill, **7**, produced no dating evidence, nor did brown grey clay silt **17**. **8** also cut layer **2** (Pl.3), a brown clay silt with charcoal and limestone inclusions, 0.50m deep in places. Deposit **2** (Pl.4) appeared to butt both walls, suggesting it is the remains of a later topsoil. This deposit, like all the other deposits encountered on the site, yielded no finds.

Directly below **2** lay **12**, 0.10m thick, which was more grey in colour than **2**, with no charcoal inclusions (Pl.3). This layer was only observed at the northernmost end of the site.

Layer **13** (Pl.3), a dirty mid grey clay silt, was sealed by **12** and cut by **14**. This layer is probably the same as **5** (Pl.4), which is the earliest soil horizon

Pl. 3 Wall 10 robber trench 8 and layers 2,12 and 13 in north wall foundation trench, looking south. Scales 0.50m (horizontal) and 1m (vertical).

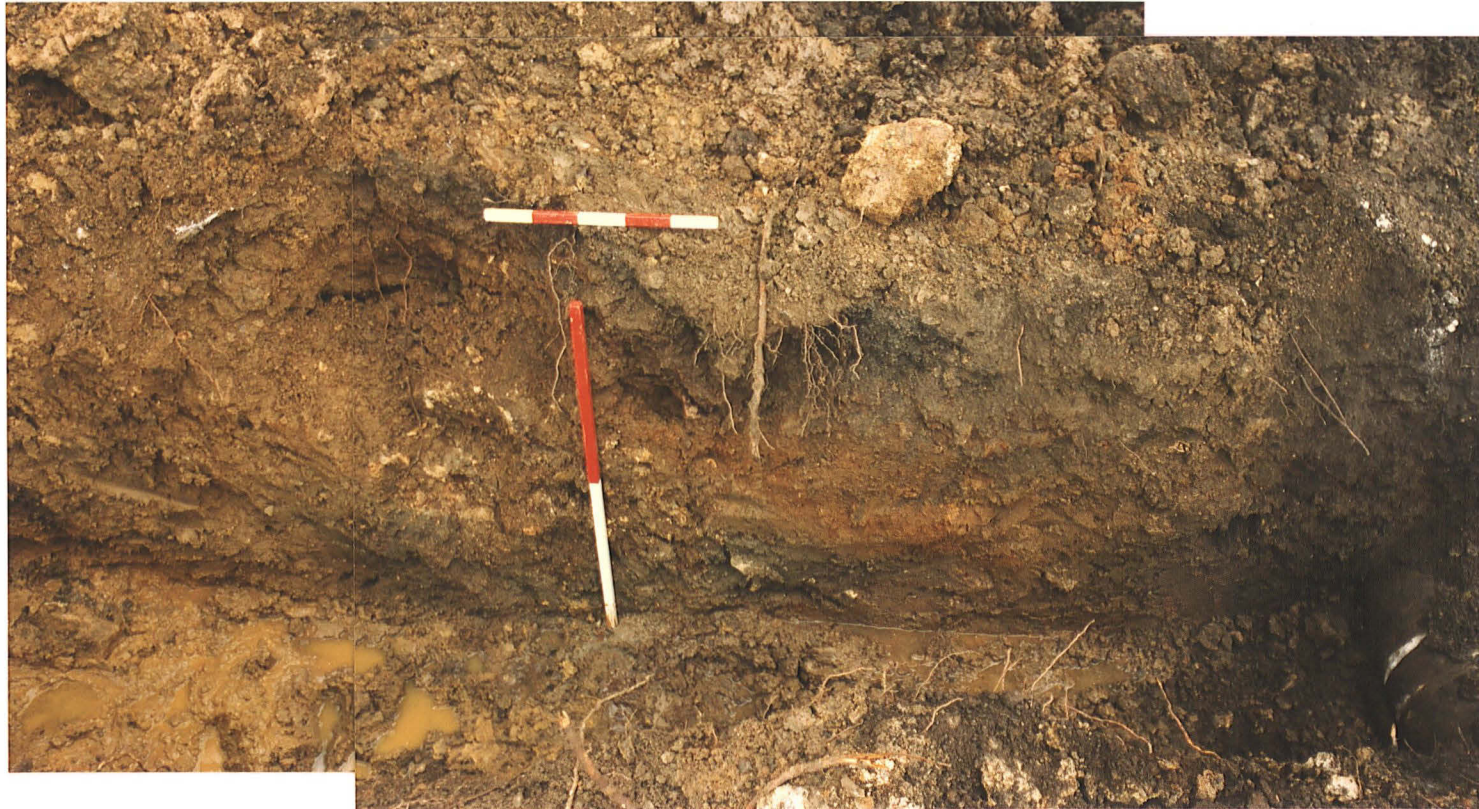
Pl. 4 Wall 10 in north wall foundation trench, looking north. Scales 0.50m (horizontal), 1m (vertical).

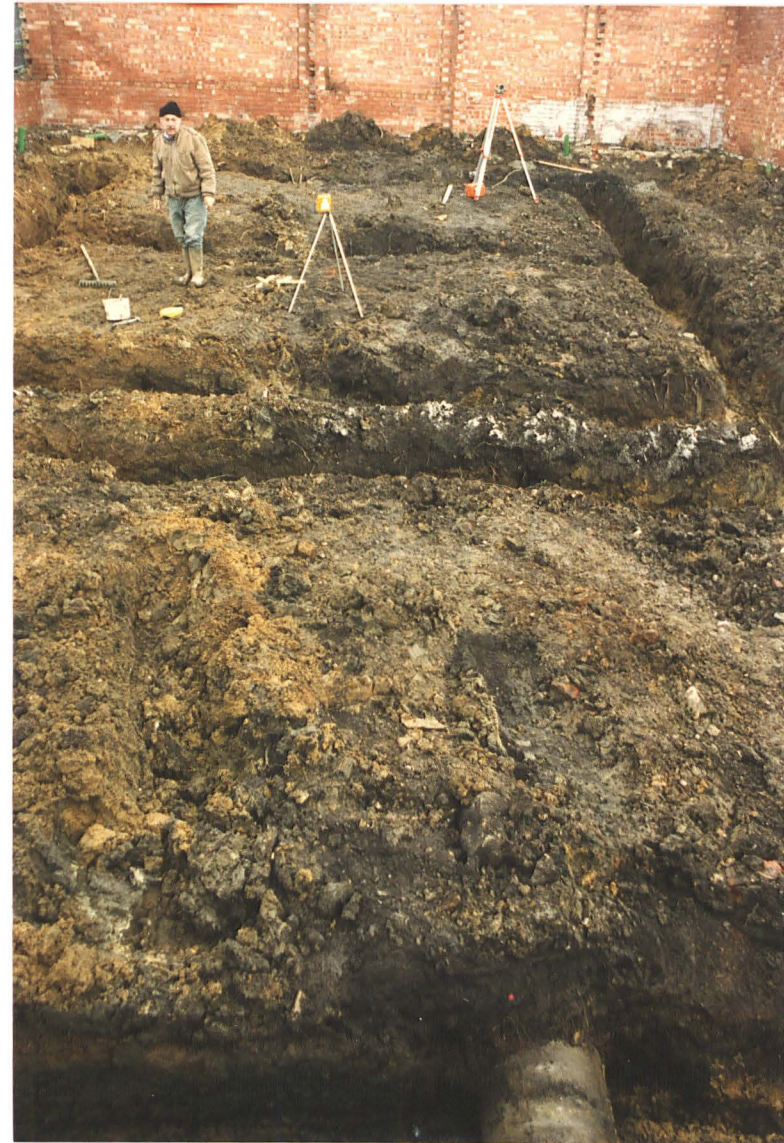
All the archaeological layers were cut by a very large modern pipe trench 15 (Pl.5), which measured c.3.30m in width and had a maximum depth of 1.20m. This feature, aligned north-south, ran the length of the site and was situated 3.30m from the site's western boundary wall which meant that approximately half the monitored area was disturbed by its presence. The trench contained a 0.40m diameter concrete water pipe and was filled with sticky buff clay and brown and grey silt clays, all assigned a single context 16 because they were clearly modern.

Pl. 6 Modern water pipe trench 15 (dark area, right hand side) looking north.

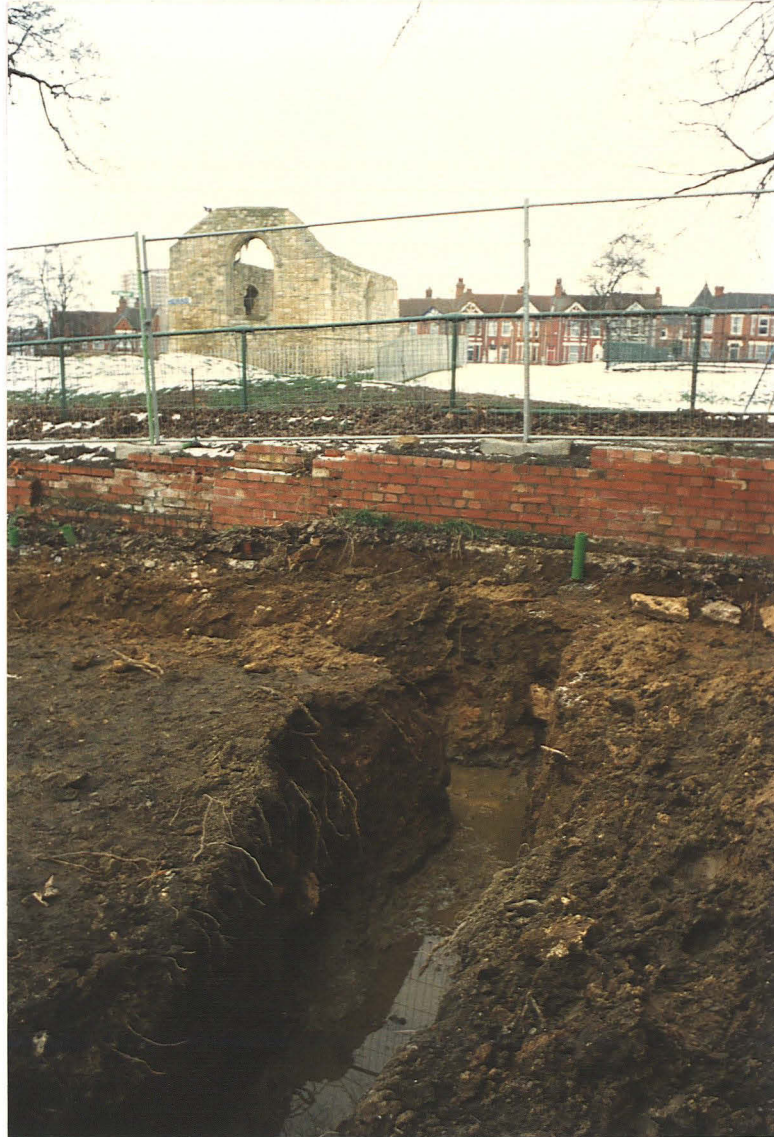
Pl. 7 Walls 3 and 10 in relation to the Priory of St Mary Magdalene. Looking WSW. Note water in base of trench.
