**ARCHAEOLOGICAL WATCHING BRIEF ON  
LAND AT ST. MARY'S CHURCH,  
COVENHAM ST. MARY,  
LINCOLNSHIRE  
(CSM96)**

Work Undertaken For  
Mack and Brown on behalf of  
Covenham St. Mary  
Parochial Church Council

March 1997

A.P.S. Report N° 52/96

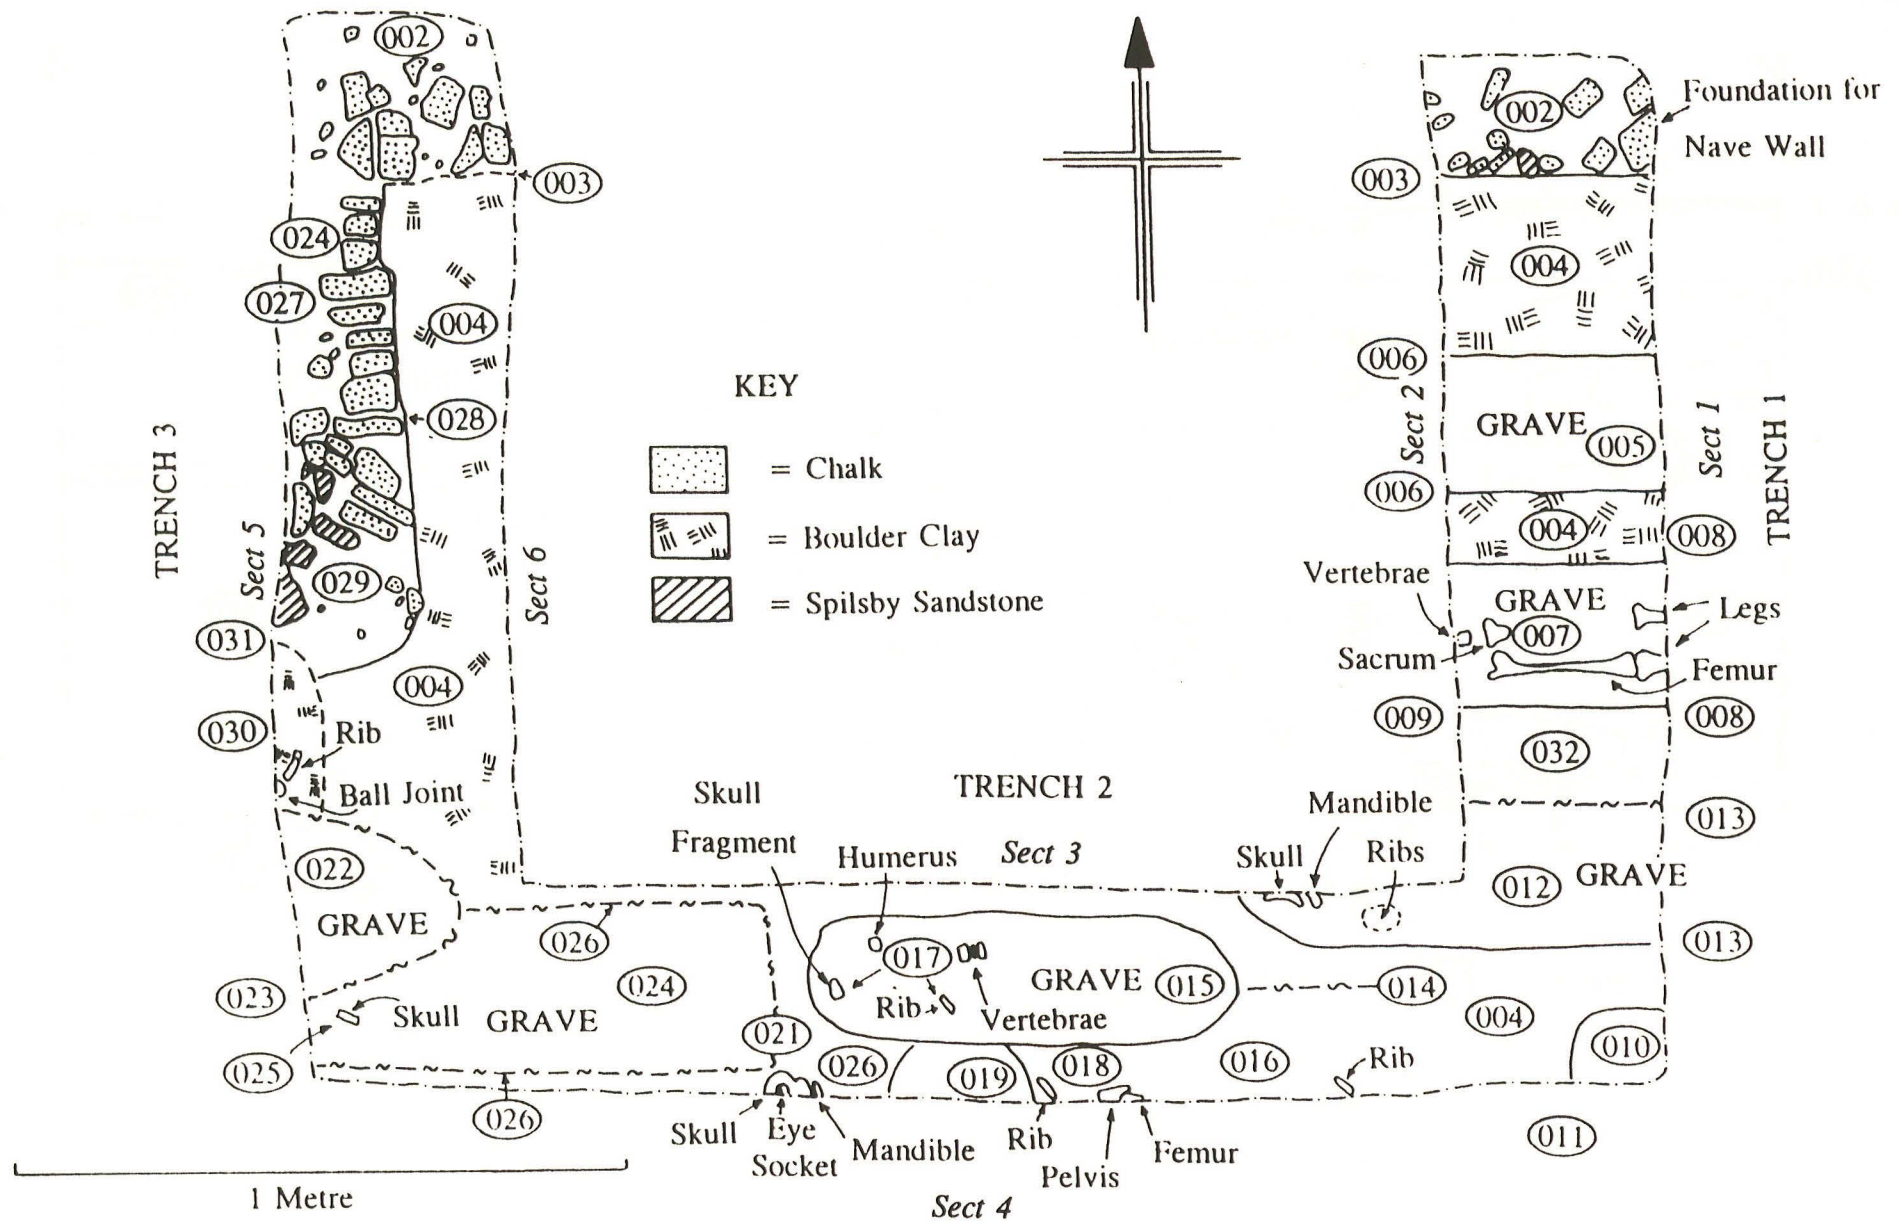
Figure 4: Plan showing trenches and locations of sections

throughout all of the trenches (Fig.4).

and (054) (Fig.7). This is also evident in plan, *eg* (023) and (026) (Fig.4) and has resulted in the development of a complex stratigraphic sequence.

At the junction of Trench 3 with the south wall of the nave (Figs.4 and 7) an earlier buttress and the foundation for the south wall of the nave, was recorded (Plate 4). Cut (003, 028) was partially exposed, and extends east-west before turning sharply to run north-south, prior to turning west into Section 5 (Fig.4). It contained the remains of chalk and sandstone fragments that formed the foundations for the south wall of the nave and an earlier buttress (002, 027) (Plate 2). The most southerly length of this feature contains (029) which has been interpreted as a backfill deposit (Fig.7), probably dumped after some of the foundations had been robbed (see Appendix 5). A sequence of brick (106) foundations overlain by a substantial footing of limestone ashlar blocks (107) had replaced the earlier

land as a graveyard. No graves were recognised as having been disturbed by the construction of the church and it is therefore difficult to assign a stratigraphic relationship between the church and the graveyard. However, it is likely that they were established at the same time, and that the church stood on land that had not previously been used for burial. It must be noted that this conclusion is drawn from what is only a very small percentage of the available archaeology on the site. Later activity, and pressure on the use of space, resulted in the relationship between the church and graveyard being compromised; grave cut (031) clearly cuts into the foundations of the original buttress (003, 028) (Fig.4).

Foundations for an earlier buttress, contemporary with the south wall of the nave, were revealed in plan and section (Figs.4 and 7). The initial foundations of the buttress, adjacent to the southern wall of the nave, was replaced at a later date by the introduction of brick and mortar footings, overlain by a significant ashlar buttress that

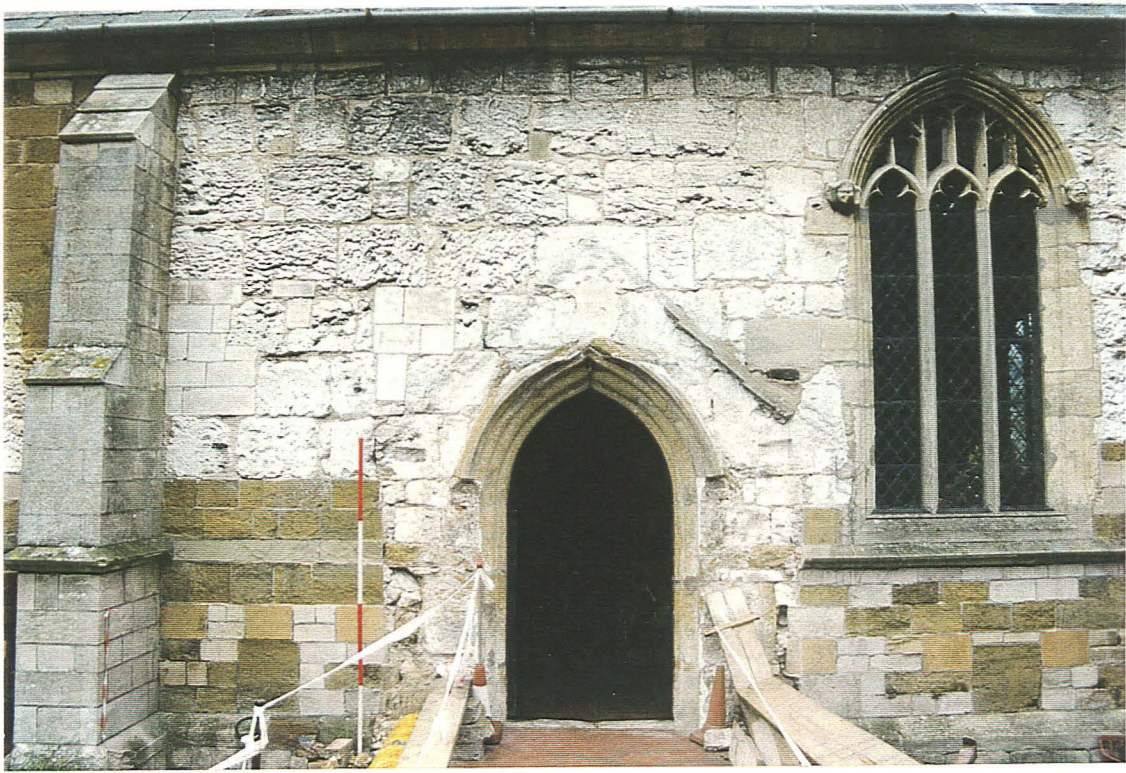
Plate 1: Area of Development. Showing entrance in medieval south nave wall and 'ghost' of 18th century porch

Demolition of this porch revealed the inner doorway, dated to the 14th century (Plate 1 and Fig.8). Features displayed by the doorway include continuous sunk wave moulding and a moulded hood. The nave roof is a 19th century timber barrel vault, but is supported on massive 15th century braced ties with blank shields towards the end of the braces, resting on 15th century corbels, probably repositioned; some of which are decorated with grotesque figures (*ibid*).

structure of (002) and forms the present buttress against the southern wall of the nave (Figs.3, 7 and Plate 1).

presently stands on the site (Plate 1). Deposits of mortar and building materials within adjacent features are likely to represent similar construction activities, though the machine excavation of the trenches has resulted in the comprehensive destruction of much of this complex sequence.

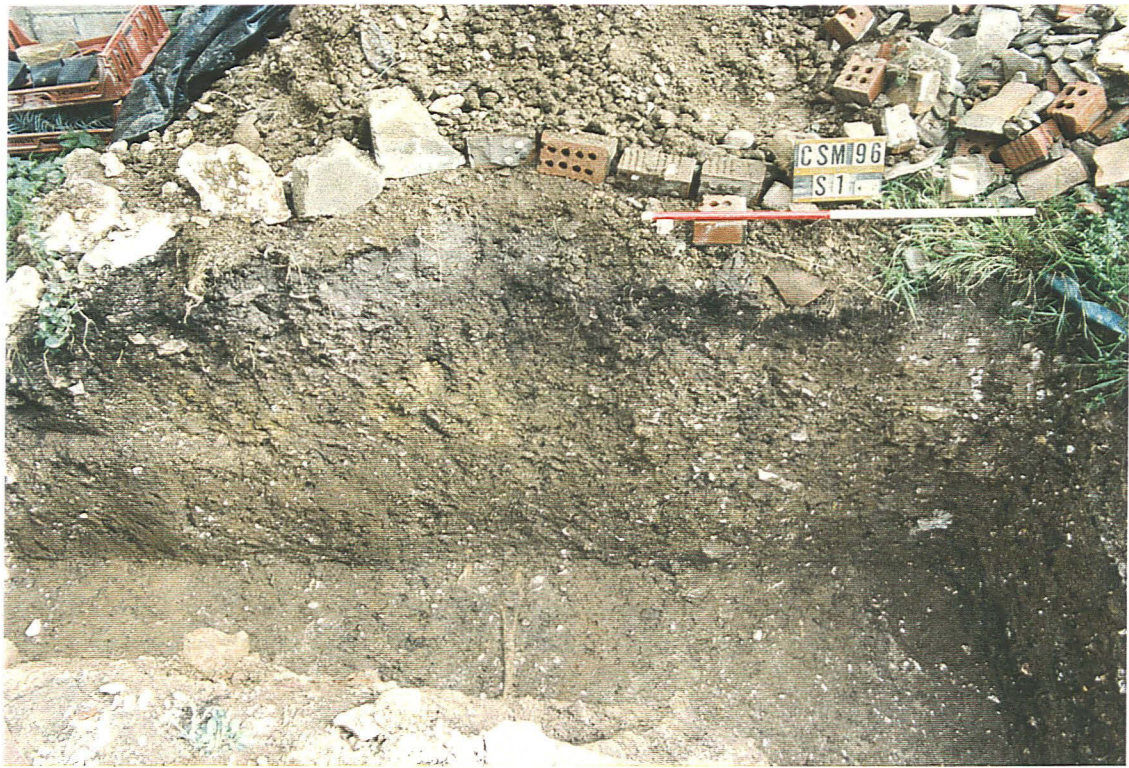
Plate 3: Section 1 (note burial in trench base)

A total of 17 possible grave cuts were identified during the watching brief (006, 008 (Plate 3), 011, 013, 016, 020, 026, 031, 047, 052, 054, 074, 077, 088, 101, 102 and 104), though only eight of these contained identifiable human remains. Human burials were exposed to a depth of 1.2m below the present ground surface.
