**ARCHAEOLOGICAL WATCHING BRIEF
AT
ST. PETER'S CHURCH,
SOUTH SOMERCOTES,
LINCOLNSHIRE
(SSP97)**

Work Undertaken For
Marshall Sisson Architect

March 1997

A.P.S. Report No. 9/97

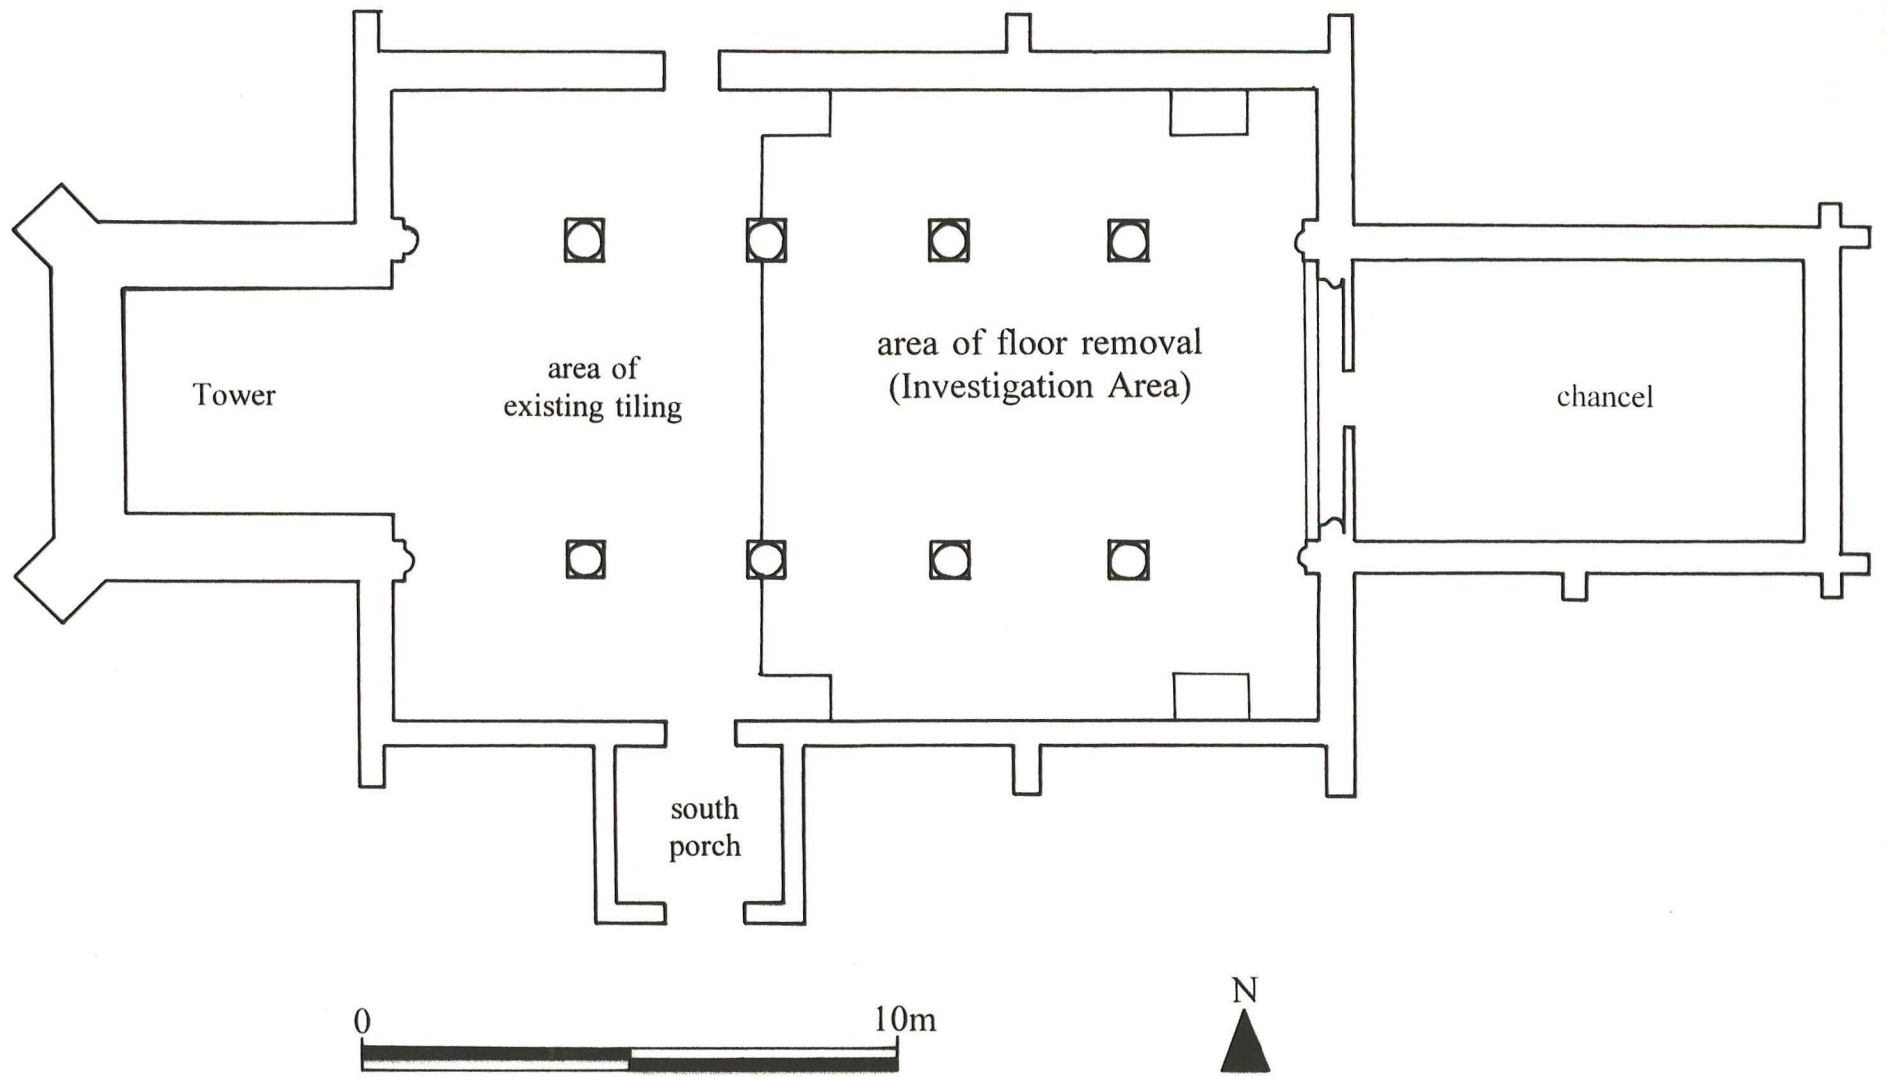
Fig. 3 St. Peter's Church, South Somercotes, showing area of investigation

2.4 Description of the church (Fig. 3)

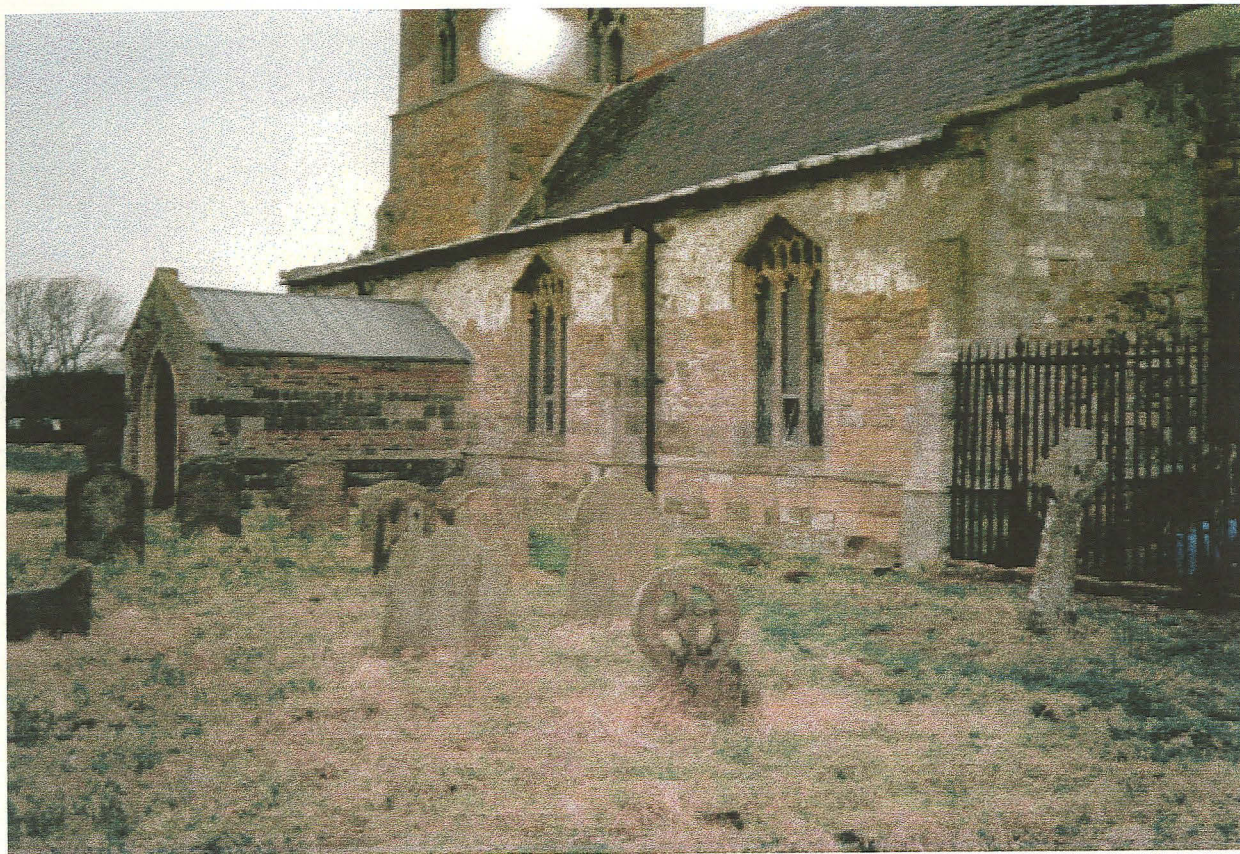
Plate 1 : General view, showing south porch.

St. Peter's church (Plate 1) dates to the 13th century, and is constructed of limestone, greenstone and ironstone coursed rubble, limestone ashlar and some red bricks. Alterations have occurred throughout the life of the church, including those undertaken in restoration work during 1866 and 1896 (DoE 1986, 53).

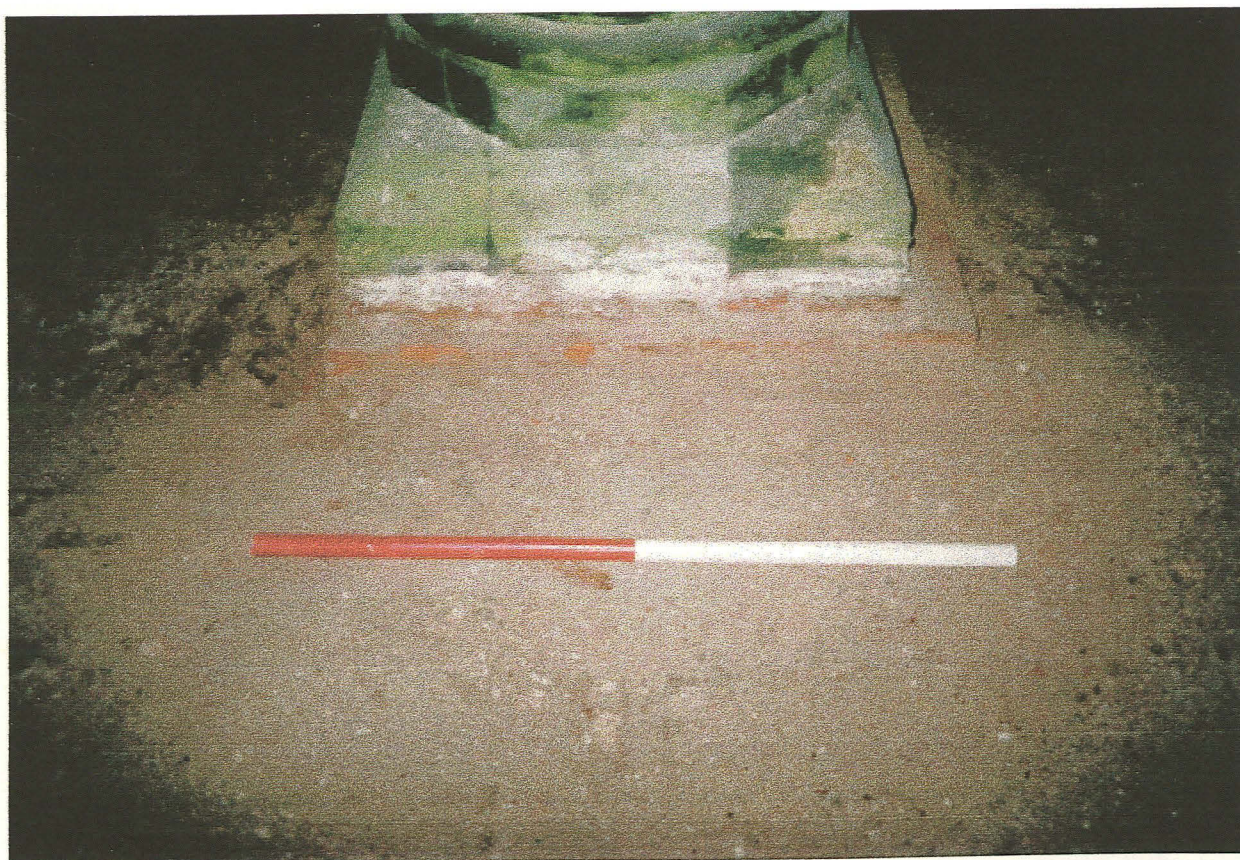
Plate 2 : Brick plinth at base of 13th century column

Piers, supporting the north and south arcades, were constructed at a similar date. Arcade abutments, either side of the chancel arch, and the first pier west of the chancel arch in the north arcade, rest directly onto the stonework of (001) and (011; Plates 3 and 4). The remaining piers within the area of investigation rest upon a foundation platform of 19th century brick and tile (Plate 2). This brick and tile directly overlies (001) and (011).

The circular arcade piers date to the 13th century, though they have 15th century chamfered arches, and are occasionally based upon 19th century brick plinths. Alterations are therefore likely to have disturbed the original position of these piers. However, the situation of the walls, recorded beneath the piers, may suggest that they date to the establishment of an earlier church.
