Fiskerton, Lincs.

Mains Relay:

Archaeological Monitoring

Report prepared for Anglian Water Services

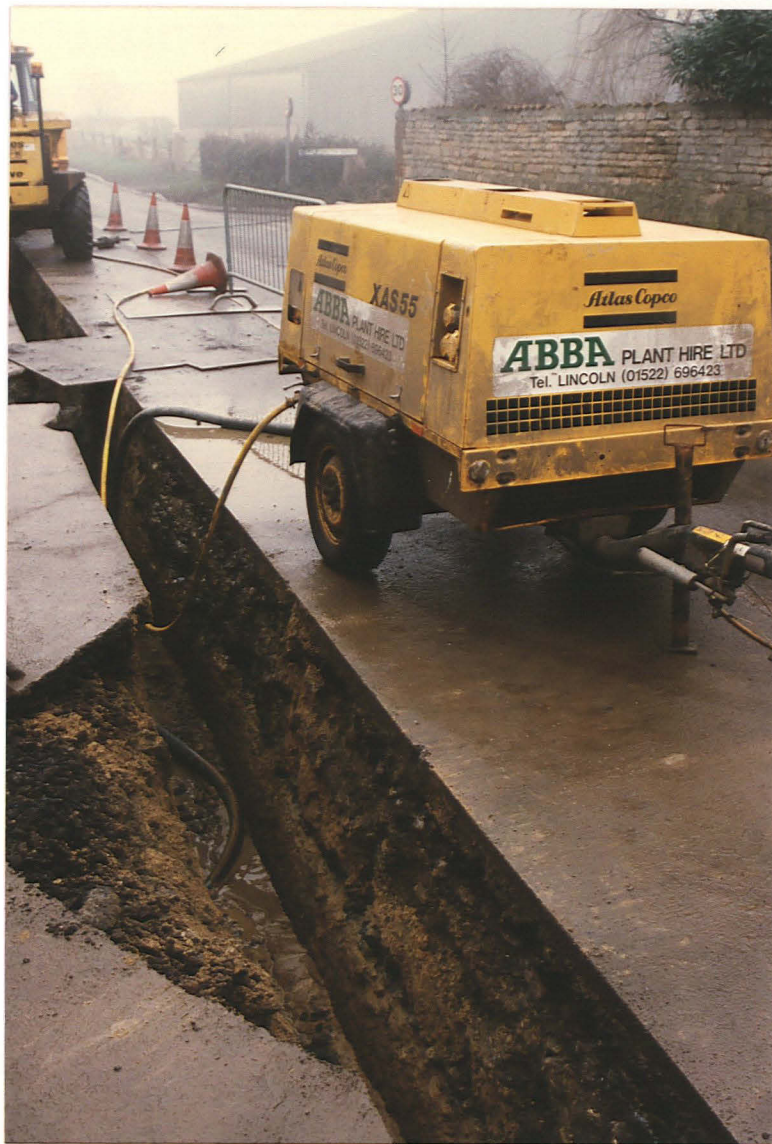
Pl. 1 Trenching along Reepham Road close to Blacksmith Road (looking east).

3. A linear spread of rounded pebbles was seen 0.3-0.4m below the modern road surface east of Plough Lane (Pls. 1 and 2). This cobbled road surface was aligned towards Plough Lane rather than along the present course of Reepham Road and probably marks the post-medieval lane which has since been realigned south of 'Chapel Side'.

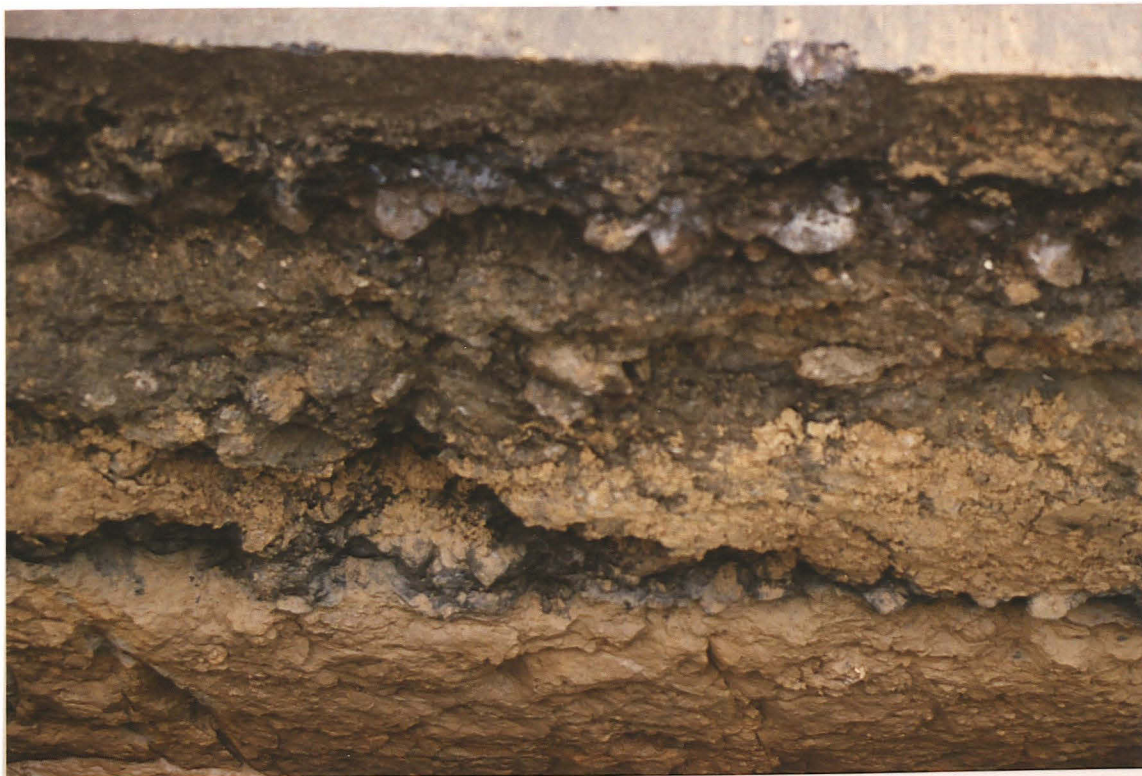
Pl. 2 Spread of rounded pebbles of a post-medieval road below the modern road surface east of Plough Lane 3.

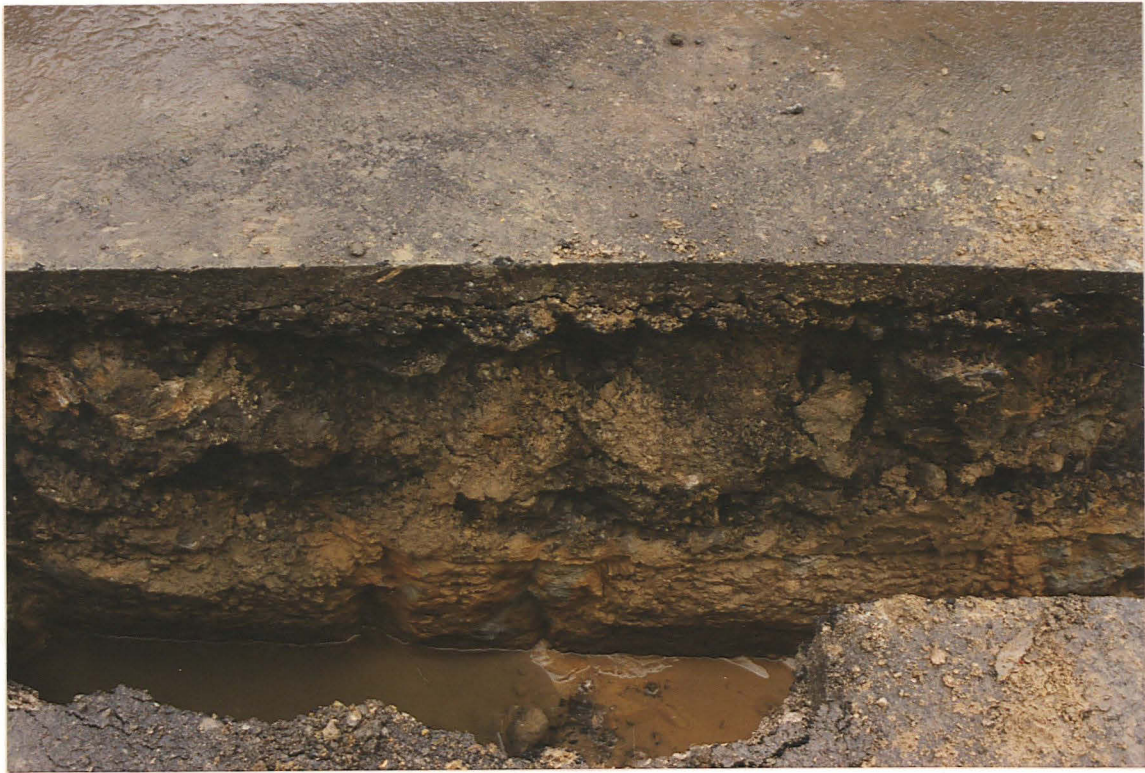
Pl. 3 The trench at 4 revealed thick road foundation material (perhaps in a roadside ditch) overlying black soil. Beneath this were sand flood deposits.

4. The trench south of 'Talltop' revealed road foundation material to 0.45m deep, overlying 0.25m of black soil. Beneath this sand (possibly flood warp deposits) was visible (Pl. 3). The sequence was only seen on the northern side of the trench and may indicate an early roadside ditch over which more recent roads have been extended.

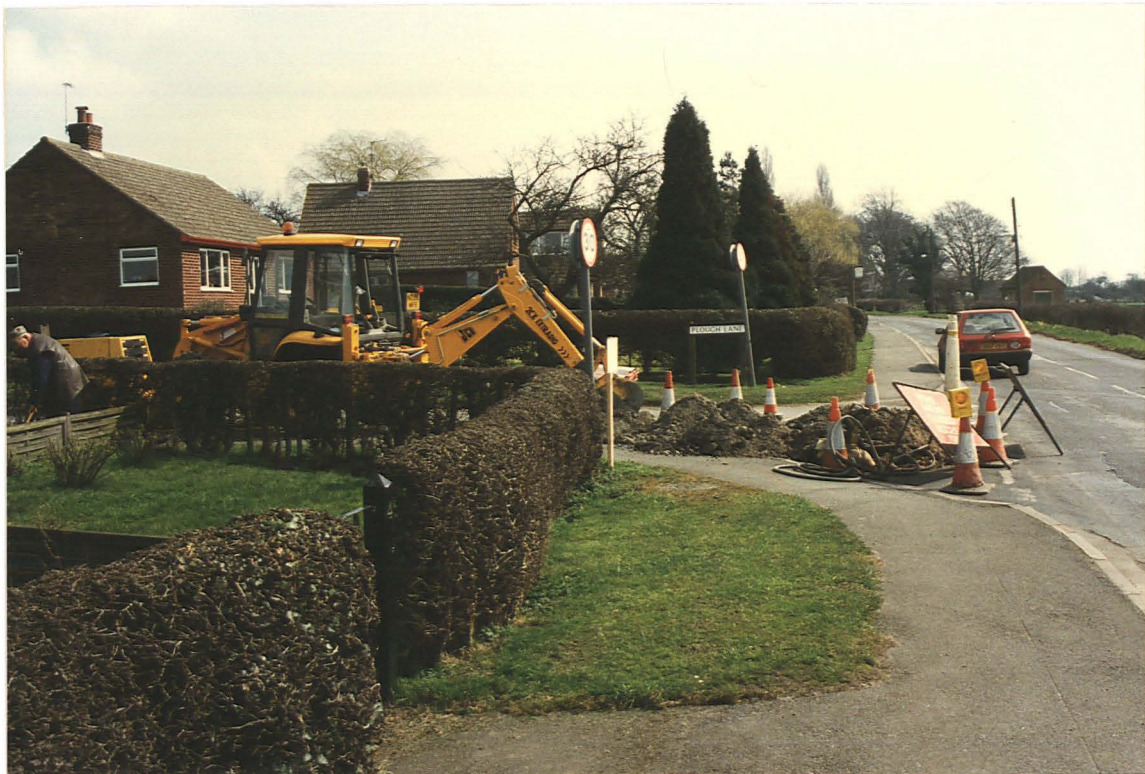
Pl. 4 Plough Lane at the western edge of the village (looking east along Lincoln Road).

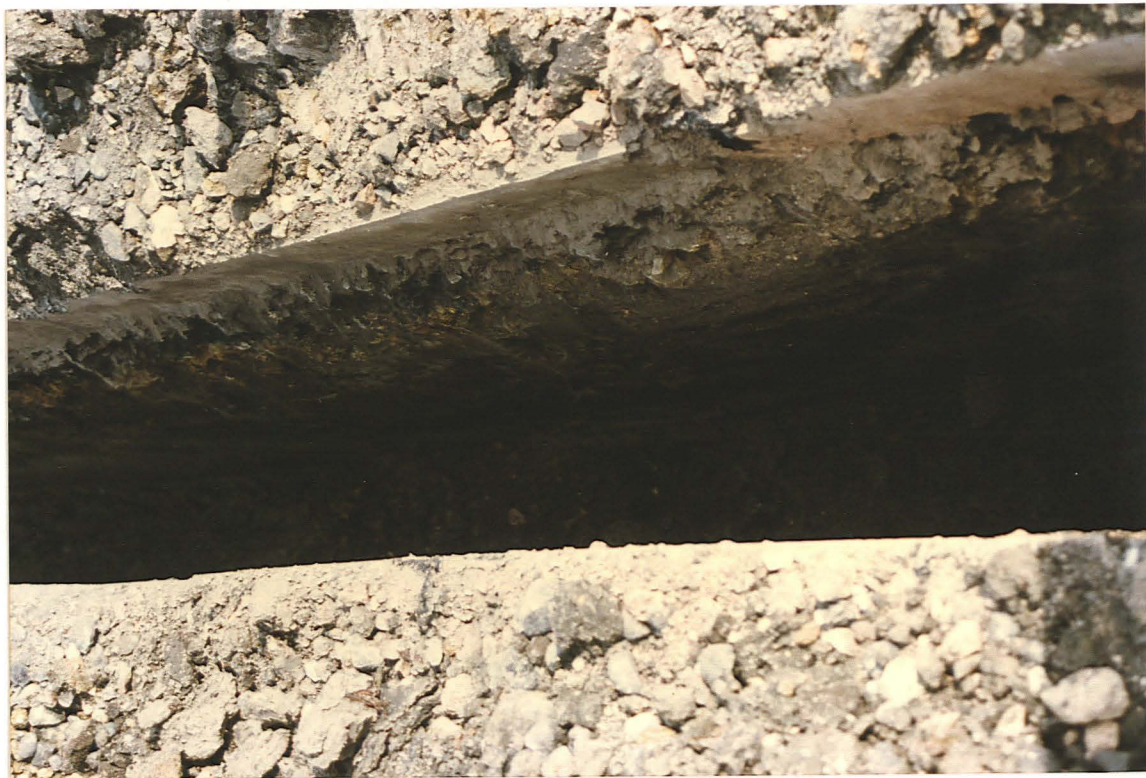
Pl. 5 Grey/white sand at the base of the slope in Plough Lane 5.

5. At the base of the slope, west of 'Fen View', a deposit of grey/white sand was visible from 0.5m below the road surface to at least the trench base at about 1m (Pl. 5). It was suspected that this sand might be the fill of a roadside ditch, and not representative of deposits at this point. To the north the trench cut through siltier deposits beneath the road foundation of limestone lumps.

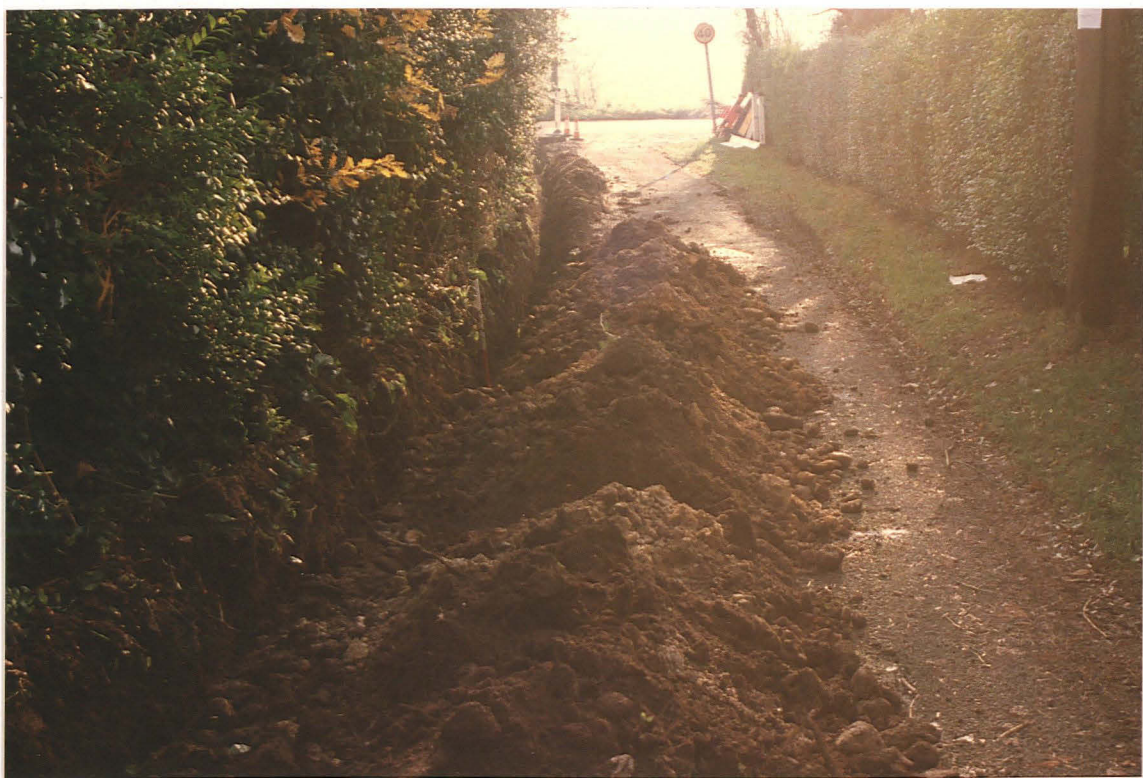
Pl. 6 In Orchard Road, large rounded pebbles forming a metalled surface were seen in the trench face 8 (looking south).

8. West of 'Ringwood' large rounded pebbles were seen in the trench face and in the spoil heap (Pls. 6 and 7). These appeared to form a metallated surface close to which several fragments of tile (one piece Roman) were recovered.

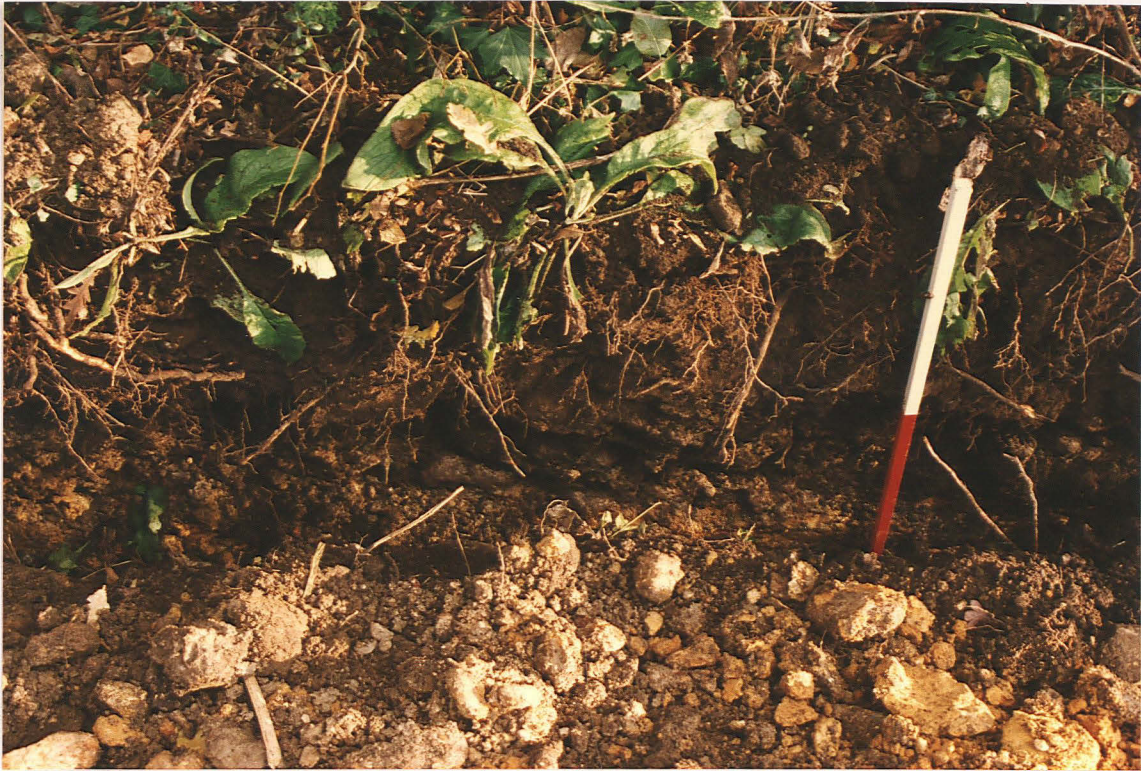
Pl. 7 Rounded pebbles in trench spoil (foreground) and in the trench face 8 (looking east, scale divisions 0.5m).

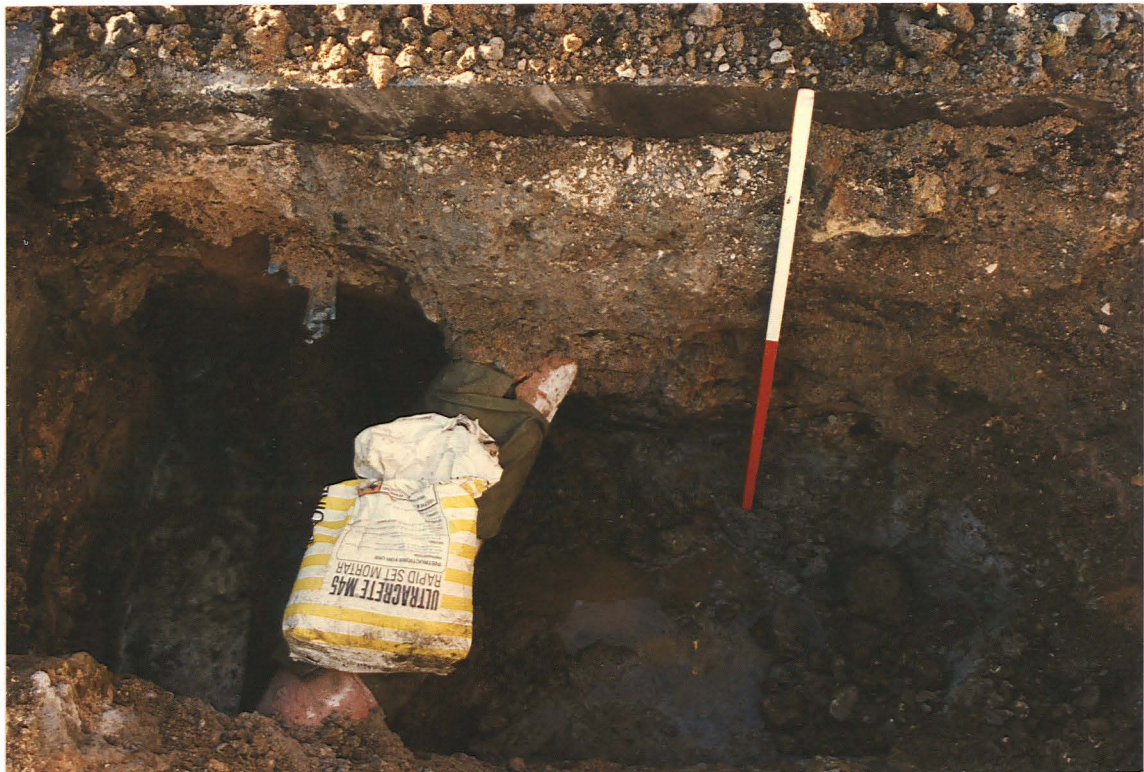
Pl. 8 At the junction of Orchard Road with Lincoln Road 11 slight traces of peat were seen below a ceramic pipe. Looking west, scale divisions 0.5m).

11. At the junction with Lincoln Road slight traces of peat were seen on the surface of bedrock 0.7m below the road surface (Pl. 8).

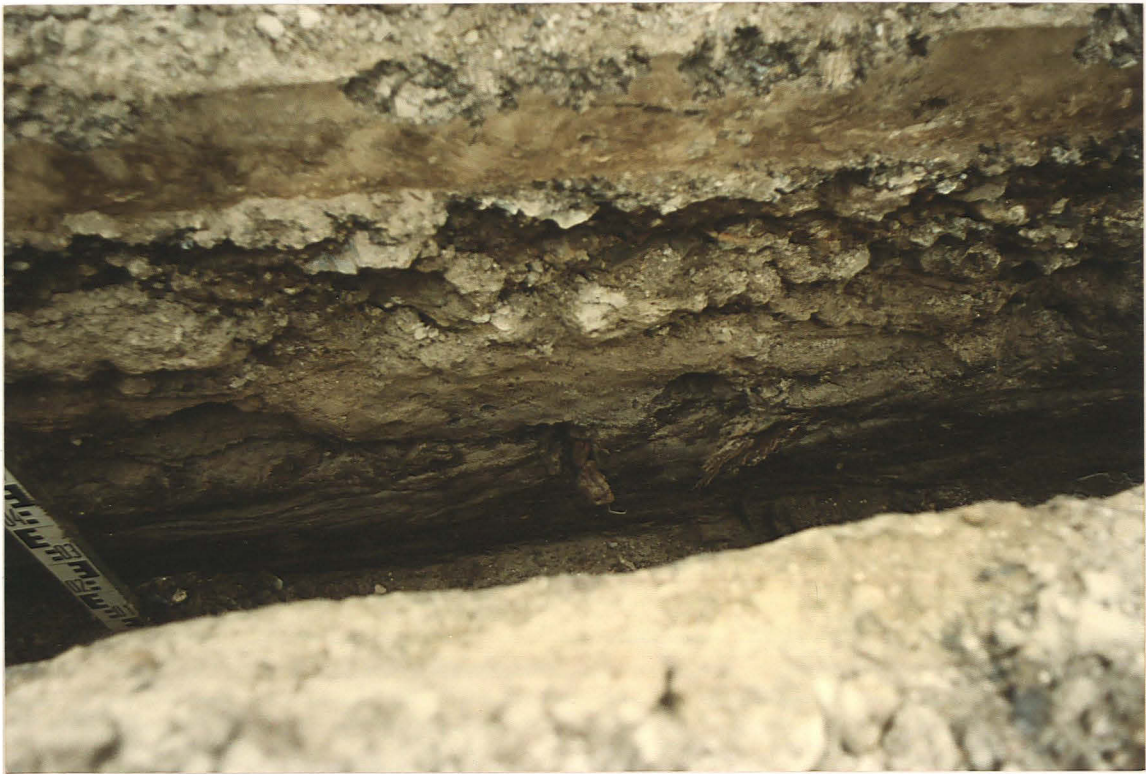
Pl. 9 Twig and small branch detritus in a former watercourse at 13, west of 'Ashwell Cottage'.

13. West of 'Ashwell Cottage' a peaty silt layer was seen in the trench faces (Pl. 9). This seems to have been situated at the eastern edge of a former depression centred between 'Perrin's Cottage' and west of 'Five Mile House', where small pieces of wood 30-60mm diam. were seen in the exposed peat (Pl. 10). None of these pieces appeared to have been sliced, cut or otherwise

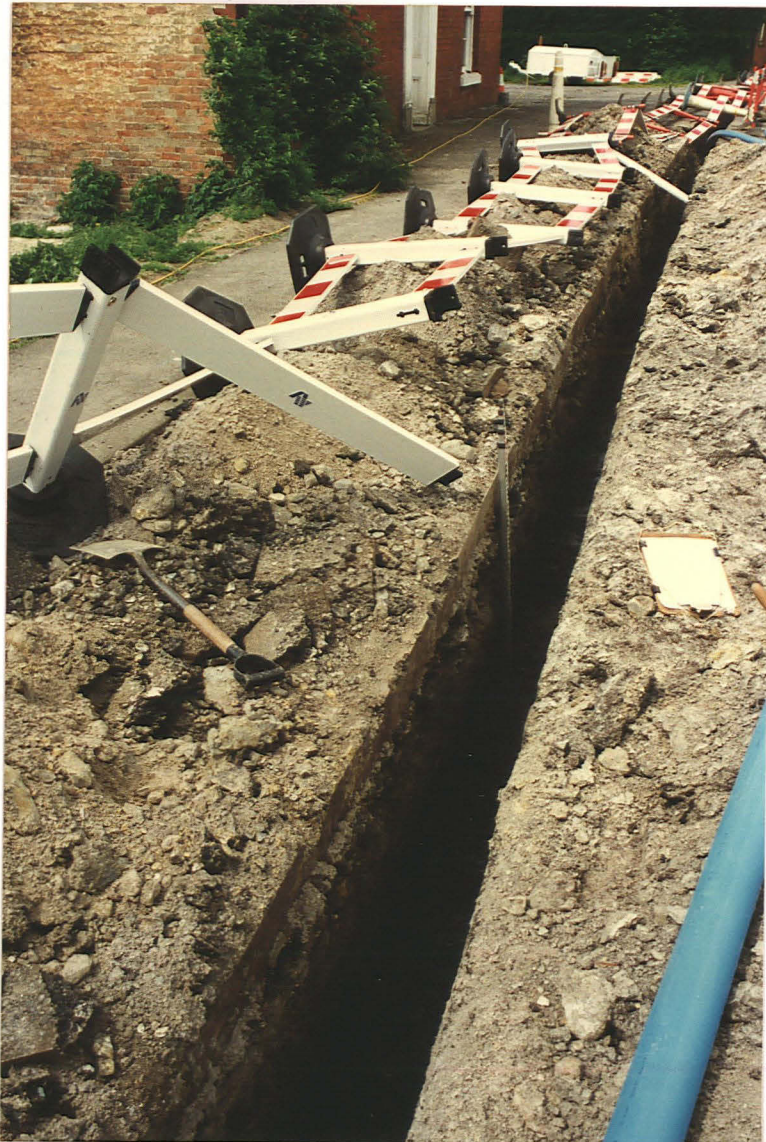
Pl. 10 Location of the peat formation centred between 'Perrin's Cottage' and 'Five Mile House' 13. Looking west past 'Five Mile House'.

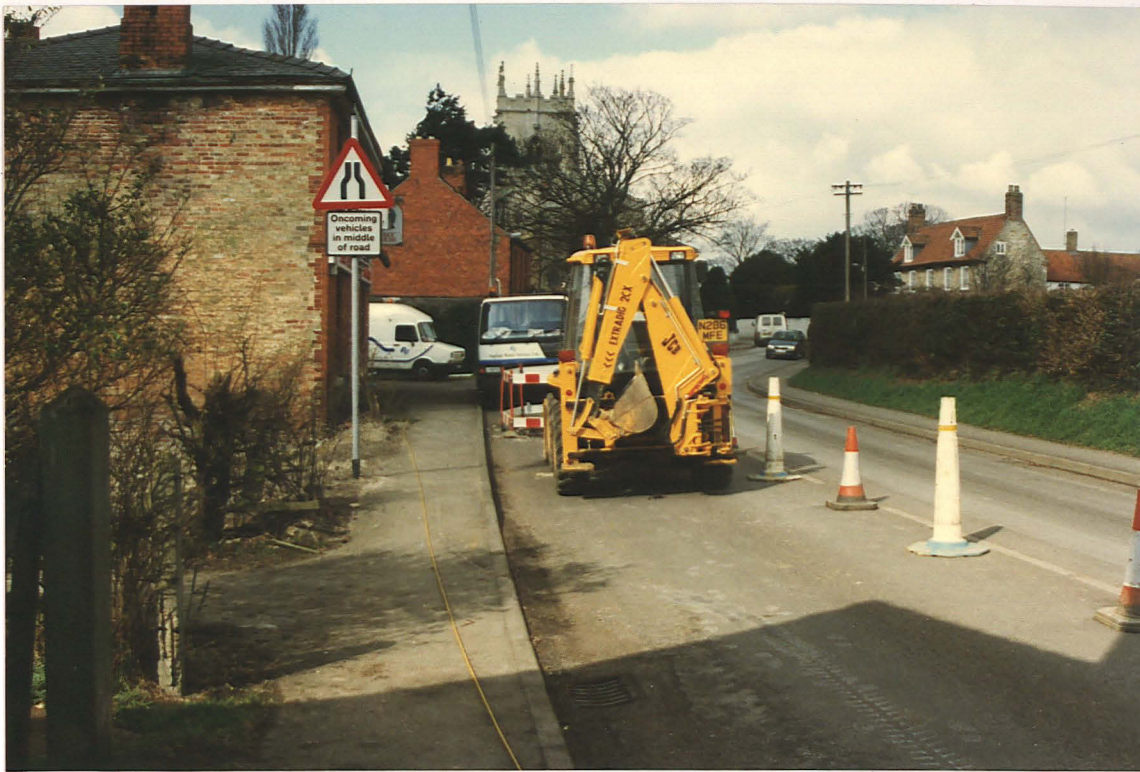
Pl. 11 The silt and peat 13 continued to the west of 'Five Mile House'. The trench barriers mark the position of Pl. 12 (looking west).

adapted for use and they did not form part of a structure or feature: they seemed to be twig and small branch detritus in a former watercourse. The sequence recorded consisted of white silt with peat lenses beneath the modern road foundation, overlying a thin peat layer; this sequence continued past 'Five Mile House' (Pls. 11 and 12). Yellow sandy clay was present 1.2m deep at the trench base (Pl. 13).

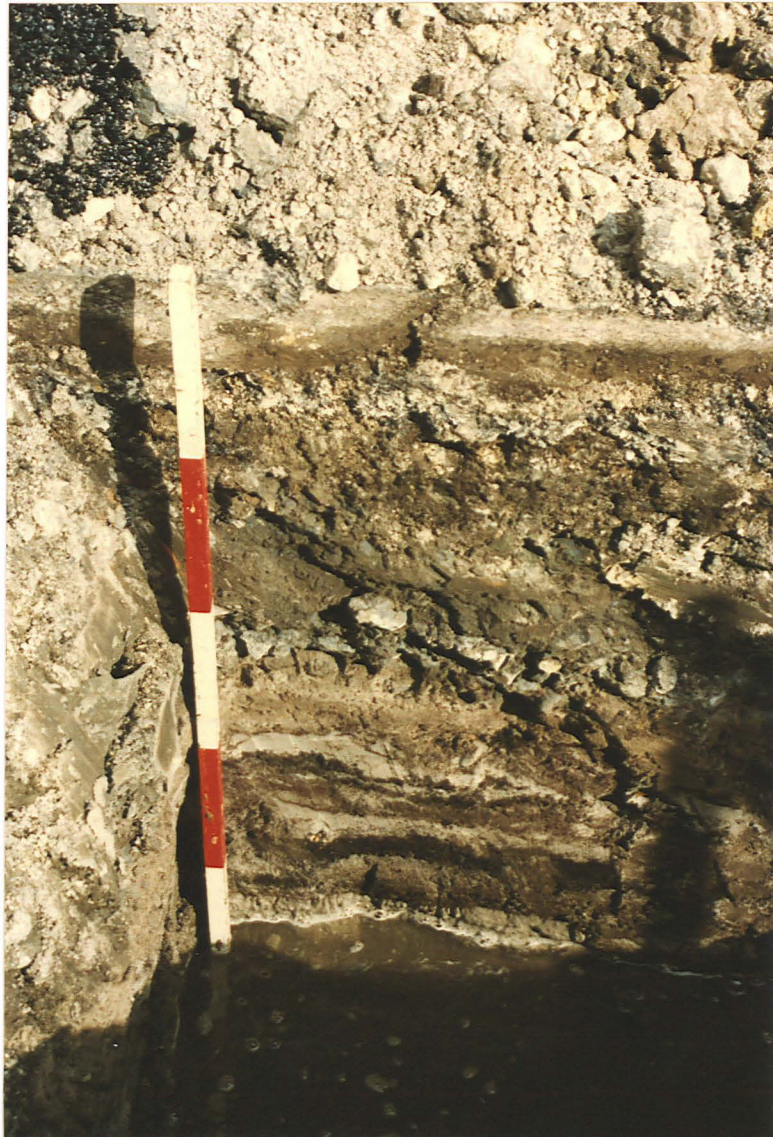
Pl. 12 Sequence of silts and peat 13 west of 'Five Mile House' (scale divisions 0.2m).

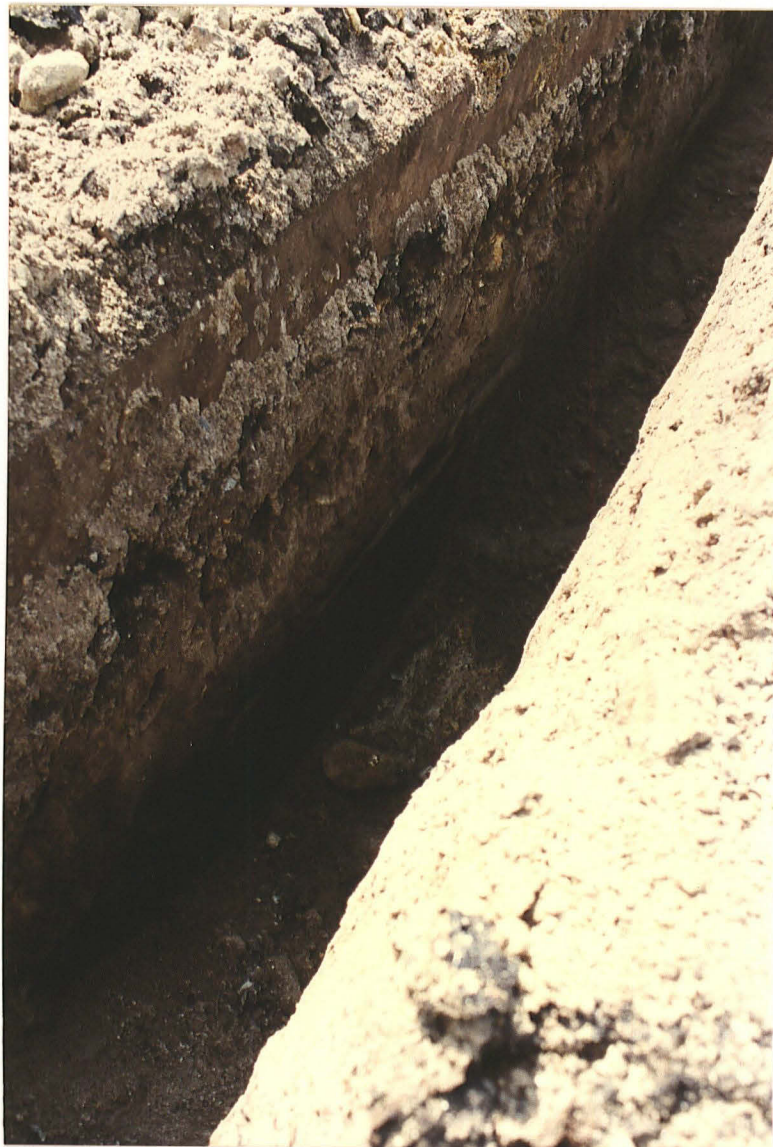
PI. 13 Yellow sandy clay flood warp was exposed at 13 on the base of the pipe trench.

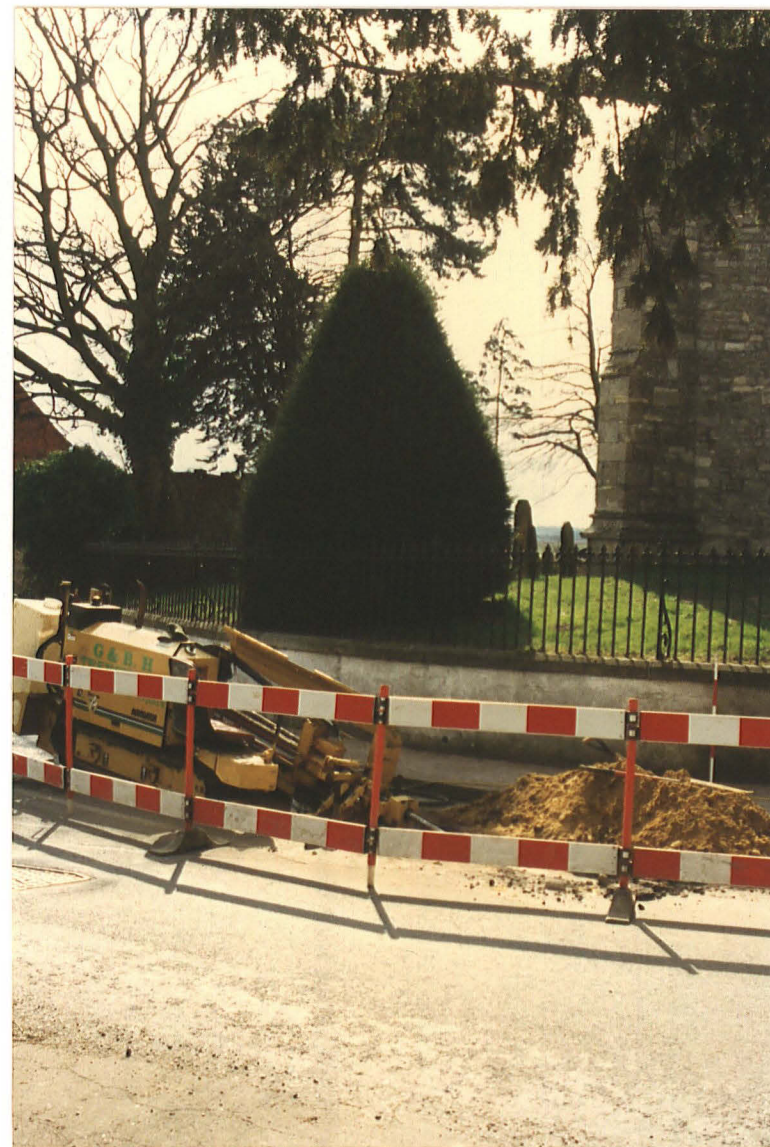
PI. 14 Yellow sandy material from a moling pit in the road close to the NE corner of St. Clement's Church 15 (looking south).

15. A moling pit excavated in the road close to the NE corner of St. Clement's Church cut through yellow sandy brash, possibly flood warp deposits (Pl. 14).

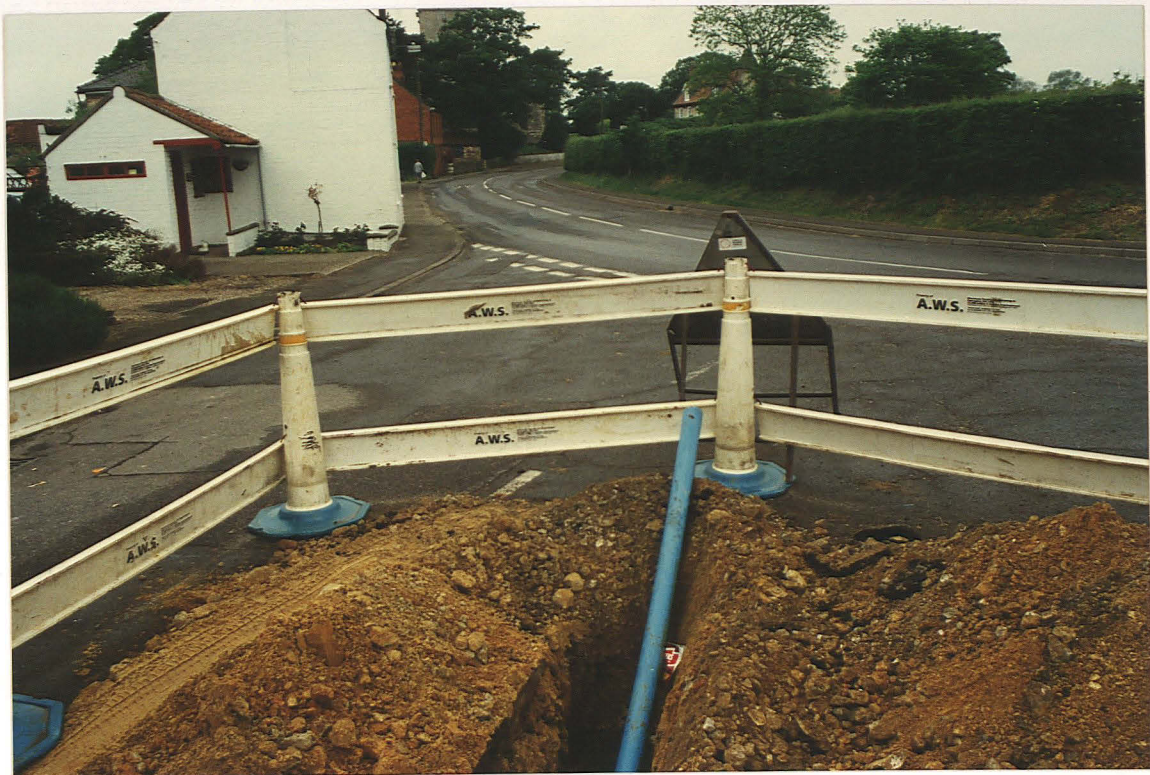
Pl. 15 Junction of Nelson Road and High Street. (looking west).

19. SE of 'Nemo Cottage' the trench cut through a thick deposit of bright yellow sand to 0.9m below the surface and no other layers were observed beneath modern topsoil. This sequence continued to the High Street junction where the road had been constructed on a spread of limestone rubble 0.15m thick.

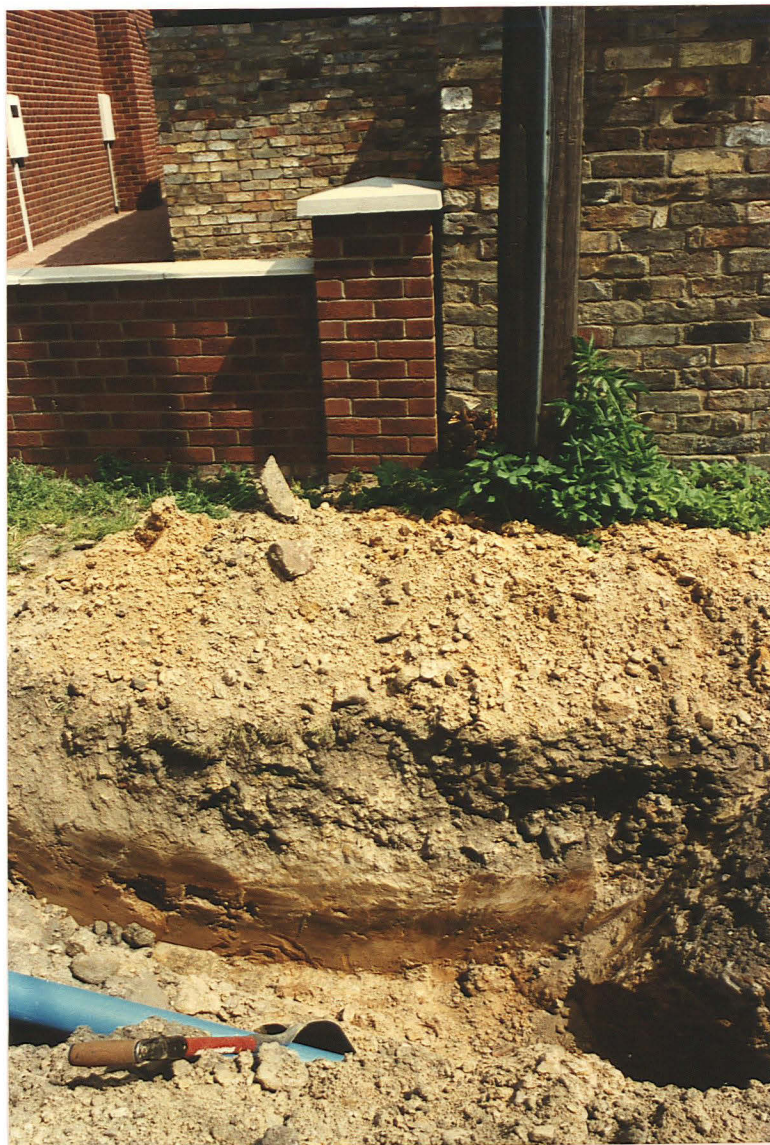
Pl. 16 Trench deposits at 17, close to 'Ferndale' in Nelson Road (looking north).

17. At the SE end of the road, close to 'Ferndale', no peat was present in the trench which cut through a thick sandy (possibly flood warp) deposit with no finds (Pl. 16).

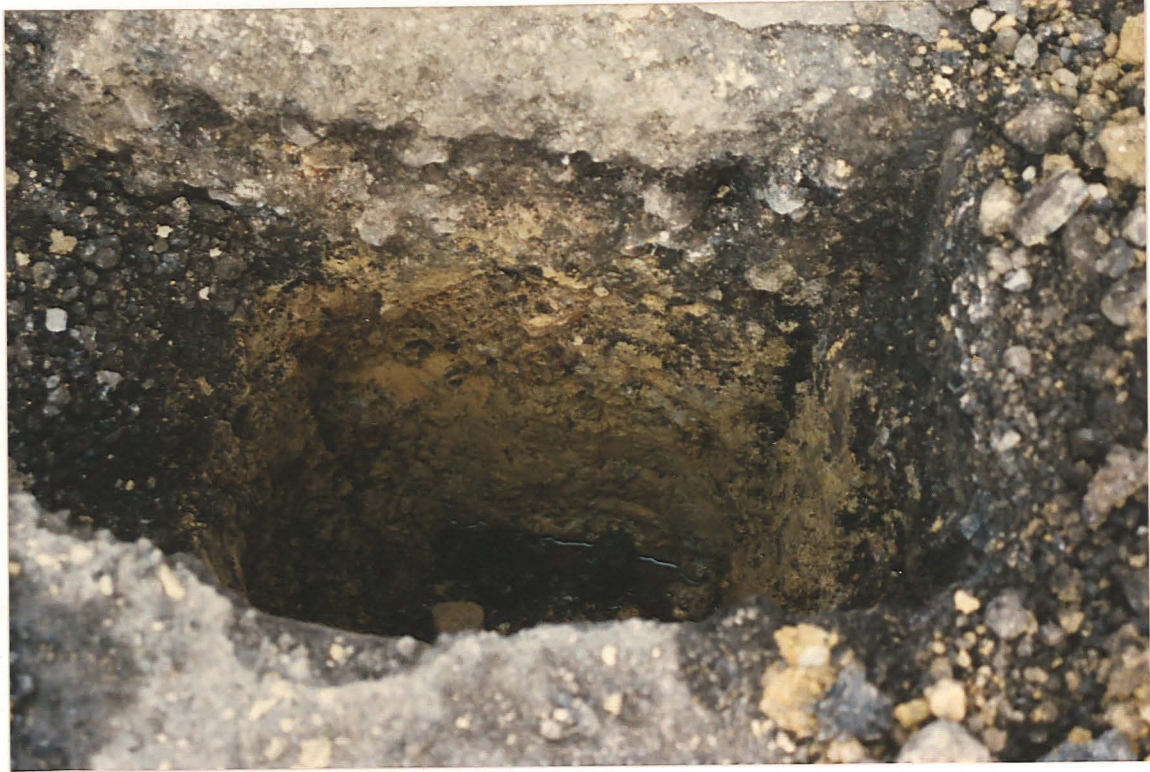
Pl. 17 Small hole excavated for the directionally-drilled pipe at 21, between 'Greengates' and the 'Carpenter's Arms'.

21. Between 'Greengates' and the 'Carpenter's Arms' several small holes were excavated for the directionally-drilled pipe. These revealed light grey sand and fragments of wood but no peat (Pl. 17). Here the indications are that this land lay within a creek.

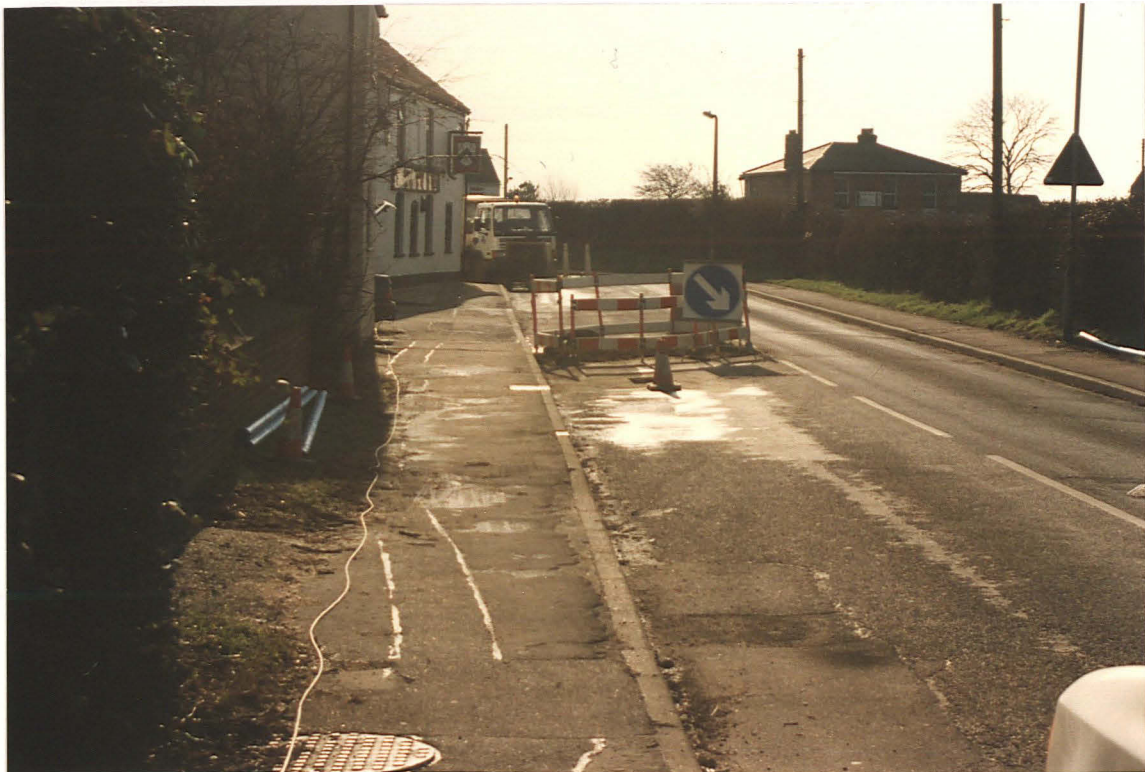
Pl. 18 Position of trench NW of the 'Carpenter's Arms' car park 22 (looking SW).

22. In an east-west trench 1.2m long excavated to receive the moled pipe NW of the 'Carpenter's Arms' car park, a deposit of grey soil with peat 0.18m thick was revealed 0.5m below the road surface (Pls. 18 and 19). The base of the peat layer dropped by 0.15m across the length of the trench, suggesting a slope downwards to the east. Beneath the peat layer was a mixed deposit of yellow and grey clay with sand, presumably close to the base of the depression.

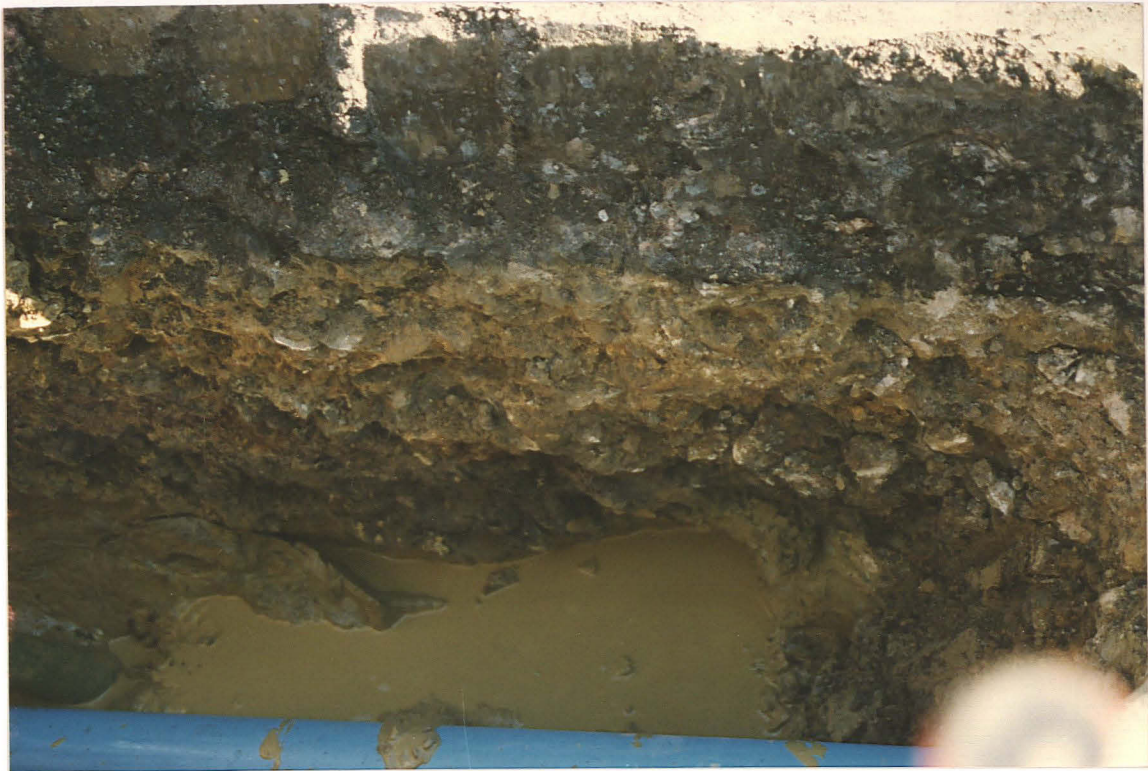
Pl. 19 Sequence of deposits at 22, showing a deposit of grey soil with peat 0.5m below the road surface. Beneath the peat was yellow and grey clay with sand.

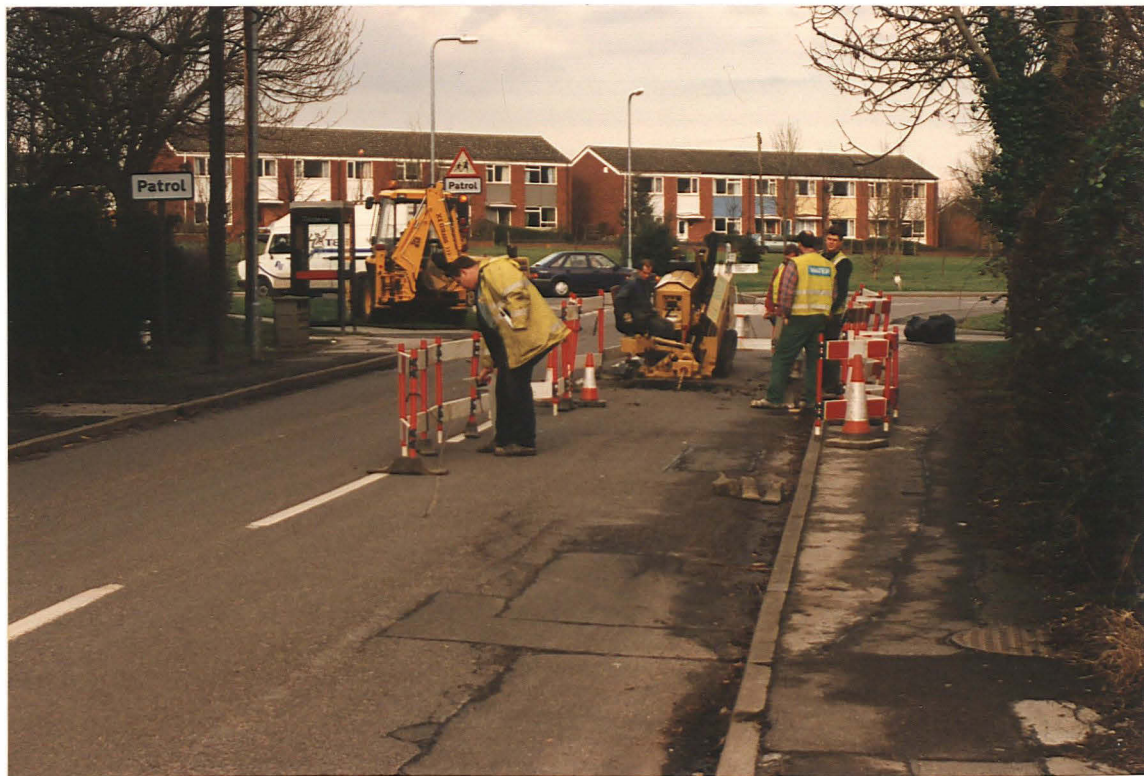
Pl. 20 The trench at 23, SW of 'Holt Farm' (looking NE).

23. SW of 'Holt Farm' the trench cut through made-up ground before reaching sandy material (Pl. 20). The extent and date of the disturbance was not apparent; it may have been fill of an adjacent service trench.
