**Land to the rear of the Old Post Office
Main Street, Torksey
Archaeological Desk Top Study
Site Code: TPO 97
LCNCC Museum Accn No. 106.97**

DESK TOP STUDY

**Land to the rear of the Old Post Office
Main Street, Torksey
Archaeological Desk Top Study
Planning Application: 96/P/0633
NGR: SK 8379 7875
Site Code: TPO 97
LCNCC Museum Accn No. 106.97**

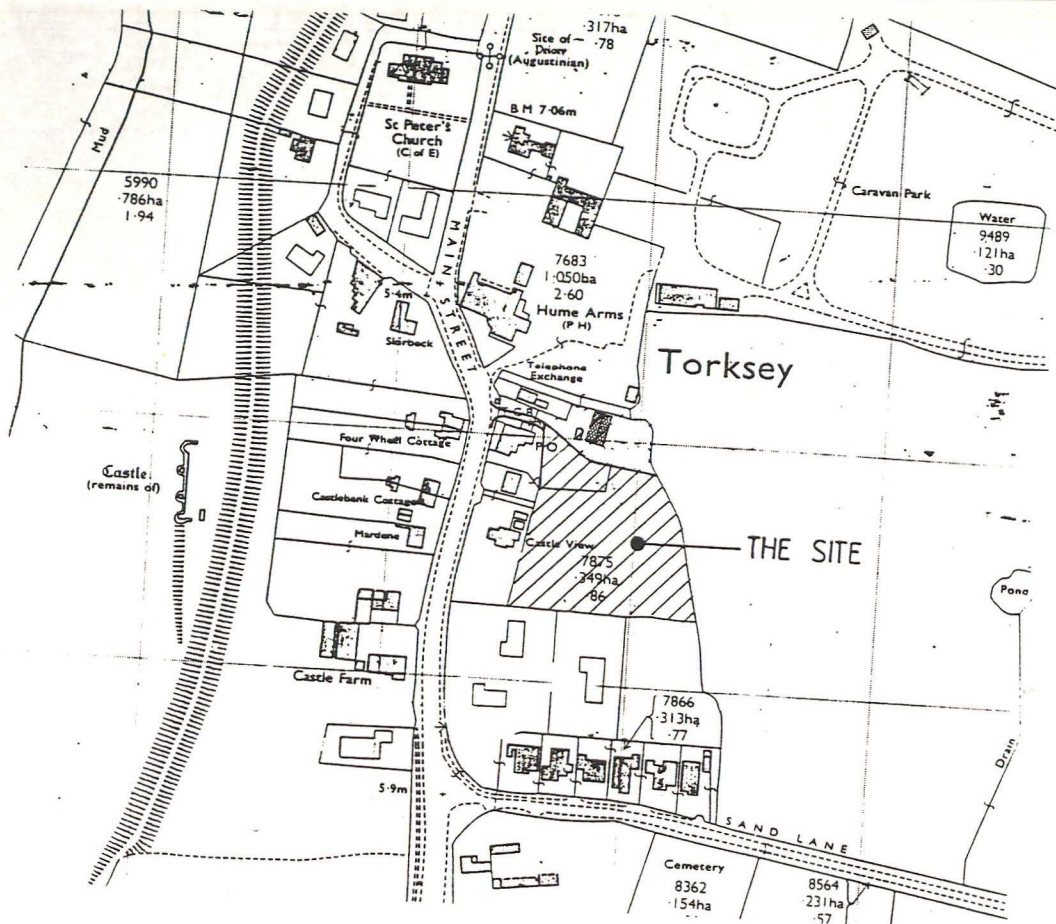
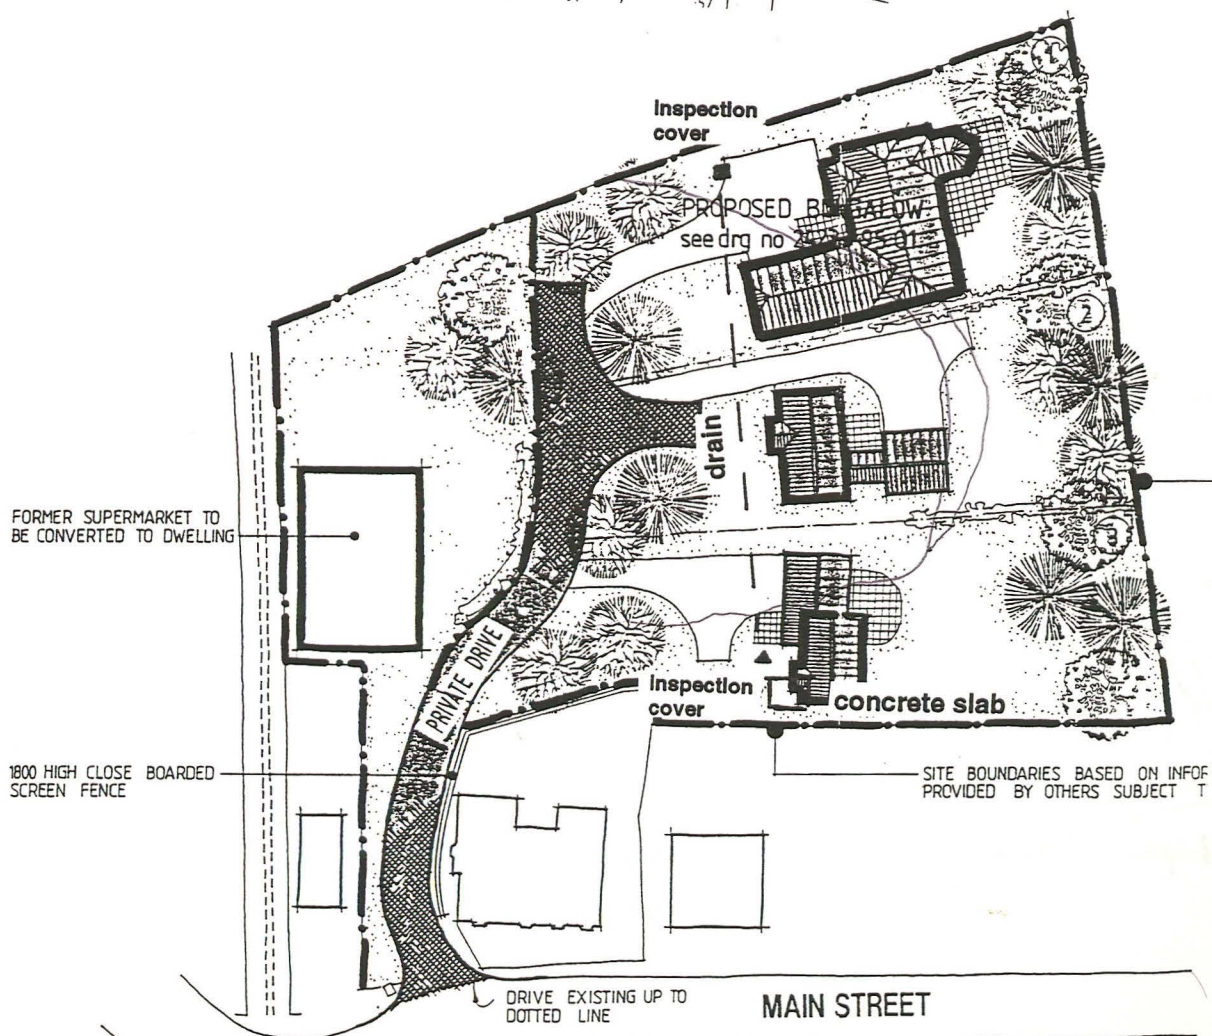
The plot is located east of Main Street, to the rear of the Old Post Office, and covers an area approximately 0.35ha in extent (Figs. 1 and 2). The land is currently rough grass and has been subdivided into three plots by two north-south post-and-rail fences.

Fig. 2 Main Street, Torksey. Proposed development site a) Reproduced from the 1:2500 O.S. map (reduced scale) with the permission of the Controller of HMSO, © copyright. Licence No. AL50424A. b) plan supplied by Costall Allen Design (reduced scale).

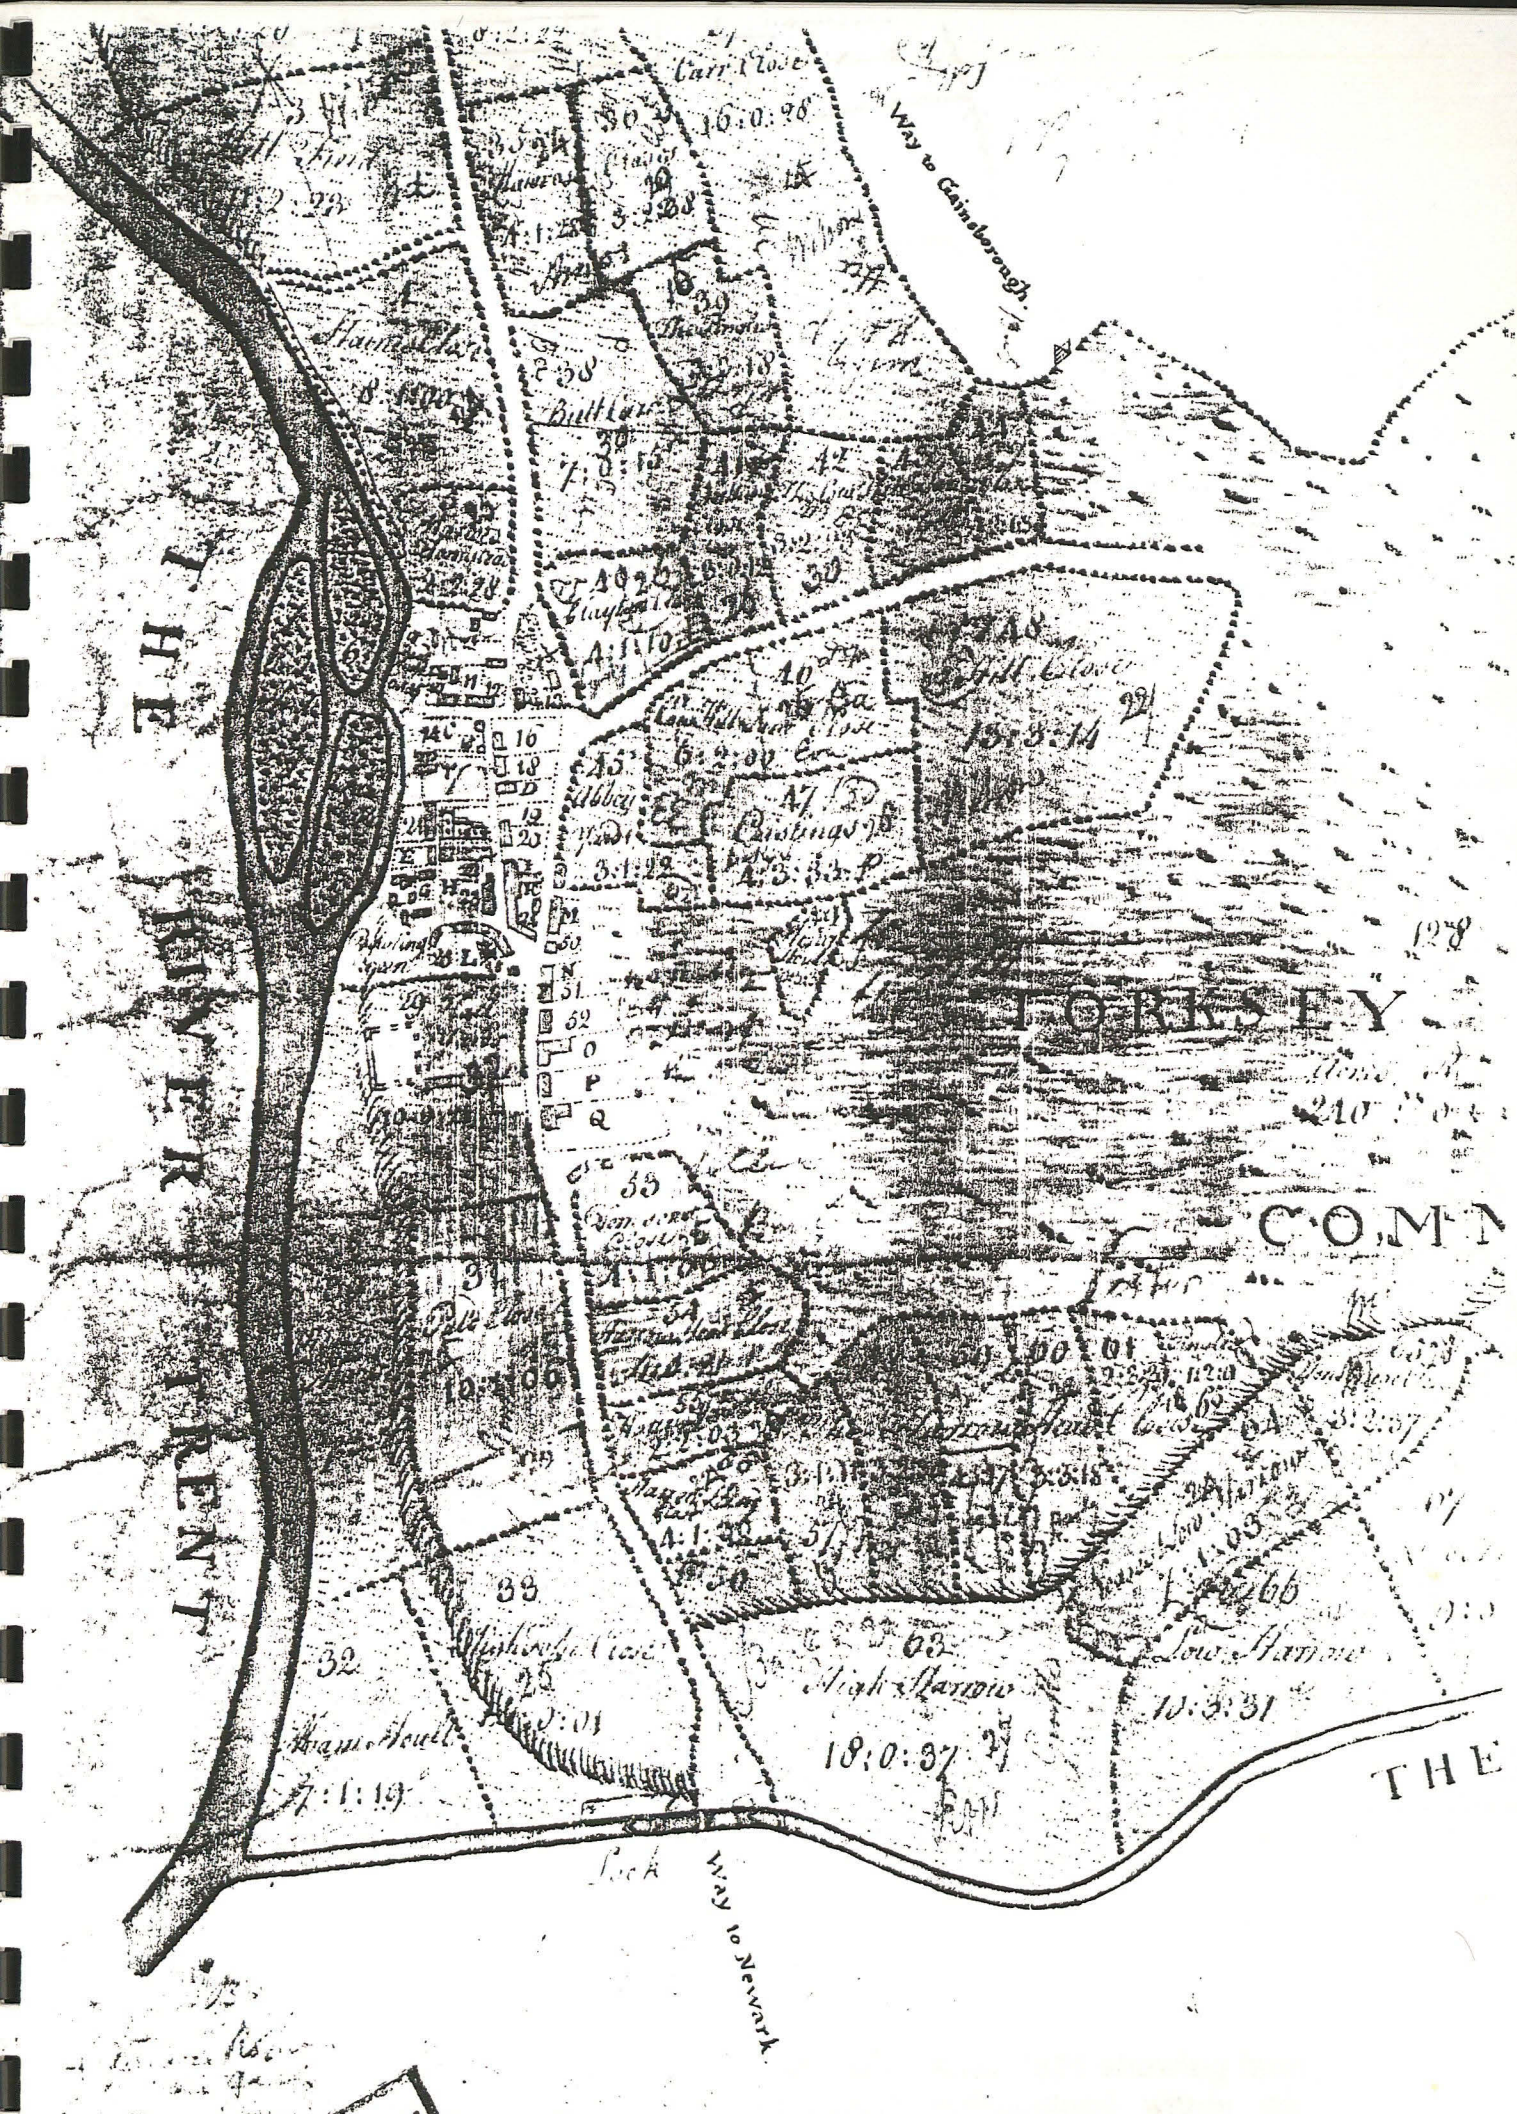
An estate map of Torksey dated 1751 (Fig. 3) shows this part of the village as part of the main street with houses along the frontage and open ground to the rear. A much more detailed and larger-scale map of 1821 shows buildings along the frontage and to the rear which are described as Farm House, Offices & Homestead (Fig. 4). The 1843 survey is less detailed but still shows buildings along the street frontage (Fig. 5). Farm buildings, including a stable block were demolished in recent years (see below) and it is possible that they were the buildings depicted on Fig. 3. It is likely that the main buildings shown on Fig. 3 lay west of the development area but that the stable block extended into the first plot. The remainder of the site appears to have been open ground for some considerable time.

Fig. 3 Main Street, Torksey. Estate map of Torksey 1751 showing buildings along the street frontage (LAO ref. 3 BNL 13)

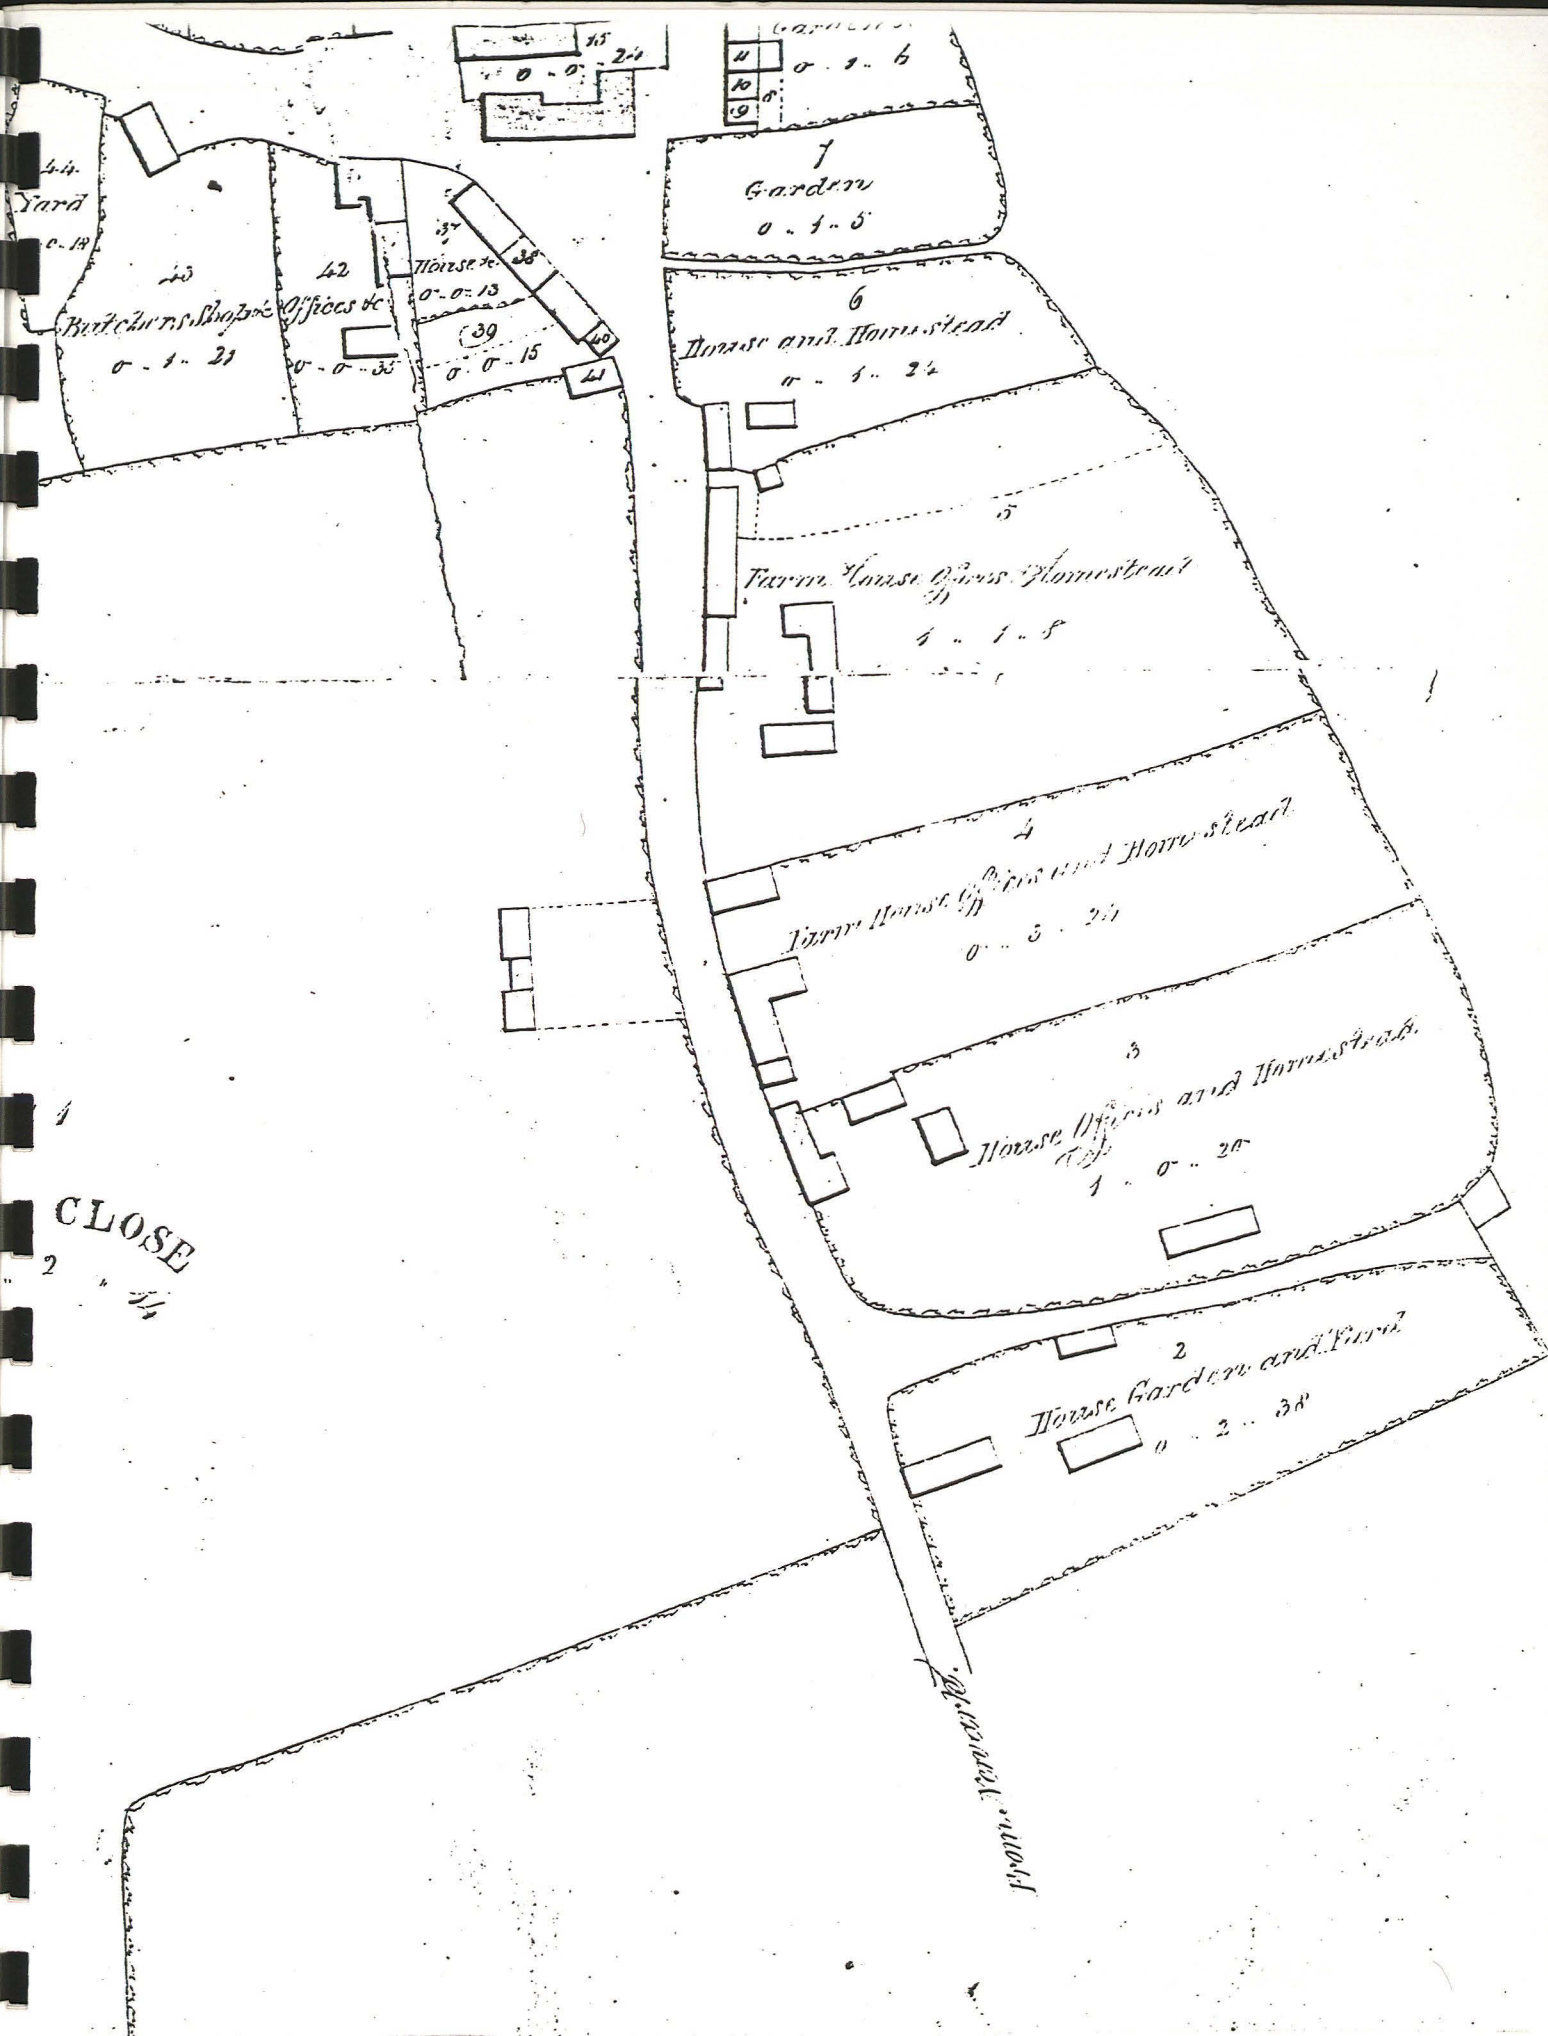
Fig. 4 Main Street, Torksey. Estate map of Torksey 1821 showing farm along the street frontage and associated outbuildings within the proposed development (LAO ref. 3 BNL 15)

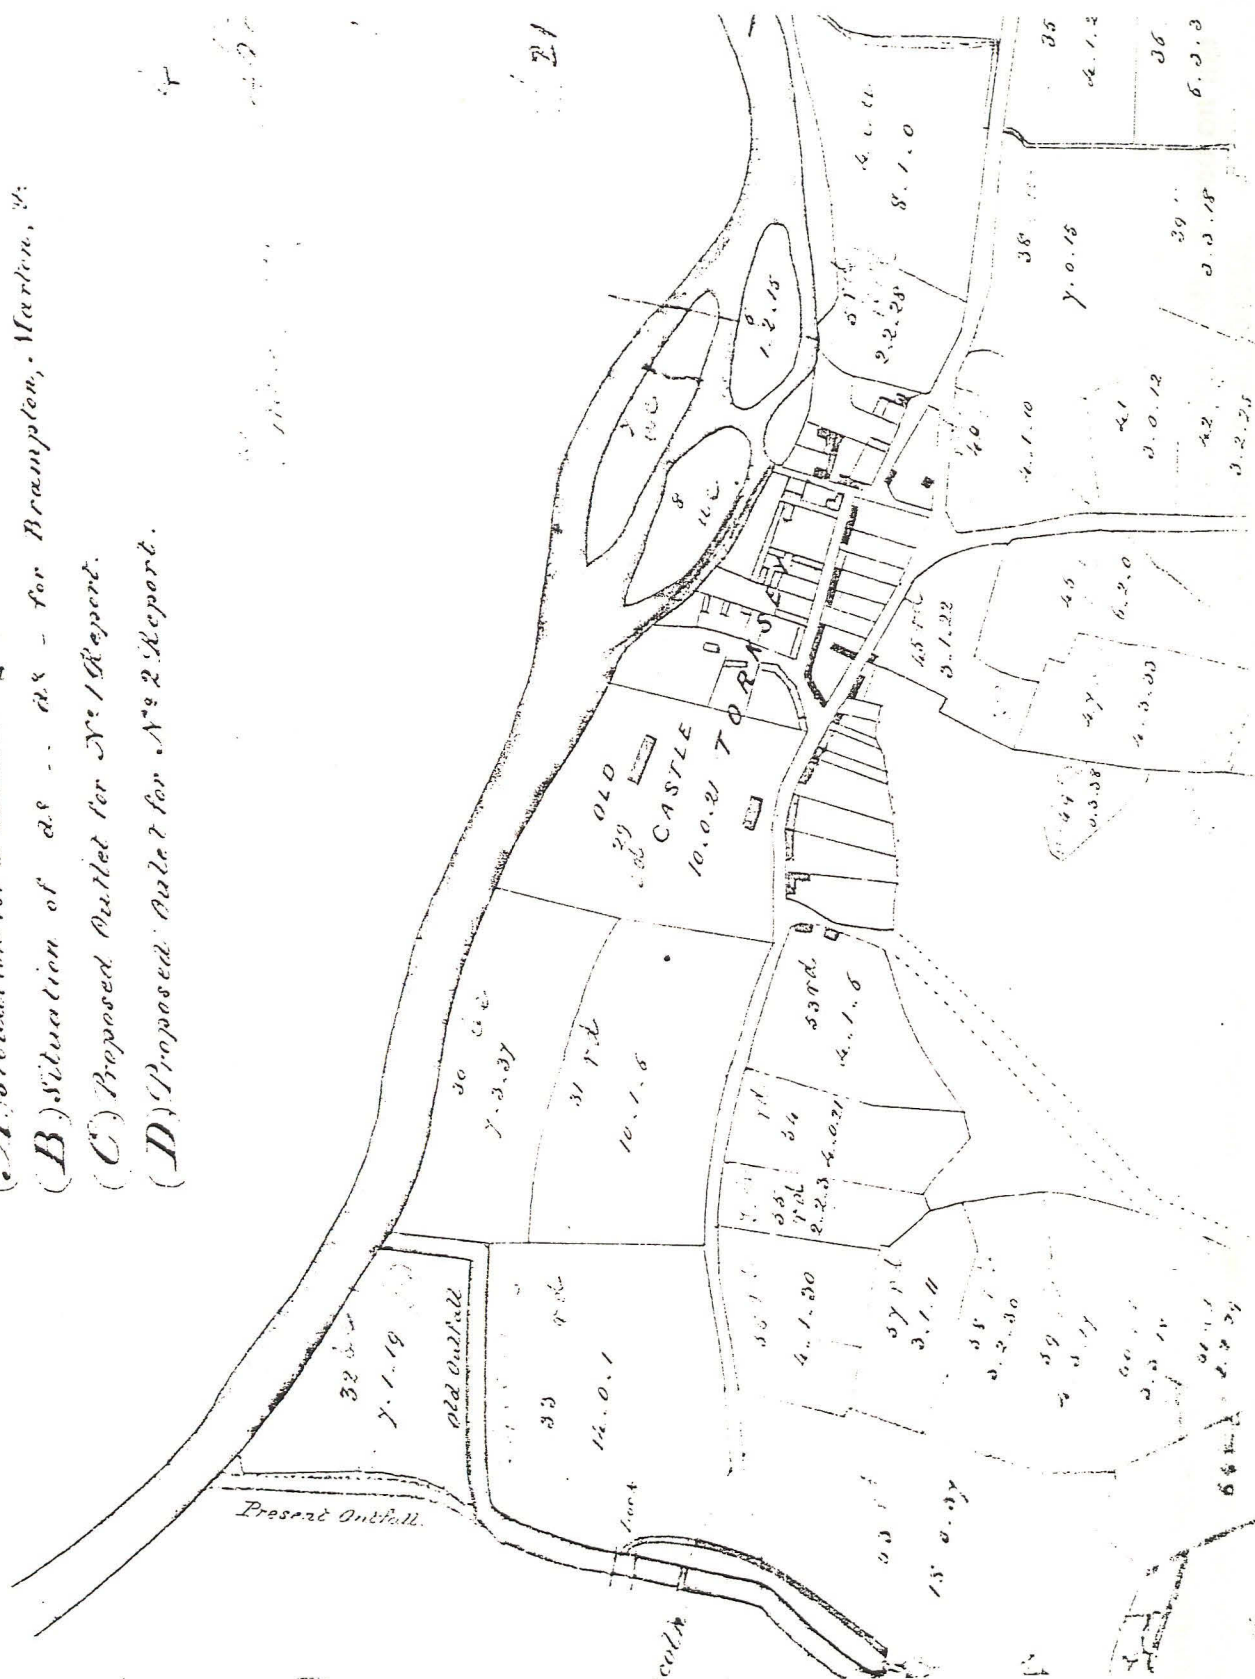
Fig. 5 Main Street, Torksey. Map of Torksey 1843 showing buildings along the street frontage (LAO ref. 3 BNL 17).

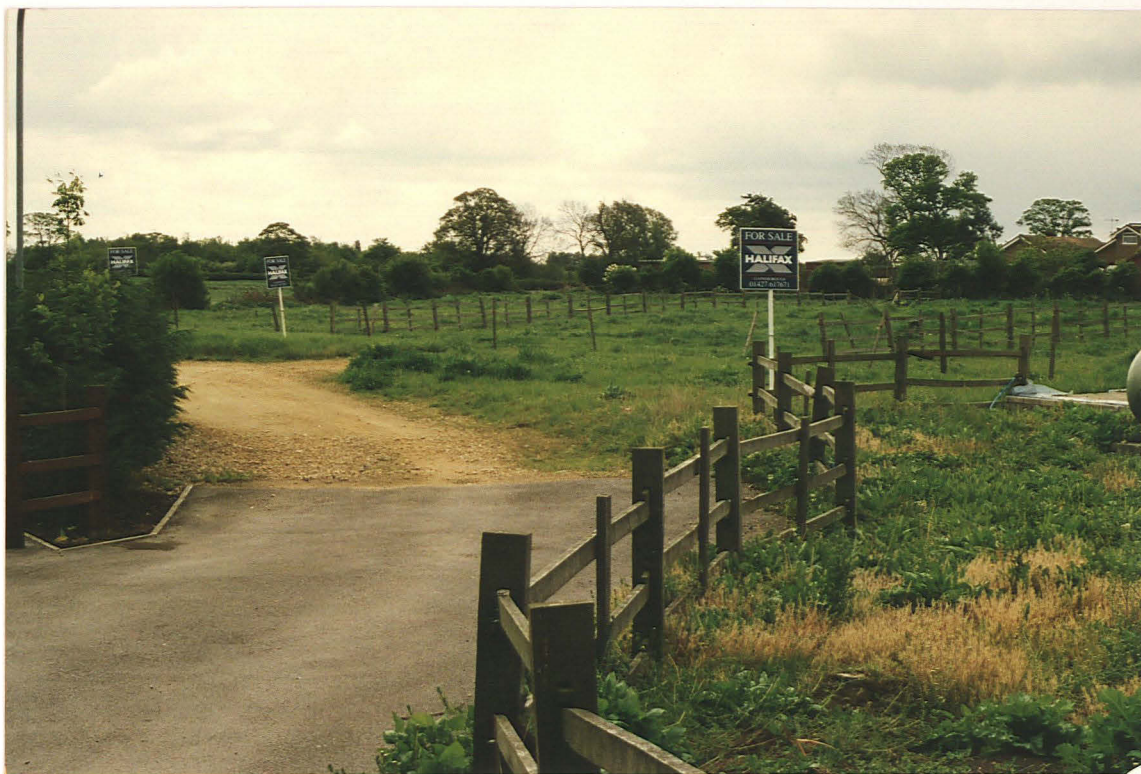
Pl. 1 Main Street, Torksey. General view looking west from the access road at the north end of the site

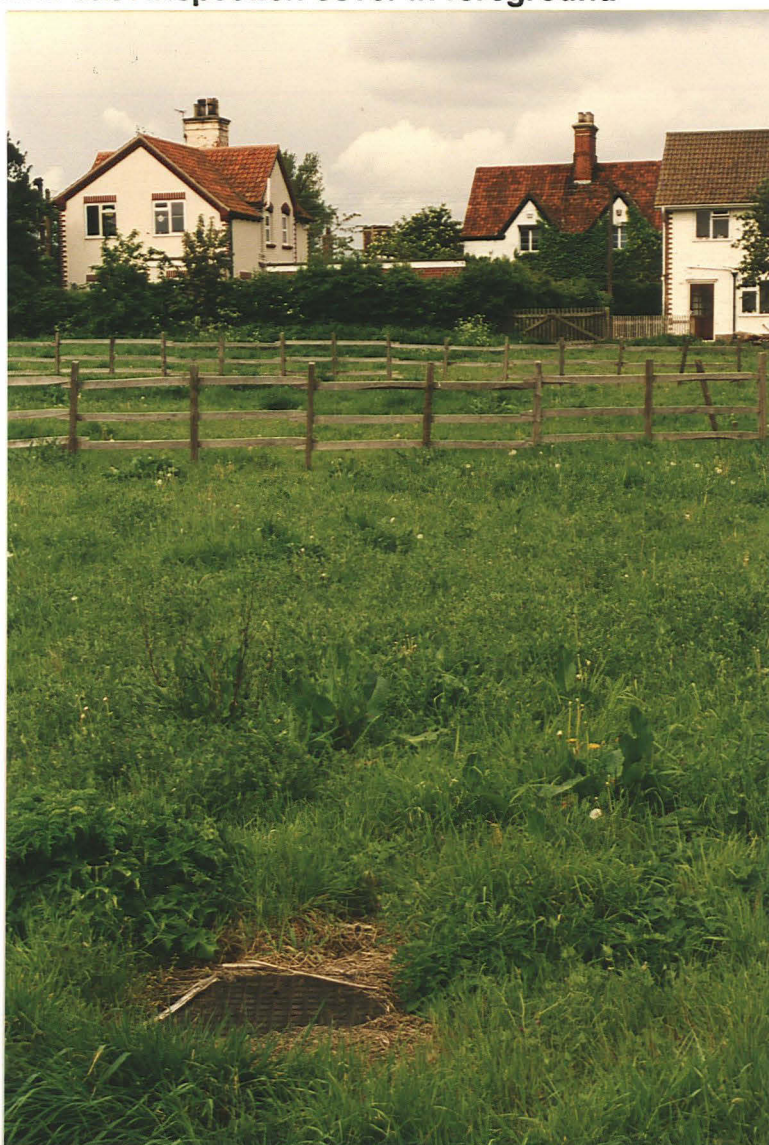
Stables and other farm outbuildings were demolished in recent years and the rubble spread, possibly buried, over the plot of land. Soil was dug out from the site to landscape ground around the former supermarket to the north of the proposed development which was constructed in the 1980s. Builders rubble from its construction was also spread over the site. In 1994 Mr Jackson, the present owner, had the building rubble cleared from the site using a JCB. The cleared ground was then covered with a thin layer of topsoil. This activity disturbed and damaged a drain/sewer which runs west-east across the site. It was replaced by Anglian Water Services Ltd and its alignment is marked by two inspection covers (Pls. 2 and 3). According to Mr Jackson, excavations went to a depth of 1.8m.

Pl. 2 Main Street, Torksey. General view looking west along line of mains sewer with east inspection cover in foreground

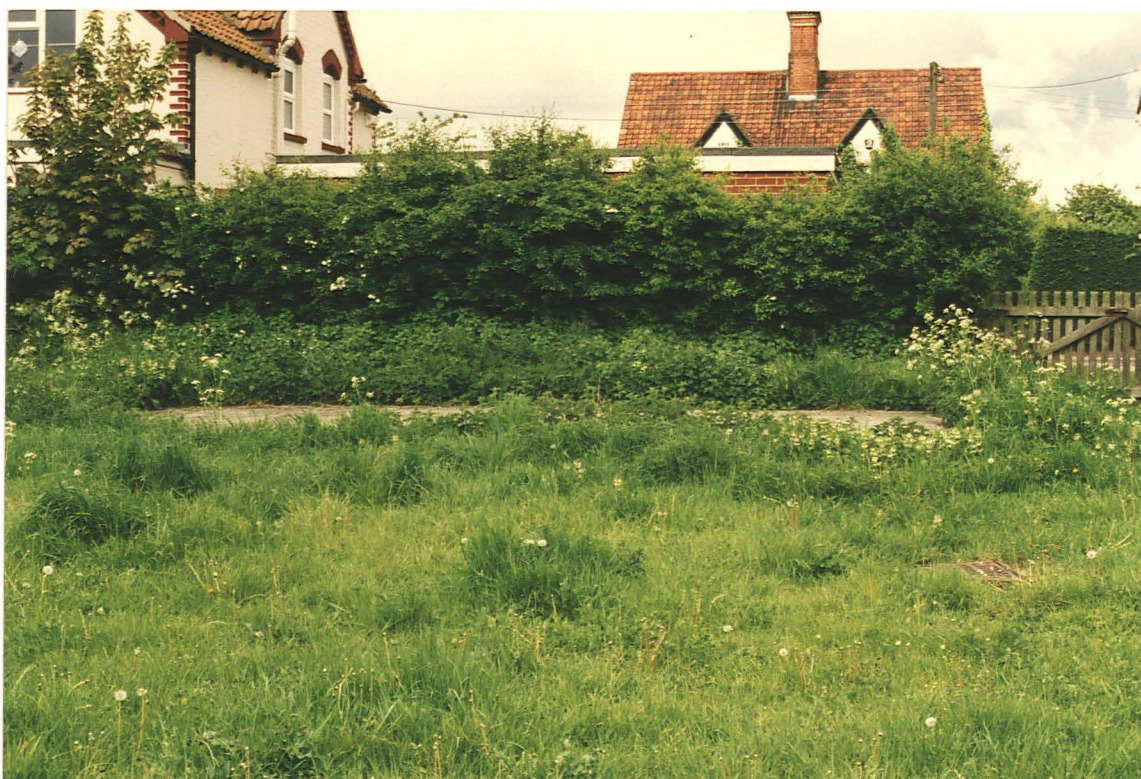
Pl. 3 Main Street, Torksey. Area to rear of showing concrete slab (former garage?) and inspection cover of sewer/drain.

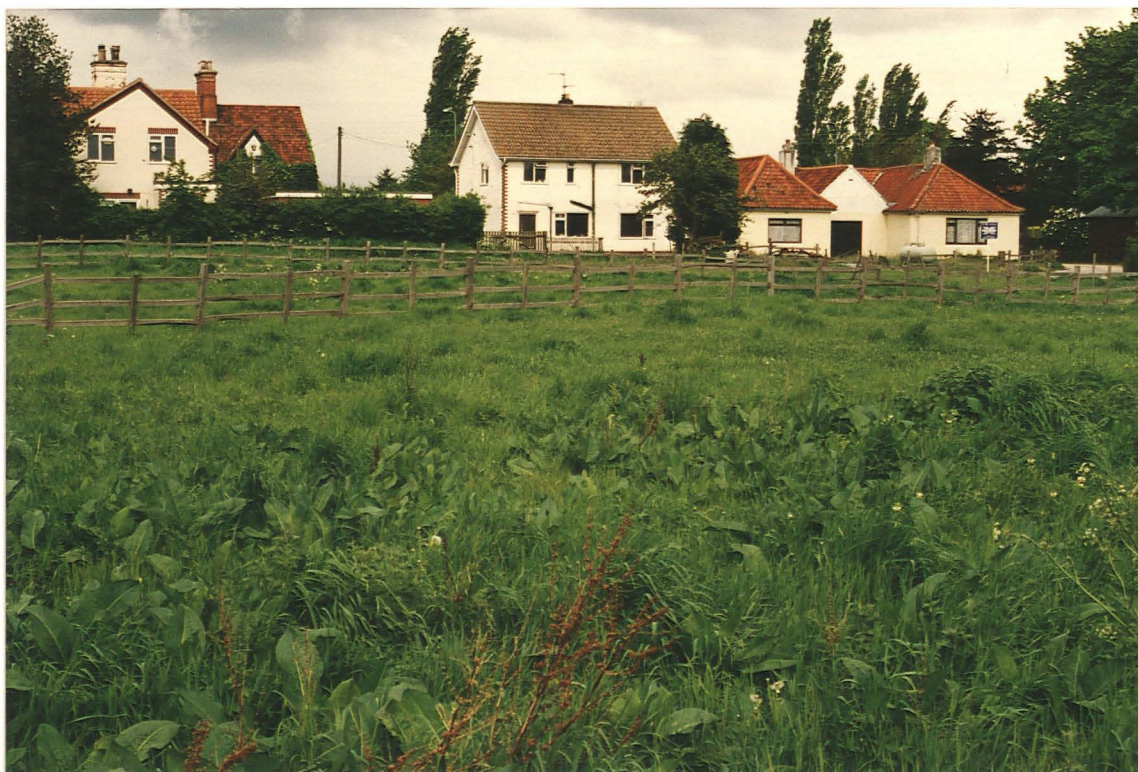
A marked ridge runs across the centre of the site, to the south of, and roughly parallel to the drain. It is not known whether this is an ancient feature or one created by the recent earthmoving activities. It certainly predates the post and rail fences which subdivide the site (Pl. 4).

Pl. 4 Main Street, Torksey. General view west showing uneven ground and ridge across centre of site to south of the sewer/drain.

A machine excavated trench(es) help to determine the degree of ground disturbance and whether archaeological deposits still survive above natural. Depending on the amount of building debris still present on the site it might be possible to carry out a rapid geophysical survey to check for the presence of pottery kilns. Other, less highly magnetic, features are unlikely to be easily identified because of previous ground disturbance and the continuing presence of building rubble.
