St. CHAD'S CHURCH,  
HOLMES LANE, DUNHOLME,  
LINCOLNSHIRE. *WJH*

ARCHAEOLOGICAL WATCHING BRIEF

CLAU ARCHAEOLOGICAL REPORT NO: 306

**A**  
**Report to**  
**St. Chads Parish Church**

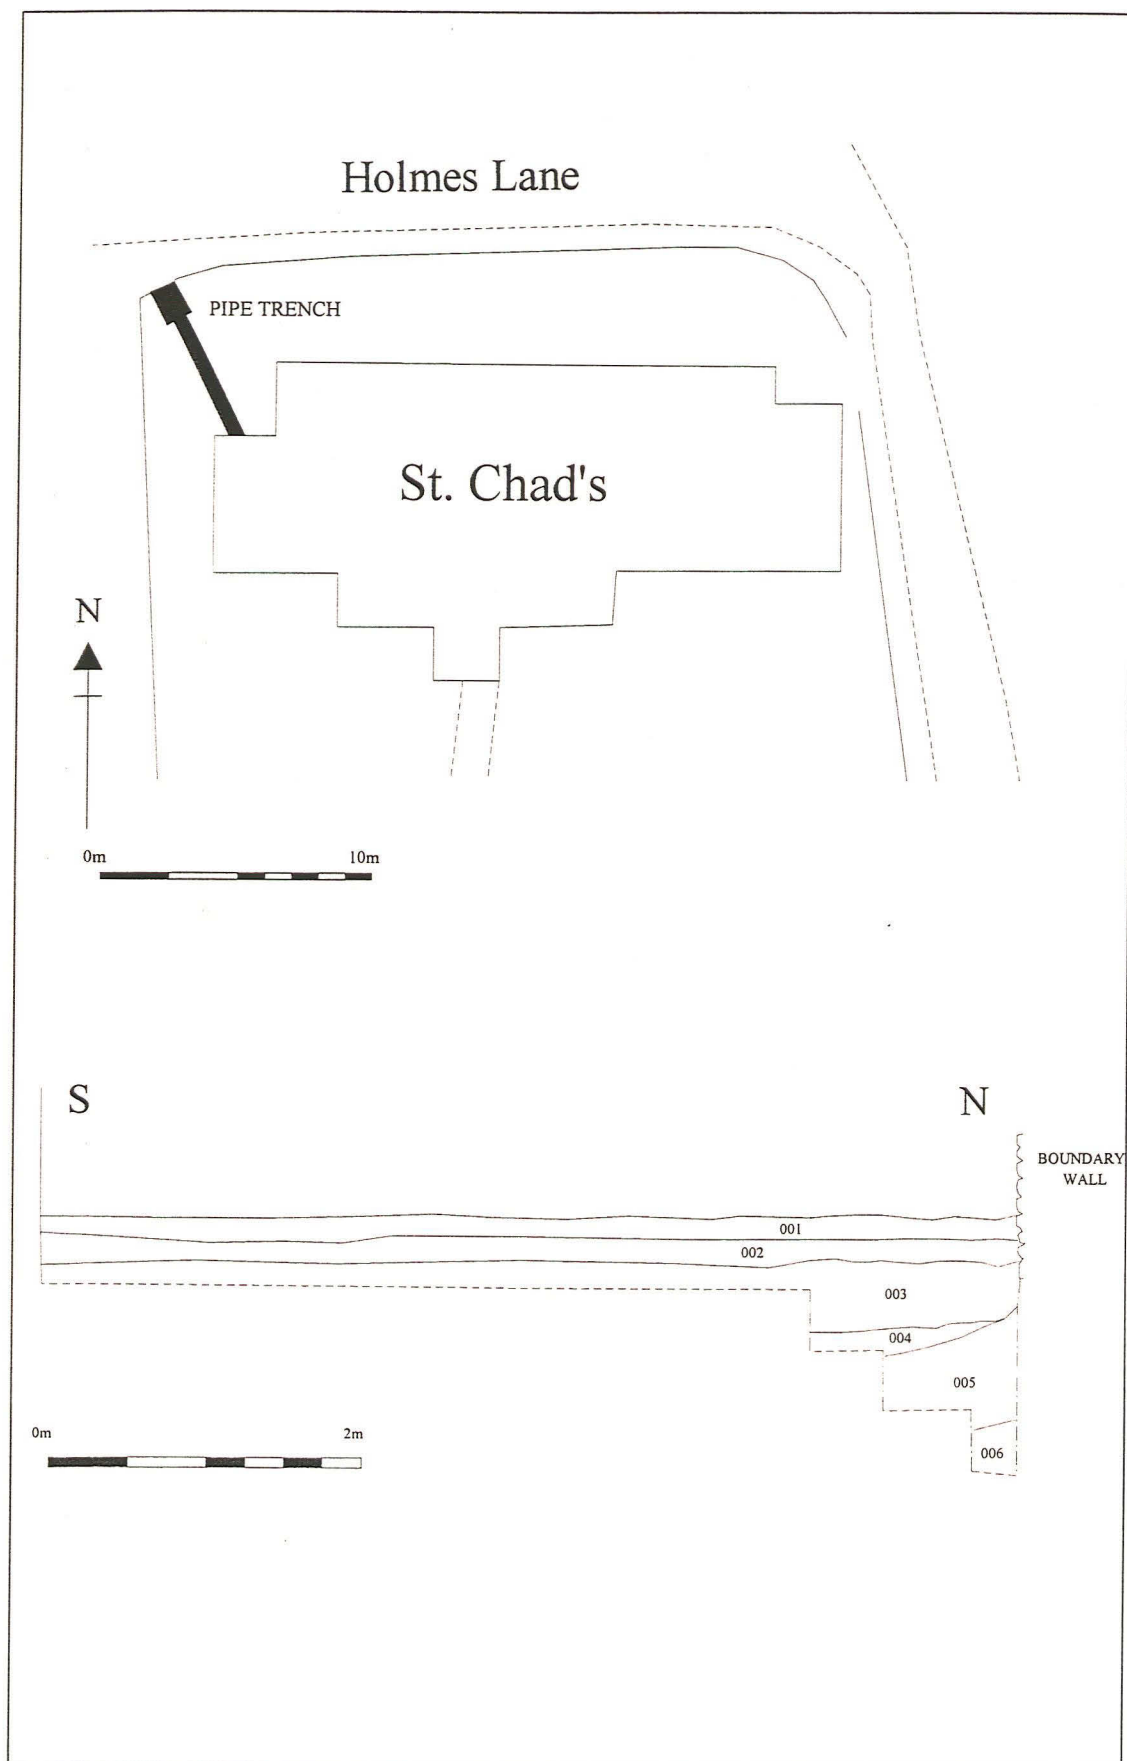
Fig. 2: Trench and Section Locations.

The earliest deposit encountered was [006], a light yellow/brown natural sand (Fig. 2). Sealing natural was [005], a 600mm thick deposit of compact, dark brown sandy soil containing frequent small-medium sized limestone fragments. At its lowest point [005] appeared to consist of laminated bands of

redeposited natural sand and bands of dark brown sandy soil. A (200mm thick) band of loose-firm, light green/brown sand, [004], overlay [005] and was in turn sealed by [003], a loose-firm deposit of light-mid brown sandy soil containing frequent small-medium sized limestone fragments (deposit c. 500mm thick). A layer of compact, mid brown sandy soil, [002], overlay [003]. This was in turn sealed by existing topsoil deposit [001].

The church of St. Chad's is essentially Early English in date (AD1190-1250), with some later medieval elements and was extensively restored in 1856 (Pevsner et al, 1989, 260). The groundworks under investigation lay external to the church, crossing a grassed area in the north west corner of the churchyard (Fig. 2). The trench extended from approximately the north west corner of the church tower, heading north west for c. 6.50m to the corner of the churchyard boundary wall. For the majority of the length of the trench its depth did not exceed 500mm, and not until c. 1.40m from the churchyard boundary wall did the trench extend to any depth (c. 1.80m at its maximum, in order to establish a connection into an existing sewer). The churchyard at St. Chad's is raised approximately 500mm above the surrounding ground level.

Deposit [005], and possibly [004], appear to represent pre-churchyard ground level. The church boundary wall then appears to have been erected and deposit [003] laid to its south in order to establish the raised ground level of the present day graveyard. Deposits [002] and [001] are also associated with this event.
