**ARCHAEOLOGICAL WATCHING BRIEF REPORT**

LAGOON WALK, SKEGNESS

Site Code: LW 97  
LCNCC Acc No. 55.97

Report prepared for the Environment Agency by James Albone  
May 1997

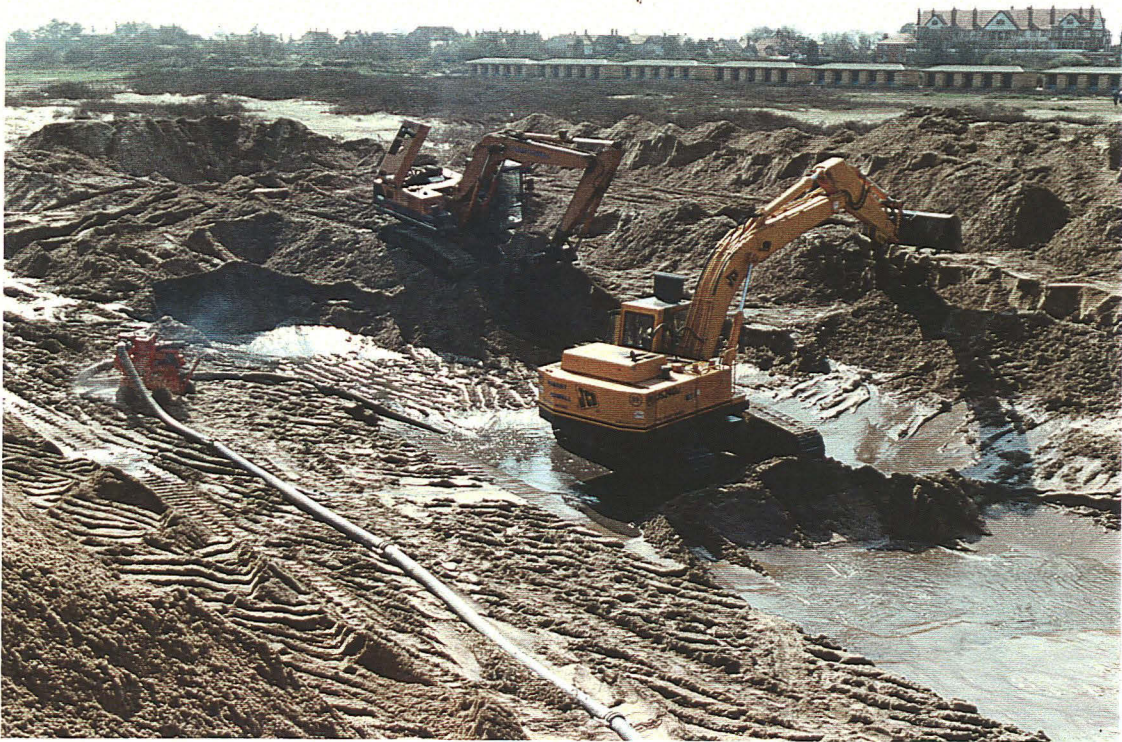
P1. General view of excavation work in progress  
(note flooding)

The nature of the deposits, environment and method of excavation presented a number of problems. Water was constantly seeping through the sides of the excavation, resulting in flooding. Despite the continual use of pumps, there was always some standing water in the bottom of the excavation. This meant that the mechanical excavators were often working in the water, making observation difficult. The continual flow of water brought with it another problem; that of mobile sand. The water washed sand into the excavation from the sides, bringing with it shells, stones and artefacts (modern and archaeological). The upper dry sand remained stable, while

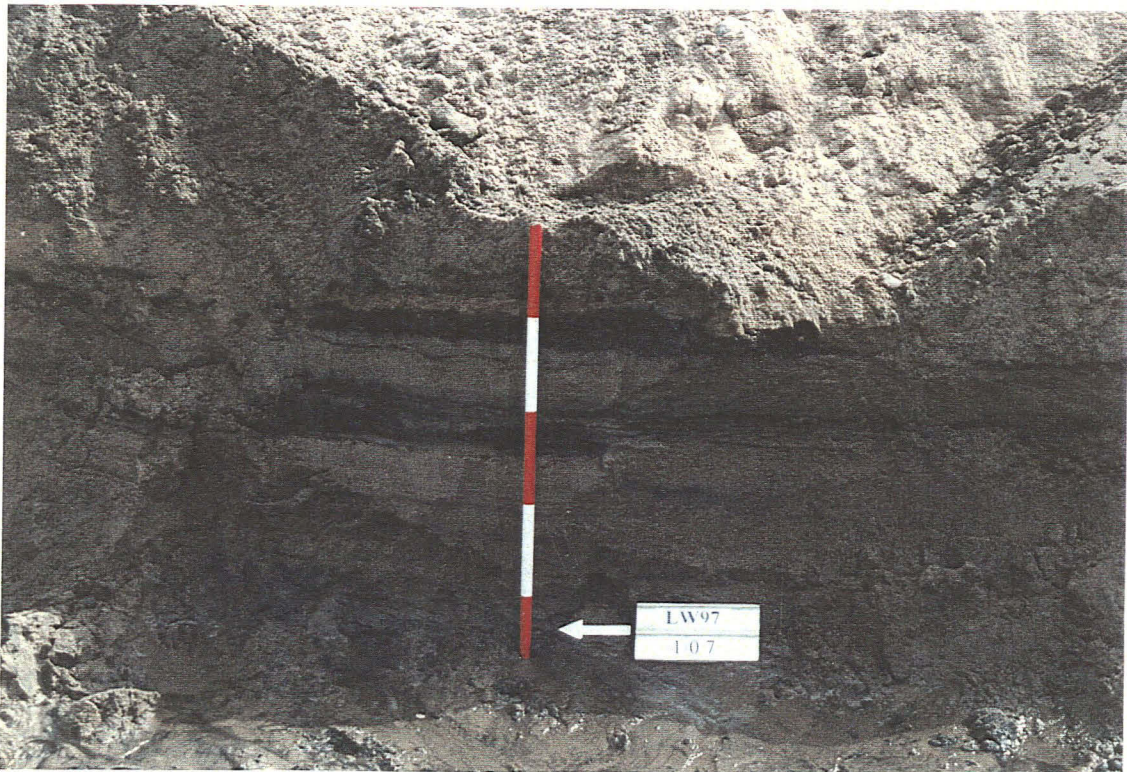
P2. Section through context (107) showing black clay-silt deposits

Underlying [106] was a layer of sand containing lenses and bands of black clay-silt up to 0.1m. thick [107]. The clay-silt contained wood, plants remains and water-worn fragments of peat. However, these deposits are only of recent date as a fragment of a modern house brick was recovered from the sand in between the silts. The bands of silt thinned towards the west ( i.e. landwards ) across the area of the excavation. A further deposit of sand with gravel patches and sparse clay-silt layers [108] was found beneath these. The upper extent of this context was marked by a layer of gravel and shell fragments. A range of artefacts, including a medieval pottery sherd, two fragments of briquetage and modern brick and glass, can be loosely assigned to this context.

The sequence of deposits encountered represent the accumulation of the modern beach. The black clay-silt layers must have been deposited in a low energy environment within the inter-tidal zone. This is likely to have happened in shallow tidal ponds, especially between periods of high tides. The presence of similar deposits on the beach at low tide, which are adjacent to tidal ponds, further support this explanation. The black clay-silt deposits on the beach, which weather to a medium brown colour, contain modern litter which suggests that they are still accumulating. In reality the three contexts [106], [107] and [108] represent a continuous sequence of deposition and could be regarded as a single stratigraphic event.
