97/8  
RAW WATER MAIN,  
GLENTHAM TO WELTON  
LINCOLNSHIRE

ARCHAEOLOGICAL  
WATCHING BRIEF

CLAU ARCHAEOLOGICAL REPORT NO: 303

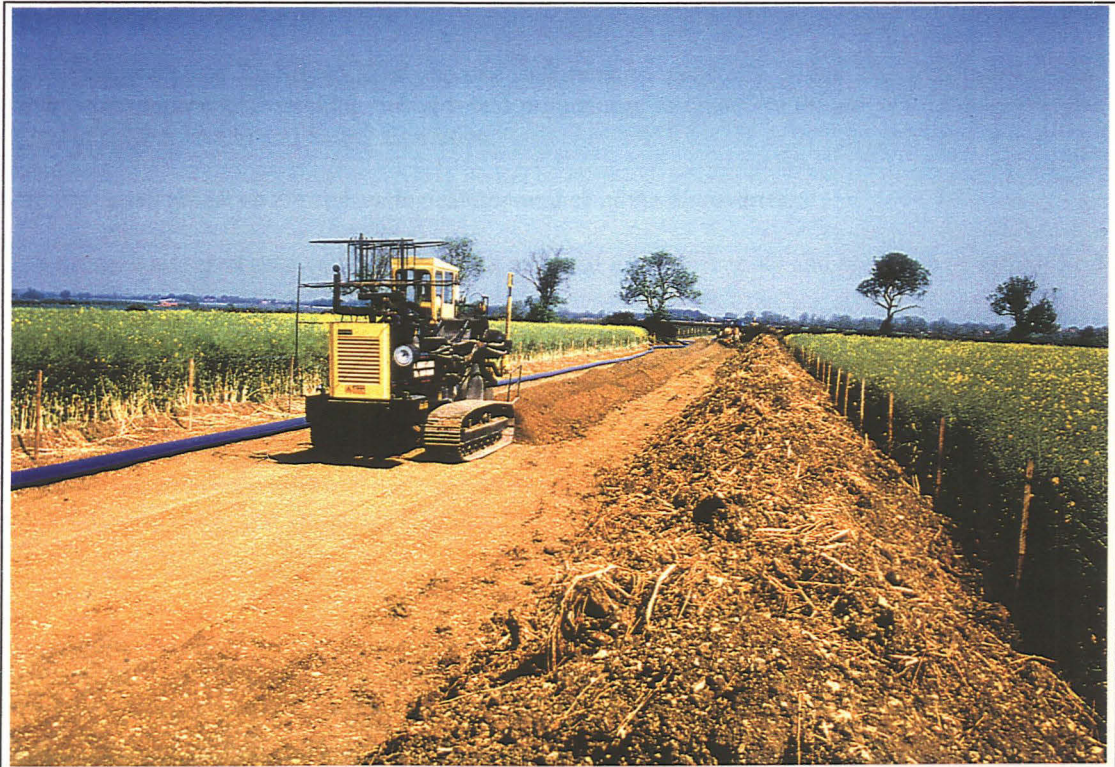
Plate 1: The trenching machine working south along the pipeline easement (Area 3). On a good day this machine could excavate a trench 2m deep, 500mm wide and 1000m in length.

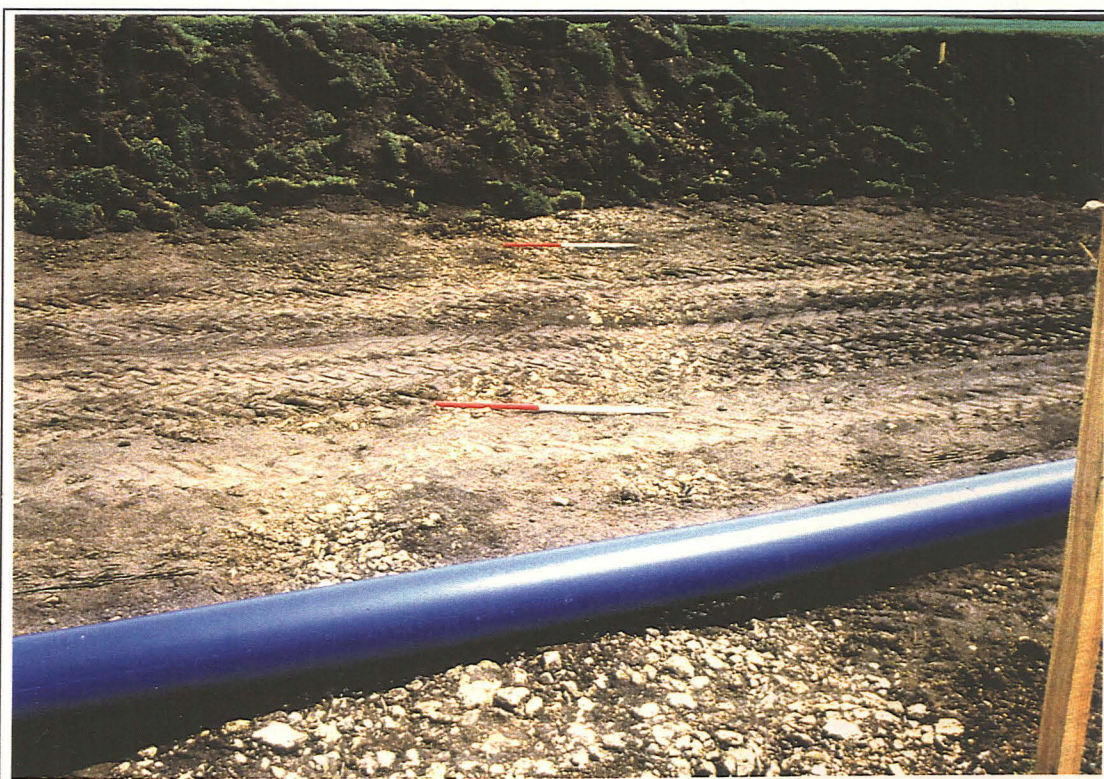
Area 2 revealed several archaeological features (Fig. 4). Crossing the line of the easement, approximately 35m to the north of Paunch Beck, lay [009], an east-west alignment of small pebbles and limestones forming a trackway or similar feature. Although partially masked by silt deposit [008], this track was seen to be c. 2.5m wide and 150mm thick. No evidence was present to suggest resurfacing/repair to the track and no dateable material was recovered from its fabric. Due to the shallow nature of this feature and the pipe-laying methodology employed by the main contractor, it was not visible in the trench section.

Plate 2: View looking east long trackway [009] (scales are 1m). Note the damage caused by construction traffic obscuring archaeological features present on the easement.

Area 2 revealed most in the way of archaeological deposits and features. Interpretation of these features was, however, difficult given the fact that they survived to such shallow depths. The un-dated metallated trackway recorded at the southern end of Area 2 appears to have been associated with the earthworks present in the field. The fact that it was not visible in the pipe trench section suggests that it was not a substantial feature. The enclosure feature to the north of the track lay at right angles to it and appears likely to be contemporary. Its function was not clear from the evidence recovered. However, it may represent a small stock enclosure or possibly delineate the position of a small free-standing structure.

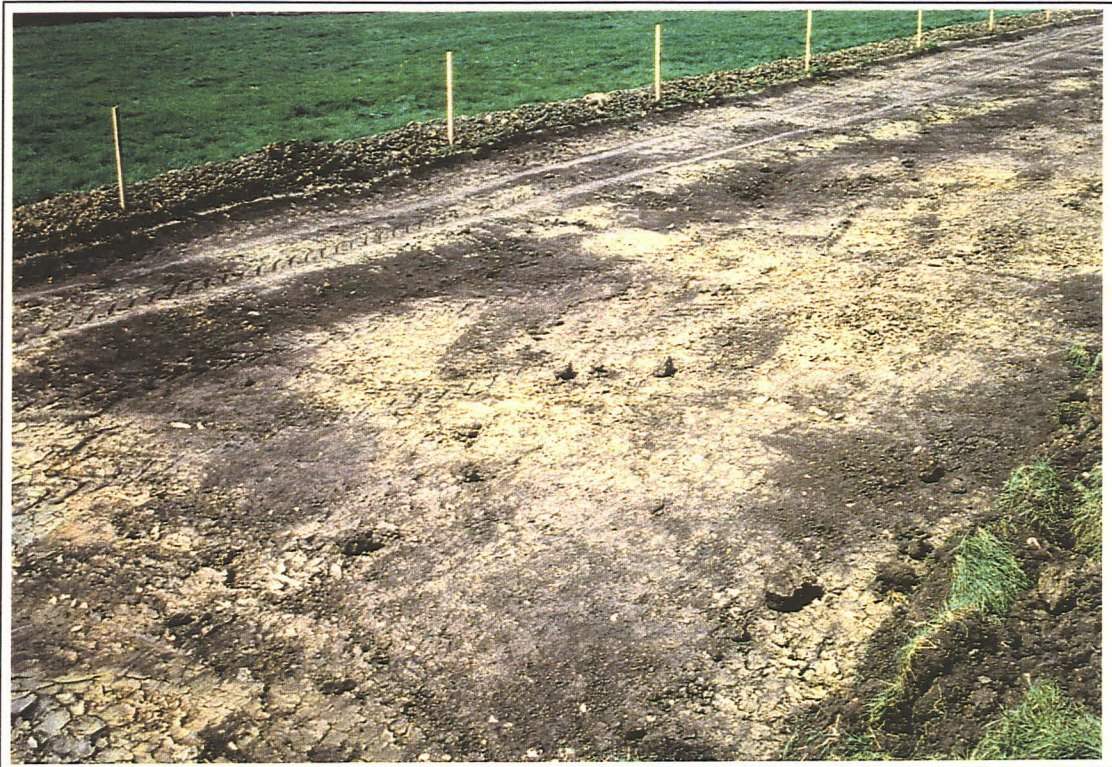
Approximately 25m to the north of the suspected trackway lay a rectangular ditched enclosure or similar feature, [001]. It measured c. 23m north-south by 7m east-west. Sections excavated across the

ditch showed it to be very shallow (max. 100mm deep). Its full extent was not established as its northern end was not visible, having probably been removed during the initial stripping off of the easement. A narrow entrance to the enclosure may have been present on its eastern side, as delineated by the presence of two terminal ends to the visible enclosure ditch, close to its south-east corner. Finds recovered from within the enclosure, context [002], suggest a date between the late 18<sup>th</sup> and 20<sup>th</sup> centuries.

Plate 3: Enclosure [001] looking north-west (the enclosure is shown in this photograph as a rectangular formation of dark soil contrasting against the generally lighter coloured natural deposits. Also see Fig. 4).
