## South View Farm, South Cockerington:

### An Archaeological Watching Brief

Site Code: SCS 97

August 1997

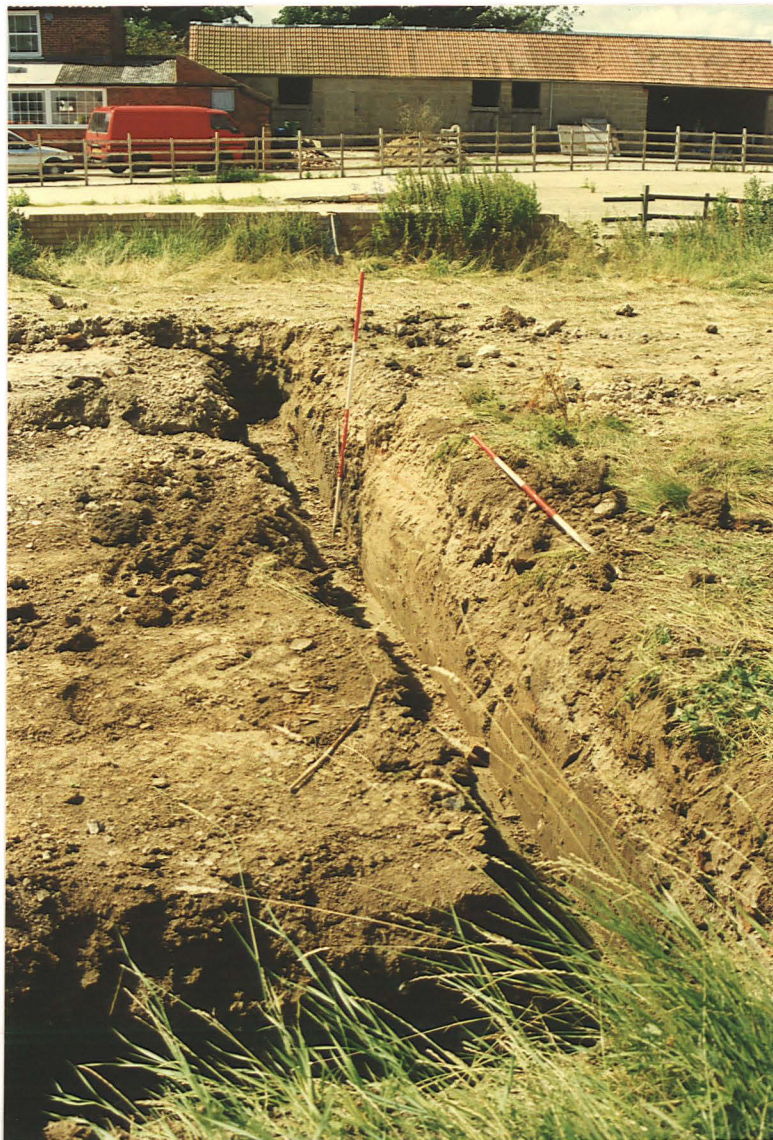
Plate 2: Stratigraphic sequence in northern-most trench, looking west

The stratigraphy of the site consisted of a layer of mixed building debris and make up deposits which included brick and soil. This deposit was up to 1.20m deep at the north western end. It decreased in depth to the east where it was approximately 0.80m deep and overlay a dark brown silty clay which extended to approximately 1.10m depth. Below this deposit, over the whole area, was a mid brown 'clean' clay which appeared to be the natural.
