#### ARCHAEOLOGICAL WATCHING BRIEF REPORT

76A Eastgate, Louth, Lincolnshire

Site Code:
 EGL 97

Report prepared for Stuart Grant (Building Surveyor) by James Albone October 1997

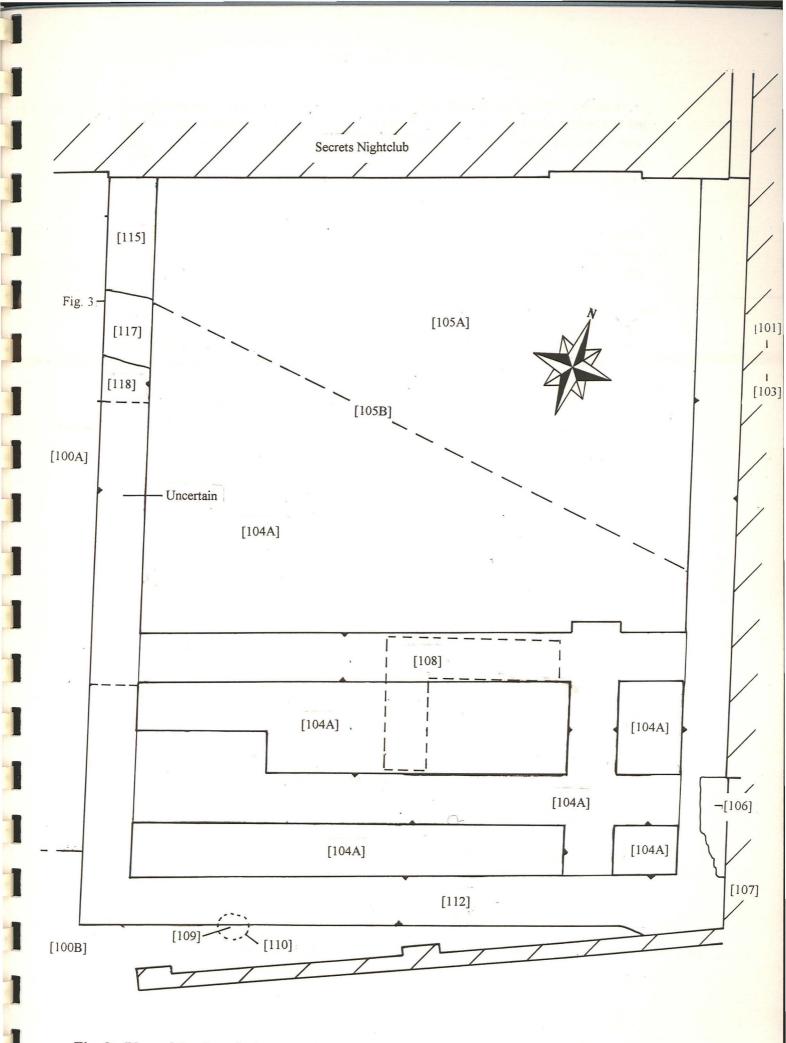
The existing surface of the site consisted mainly of modern concrete, brick and underlying hardcore [100A]. A small area along the south boundary was covered with light brown sand-silt containing rubble [100B]. Below these were further modern deposits. The north part of the site was covered by dark grey silt-clay [105A]. This deposit contained modern pottery, brick and stone fragments and was within a straight sided cut [105B]. Cut by this, and extending over the rest of the site, was a loose sand-silt containing abundant brick, stone rubble and 20th century pottery [104A]. This deposit represents dumping to raise or level the ground surface. It filled a previously existing hollow [104B]. Contained within, and occasionally at the base of, [104] was an intermittent layer of chalk rubble [111]. The variation in the position of this layer within [104] suggested that it represented 'tip lines' in the dumped deposit.

A right angled section of brick wall [108], possibly relating to the site's use as a foundry, had been built into the top of [104]. A small pit [110], 0.4m across x 0.4m. deep, was also cut into the top of [104] at the south side of the site. The fill of this [109] contained modern pottery and oyster shell. At the base of [104], in the south east corner of the site and adjacent to wall [107], were the remains of a brick built open drain [106].

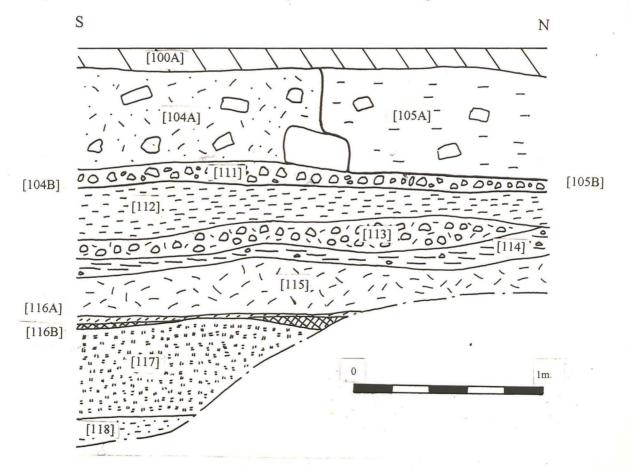
(location indicated on Fig. 2)

Below the modern cuts [104B] and [105B] a dark grey-brown clay [112] extended across all of the site. It contained 16th to early 17th century pottery. Animal bones and cockle and oyster shells were also found but were not retained. Deposits below this layer were only visible in the western section. A lens of chalk rubble [113] was between [112] and another clay layer [114]. This clay was medium grey in colour and contained small brick/tile fragments. A single, unstratified, sherd of medieval pottery may have derived from this layer. Below this was a layer of, apparently burnt, redbrown clay [115] overlying a thin layer of black, organic-rich, clay [116A]. It is likely that both of these deposits related to fragments of a pink-red baked clay surface which was underlying them [116B], (as already stated, time constraints prevented detailed recording and sampling of these deposits). Underlying the clay surface was a dark grey silt-clay [117] and a yellow silt-sand containing limestone fragments [118]. It is impossible to be certain whether these deposits were archaeological or natural.

The sequence of deposits encountered can only superficially be interpreted. The baked clay surface and overlying deposits, presumably relate to a structure of some kind, perhaps a medieval hearth or oven, but further interpretation is not possible. The absence of any building remains in the observed sections does not preclude the presence of larger structures on the site. The lack of dating evidence and environmental information from the lower deposits is particularly disappointing, as these had the potential to provide important new information on the development of Louth before the 16th century.

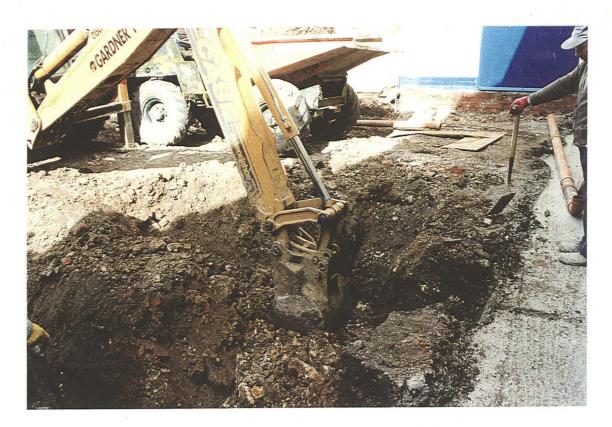
P1. Excavation of an internal wall trench through [104] showing the loose nature of the deposit. Looking north-west.

A wide range of problems were encountered during the watching brief. A dumped sand-silt [104] which covered the south part of the site was very loose and did not result in stable section faces for recording purposes (Plate 1.). The only stable section was on the west side, where this remained capped by a concrete yard surface [100]. The use of a backhoe excavator in the small space remaining in the yard (5-7m. x 12m.) presented further problems as all work was being carried out over the top of the western trench, making recording virtually impossible (at the building inspectors
