NEW LIFE
CHRISTIAN FELLOWSHIP CHURCH,
NEWLAND, LINCOLN,
LINCOLNSHIRE

ARCHAEOLOGICAL WATCHING BRIEF

CLAU ARCHAEOLOGICAL REPORT NO: 309

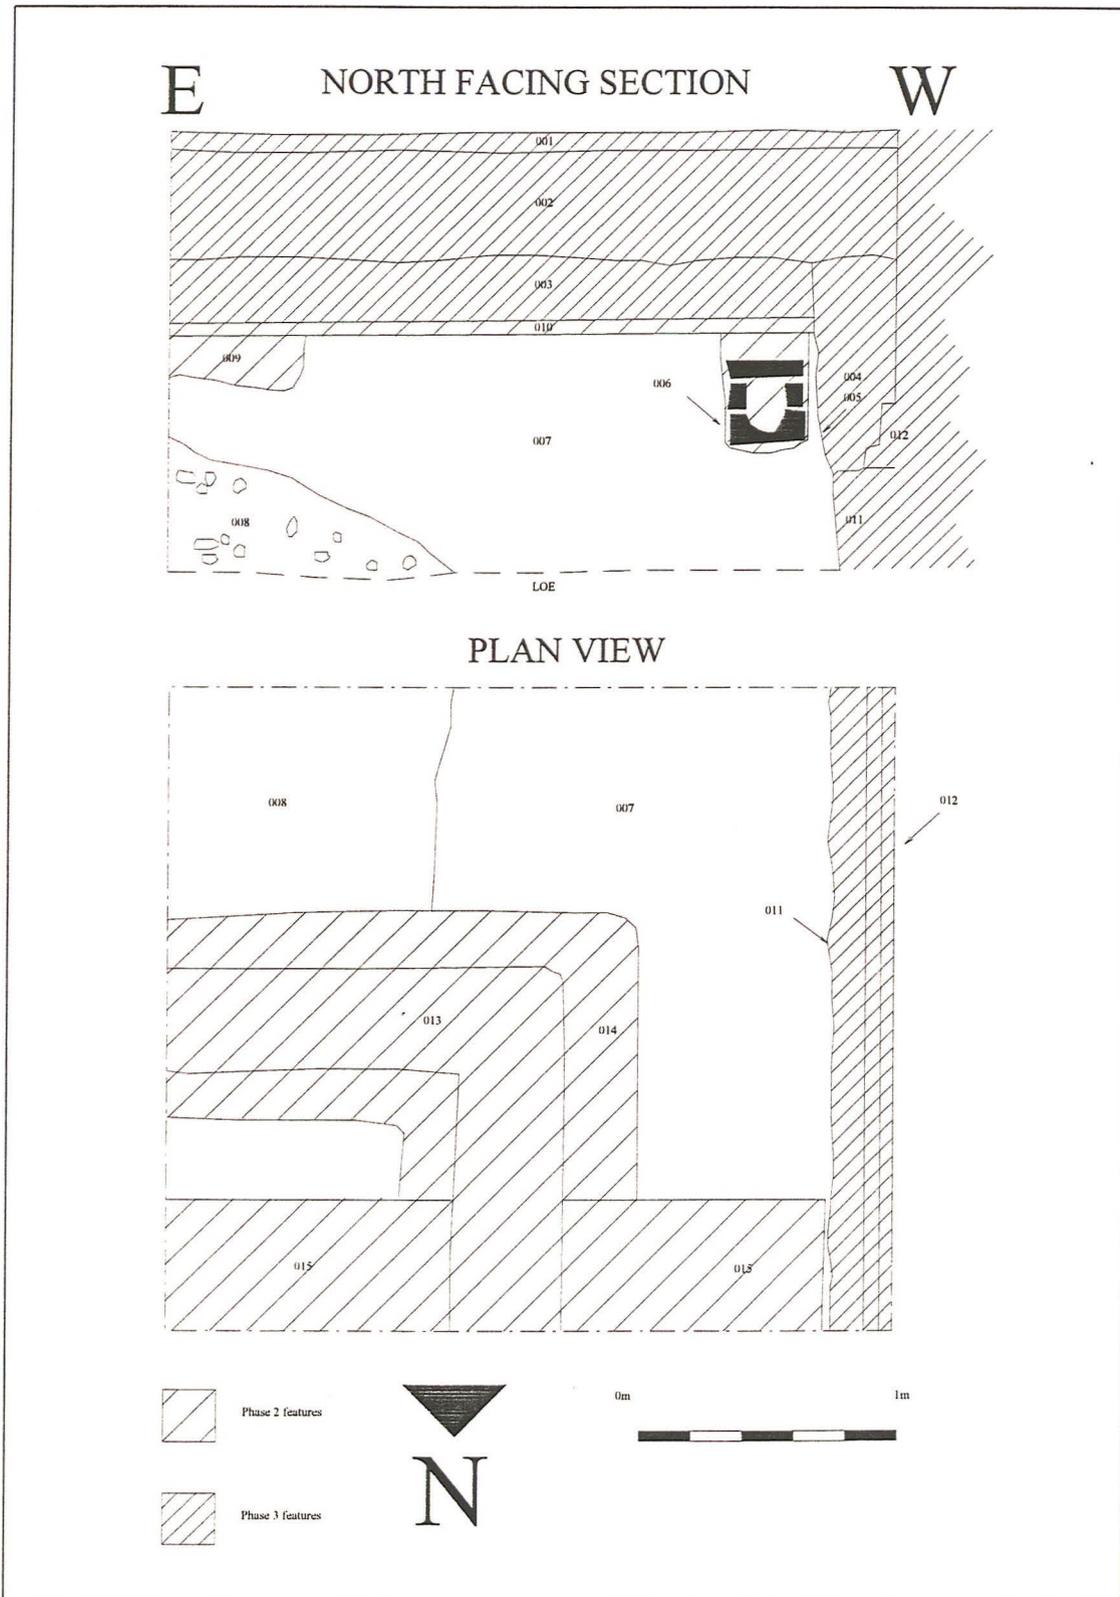
Fig. 2: Trench plan and section.

Post-excavation analysis of the resulting site archive has identified three chronological phases of occupation present on the site (Fig. 2).

The earliest deposit encountered during the watching brief was [008], a firm, silty clay soil containing frequent small-medium sized limestone fragments (c. 200mm x 100mm x 100mm). This deposit was present in the south-east corner of the lift pit and was seen to be c.500mm thick in places. A further firm layer of silty clay earth, [007], overlay [008]. Deposit [007] also contained small limestone fragments as well as some charcoal and oyster shell and was up to 700mm thick. Fragments of Roof tile recovered from deposit [007] suggests a late medieval or post medieval date.

Deposits and features associated with Phase 2 occupation within the trench were, in the main, associated with the church hall prior to some alteration of the buildings facade. Excavation of the lift pit by the main contractor revealed a series of brick walls with limestone foundations, extending south and east from the brick wall of the church hall, which formed the northern edge to the lift pit (contexts [013], [014] and [015] - also see Fig. 2).

A north-south brick drain/gully, [006], was present in the south section of the lift pit. To the east of the drain lay [009], a 200mm thick deposit of sandy mortar (this deposit was also present in the east section of the trench where it was noted to abut wall [013]). A surface of cement/concrete, [010], overlay drain [006] and deposit [009]. Surface [010] was noted to equate approximately to the height of ground level present outside of the church hall.

Phase 3 deposits and features were associated with the construction of the church hall's later facade. A firm, light brown sandy soil containing frequent brick and tile fragments, overlay surface [010]. Cutting in to this layer was wall [012], the primary north-south wall of the new church hall facade. A further levelling deposit, [002], containing very frequent building rubble, sealed the construction cut to wall [012]. This levelling material was in turn sealed by flag-stone floor [001], which constituted the internal ground floor to the room containing the stairwell.
