**Land at New Park Farm, Tattershall Thorpe:**

**Archaeological Monitoring of Topsoil Stripping  
Phase 2-3 of the Tattershall Quarry Extension**

Report prepared for  
Butterley Aggregates Limited

October 1997

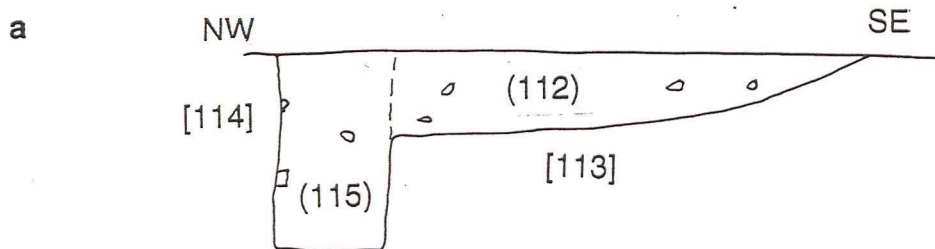
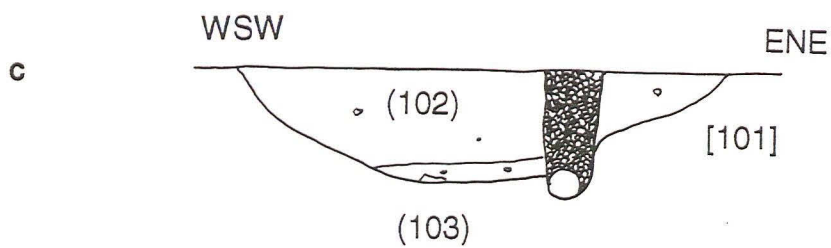
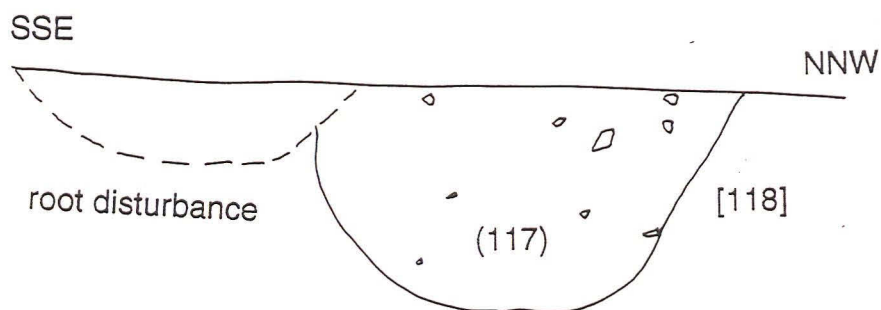
Fig 4: Sections of features a) [113], b) [124] and c) [101]

Two ditches were located running north-east south-west across the site. These were approximately 100m apart and had similar profiles. The westernmost ditch [113] (Fig. 4a) was a shallow rounded asymmetrical cut with a steeper NW side. It contained a dark grey brown silty sand deposit (112), and was cut through by a field drain [114] on its north-west side.

The eastern ditch [124] (Fig. 4b and Pl. 8) was straight and very regular in plan, in section it had a widely rounded profile, 1.19m wide and 0.25m deep. This feature contained a dark grey brown silty sand (123). A field drain cut the southern side of this feature.

A concentration of drainage features was observed south of ditch [144], three of them [101], [104] and [139], forming 3 sides of a rectangle. Ditch [101] (Fig. 4c and Pl. 9) was aligned NNE-SSW and extended below the concrete turning circle. It had a rounded base and contained a 0.06m deep deposit of light grey silty sand (113) overlain by a dark grey brown sandy silt (112). Ditches [104] (Fig. 5a and Pl. 10) and [139] extended at right angles from each end of [101], both of the ditches extended beyond the area of this phase of works. A brick drain [147] was observed running NW-SE in area 3 and truncating [139] (Pl. 14). A functioning 6 inch water pipe was also observed running NE SW through this area.

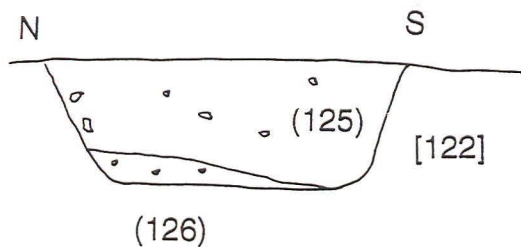
Fig 5: Sections of features a) [104], b) [118] and c) [122].

Three large drains which appeared on the surveyor's plan were observed. One ran from south-west of the site and extended northwards to the limit of the excavated area. This drain was 1.25m wide by 0.36m deep and contained [134] a dark brown clay-silty sand. A second large drain [118] (Fig. 5b) was observed running ENE-WSW across the site. This was 1.25m wide and 0.30m deep containing a dark brown clay silt (117). Both of these features contained a large ceramic pipe which had been ploughed over most of the length of the ditch and only exposed in certain sections. A third large [142] drain was observed running ENE-WSW across the northern part of the site.

An irregular-shaped pit [122] with steep sides and a flat bottom was excavated adjacent to [124] in Area 1. Its fill was a dark grey brown silty sand, was very similar to the fills of the drainage features and therefore probably contemporary. There is nothing to suggest that this feature was of any antiquity.

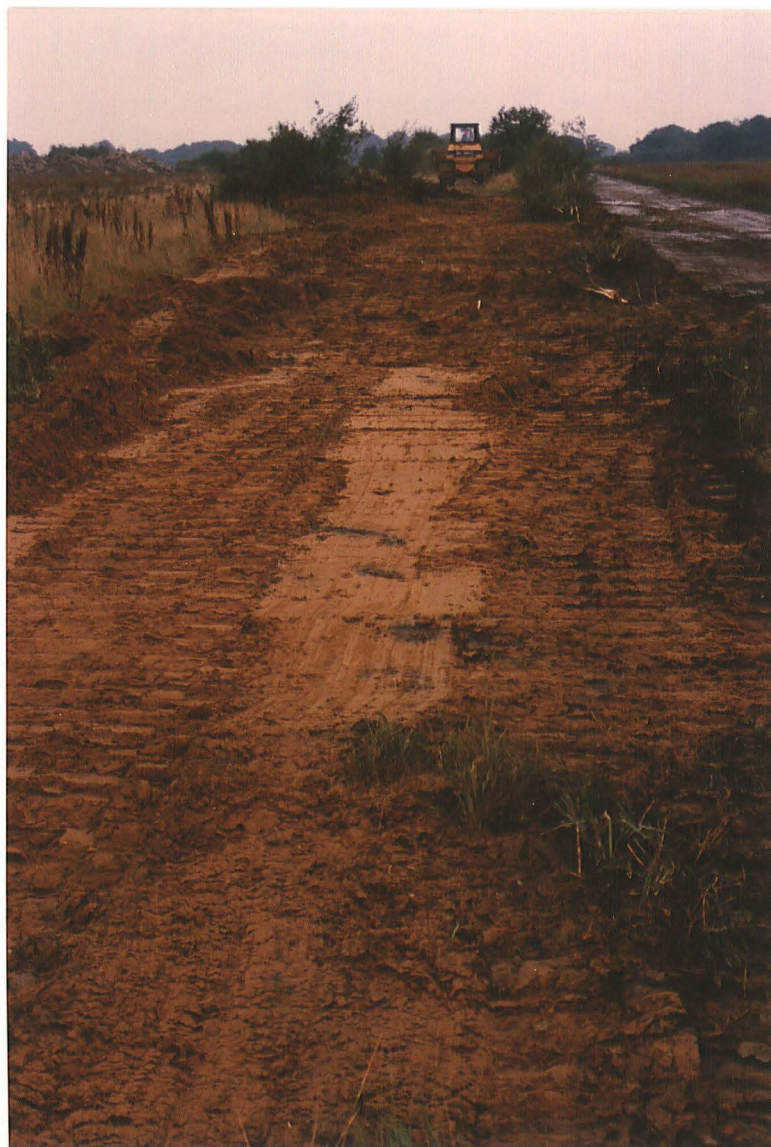
The proximity of power cables in the Phase 1 area meant that a bulldozer had to be used to remove the topsoil, although the ground was extensively disturbed by the tracks of the vehicle it was still possible to observe variations in colour and texture of the natural (Pl. 5).

Pl. 5 Part of area 1 stripped by bulldozer.

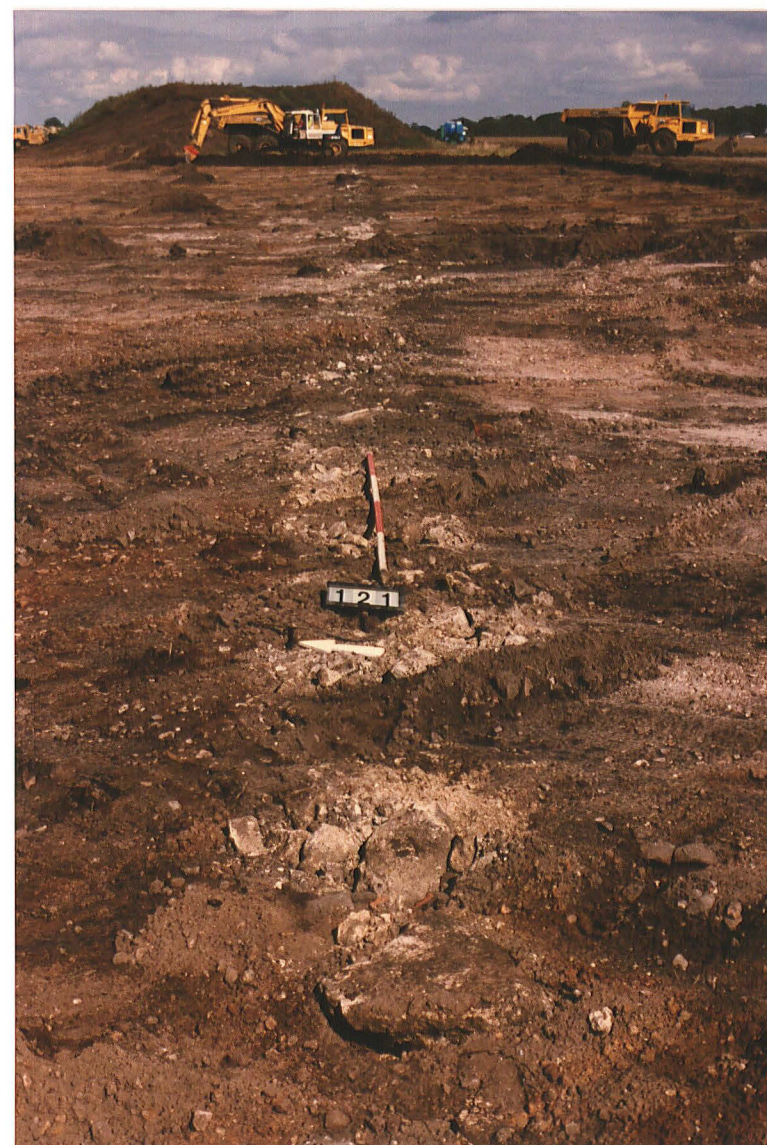
In the northern part of the site where the remainder of Phase 1 was stripped a number of features was uncovered. A large drainage ditch was found running 10m north and parallel to the ENE to WSW runway. The ditch [121] was 1.19m wide and 0.25m deep it had a shallow rounded profile and contained a dark grey brown silty sand (see Pl. 7). Brick access points were located periodically along the drain. Local information indicates that the runway was substantially larger during the war and ditch may have originally been its perimeter drainage ditch.

Pl. 6 Drainage ditch [121] looking east

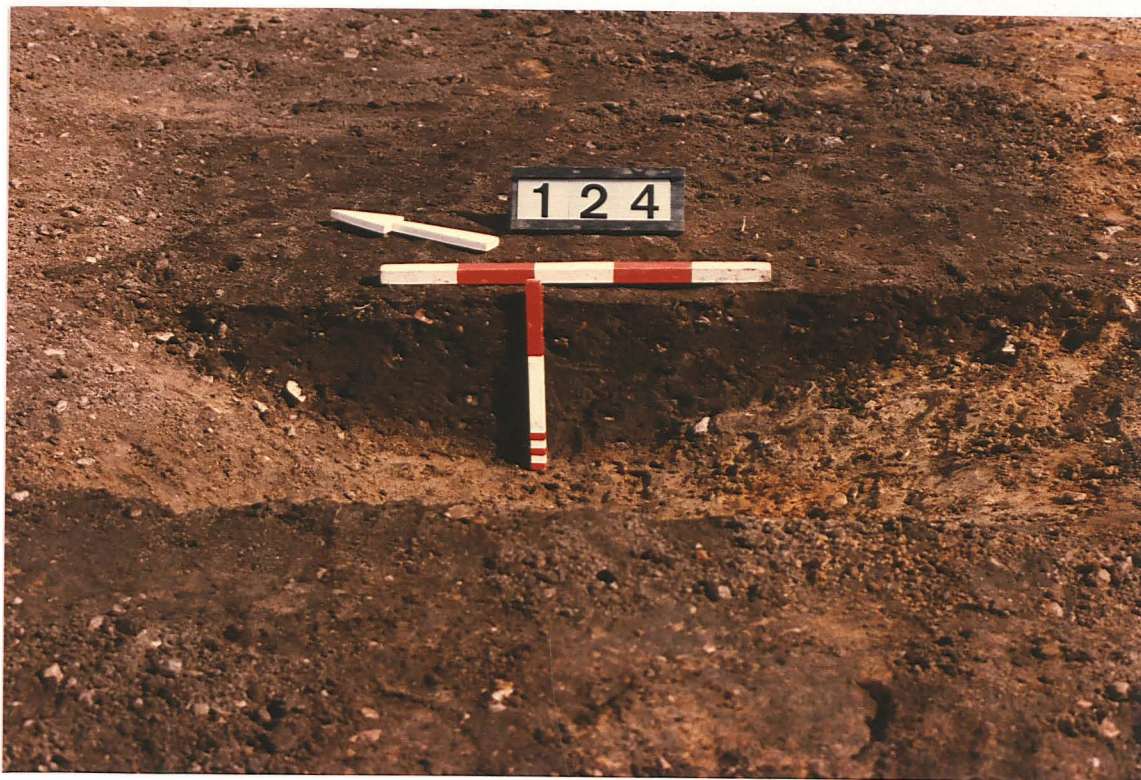
Pl. 7 Drainage ditch [124] looking north-east

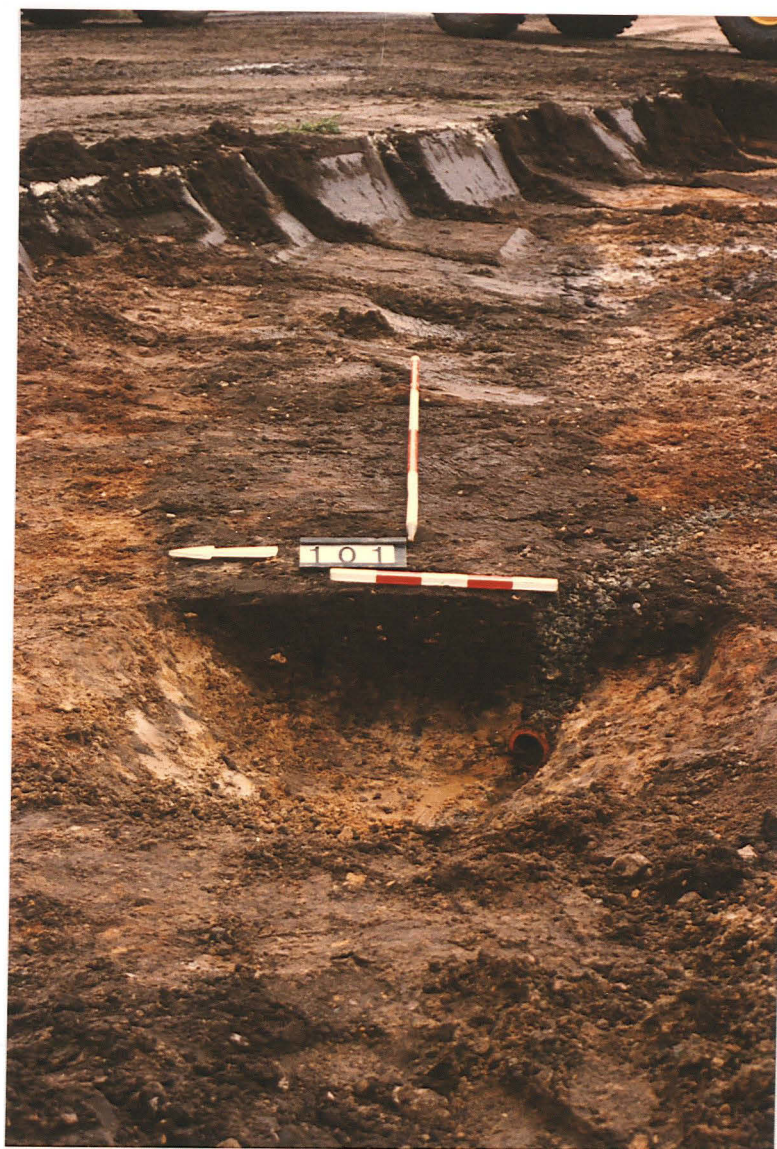
Pl. 8 Drainage ditch [101] looking east

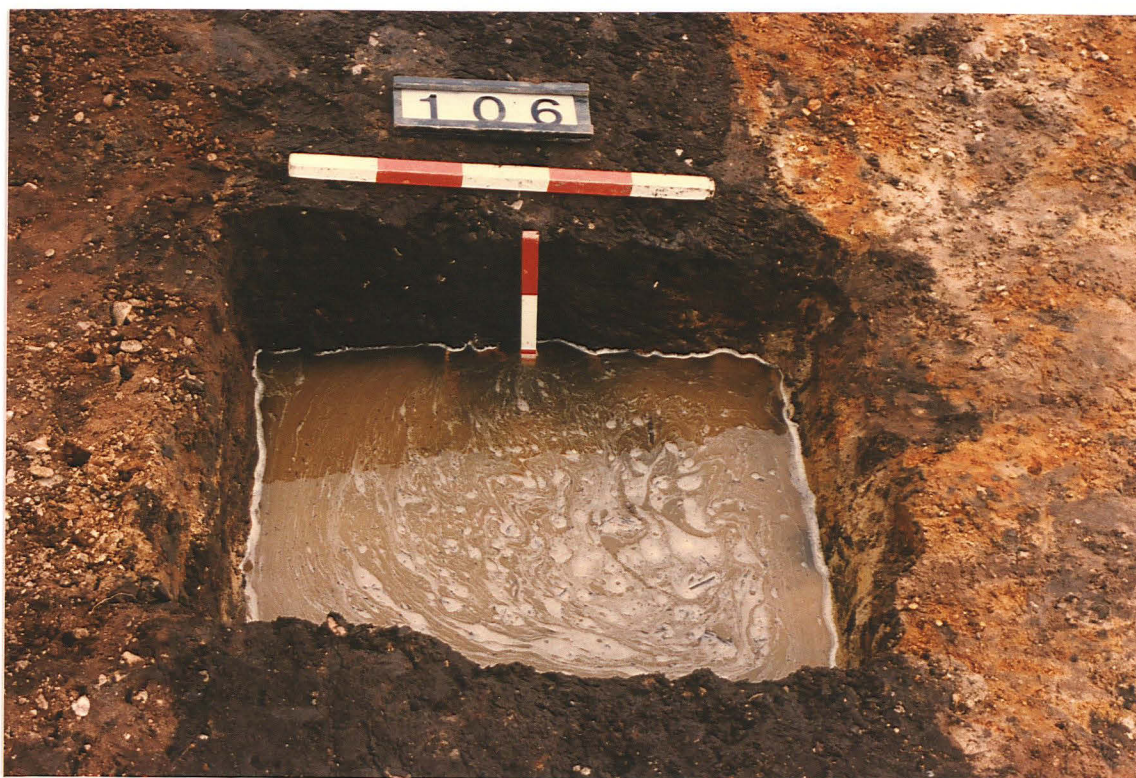
A number of drains were observed that were directly related to the concrete airfield staging areas. These varied in form from circular field drains around the turning circles to large ditches along the main runway. Ditch [106] (Pl. 10) was excavated in the south-western part of the site where the length of runway and turning circle had been removed prior to commencement of this phase. The ditch consisted of a steep sided feature which tapered to a field drain at the base.

Pl.9 Drainage ditch [106] looking south

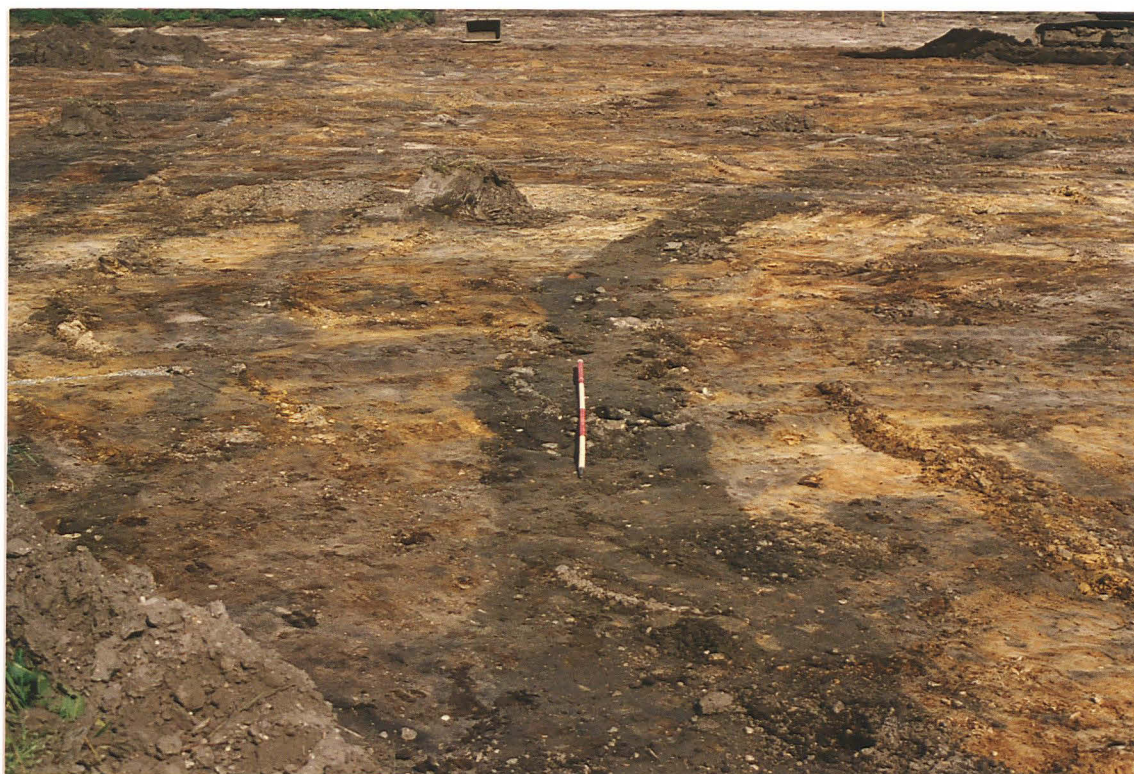
Pl.10 Curved field drain in western part of site

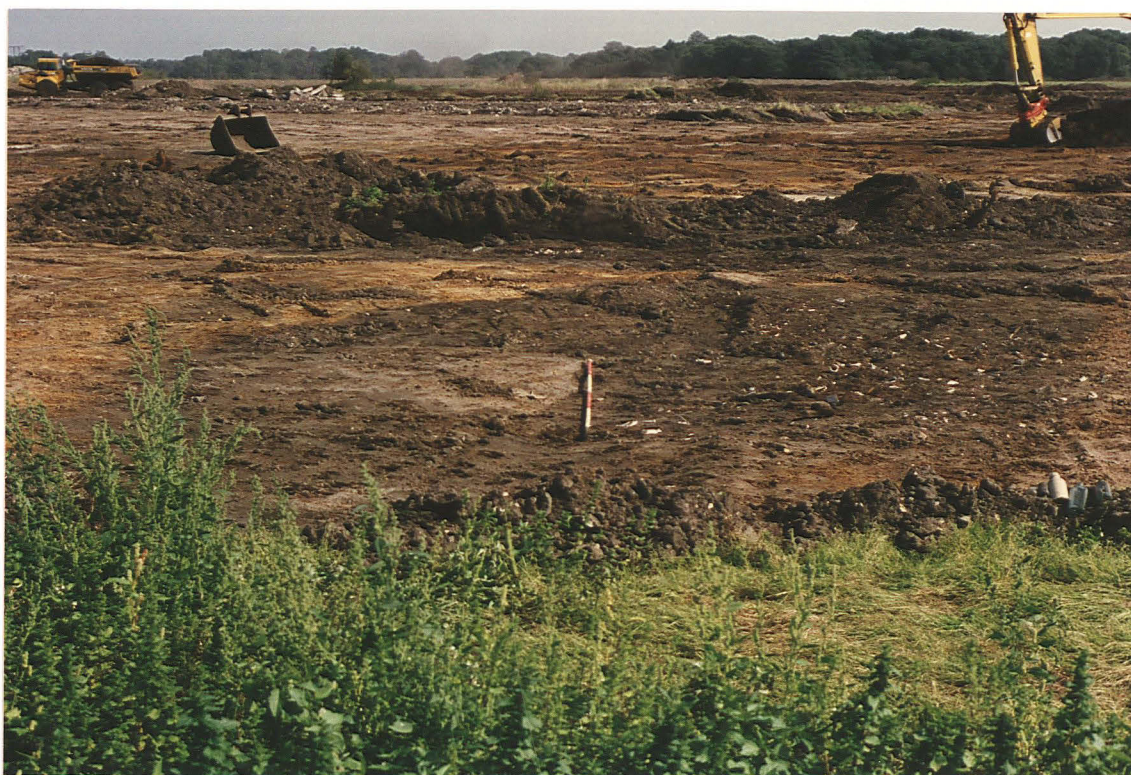
A number of pits were observed on the site, the largest of which was a bomb crater approximately 35m x 15m which had been backfilled with refuse

material, probably from the airbase. This material included a pottery, glass ware and tyres ( Pl. 11).

Pl.11 Pit [146] the bomb crater looking east

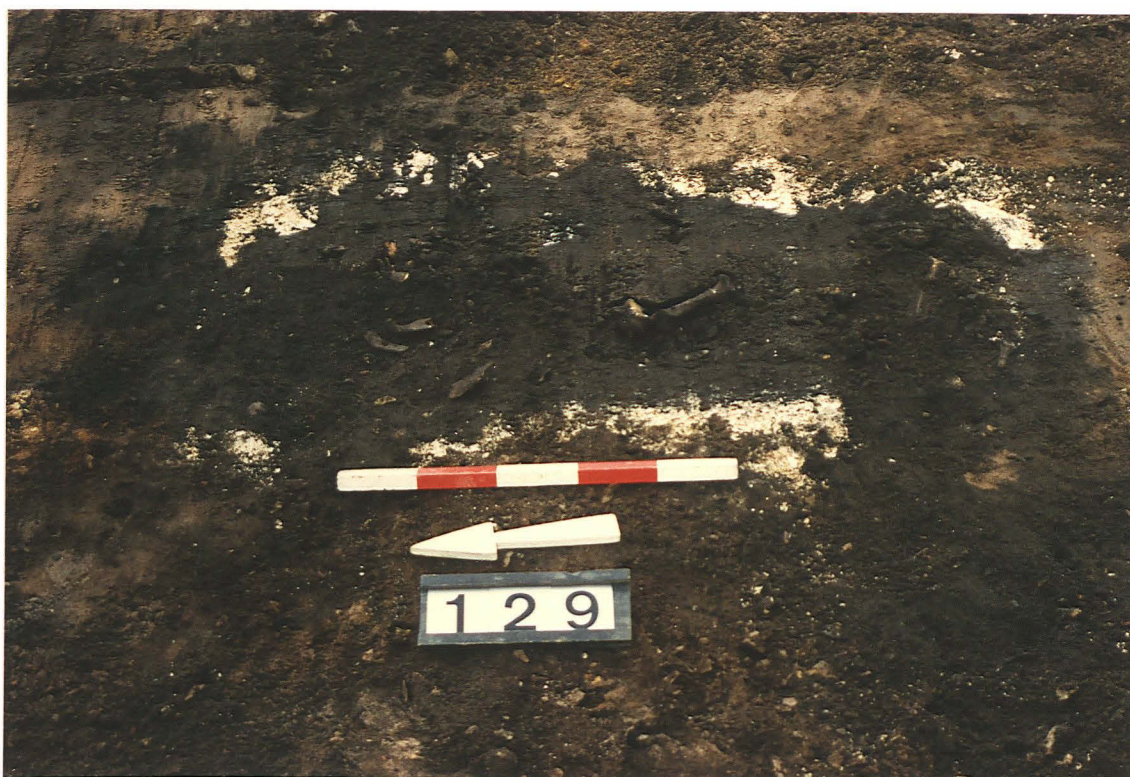
Several animal burials were located in pits lined with lime. These were left unexcavated (Pls. 12 and 13). A single burial, that of a pig, was located which was not lined with quicklime, probably associated with the nearby pig farm. The well-preserved nature of the bone in this free draining environment suggested that the burial was recent.

Pl. 12 Pit [129] lime lined animal burial

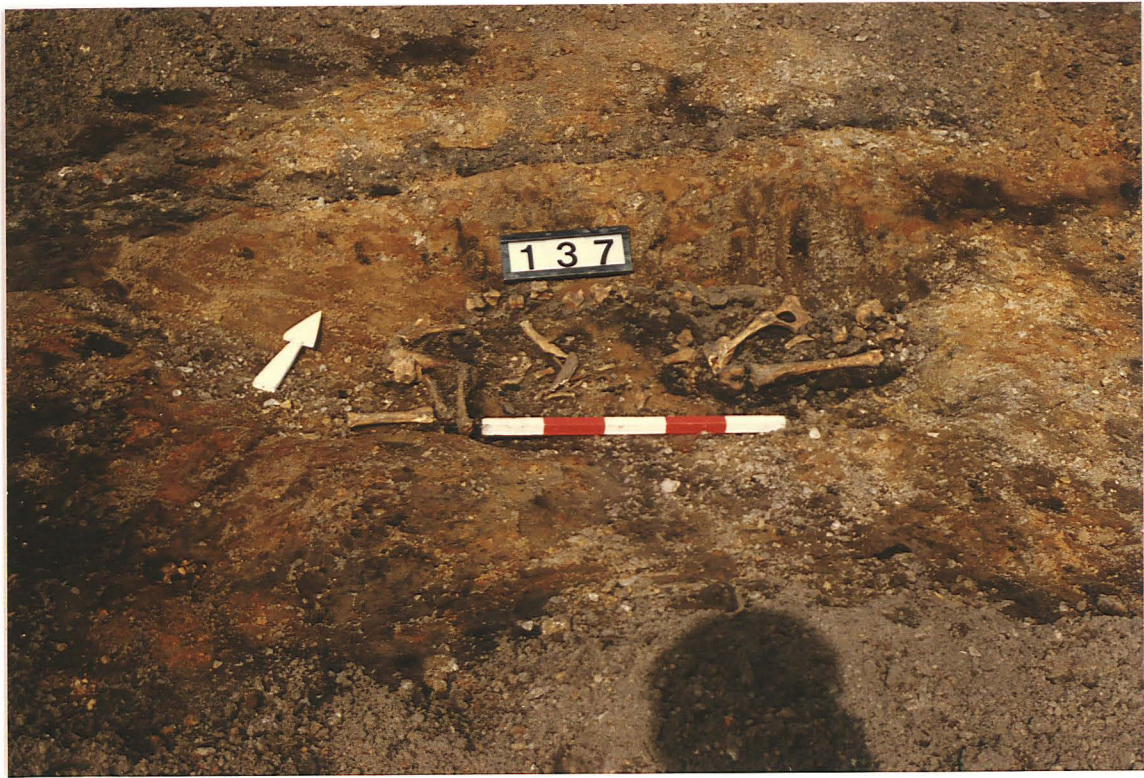
Pl. 13 Pit [137] modern animal burial
