**Roman Bank
Moulton Seas End**

Archaeological Watching Brief

**NGR: TF 3265 2768
Site Code: MSE97
LCNCC Accession No. 272.97**

Report No. 269

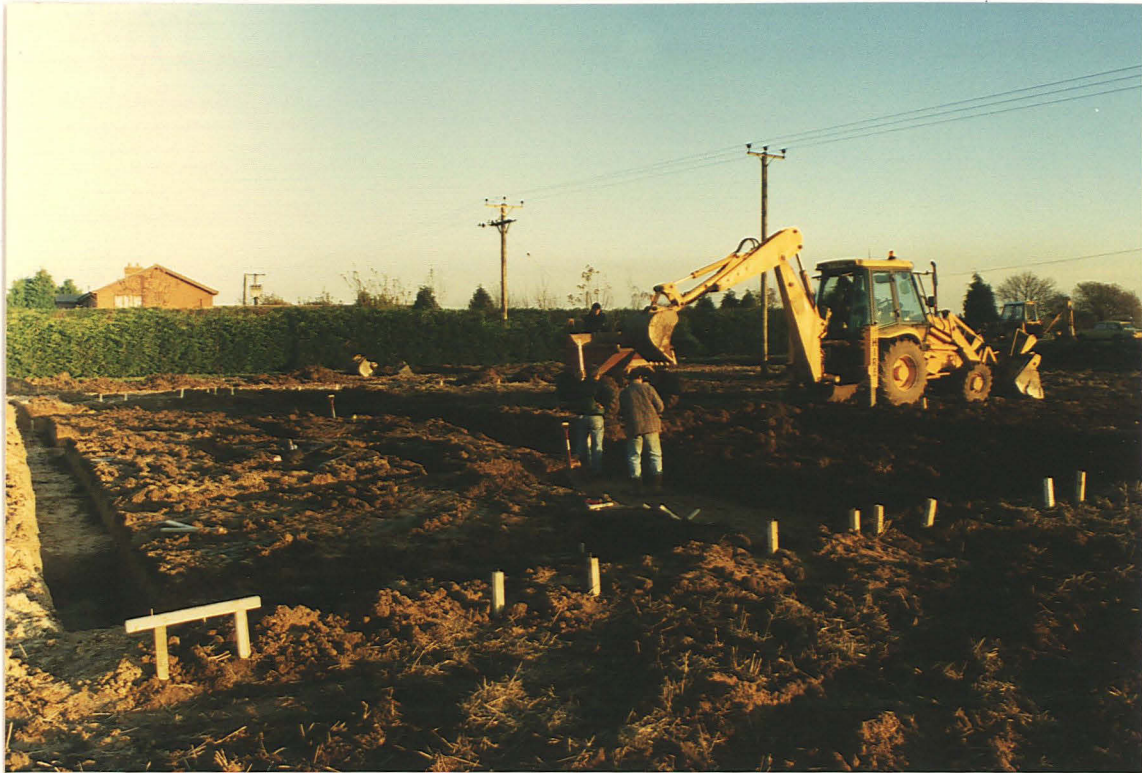
The watching brief was carried out on Wednesday 12th November 1997. Trenches for the house foundations were excavated using the backhoe arm of a JCB fitted with a 60 cm wide bucket, which was changed to a 45 cm bucket for the internal walls (Fig. 2, Pl. 1, 2). The depth was generally around 0.60 m, although a section through the darker clay deposit, to confirm that it was natural, was extended to a depth of around 0.95 m in the north-west corner (Pl. 3).

Pl. 1: View of excavated foundation trenches, from north-west corner, looking south-east.

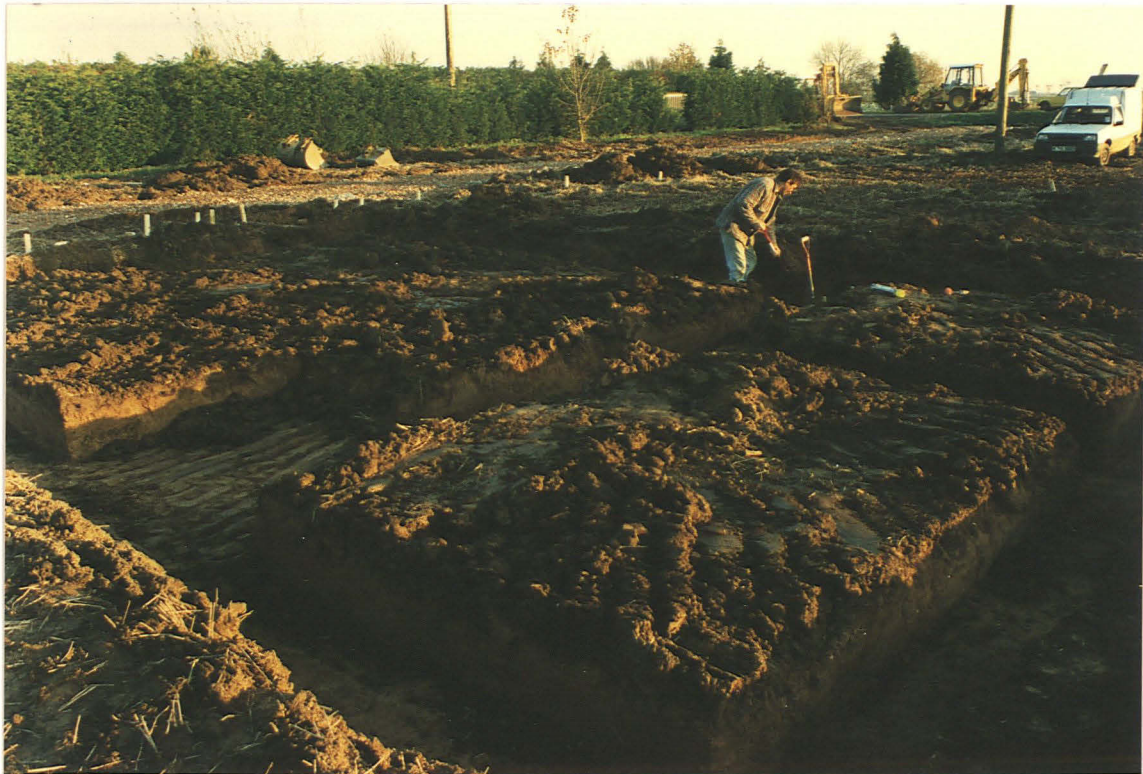
Pl. 2: View of excavated foundation trenches, from centre of back wall, looking south-east.

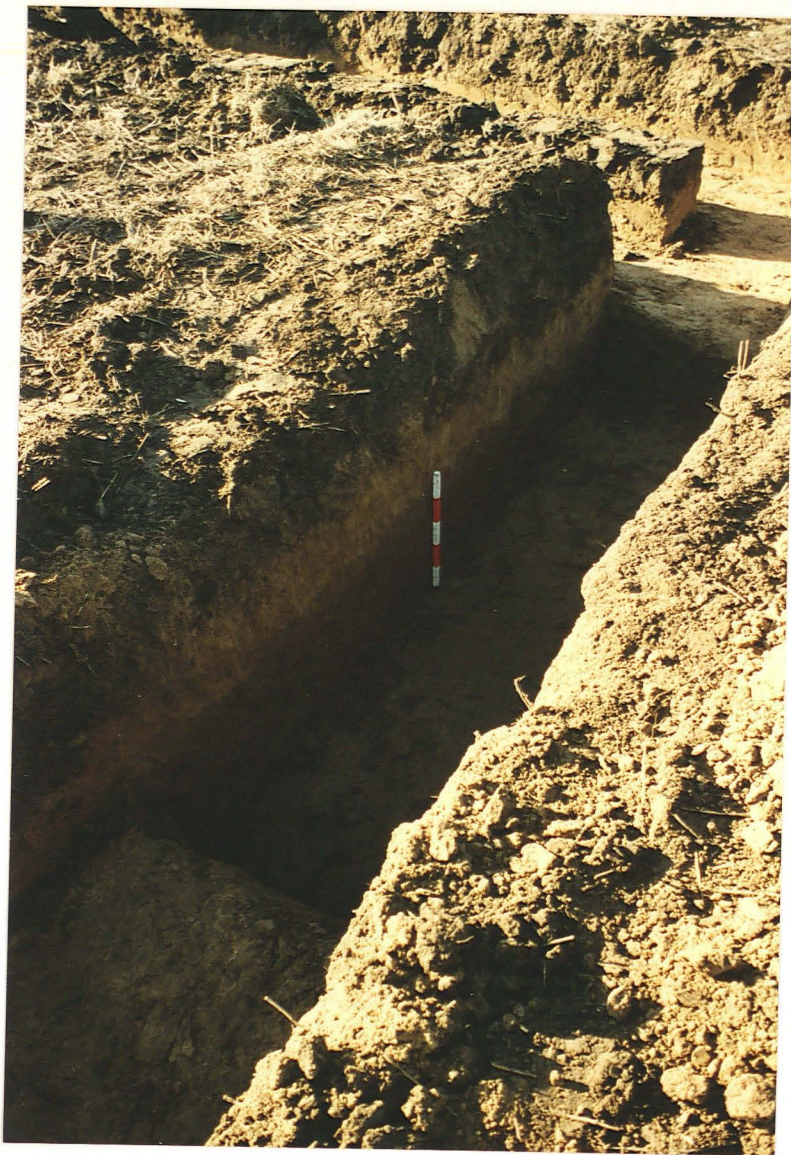
The topsoil layer was about 0.25 m thick, and consisted of a mid-grey, friable, clayey silt. It had remains of roots and ploughed stubble, with occasional charcoal flecks, but was otherwise very homogenous, with few inclusions. Below was a layer of pale orangey yellow sandy silt, with some greyer silt mottling. At a depth of around 0.55 m to 0.65 m, this gave way to a thick band of buff-grey compact clayey silt. Again, this was very homogeneous, apart from occasional yellow sandy mottling. Where the trenches were excavated to greater depth, at around 0.90 to 0.95 m the base was a mottled sandy-buff hard sandy silt, with black streaks characteristic of iron in chemically reducing conditions (Pl. 4).

Pl. 3: Section of trench in north-west corner, showing sand and silt layers. Scale 0.5 m.

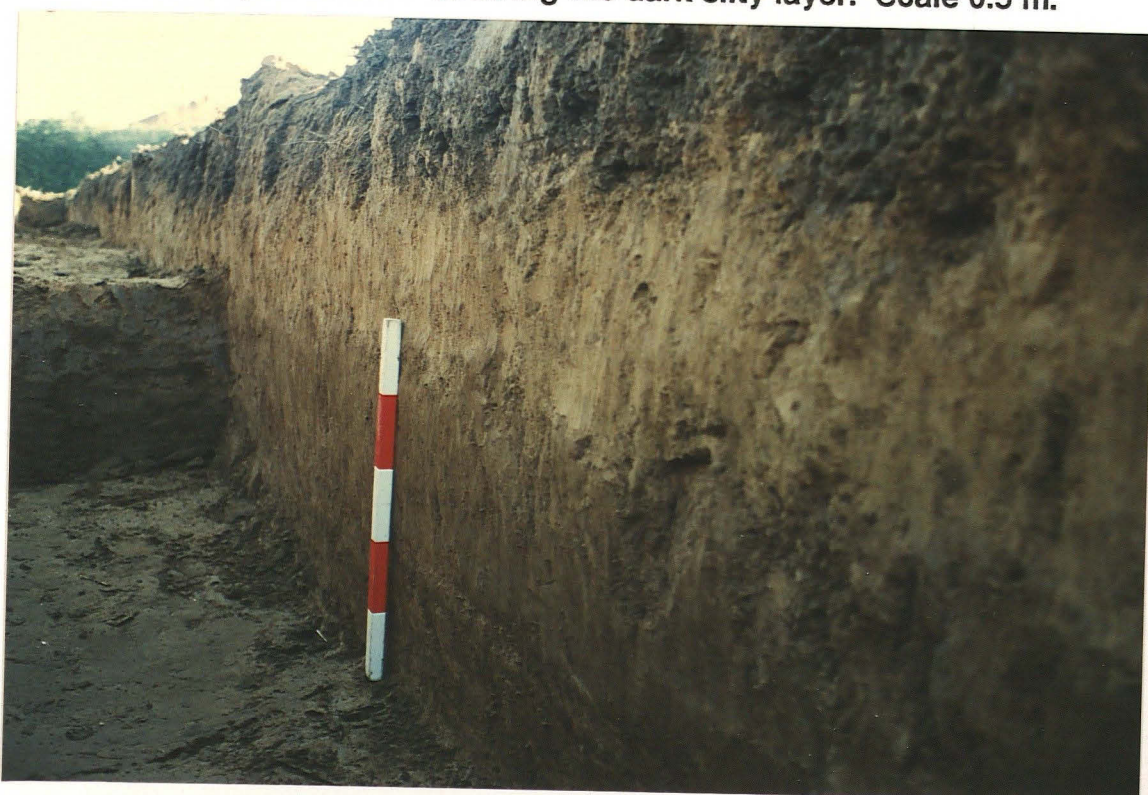
Pl. 4: Close up of section showing the dark silty layer. Scale 0.5 m.
