**AN ARCHAEOLOGICAL WATCHING BRIEF
OF EXCAVATIONS FOR A LAGOON,
STOKE ROCHFORD GOLF COURSE
STOKE ROCHFORD,
LINCOLNSHIRE
(SRG97)**

Work Undertaken For
C J Collins Construction

December 1997

Planning Application No: SK97/327/70/14
National Grid Reference: SK 9248 2890
City and County Museum Accession No: 221.97
A.P.S. Report No: 49/97

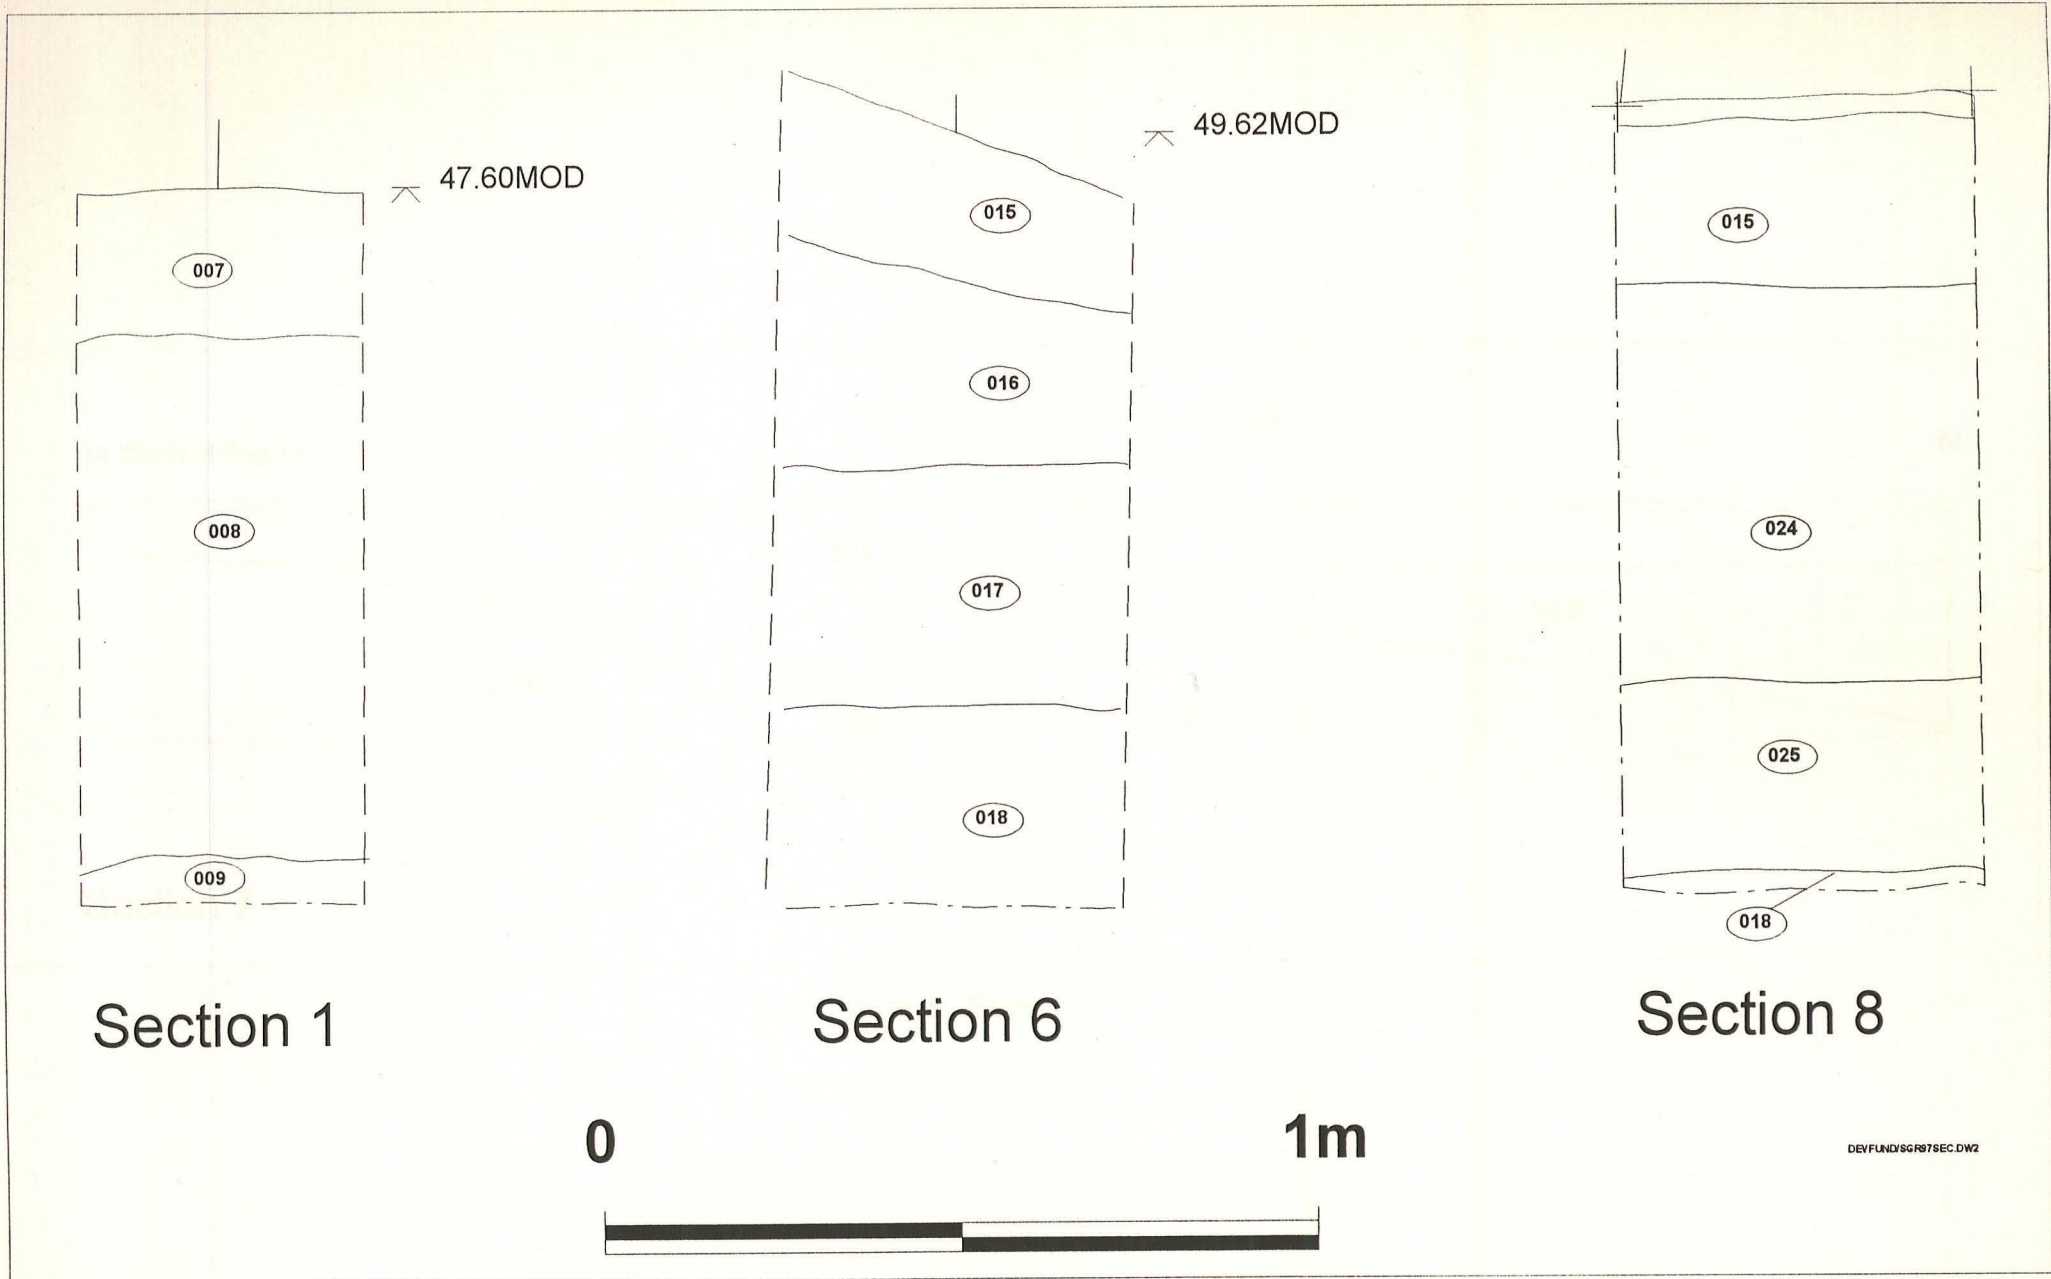
Figure 4 - Sections 1, 6 and 8

These include deposits of fine yellow sand (027) encountered along the northern edge of the site. The central and southern portions of the development area were dominated by a similar deposit (018) of light yellow sand, but including very fine stone (Fig.4 Section 6 and Section 8).

Other Phase 2 deposits include a light-mid brown sandy clay (003) on the top of the slope at the north end of the site to a light-mid greyish brown clayey silt (007) (Fig. 4 Section 1), on the middle to lower part of the gradient. These sediments are also likely to represent sediment accumulation either through alluvation or colluviation. At the base of the slope a dark brownish black peaty silt (005) represents sediment accumulation in waterlogged conditions (Fig 5 Section 7).

Around the southern edge of the site deposits varied from mid grey bands of fine sands and silts (023) (Fig 5 Section 7), through creamy or rusty sand and grit (014) (Fig 6 Section 5). A mid grey sandy silt (009) (Fig. 4) recorded in Section 1 at the northern limit of the investigation is very similar to (023). These assorted silts and sands are likely to be alluvial in origin and were probably deposited during a phase when the Cringle Brook was a much more substantial watercourse.

Topsoil deposits recorded on the site are represented by a mid yellowish brown to brown silt (012) (Fig 6 Section 5), (015) (Fig. 4 section 6) and a 0.25m thick brown sandy clay (002). Modern pottery was recovered from (002), together with redeposited fragments of medieval pottery and a piece of prehistoric flint.

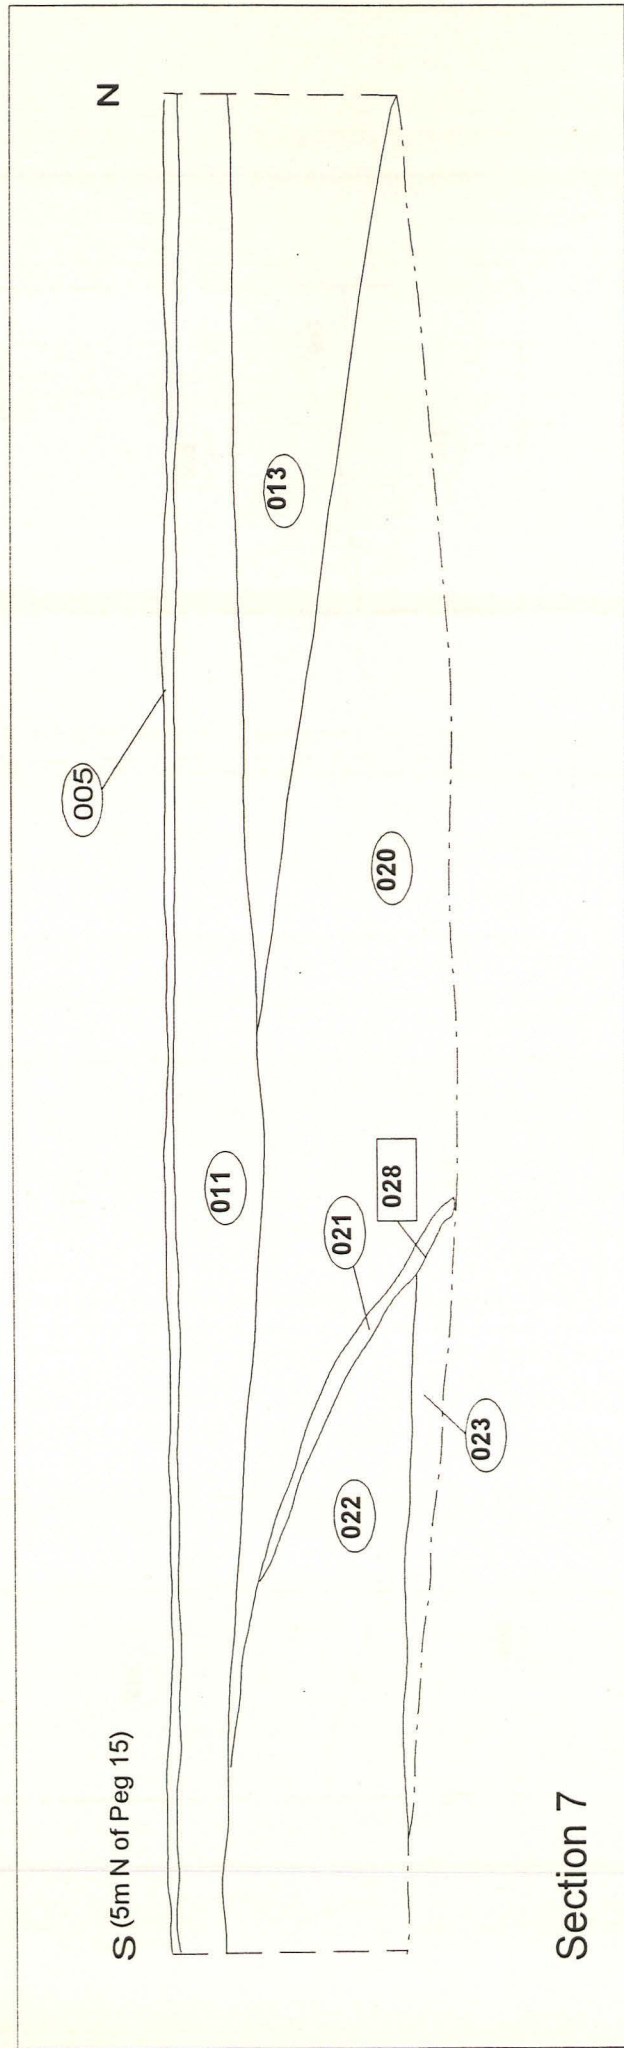
Figure 5 - Section 7

Also included within Phase 1 are clays and clayey silts overlying the sands and silts described above. Phase 1 deposits in this category include (025), a yellowish brown clayish silt located towards the north end of the site (Fig 4 Section 8). A yellowish fawn clay (022) recorded in Section 7 represents the only clayey Phase 1 deposit located in the southern area of the development (Fig.5 Section 7).

At the southeast corner of the site a possible former stream channel was recorded [028] (Fig 5 Section 7). Although only the upper edge of the south side of [028] was visible, the truncation of horizontal deposits (022) and (023) does suggest a cut feature of some kind. The 'rusty' coloured, smooth sandy silt (021) which lies immediately above cut [028] is probably an iron pan deposit formed by leaching of organic material when the channel was active. A tile fragment of possible Romano-British date retrieved from fill (020) of the channel suggests that watercourse was open, at least as a visible hollow, during the Roman period or later.
