9812
YATES'S WINE LODGE,
274-277 HIGH STREET,
LINCOLN

ARCHAEOLOGICAL WATCHING BRIEF

CLAU ARCHAEOLOGICAL REPORT NO: 334

Site Code: HSG97
LCCM Accession No.: 86.97
NGR: SK 9760/7145

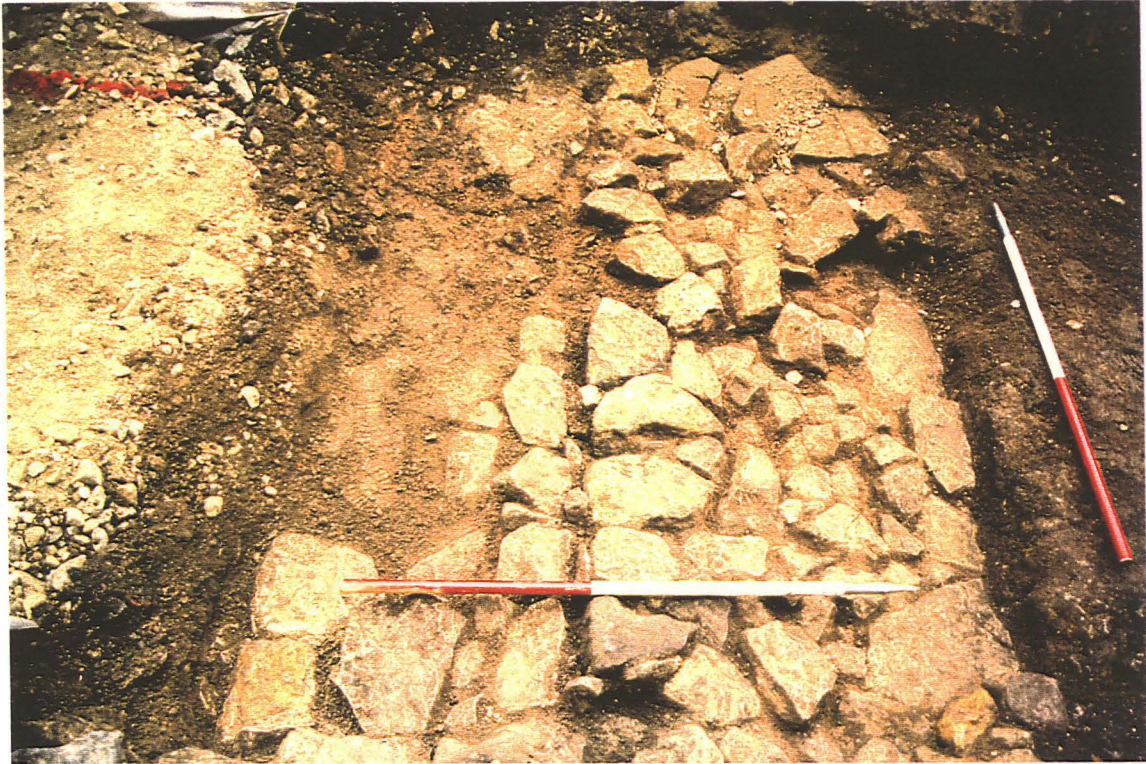
Plate 1: Overhead view of walls [119] & [120], looking east

S) (**Structure 1**). This comprised two limestone walls ([120], with its construction cut [121] to the north, and [122] to the south), enclosing a series of floors ([129]; [133], [134] & [136]), and the remains of a possible hearth ([126], [127], [128] & [140]). The walls featured at least five courses of loosely bonded roughly worked blocks, while the floors included layers of mortar, limestone pieces, ash and burnt silts and clays. The possible hearth was made up of a lining of clay bonded to a foundation of limestone blocks, all within a bowl-shaped cut. This was filled with ash and grey-black clayey silt.

To the north of this building, a further stone structure (**Structure 2**) was constructed, with its south wall ([119]) virtually touching the north wall of its neighbour. Only the south side of this later building was revealed, but it was apparent that it was probably of a similar size to that to the south. No evidence for internal floors was preserved within this new structure, but the remains of a N-S internal dividing wall ([114]) were present.
