**ARCHAEOLOGICAL WATCHING BRIEF REPORT  
LAND SOUTH OF WILLOUGHBY ROAD,  
CUMBERWORTH, LINCOLNSHIRE**

Site Code: WRC98  
LCNCC Acc No. 42.98  
NGR TF 550640 733480  
Planning Ref. N/040/1318/97

Report prepared Mr A Carr by  
CPH Palmer-Brown  
February 1998

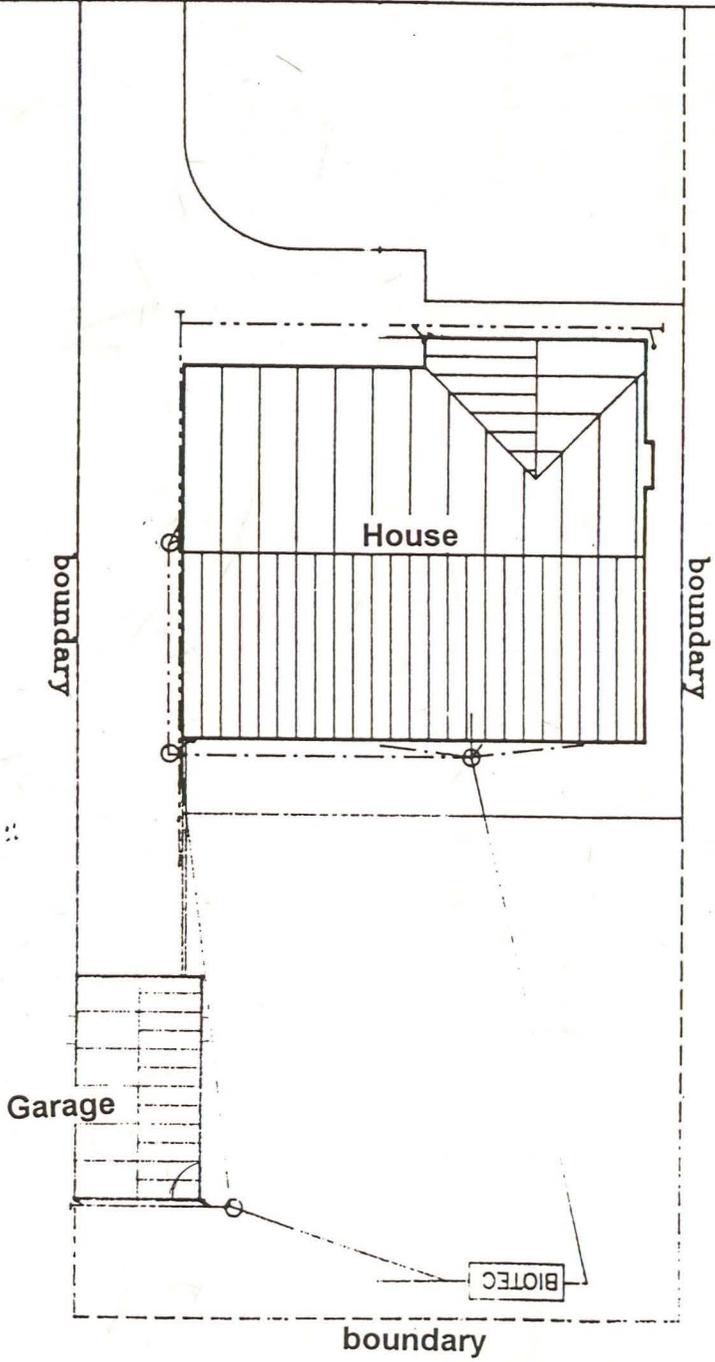
Fig. 2 Development footprint at 1:200

No archaeological deposits were exposed within the house foundation footprint.

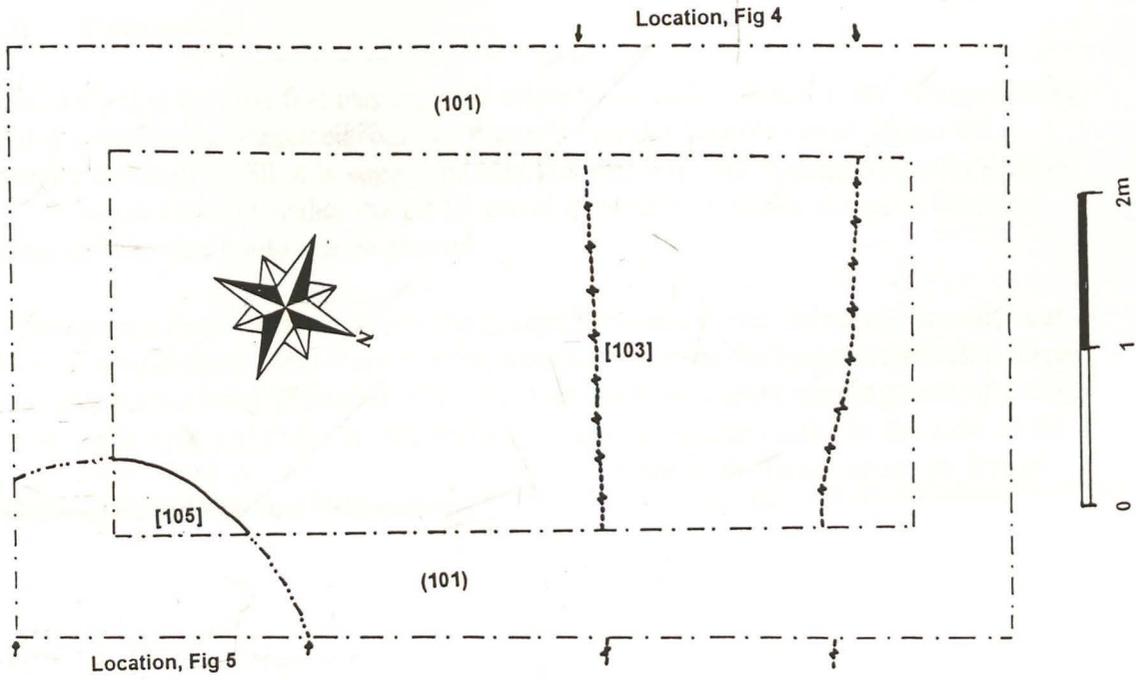
Fig;3 Plan of Garage Area

Two earth-cut features were exposed in the sides and base of the garage foundation: a ditch orientated east-west, and a pit-like feature in the south-east corner (Fig.'s 3, 4 and 5)

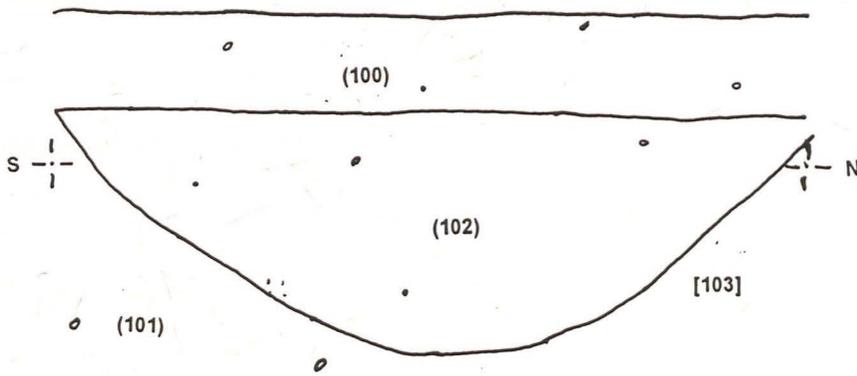
Fig;4 Section of cut [103]  
Scale 1:20

The ditch, which extended east-west through the north side of the garage footprint measured approximately 2.0m in width (maximum) and was up to 60cm in depth. It had a wide U-shaped profile and was filled with dark grey silty clay, free of coarse inclusions and domestic waste (attempts were made to recover datable artefacts but to no avail).

It is likely that the two features exposed relate to an earlier phase of the village history, and it is tenuously suggested (but not proved) that they are medieval. Given the sterility of the ditch fill, it is suggested that this was a former drainage/boundary ditch. The charcoal element within the pit fill could indicate a primarily domestic function, although this also could not be proved.

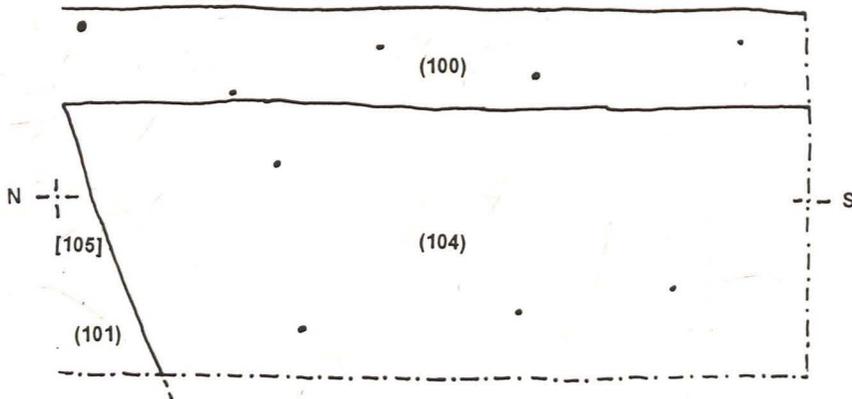
Fig;5 Section of pit cut [105]  
Scale 1:20

In the south-east corner of the garage foundation, a pit-like feature was exposed. This was difficult to examine due to standing water in this location, although it was possible to define its limits in plan and draw one profile where it appeared in the sides of the east foundation trench (Fig. 5).

The depth of the pit exceeded 0.7m, and it was filled with dark grey silty clay containing fragments of charcoal. Again, no datable artefacts were recovered.

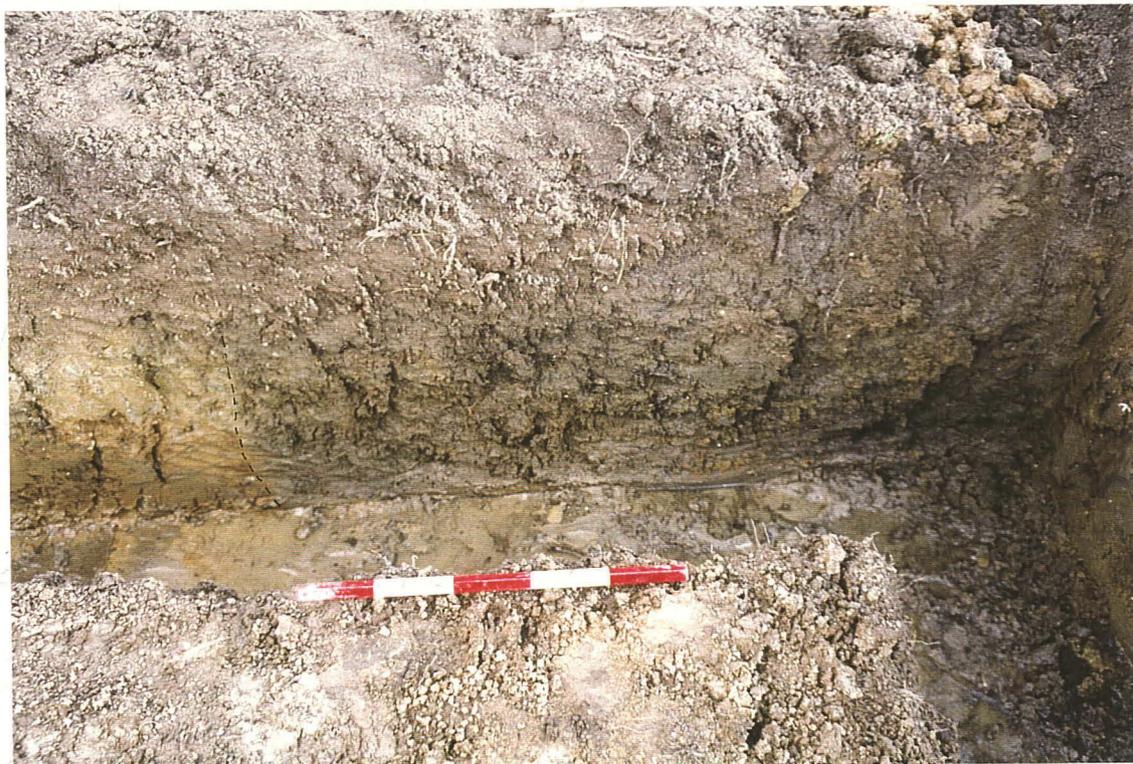
P1. Section through pit [105], looking east

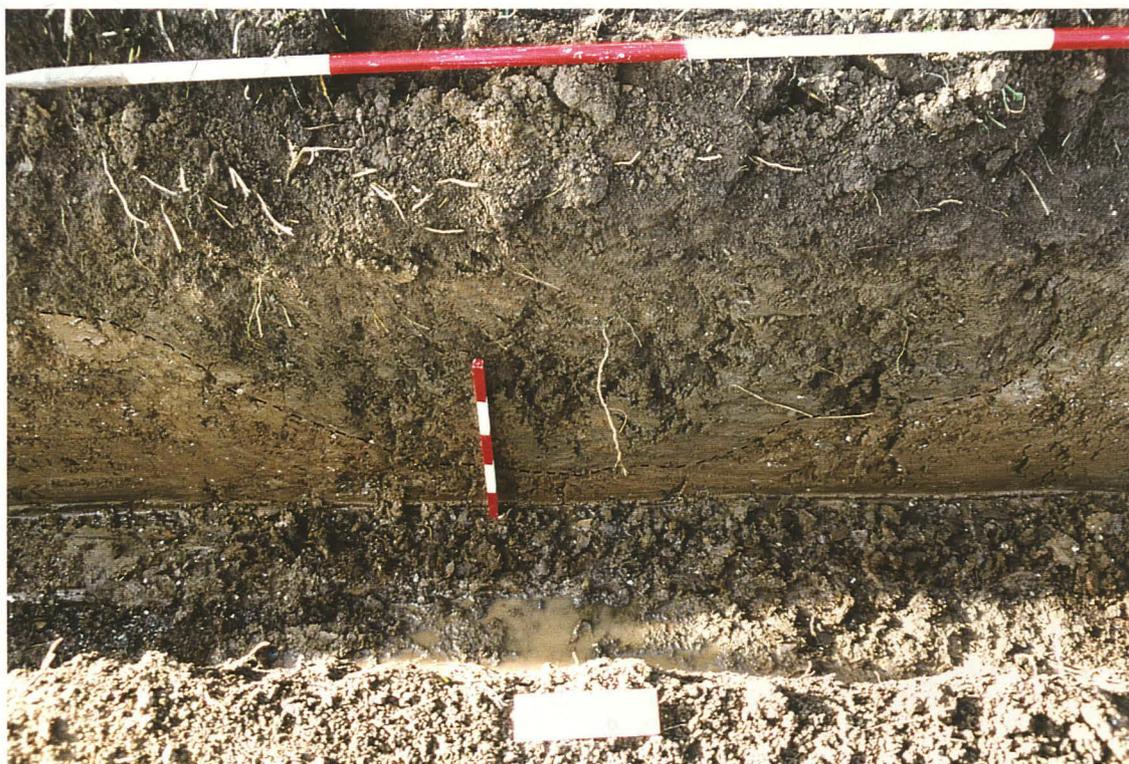
P2. Section through ditch [103], looking west
