98/7
RASEN LANE/BAILGATE,
LINCOLN -
Traffic Calming Scheme

ARCHAEOLOGICAL WATCHING BRIEF

CLAU ARCHAEOLOGICAL REPORT NO: 329

RASEN LANE/BAILGATE,
LINCOLN -
Traffic Calming Scheme

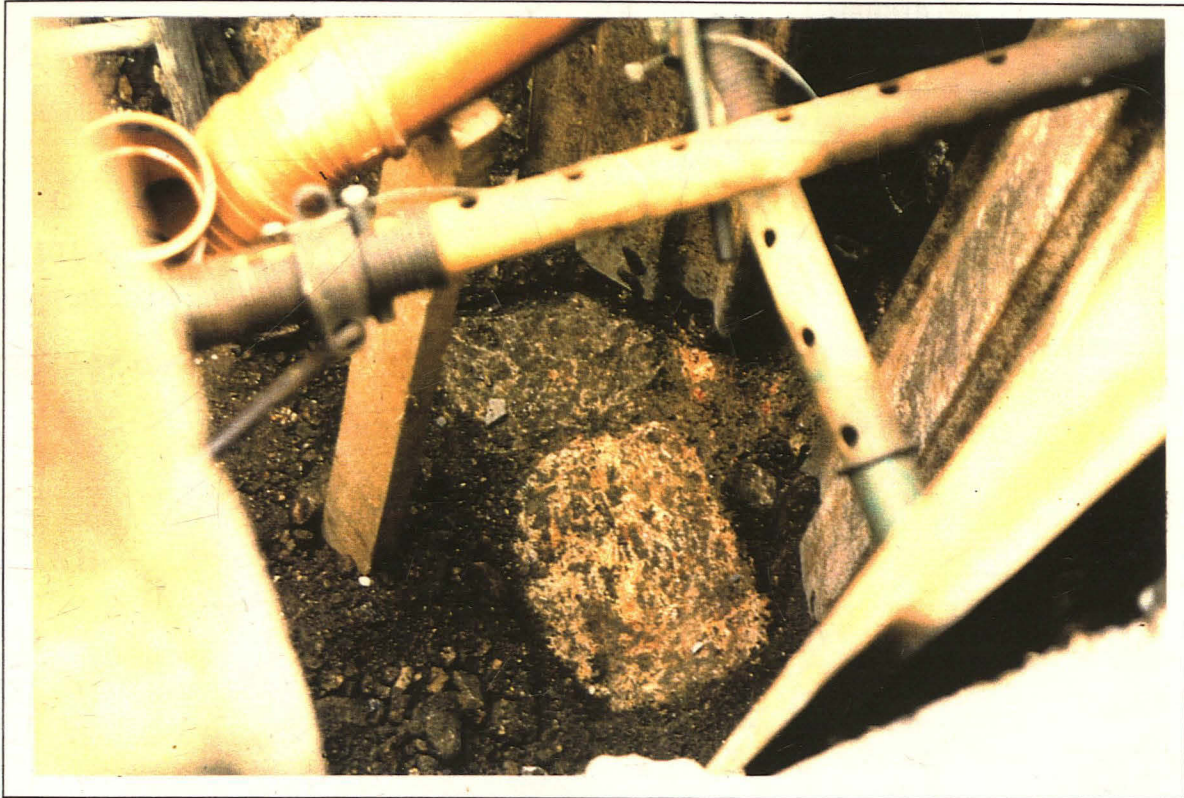
Plate 1: Overhead view of paving slabs in base of trench

The earliest feature revealed in this part of the trench comprised at least two large (c.400mm square) flat limestone slabs [125], appearing to form part of a paved surface. This feature was only revealed at the limit of excavation (L.O.E.) of the trench, and therefore no indication of the thickness of the surface could be seen. Similarly the precise alignment and extent of the feature is not known, and no dating evidence was found during excavation. However, given the depth at which the surface appeared (the upper boundary was present c.2.2m below the present road surface), it seems very likely that the surface is associated with either the Roman road, or roadside pavement. As such, this constitutes the first definite evidence that, at one period at least, the main N-S street of the Roman city was formed of paving slabs.

In this way, it would seem likely that the possible paving slabs [125] revealed towards the base of the trench were associated with either the Roman road itself, or perhaps with a roadside pavement.

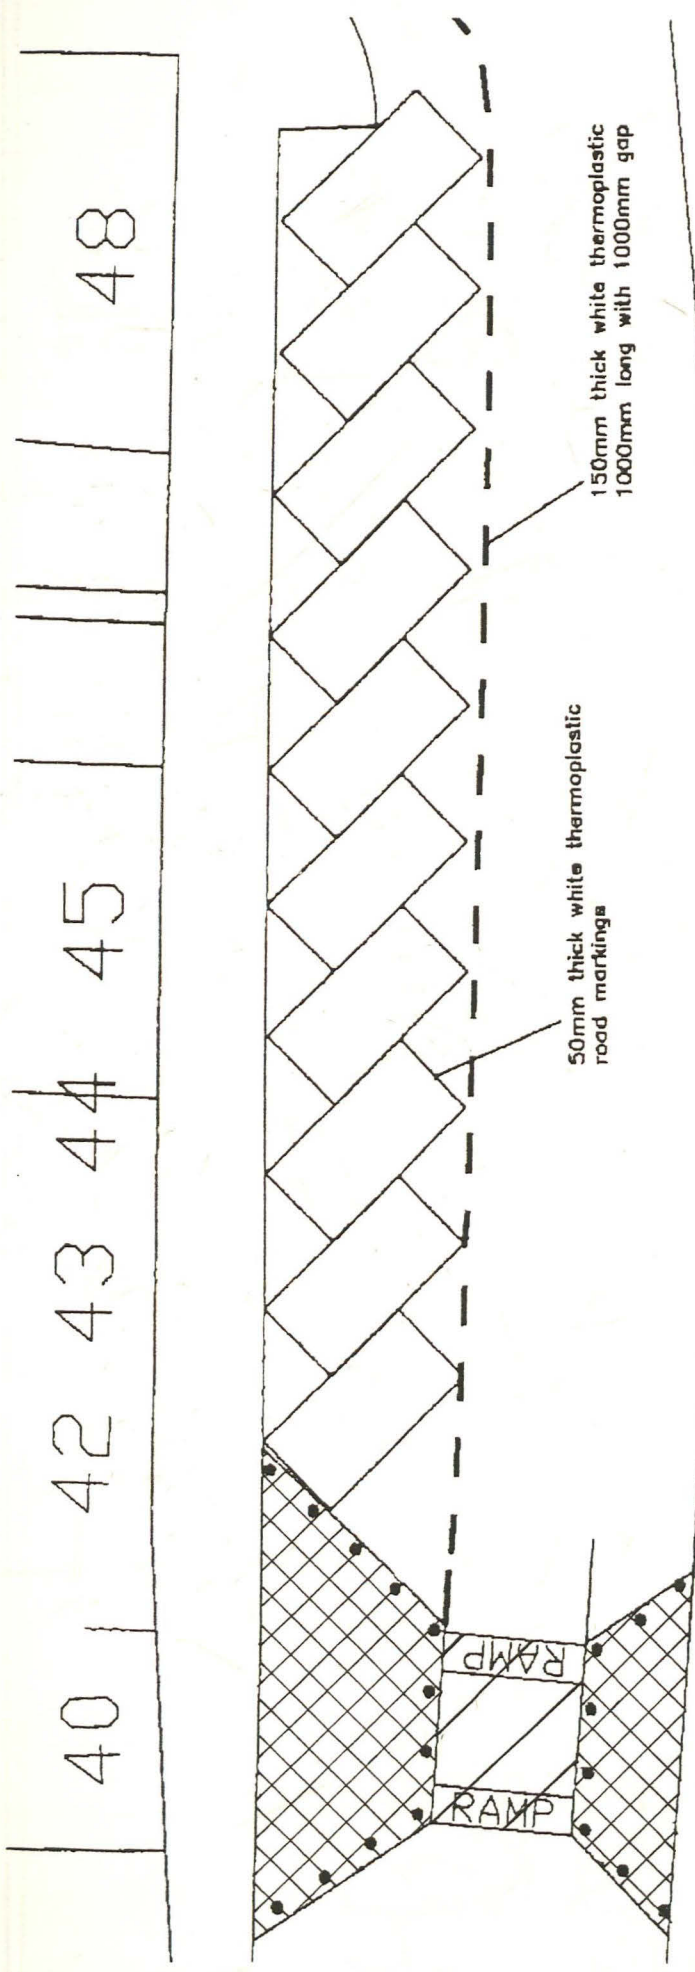
Fig.3

The proposed works along Bailgate related to the remodelling of the existing kerb alignments, provision of two new ramped areas (adjacent to nos.40 & 42 Bailgate, and at the junction with Westgate), repaving/surfacing, and limited provision of new surface water drainage arrangements. The improvements along Rasen Lane were limited to realignment of various kerbs, and the provision of several raised areas in each carriageway, and did not involve any substantial groundworks.

CITY OF LINCOLN ARCHAEOLOGY UNIT		
SITE CODE: RLB97	PLAN/ELEV/SECTION NO:	
CLIENT: City Engineering Consultants, Lincoln City Council		
DESCRIPTION: Plan of Proposed Works at North End of Bailgate (Junction with Chapel Lane)		
SCALE: 1:200	ARCHIVE NO:	
DRAWN BY:	CHECKED:	DATE:
MUSEUM ACCESSION NO: 54.97
