**ARCHAEOLOGICAL WATCHING BRIEF REPORT  
NORTH KYME TO SOUTH KYME WATER MAINS REPLACEMENT  
LINCOLNSHIRE**

Site Code:       NSK98  
LCNCC Acc. No: 1.98  
NGR               TF152527 to TF172495

Report prepared Anglian Water Services Ltd  
by James Albone and Robert Schofield  
June 1998

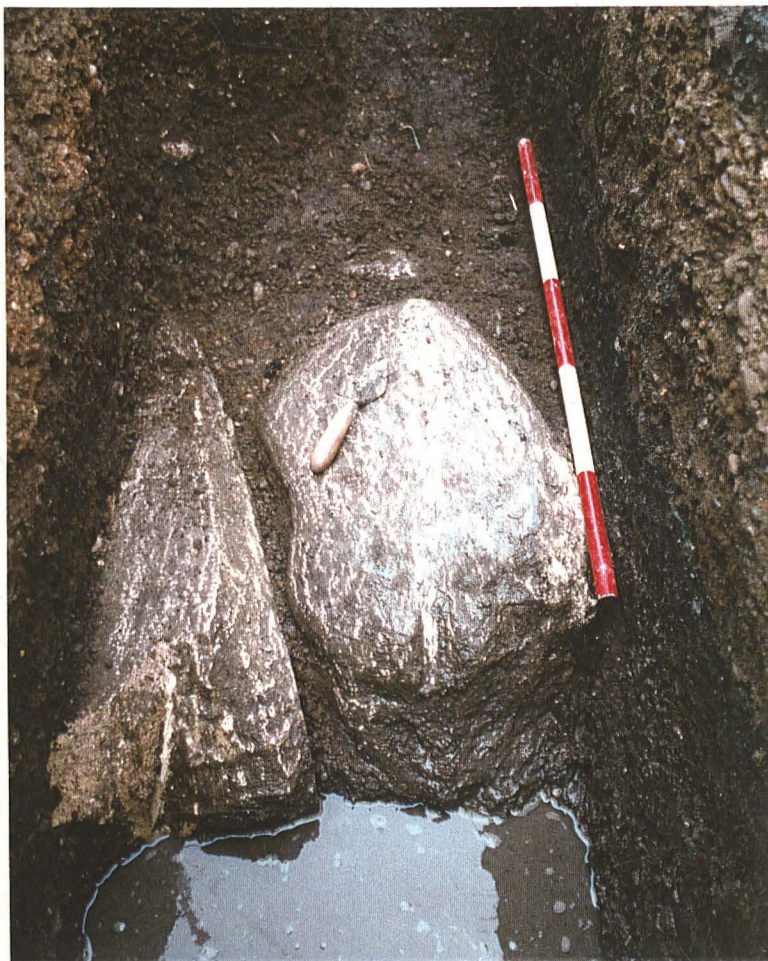
At the southern end of the area, close to the medieval fishponds, a short section of wall [105] was located in trench 1. Two substantial limestone blocks, on a south-west to north-east alignment were revealed, one of which was ashlar with a chamfered edge indicating that the stonework was reused. It is likely that the stonework had come from the demolished parts of the fortified manor house, which would place the construction of the wall sometime after 1720-5. Although the adjacent part of the trench was flooded the thickness of the blocks was traced by hand and the presence of another course beneath was confirmed. The rest of the trench was not deep enough for any other structural remains to be exposed.

P 1. Wall [105] in trench 1 looking north-west.

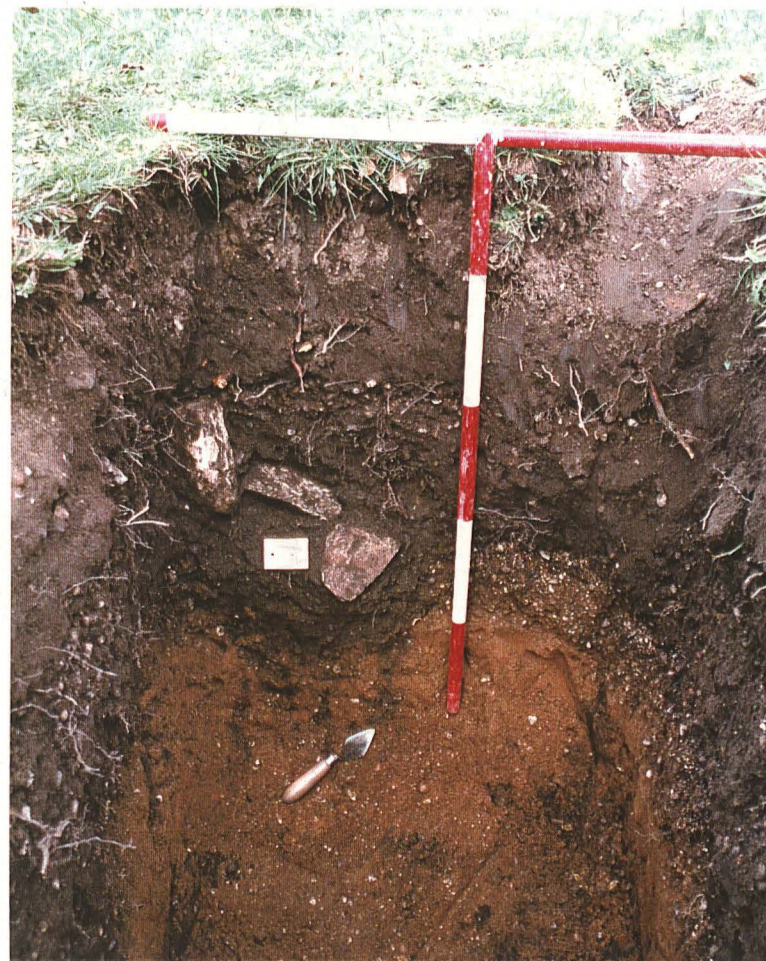
In the north end section of access pit 2 was a U-shaped post pit [114] which cut through layer (111). It contained a dark brown silt fill (113) with limestone post packing. Two sherds of 13th to 14th century pottery were found in the fill.

P 2. Post pit [114] in access pit 2 looking north-west.
