A Report to Anglian Water Services Limited

WATERMAINS REPLACEMENT: DORRINGTON, LINCOLNSHIRE

ARCHAEOLOGICAL WATCHING BRIEF

CLAU ARCHAEOLOGICAL REPORT NO: 344

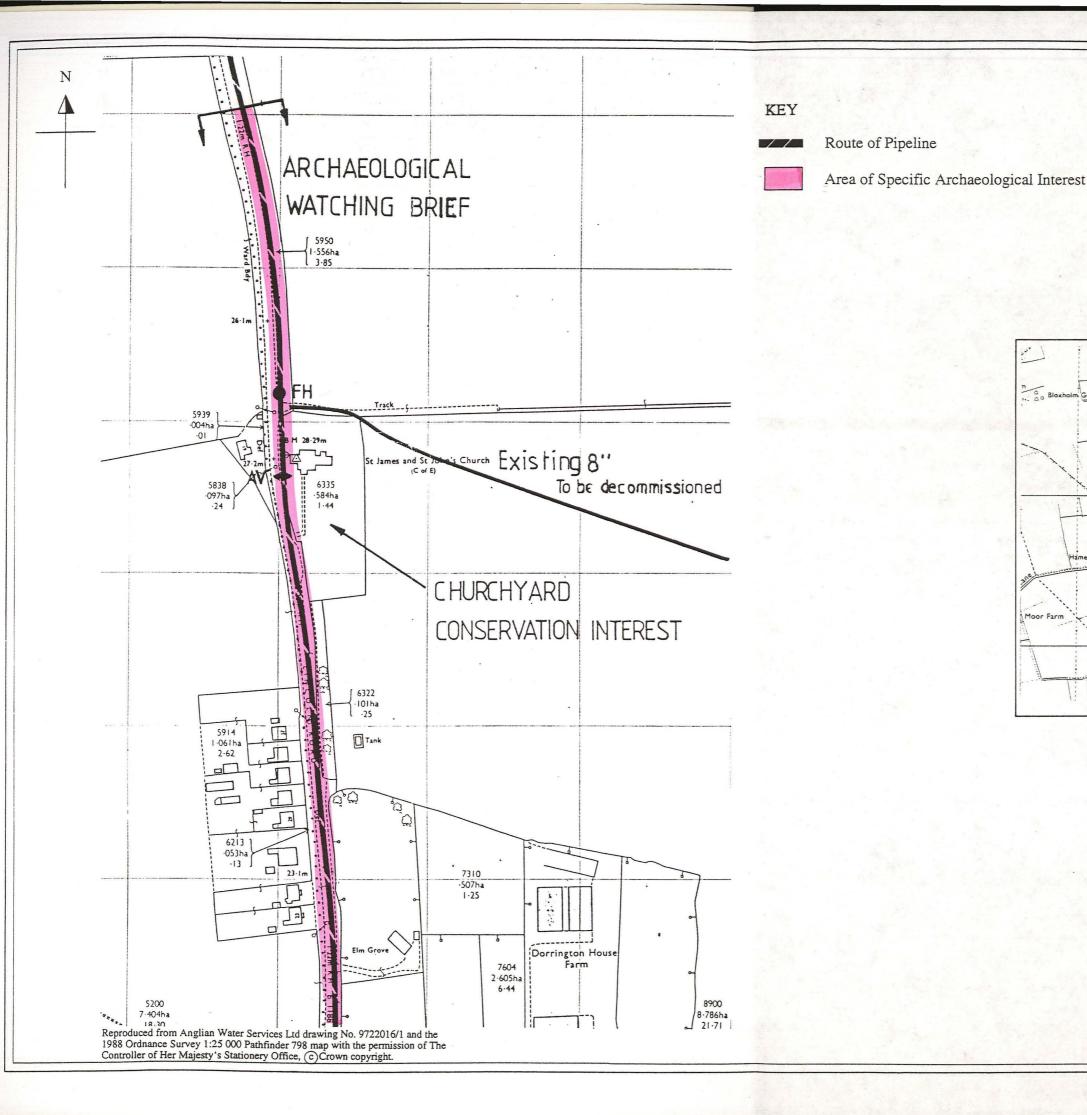
CITY OF LINCOLN ARCHAEOLOGY UNIT SITE CODE: DWR97 PLAN/ELEV/SECTION NO: CLIENT: Anglian Water Services Ltd. DESCRIPTION: Plan of Pipeline Route - Area B SCALE: 1:2500 ARCHIVE NO: DRAWN BY: CHECKED: DATE: MUSEUM ACCESSION NO: 262.97

This section of the trenching was actually the third area to be undertaken, and followed the line of the B1188. The area of archaeological interest extended from a point c.200m north of the parish church, down a falling incline to the junction with Main Street, a distance of approximately 600m.

As with the majority of Area A above, the trenching was carried out using a mechanical excavator, with the trench located in the

eastern side of the carriageway. The trench again measured c.350mm-400mm wide with a depth of between 1m-1.2m. The pipework was again of 225mm diameter.
