Caistor
Former Hospital Site, North Kelsey Road
Archaeological Desk-Based Assessment

NGR: TA 1025 0140
WLDC Planning Application Nos. 98/P/0492 and 98/P/0493
Site Code: COH 98

LAS Report No. 305
July 1998

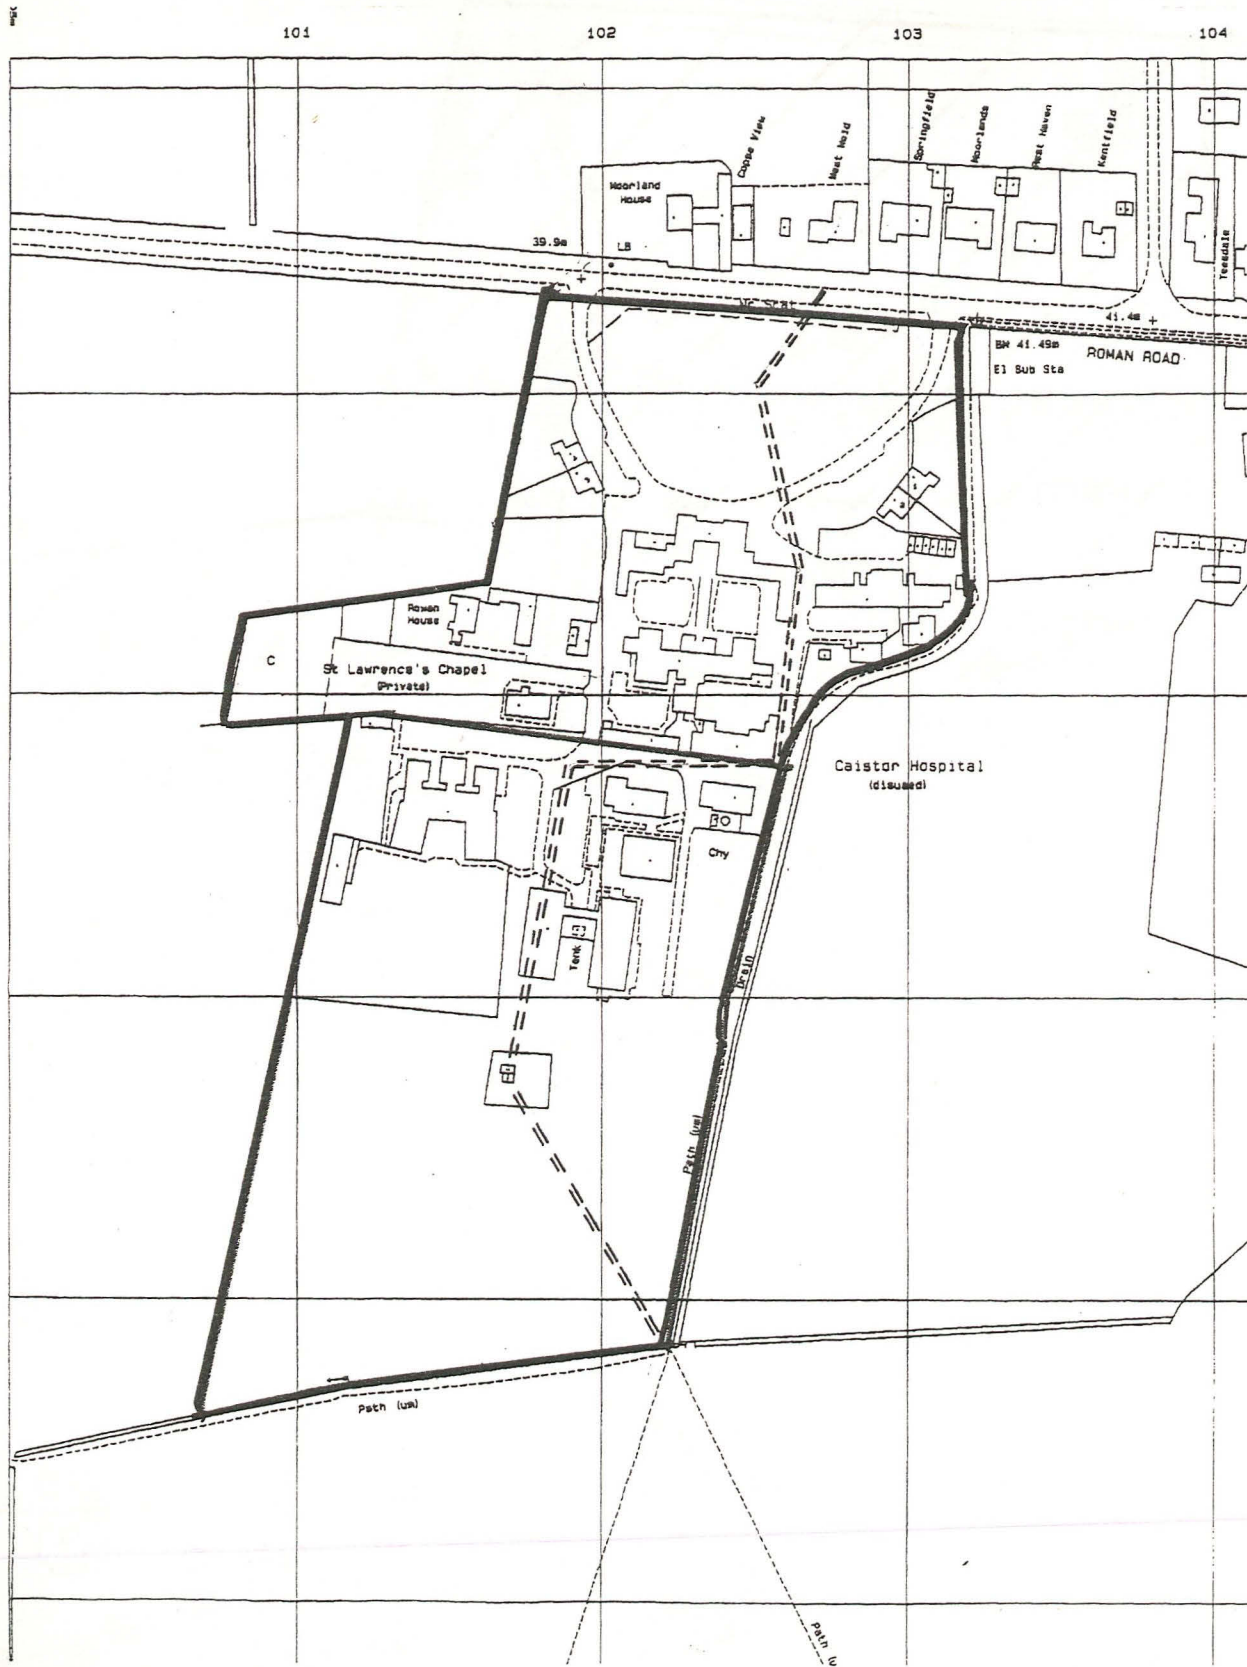
Fig. 2 Site location, showing water and sewage services. Based on a 1: 2000 plan by Tripos Architects (dwg. no. 8338.6A) with added information from a 1981 plan relating to adoption of the sewerage system. © Crown Copyright; reproduced with the permission of the Controller of HMSO. (LAS Licence No. AL50424A).

The sewage pumping station which served the site lies within a fenced compound. The slight sloping mound around the exterior of the compound presumably covers underground tanks. The predecessor of the pumping station, filter beds, occupied the same site. It must be assumed that numerous drains converge from the north to this compound; some inspection covers or drain runs were seen around the buildings (see Fig. 2). A plan supplied by the client indicates a rising main between the compound and the SE corner of the application site but no trace of this was seen.

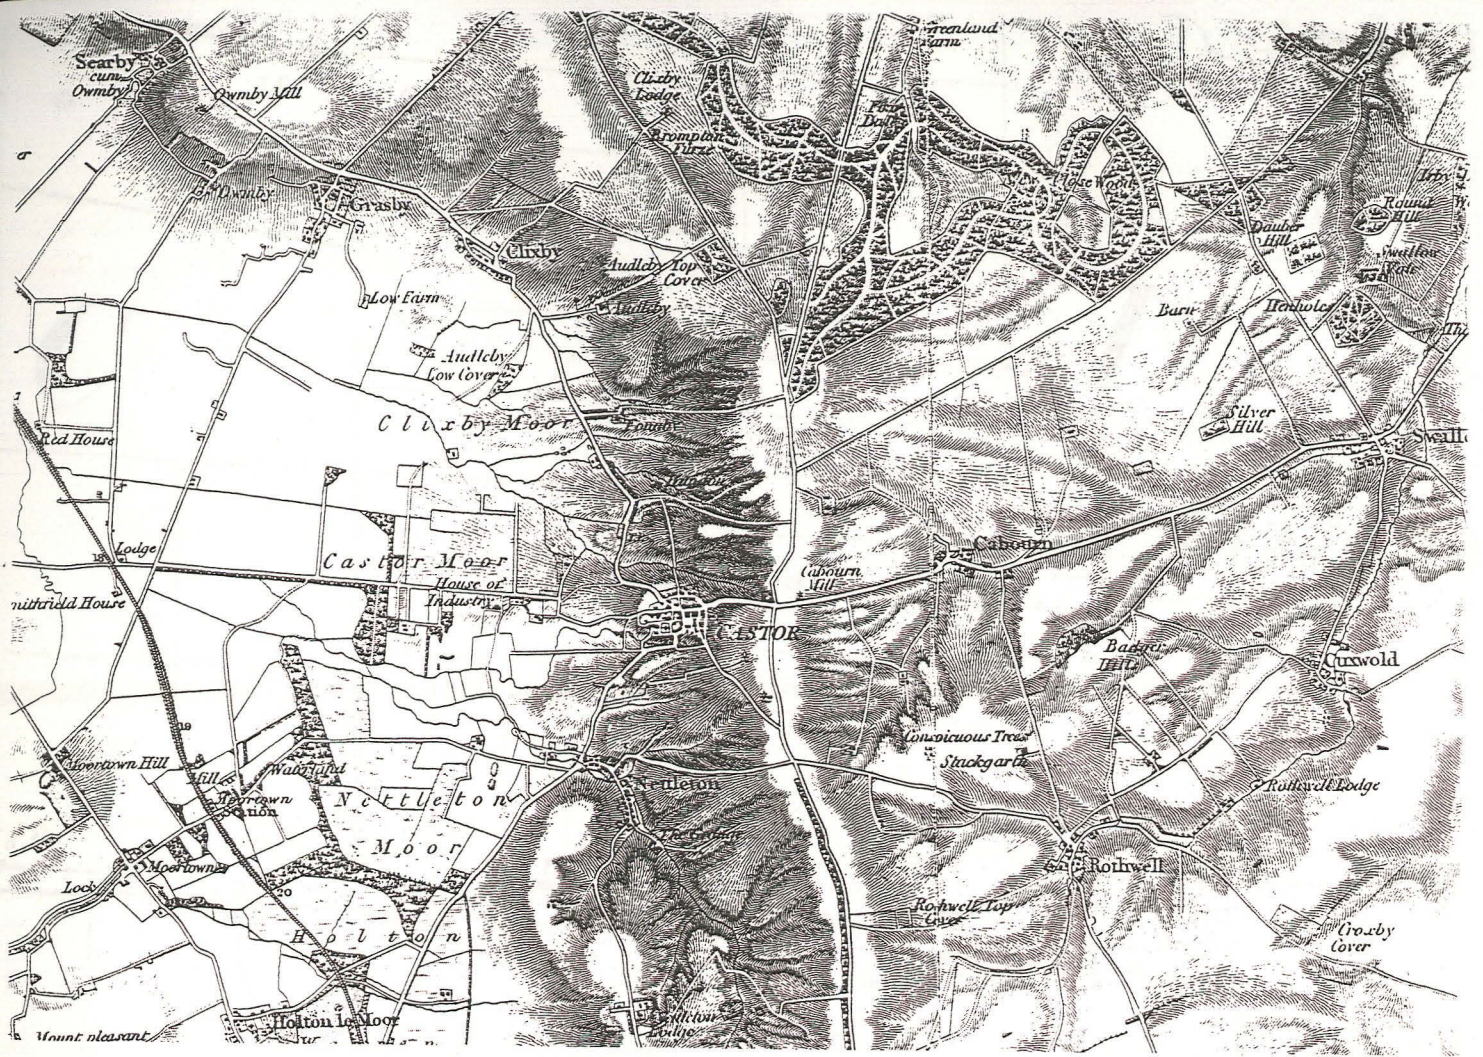
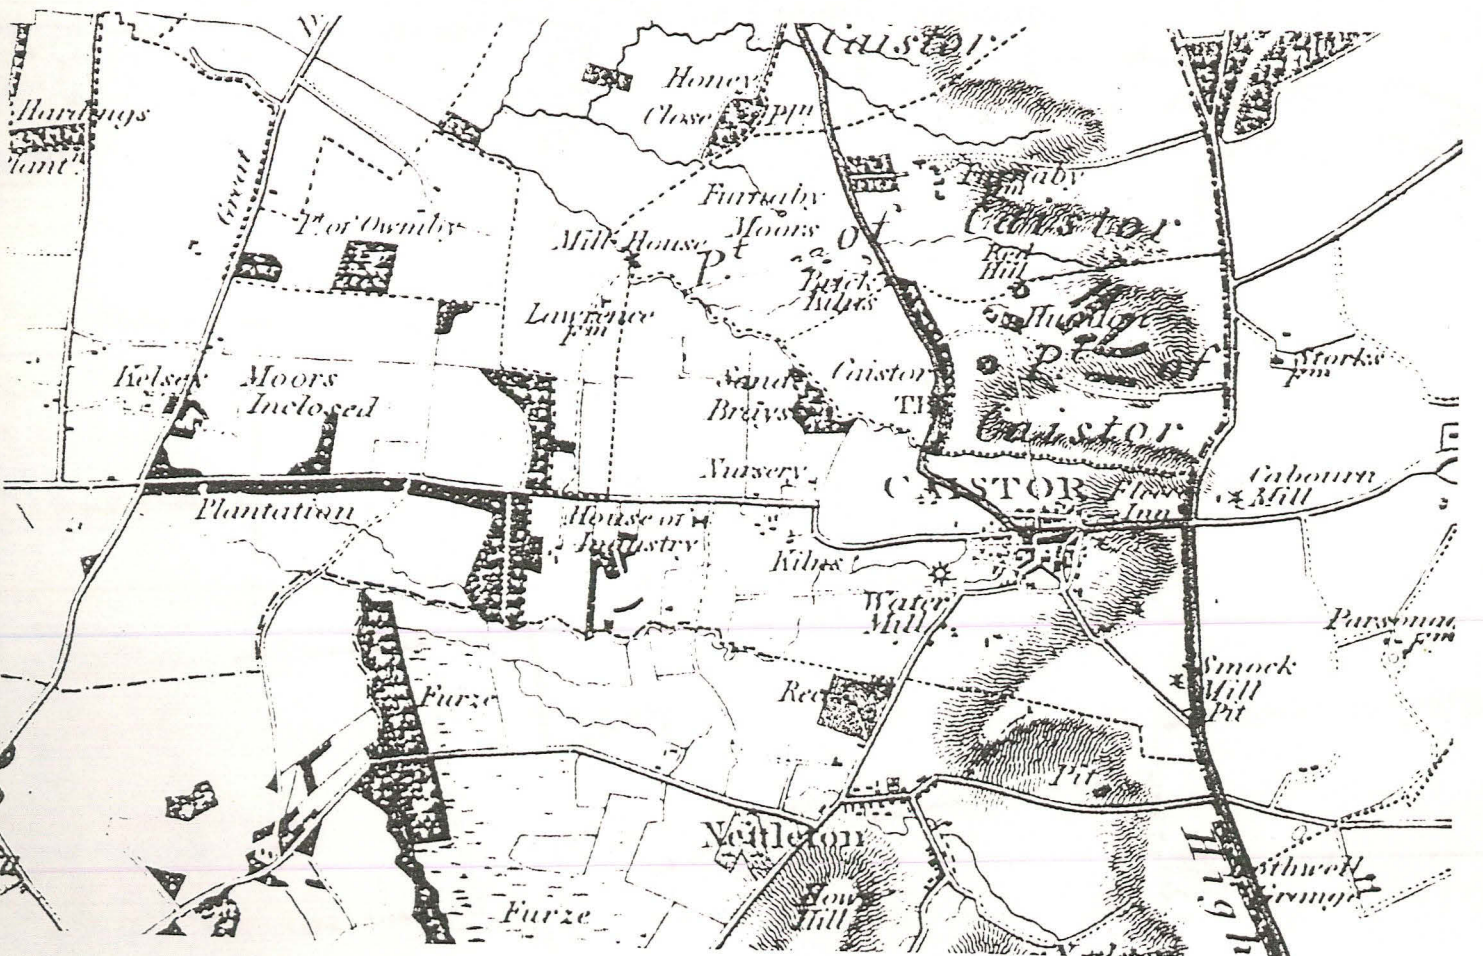
Fig. 5 The House of Industry site. a) as depicted on the 1824 Ordnance Survey 1: 63,360 map Sheet 86; b) as depicted on the 1828 Map of Lincolnshire (Bryant).

The former hospital had its origins in the Caistor House of Industry built on the site in 1802 and serving up to about 45 parishes. At that time the building was immediately outside the Caistor boundary on the unenclosed common moor, occupying a 3.75 ha. (9 acres) site provided by the Lord of the Manor and various Freeholders (Russell and Frankish 1993, 3). Both the 1824 Ordnance Survey map and Bryant's map of Lincolnshire (1828) mark a track or lane leading north-south along the eastern side of the House of Industry, crossing Nettleton Beck and joining a road to Nettleton (Fig. 5). The straight eastern edge to the site suggests that the grounds were extended eastwards later that century; an undated sketch shows a path skirting around the extension but by 1886 the track was incorporated within the Caistor Union Workhouse grounds and the footpath was absent (LAO Tenn 4/1; OS 1891).

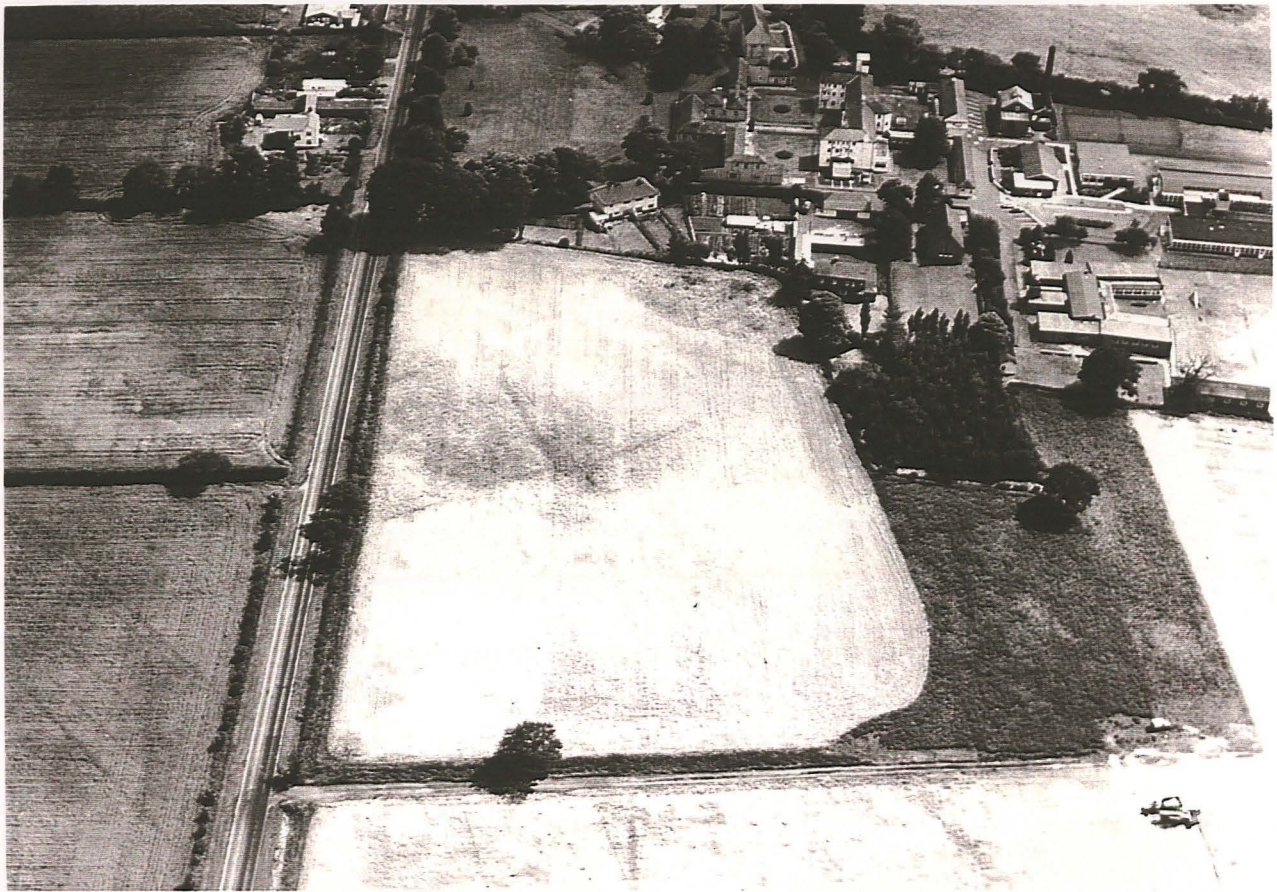
Pl. 1 Air photograph showing buildings on the hospital site (top right) with linear cropmarks in fields either side of North Kelsey Road. Looking east; RCHME 2921/30, 25.7.1976. Copyright reserved.

Undated cropmark features of linear ditches forming rectangular plots have been identified in an arable field fronting onto North Kelsey Road to the west of the hospital (SMR 52668). The cropmarks extend further to the west and to the north of the road where parallel linear features are also present. The alignments do not correspond with the existing enclosure-date field system or with the early enclosures east of the hospital. A late prehistoric or Romano-British date is likely on morphological grounds.

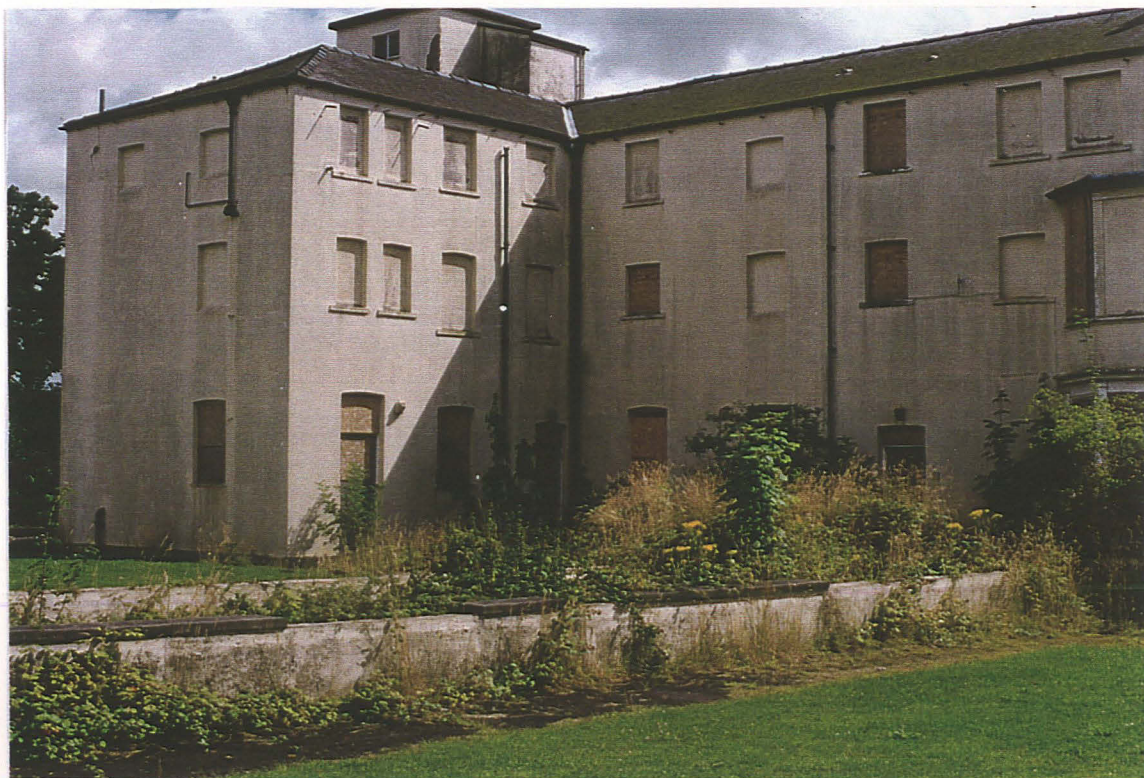
Pl. 3 Front elevation of the House of Industry block (looking east).

The application site is set back from the road beyond the large front lawn (Pl. 2). The buildings consist of various brick buildings around the largest (apparently oldest) building, the original House of Industry built in 1802 (Pls. 3-6). At the rear of the complex are several sectional buildings of 20th century date (Pls. 7 and 8). The chapel is located within an overgrown burial ground; no grave markers were seen (Pl. 9). It was difficult to distinguish the extent or sequence of nineteenth century buildings from a cursory visit.

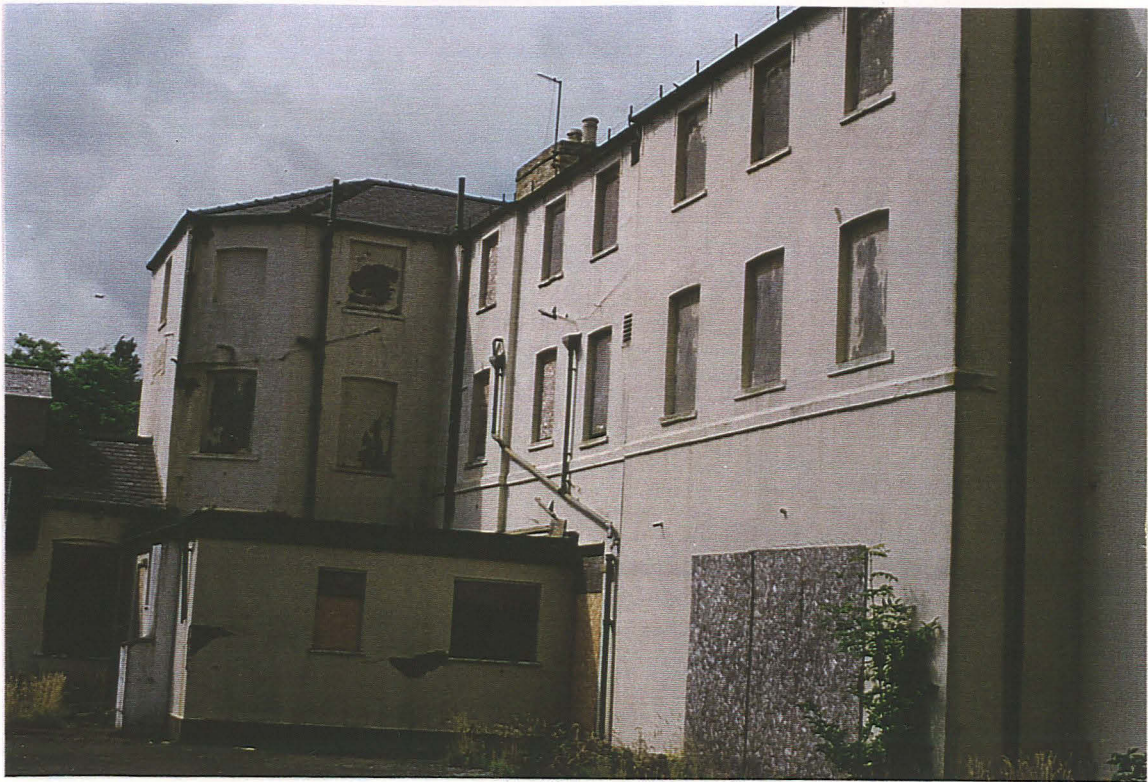
Pl. 4 Part of the rear of the House of Industry block.

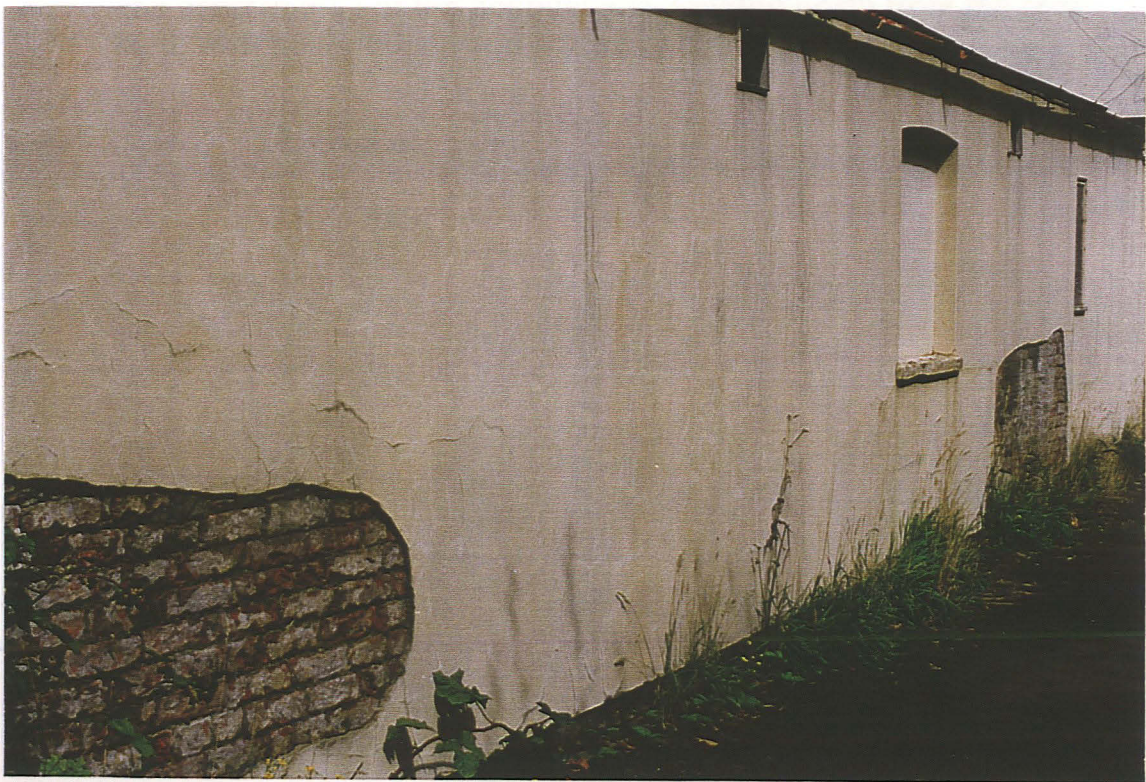
Pl. 5 Exposed brickwork at the rear of the House of Industry block.

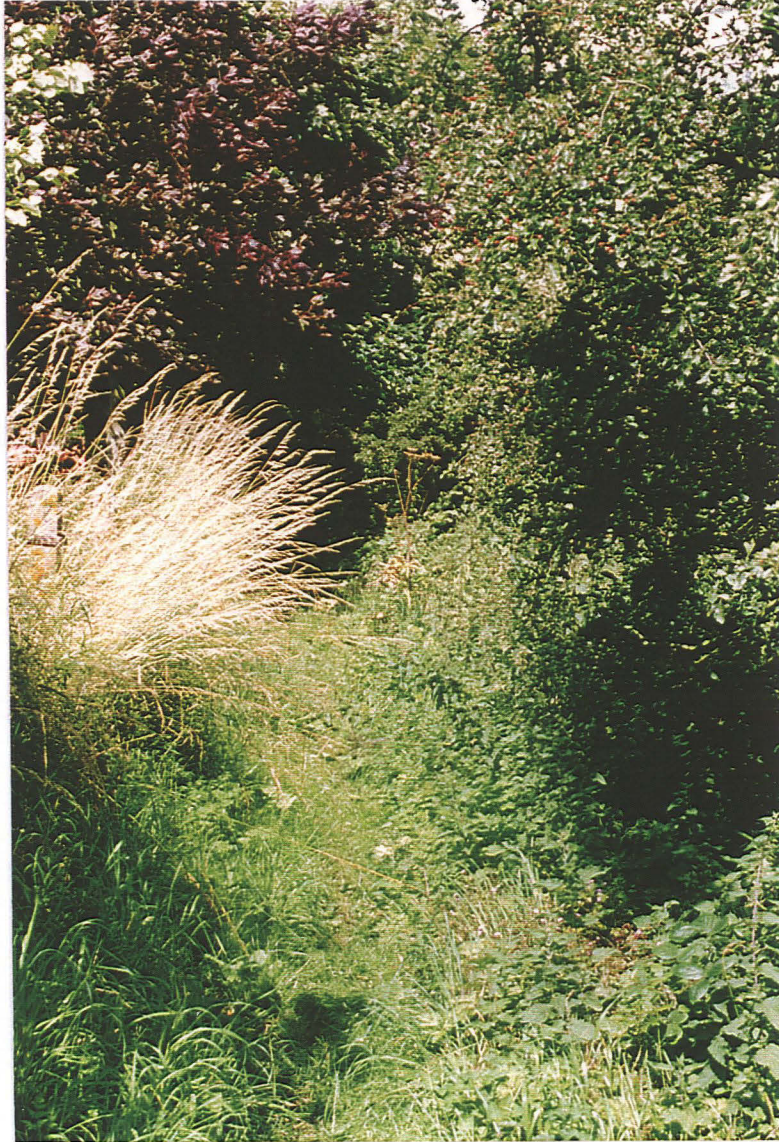
Pl. 11 Overgrown former track or lane at the eastern edge of the hospital site (looking north).

The former track or lane survives at the eastern edge of the application area (Pl. 11). A slight depression along a tarmac path near the front of the site may reflect the course of that lane before it was covered by the House of Industry premises. Interpretation is complicated by the obvious presence of a covered drain along the same path.

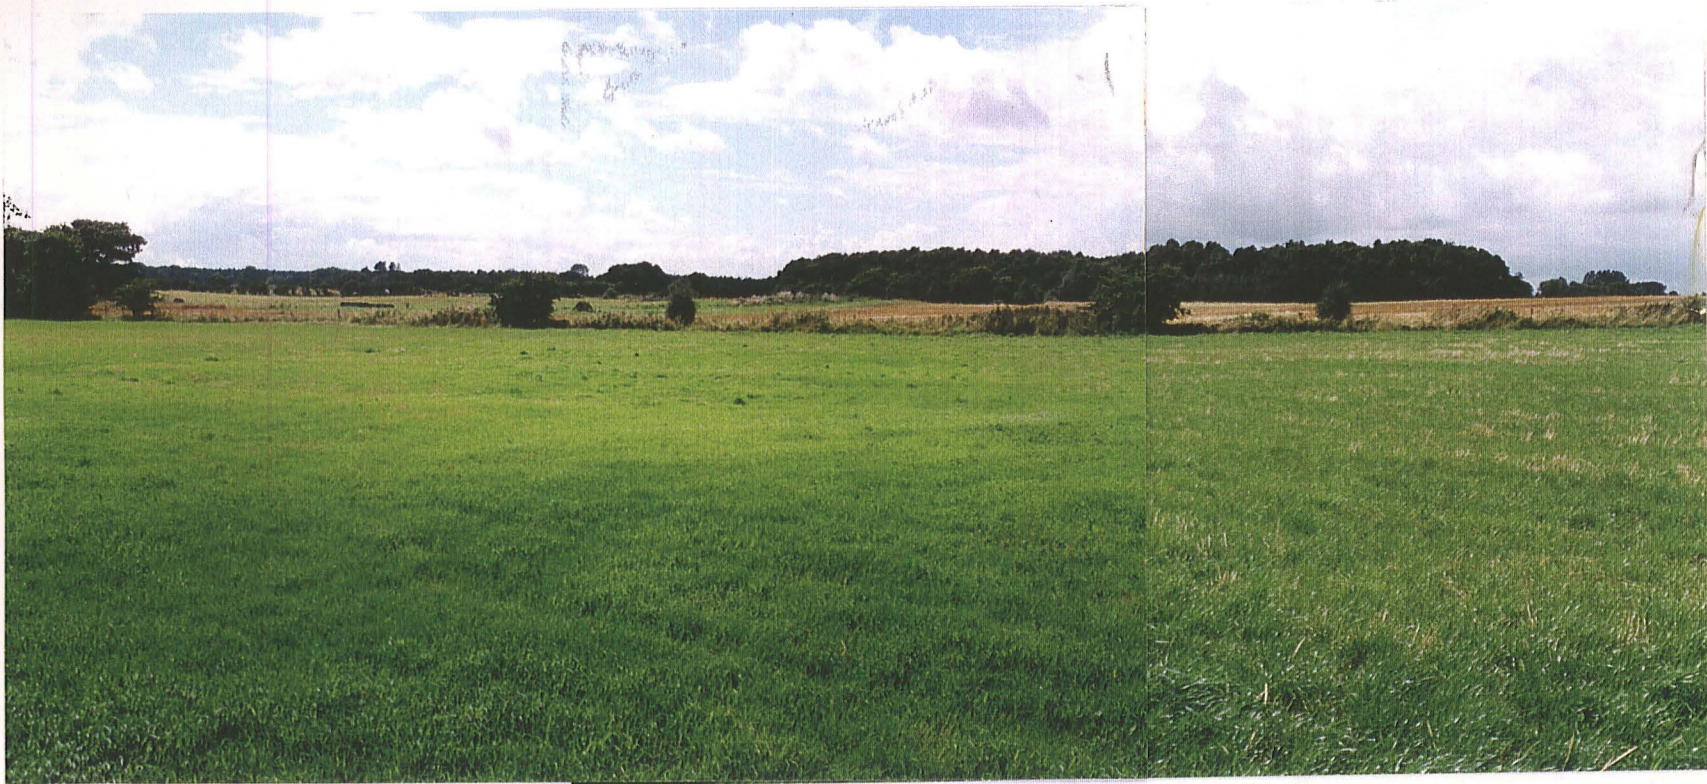
PI. 10 The rear field (looking west, showing the ridge crossing the adjacent field).

To the rear of the buildings the land is under mown grass, part of it deliberately drilled as a crop. The ground surface is uneven but no discernible pattern was noted and the variations may be naturally produced. A distinct broad ridge aligned NE-SW is visible in the field west of the application site, and North Kelsey Road drops abruptly west of the hospital site by about 3m (Pl. 10). These apparently natural features may be the western limit of wind blown sand deposits against the Wolds scarp, easily seen from the site.
