## **Baston, Land off Car Dyke Drive**

### **Archaeological Monitoring**

**LAS Report No. 311**

**September 1998**

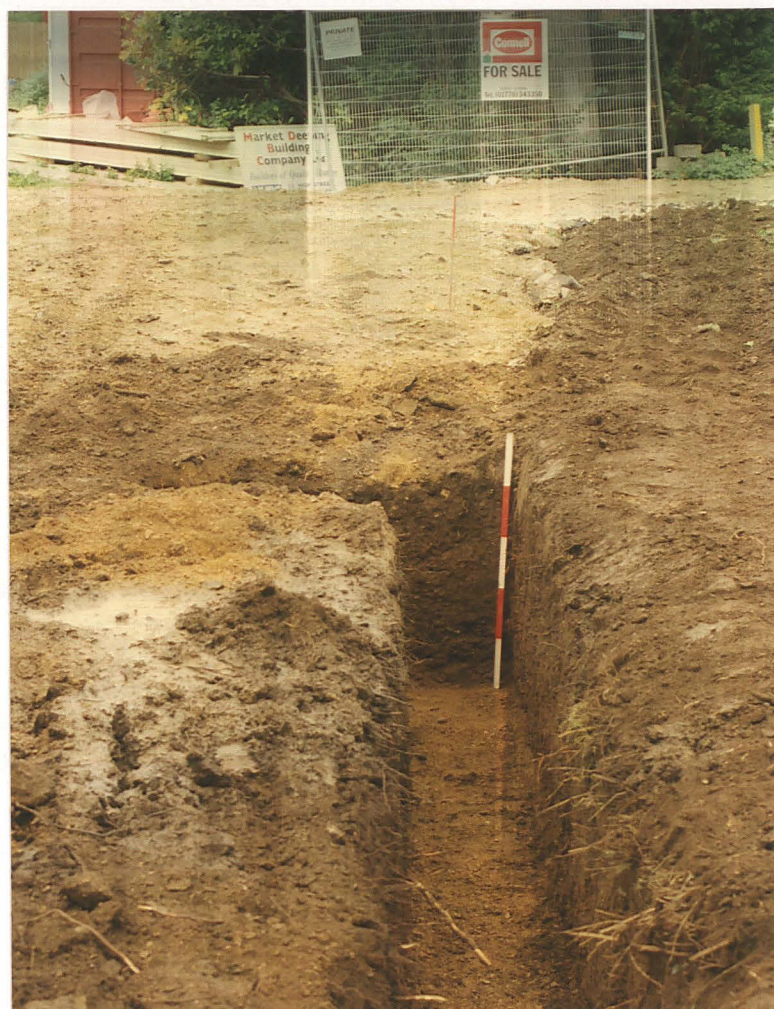
**Pl. 1** Alignment of boundary ditch 151 looking north along foundation trench, House Plot 1. The yellow hydrant marks the end of Car Dyke Drive. Scale divisions 0.2m.

The trenches revealed two, approximately parallel, ditches aligned NW-SE and about 4m apart. Ditch **151**, closest to an existing house on Cardyke Drive, survived to a depth of 0.65m directly below modern topsoil. Its width was not determined but was at least 1.5m and probably over 2.25m (Pls. 1 and 2). Two fill layers were identified. The thicker uppermost layer **150** was a light brown sandy loam, covering the primary fill **152** which contained a high gravel component.

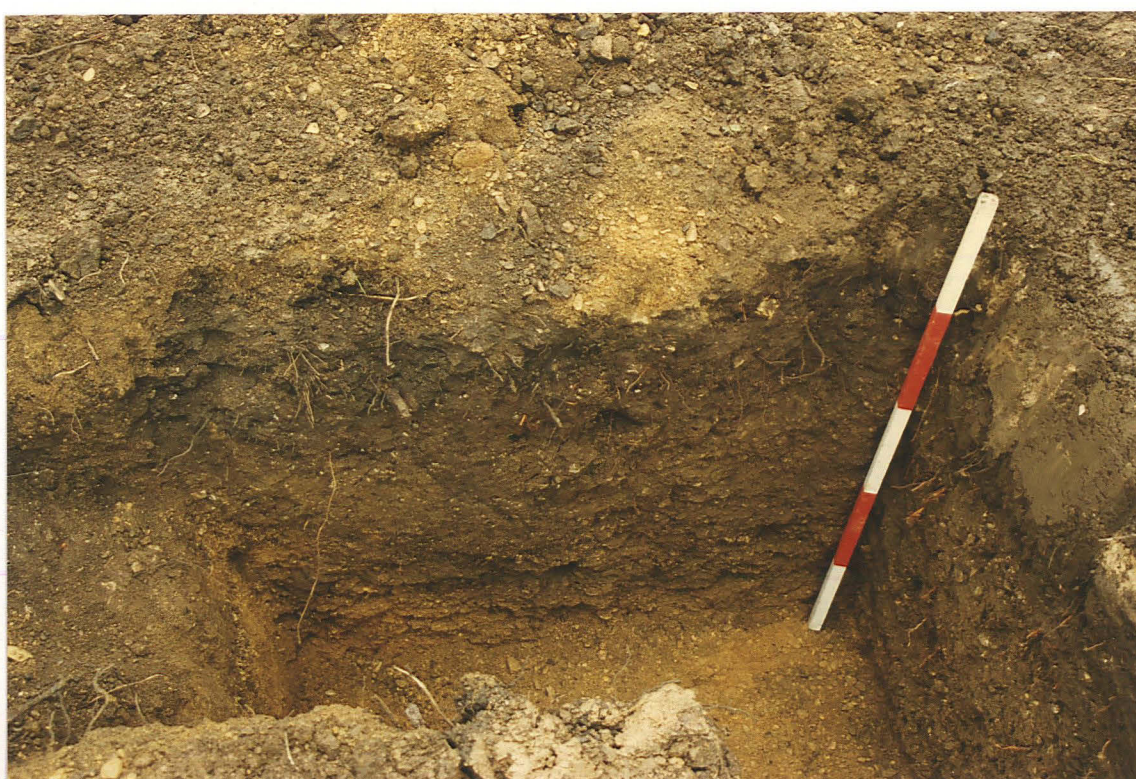
**Pl. 2** Western edge of ditch 151 revealed at base of house foundation trench. Looking north, scale divisions 0.2m.

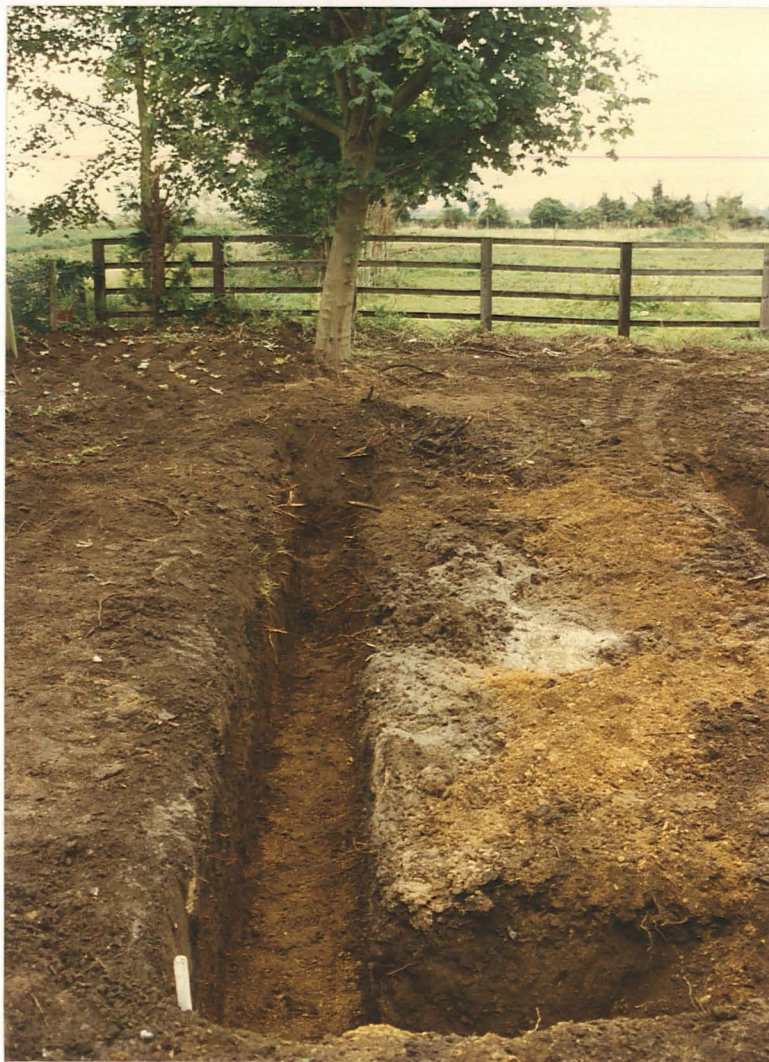
**Pl. 3** Existing hedge boundary extending the alignment of ditch 151 to the south of the garage foundation trench. The present plot boundary is at the left of the photograph.

Ditch **151** was interpreted as being part of a field or property boundary ditch which survives between pasture fields to the SE of this development (Pl. 3). It would appear to be of medieval date; the pot sherds recovered from **150** were mostly of thirteenth century date, but with one more recent (probably intrusive) sherd.

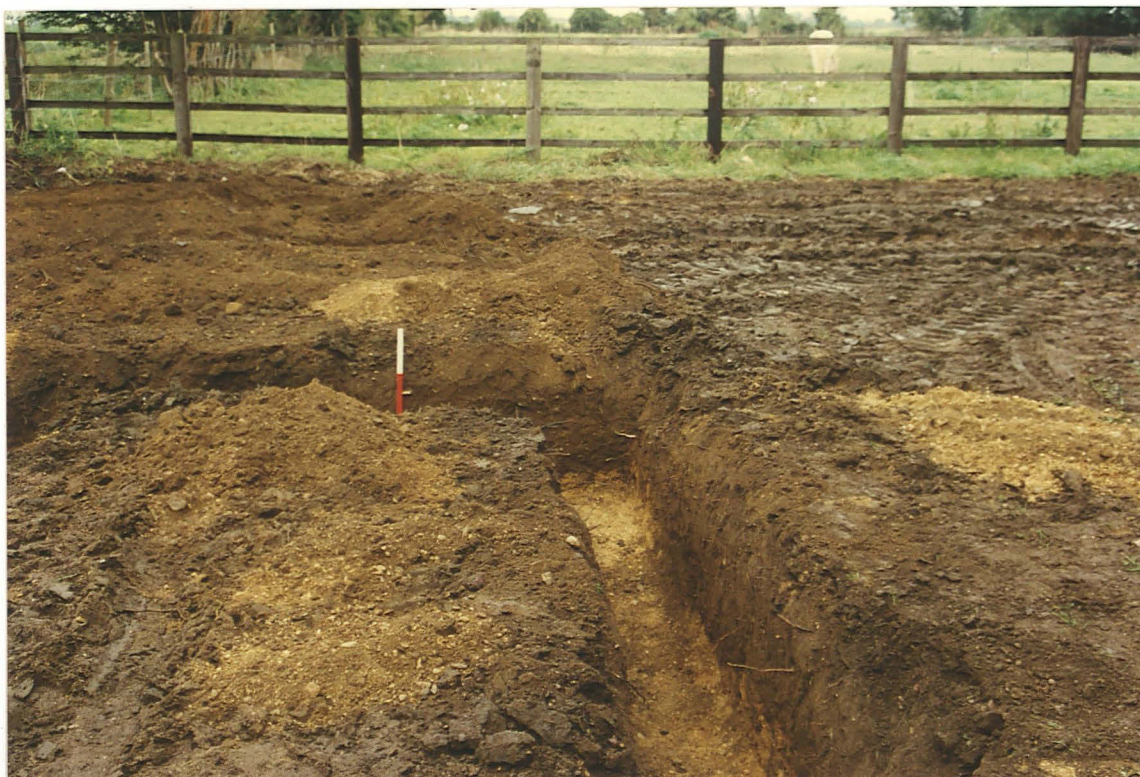
**Pl. 4** Brown fill of ditch 157 visible at southern corner of garage foundation, cut into the natural sandy gravel. Looking south scale divisions 0.2m.

The other ditch **157** lay to the west and was found to be about 1.5m wide and 0.5m deep (Pls. 4 and 5). This feature had probably been dug through the subsoil layer but as its fill **158** was almost identical, confirmation of this was not found. This ditch may be of Romano-British date; two sherds (including a samian sherd dated AD 120-160) were recovered.

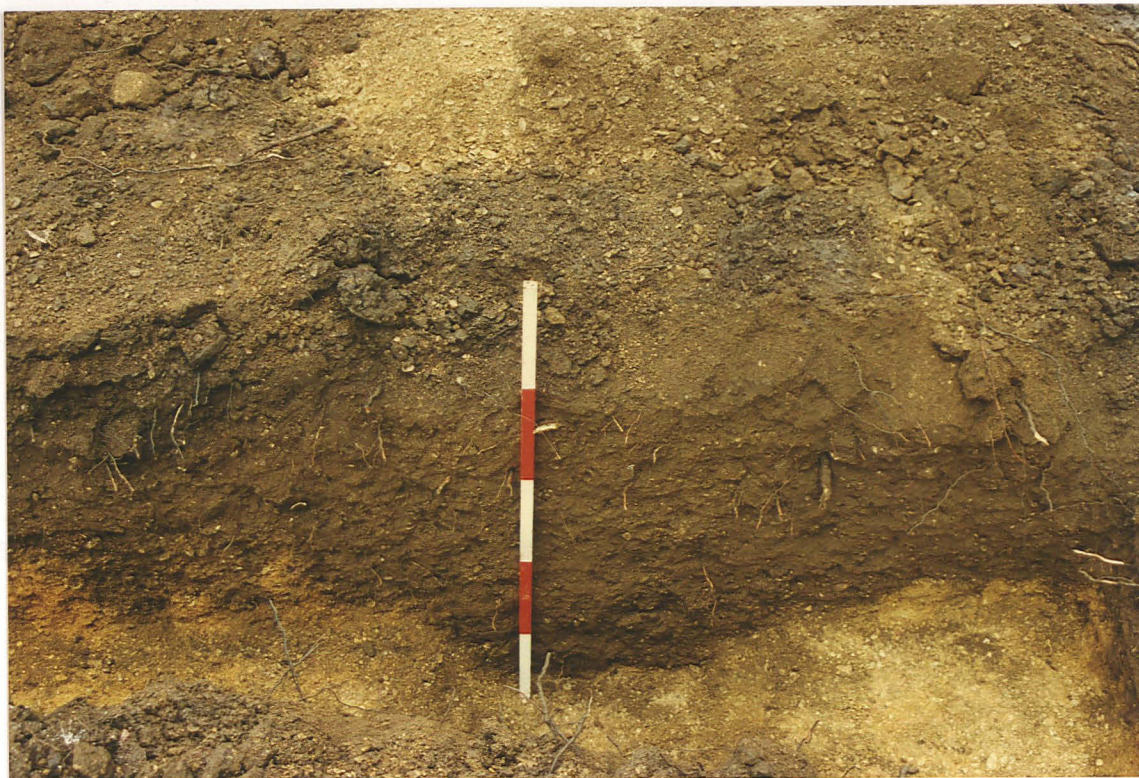
**Pl. 5** Fill of ditch 157 visible in the southern face of the garage foundation. Looking south, scale divisions 0.2m.

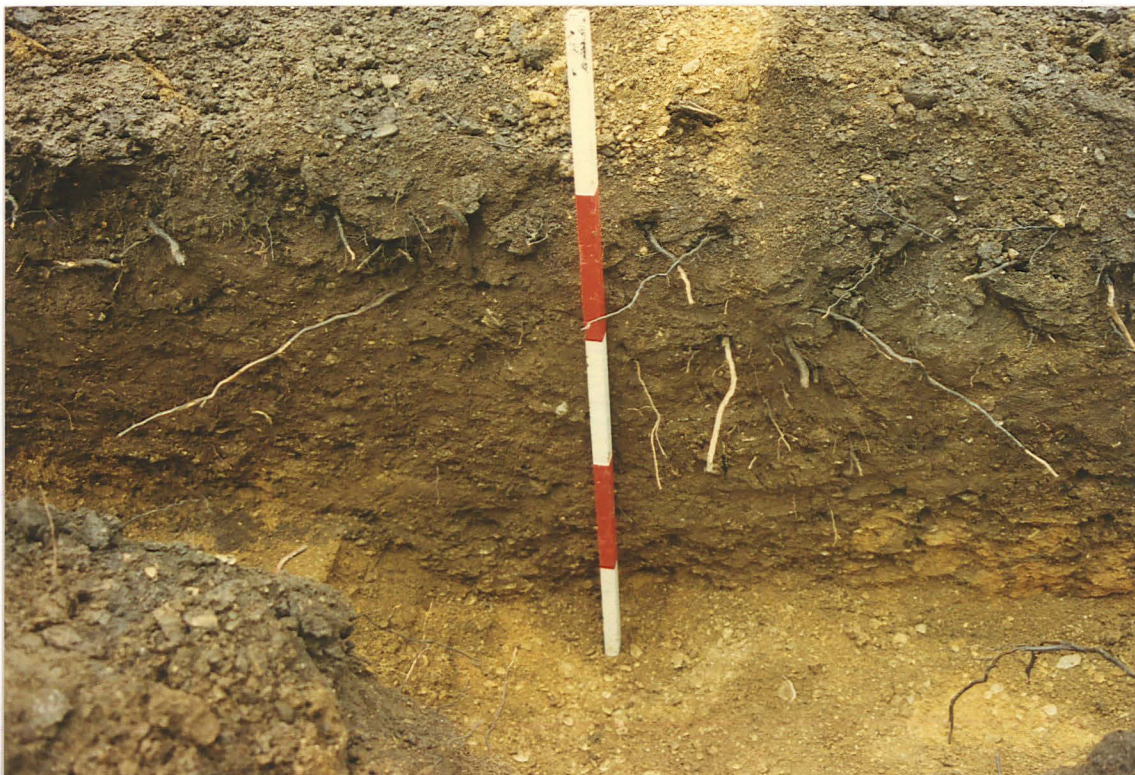
**Pl. 6** Centre of pit 159 cut into gravel, with brown fill, as seen in the centre rear of the garage foundation. Looking south, scale divisions 0.2m.

In addition to the two ditches, two other features thought to be small pits or large post-holes were recorded. The northern end of an ovoid feature **159**, 0.9m wide and 0.3m deep below subsoil **161**, was revealed at the rear of the garage (Pl. 6). Another apparently ovoid feature **154** was seen in the centre of the garage, aligned NE-SW (Pl. 7). During subsequent trenching for a soakaway close to the fence (to the south of the garage) **159** and **157** were seen in the trench face, indicating that both extend beyond the development.

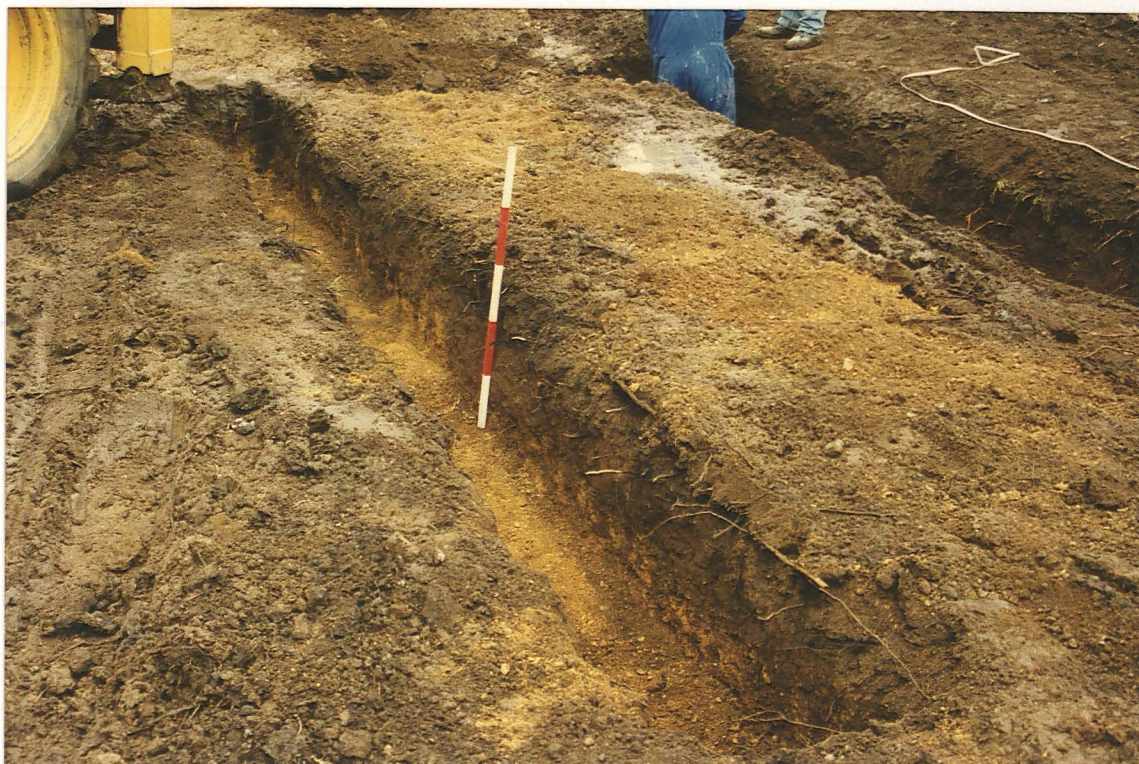
**Pl. 7** Pit or post-hole 154 showing as deeper brown loam in centre of the garage foundation. Looking NE, scale divisions 0.2m.

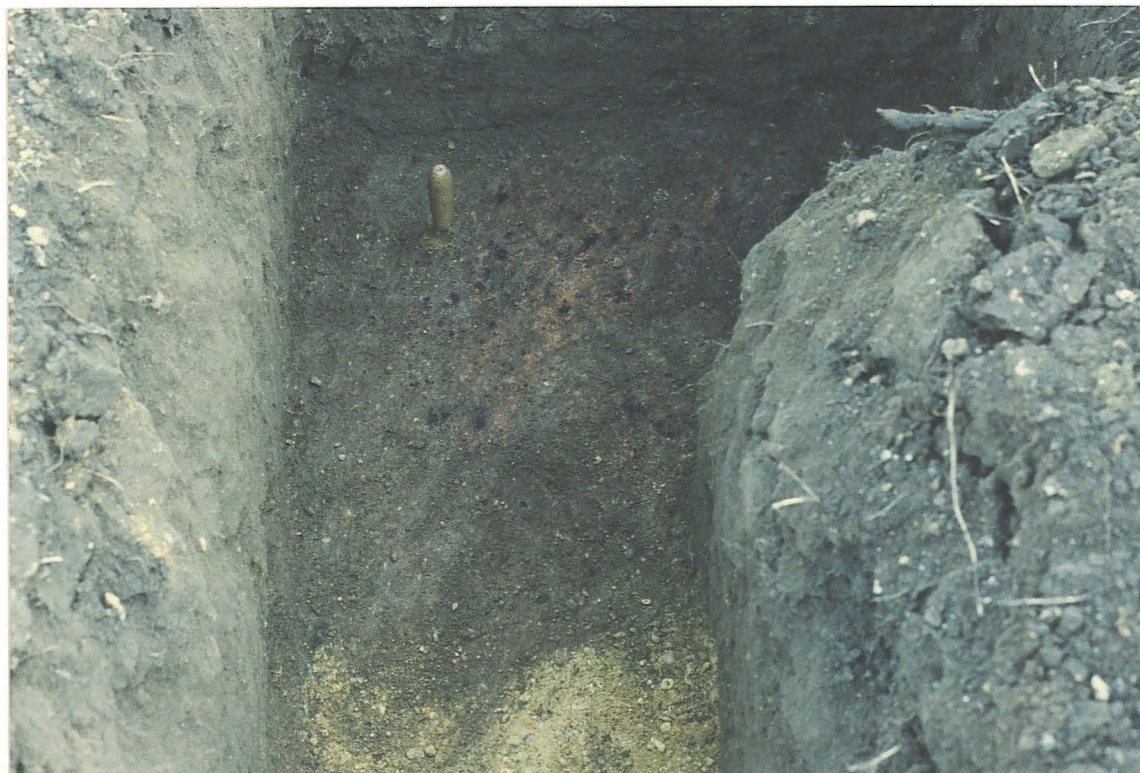
**Pl. 8** Ash and charcoal fill of pit 264 visible at the base of the garage foundation trench, Plot 2. Looking NE.

At the NW corner of the garage, the southern edge of a rubbish pit or hollow for hearth **264** was identified. This feature contained a grey/brown silt loam fill **265** with numerous charcoal flecks, ash and fragments of burnt clay (Pl. 8). A single glazed sherd of twelfth/thirteenth century pottery was found.

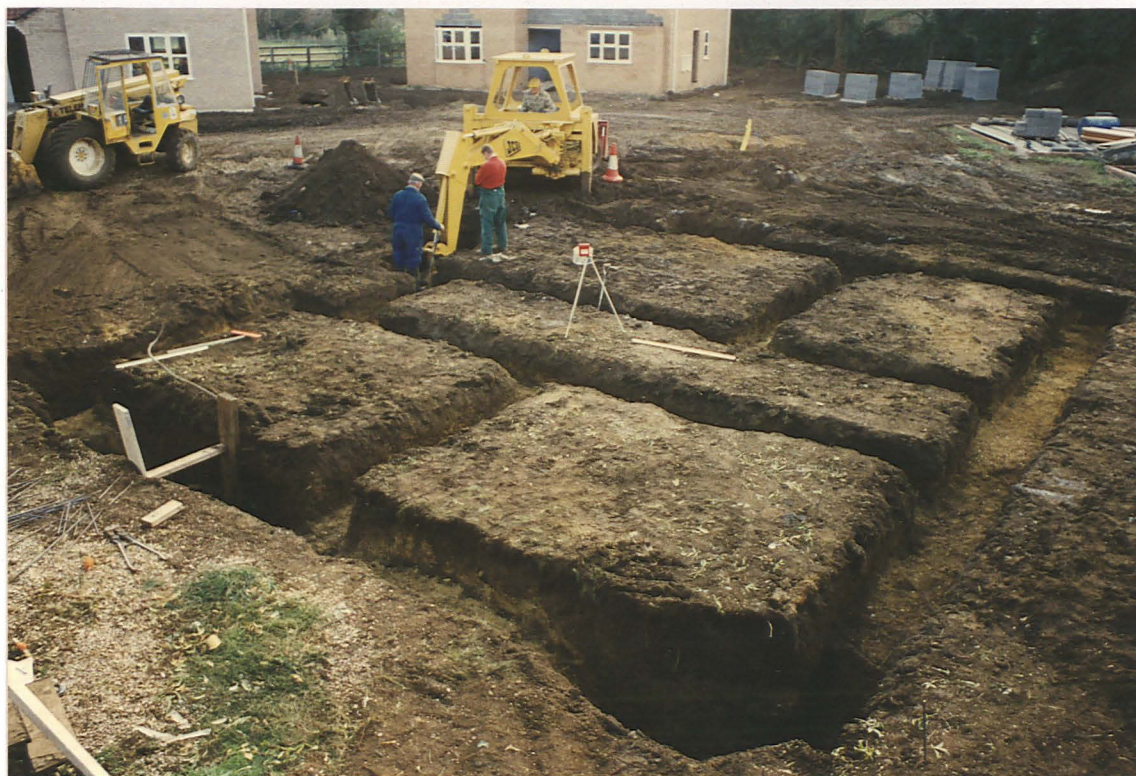
**Pl. 9** Foundation trenches for House Plot 4, looking south towards completed House Plot 2. Pit 404 is in the foreground.

The last house plot to be built lay in the NE of the development area. Trenches for this plot were between 0.45m deep and 1.5m deep where ground had been previously disturbed. Deep modern features were found close to the SE and NE corners of the plot. Three undated features were recorded.

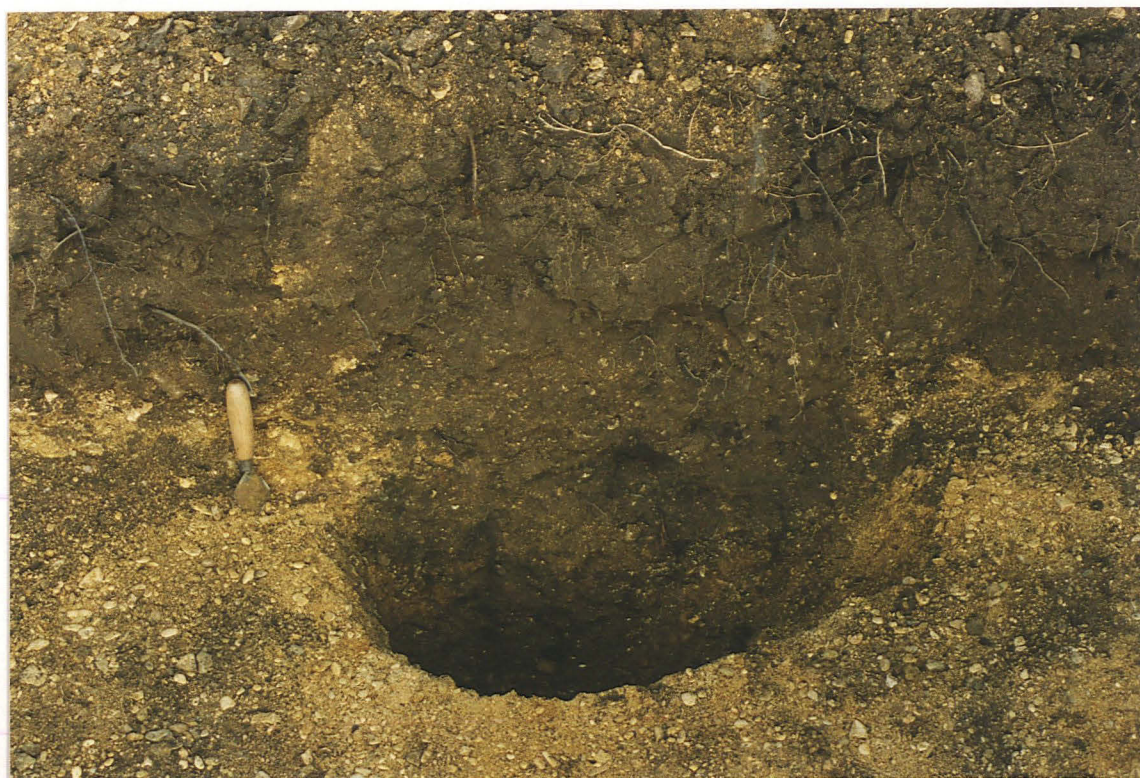
**Pl. 10** Post-hole 408, partly revealed at base of foundation trench.

To the SW of the plot footings the southern side of a sub-rectangular or sub-circular feature **408**, possibly a substantial post-hole, was revealed (Pl. 10). This survived to a maximum width of 0.75m, with its base 0.9m below the modern surface and overlain by 0.45m of topsoil. Its fill **407** was a grey silty gravel with tip lines and lenses, described as unlike the fill of adjacent modern features.

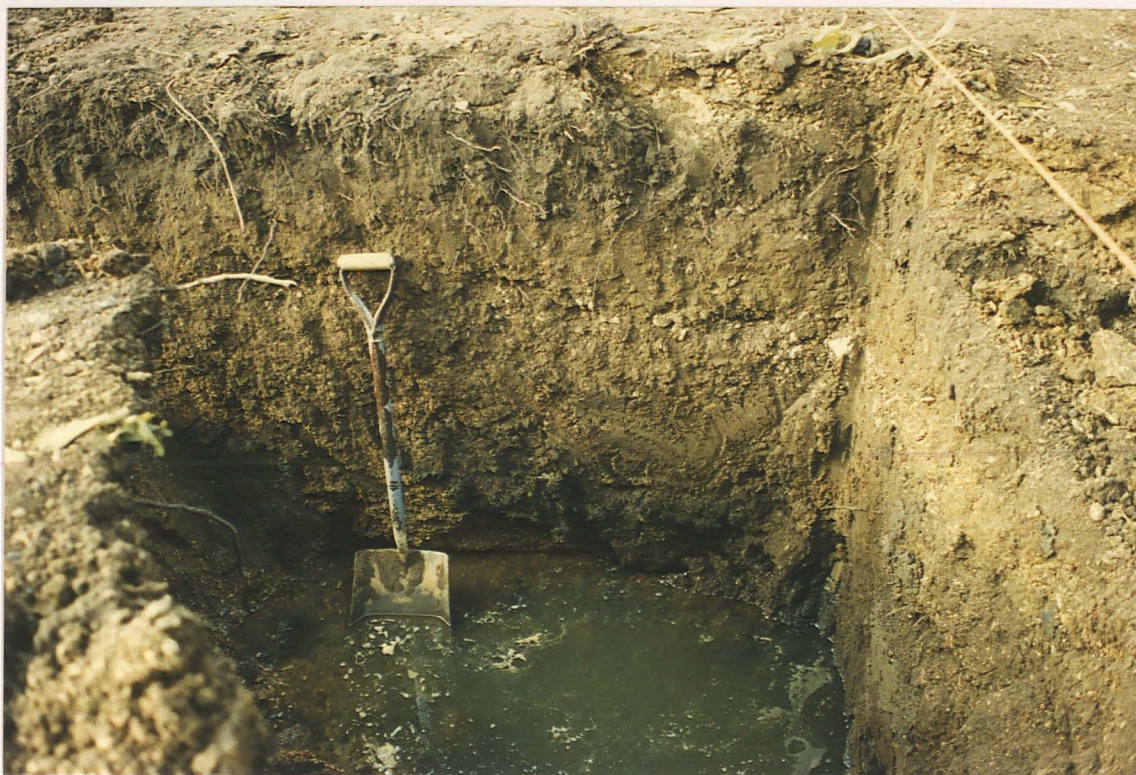
Pl. 11 Dark fill of pit 404 in corner of House Plot 4 foundation trenches. Looking NW.

The NW side of the garage footings was crossed by a broad ditch **414** over 0.55m deep (Pl. 11). Only part of one edge of this ditch was exposed, with a visible fill of grey/brown silty and sandy gravel **413**, slightly darker than the undisturbed natural. The edge suggested a west-east alignment but was not visible in adjacent trenches. At the northern corner of the plot this feature was apparently cut by a pit **404** filled with three distinct deposits. The upper fill **401** was 0.1m thick and contained pieces of local building stone, possibly indicating a spread of demolition or construction debris for levelling and consolidation. Beneath this rubble was **402**, 0.5m of silty material probably derived from natural silting of an open feature. The lowest exposed fill, apparently on the base of the pit, was a grey silty gravel with charcoal flecks. This may have derived from refuse disposal within an open pit.

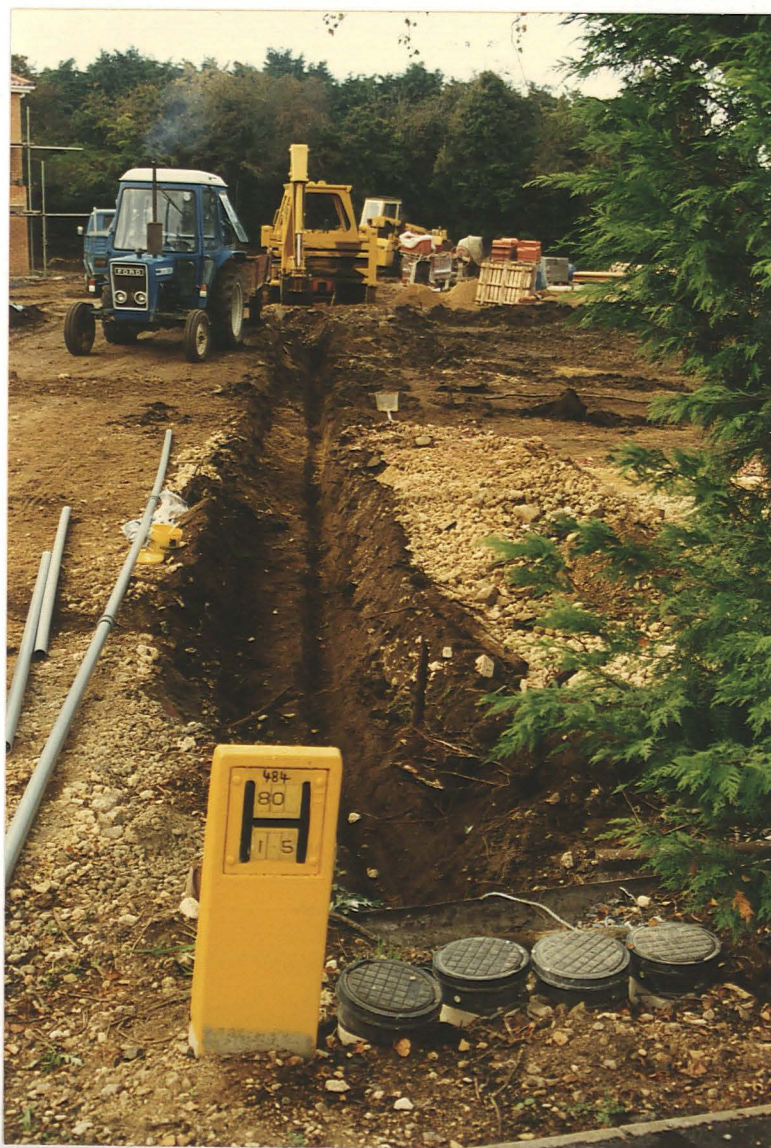
Pl. 12 Trench excavated for services along northern edge of the access road. Looking SW from Car Dyke Drive.

At the northern edge of the road a narrower trench was excavated by machine to hold the ducts containing services for the development (Pl. 12). The trench extended the line of a water main and other services which existed in Cardyke Drive. Ditches **502** and **504** were again revealed although here they were narrower. Ditch **502** was 2.7m wide and visible to at least 0.55m below the surface; **504**, 2.8m further west, was 0.9m wide. Neither of these features were seen either in a service trench leading to House Plot 4 or in that plot's footings, and this suggests that the reduced width represents the butt end or northern terminal of each ditch.
