**Stenigot Reservoir Extension, Donington-on-Bain**  
**Archaeological Monitoring**

NGR: TF 2585 8280  
Site Code: SDR 97  
LCNCC Museum Accn. No. 276.97

**LAS Report No. 287**

**June 1998**

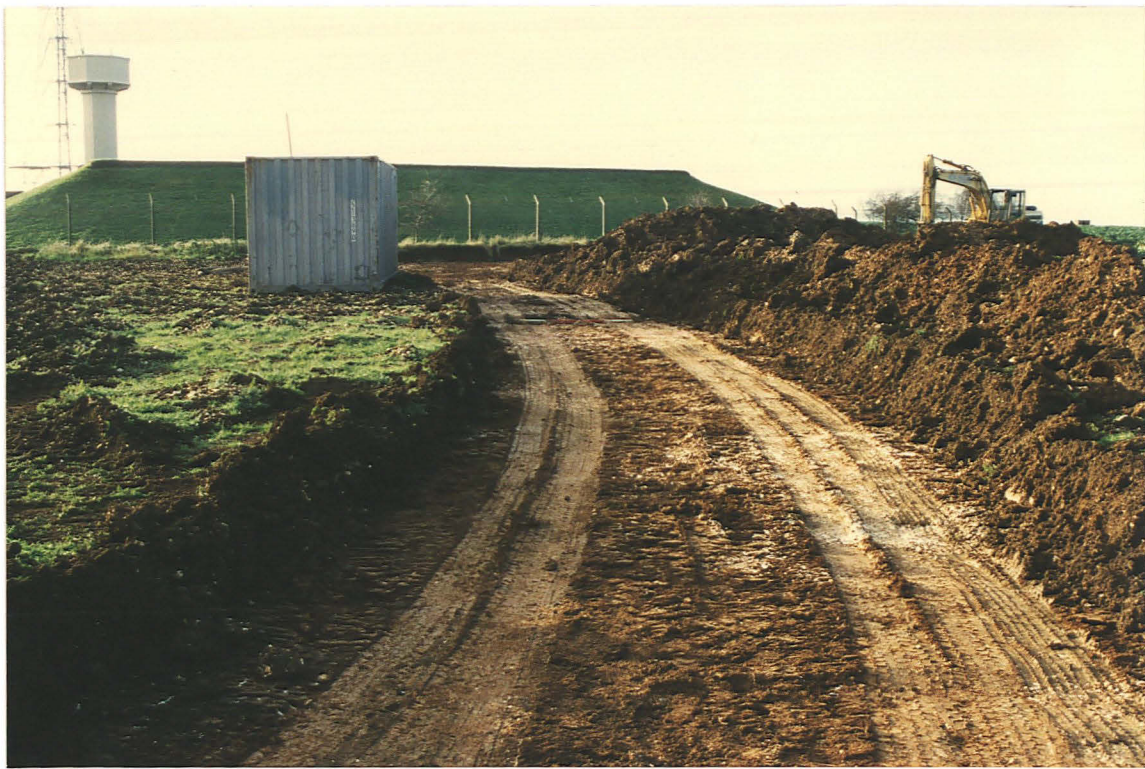
**PI. 1** Surface conditions during topsoil stripping for the reservoir extension (looking west to the existing reservoir compound).

Ground conditions within this area were not ideal during the watching brief: contractors' site cabins were positioned on the stripped surface and a temporary topsoil heap occupied part of the area (Pl. 1). Preparation and consolidation of the surface immediately after topsoil removal obliterated or removed fill of previously identified ditches and no further artefacts could be collected (Pl. 2). Vehicles transporting topsoil crossed the stripped surface and restricted the available opportunity to inspect the subsoil horizon where features were visible.

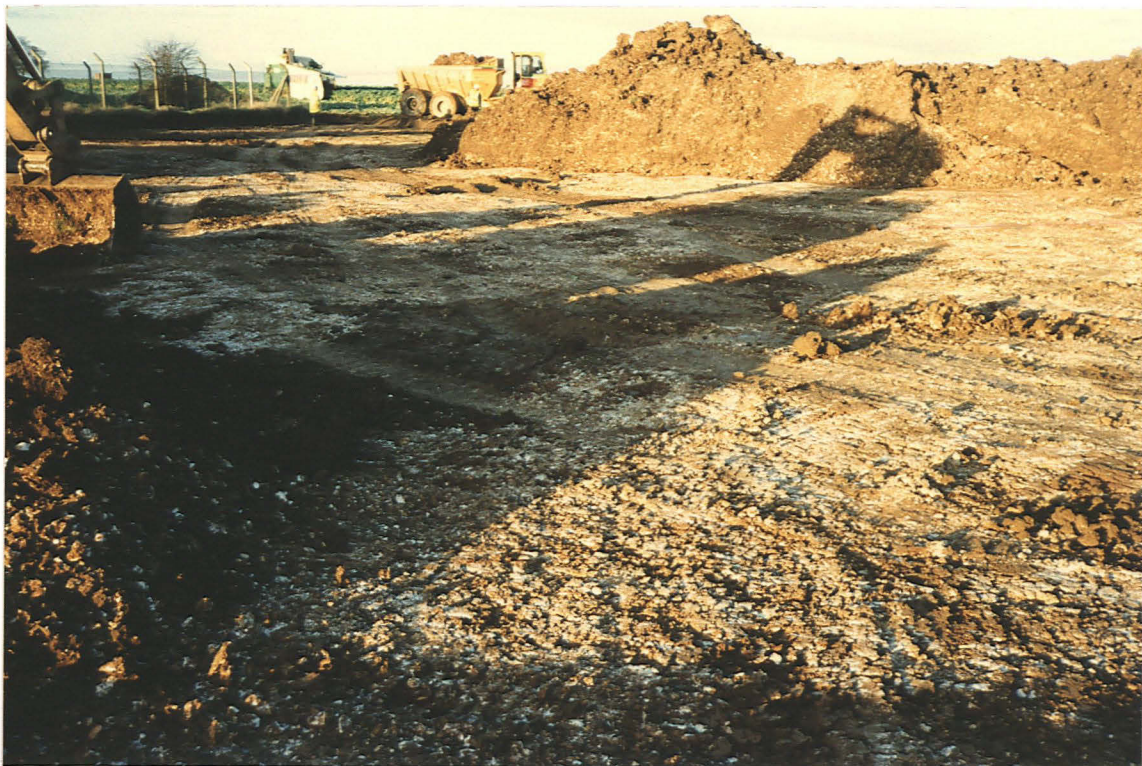
**PI. 2** Vehicle trample obscured the stripped surface although soil-filled ditches remained visible (looking west to the existing reservoir compound).

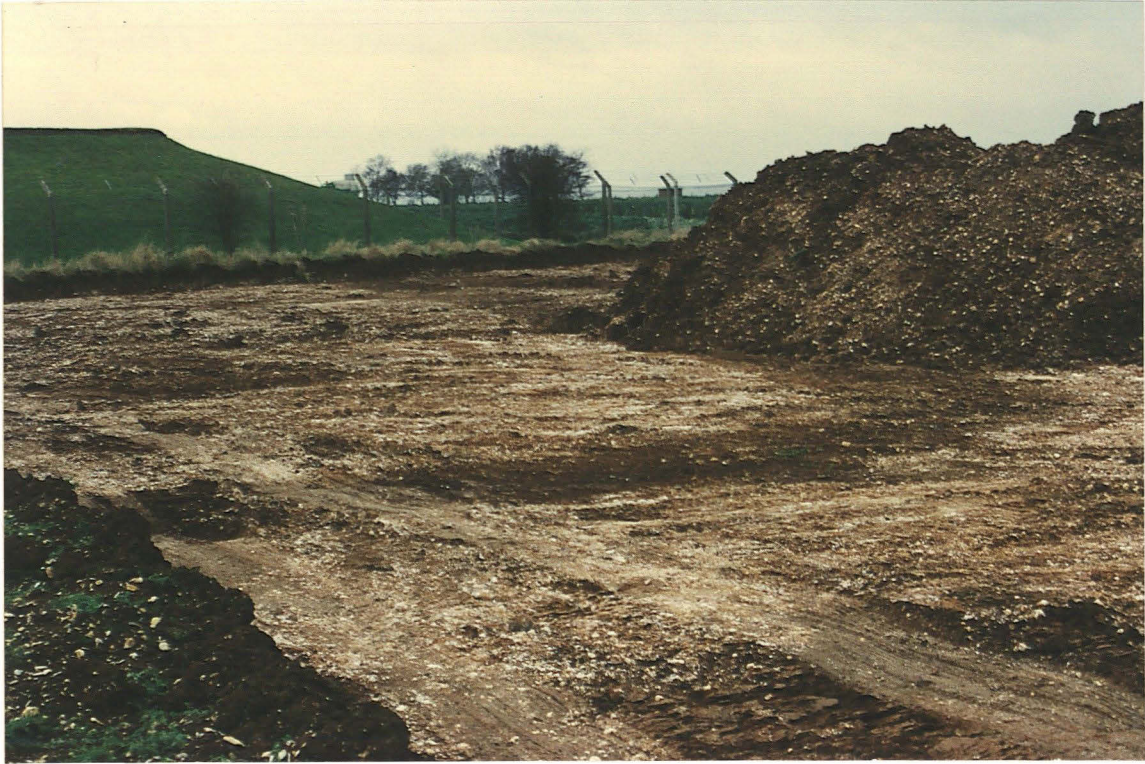
**Pl. 3** Dark soil filling the NE segment of Late Iron Age enclosure ditch 0208 (looking west to the existing reservoir compound).

A Late Iron Age enclosure ditch **0208** had been recorded during the previous excavation (Armour-Chelu 1997). During the watching brief its dark fill was readily identifiable but ground conditions were unsuitable to recover useful

further information (Pl. 3). The topsoil stripping extended slightly further west than the excavation area and the ditch continued at least as far as the existing compound fence.

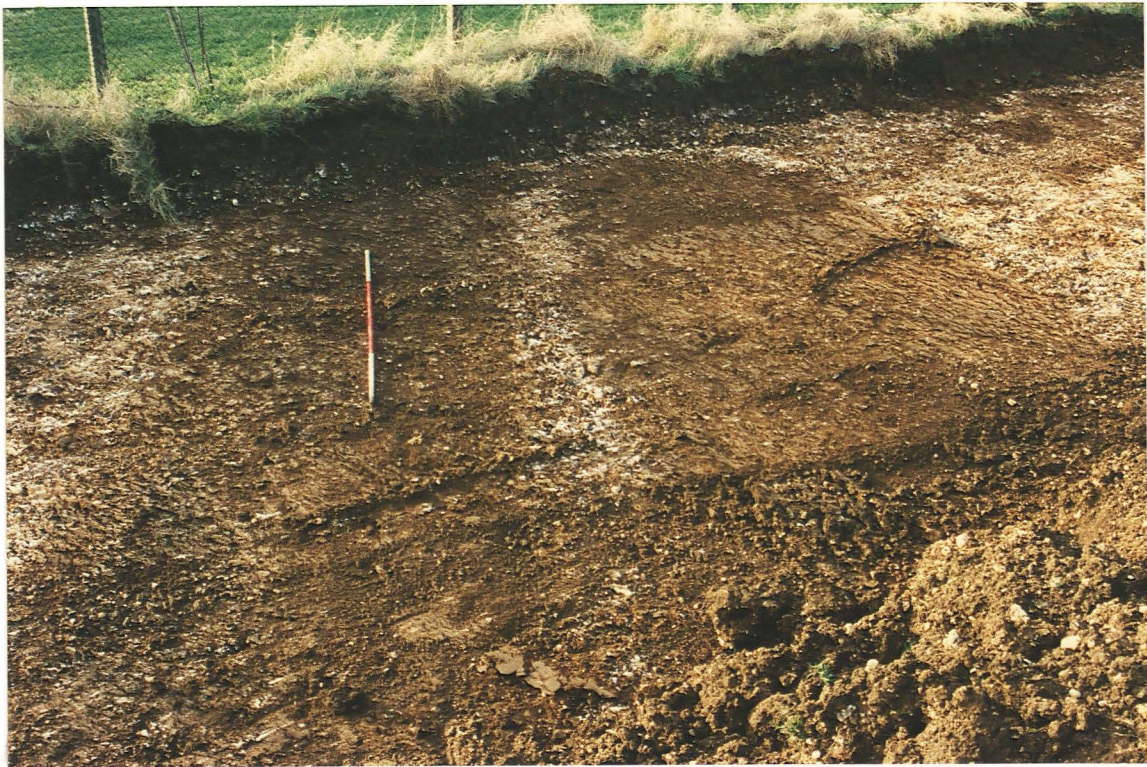
**Pl. 4** Late Iron Age enclosure ditch 0208 (below 2m scale) and adjacent pit 0005 (looking west at the edge of the existing reservoir compound).

The western end of an ovoid pit or ditch section was revealed immediately north of the enclosure ditch beside the compound fence (Fig. 4). The pit had been recorded as **0005** in the excavation but its length had not been determined. Monitoring allowed the full extent of the feature (9.8m west-east) to be established.

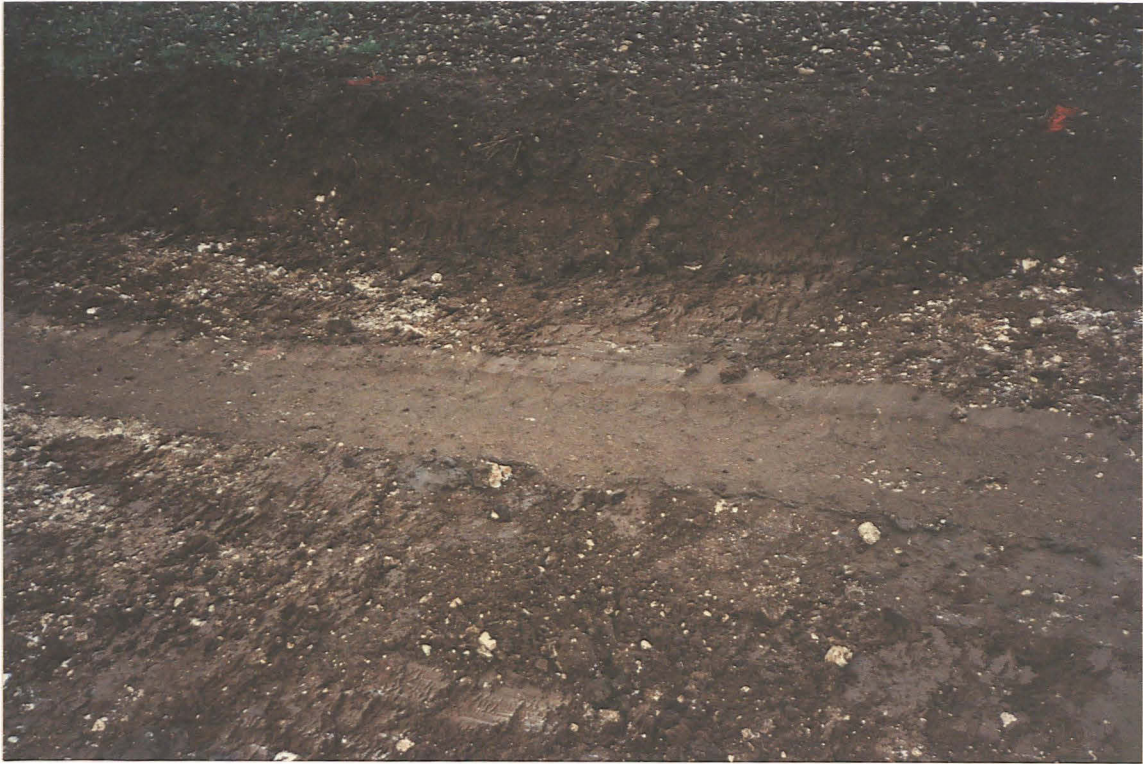
Pl. 5 Dark clay loam fill of ditch 9000 visible cutting chalk bedrock at base of the farm track realignment trench; widest surviving extent marked by red lines.

Context **9000** was a linear or curvilinear feature about 2.5m wide, 125m NW of the hedge (Pl. 5). **9001**, a 3m wide north-south aligned ditch or gully lay 26m to the NW (Pl. 6). It was filled with light brown clay loam and its base was at least 0.6m below the field surface. Similar loam thought to be filling several small intercutting pits **9002** was seen 30m further to the NW on the NE side of the new track. At the NW end of the new track, part of a 1.5m wide curving ditch **9003** crossed the trench; two sherds of locally produced Romano-British pottery were recovered from the surface of this feature (Pl. 7).

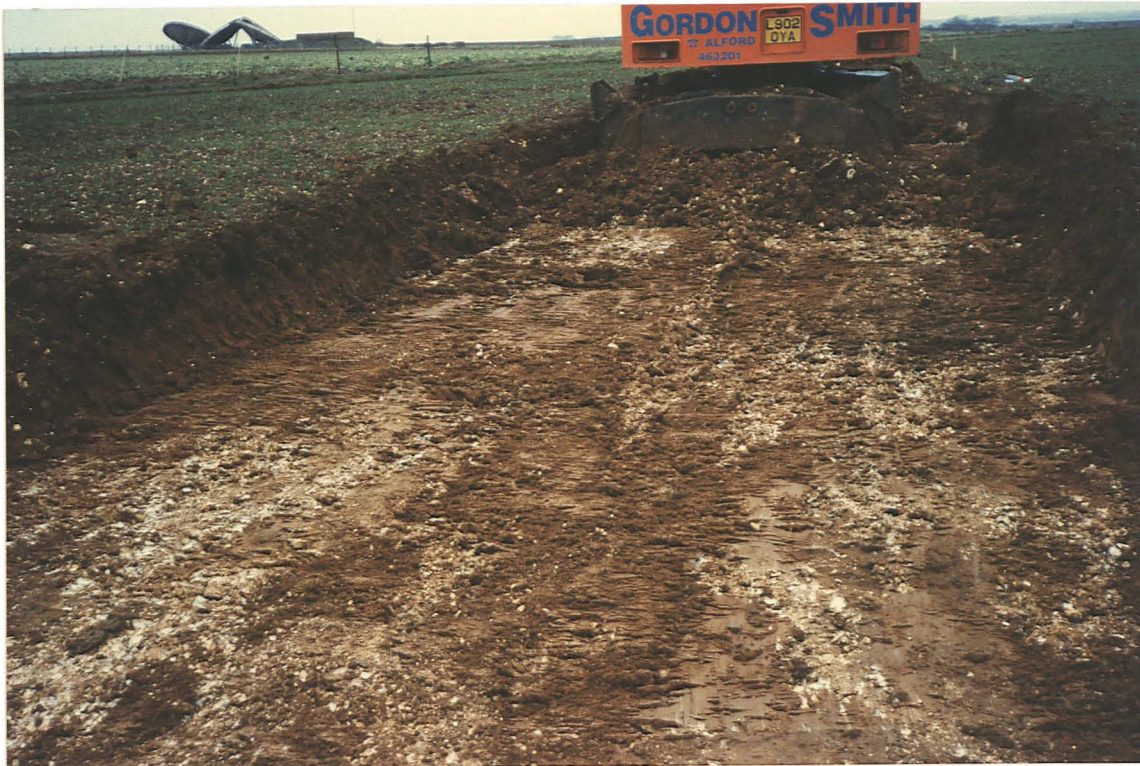
Pl. 6 Ditch 9001 visible as broad brown loam crossing track trench (centre). Looking NW towards dismantled radar site.

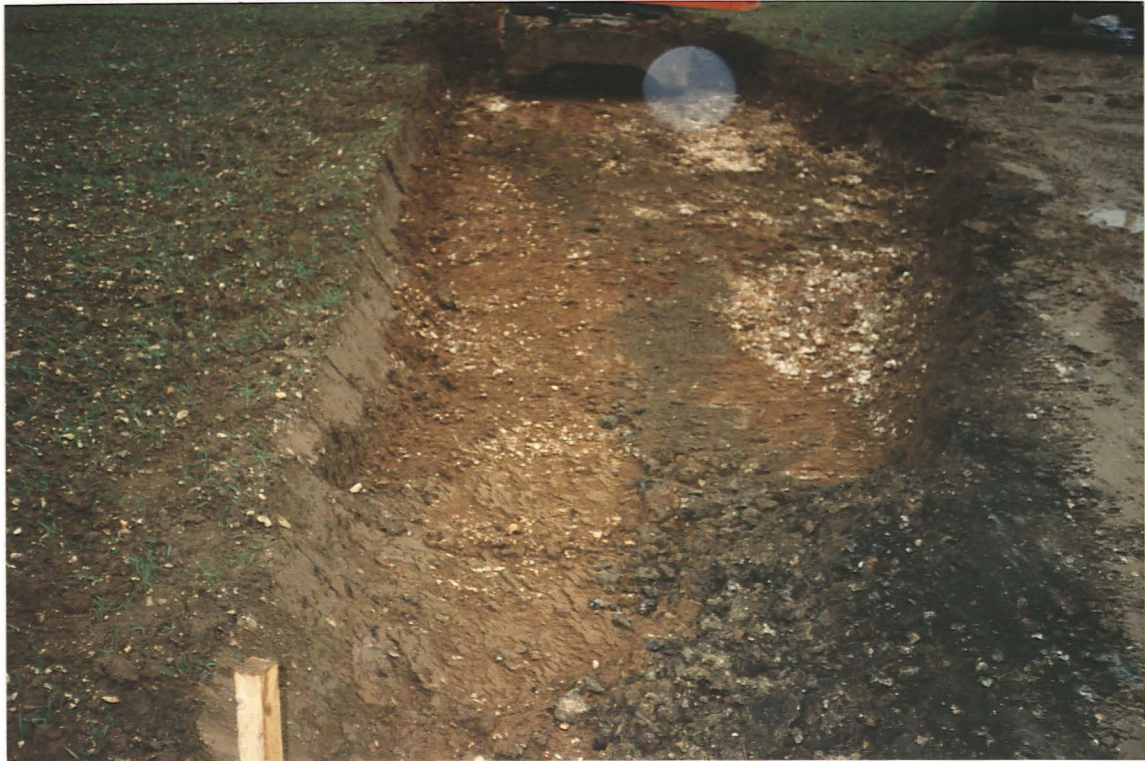
Pl. 7 Light brown fill of ditch 9003 beside existing farm track (looking SE).

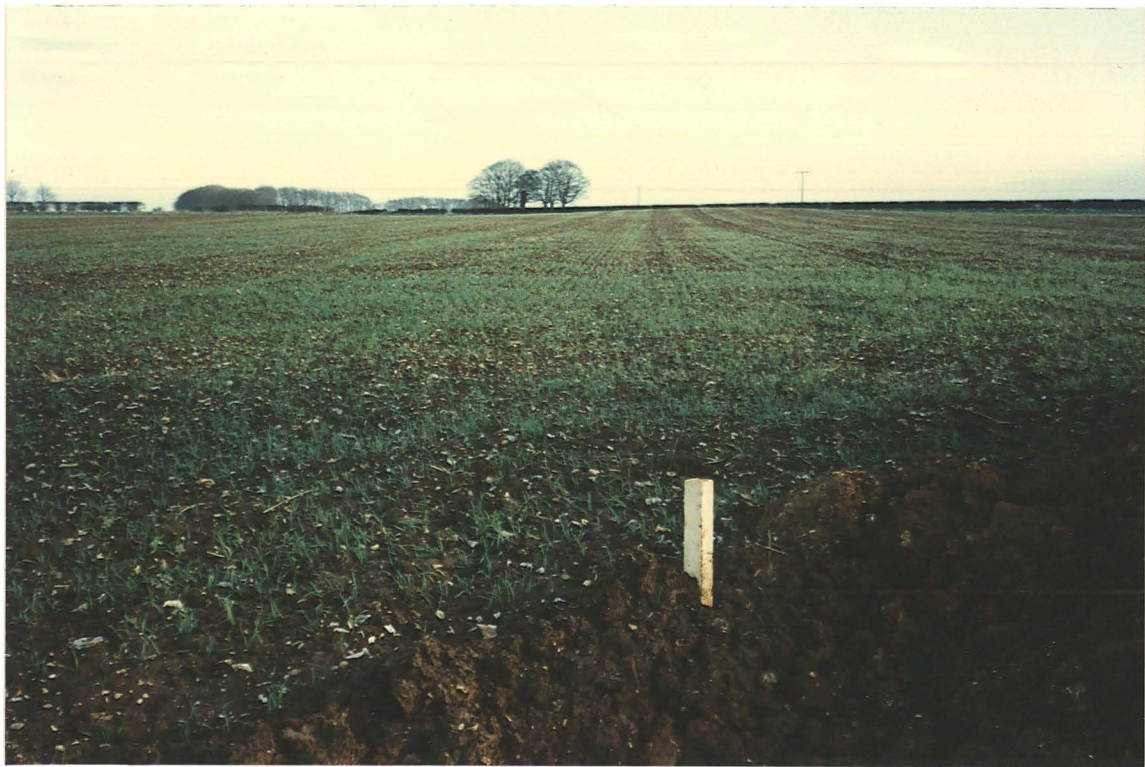
Pl. 8 Prehistoric burial mound (SAM 27879) under cultivation, as seen from the farm track realignment trench. Looking SE, Bluestone Heath Road top left.

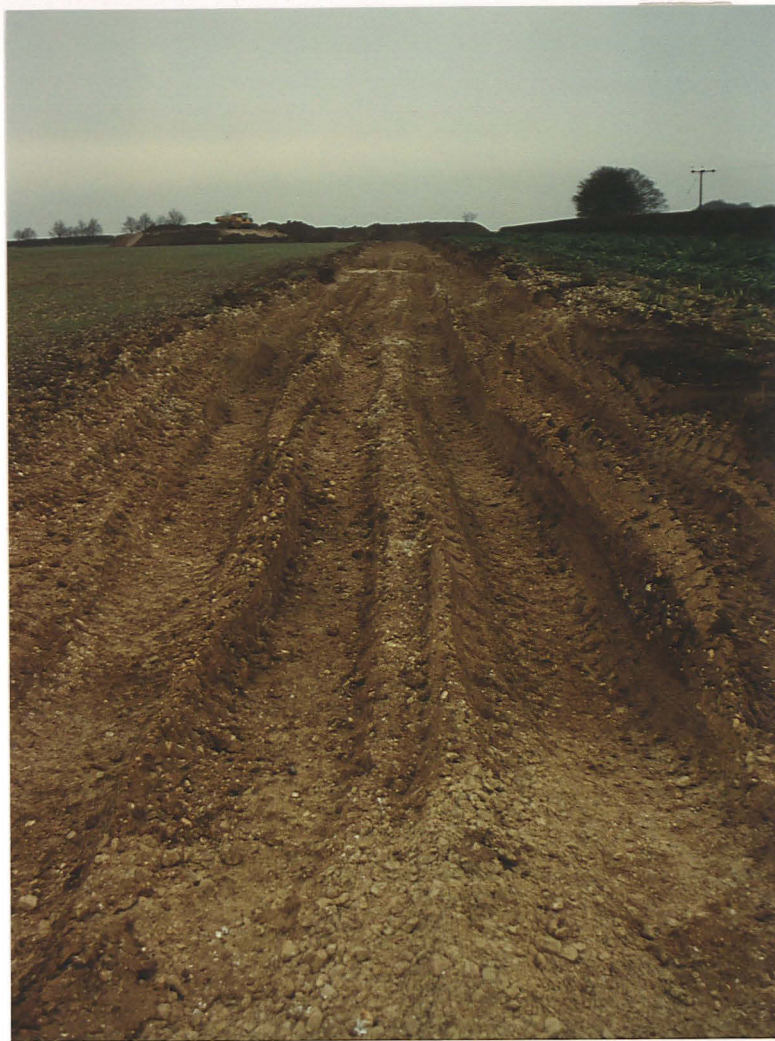
PI. 9 Ground conditions on the temporary haul track (looking NE).

In practice, soil was transported over the field surface along the line of the haul track without archaeological monitoring. When the surface became rutted, the ruts were planed by machine; eventually most of the topsoil cover had been removed and extensive ruts marked the position of deeper soil, presumably filling archaeological features (Pls. 9 and 10).

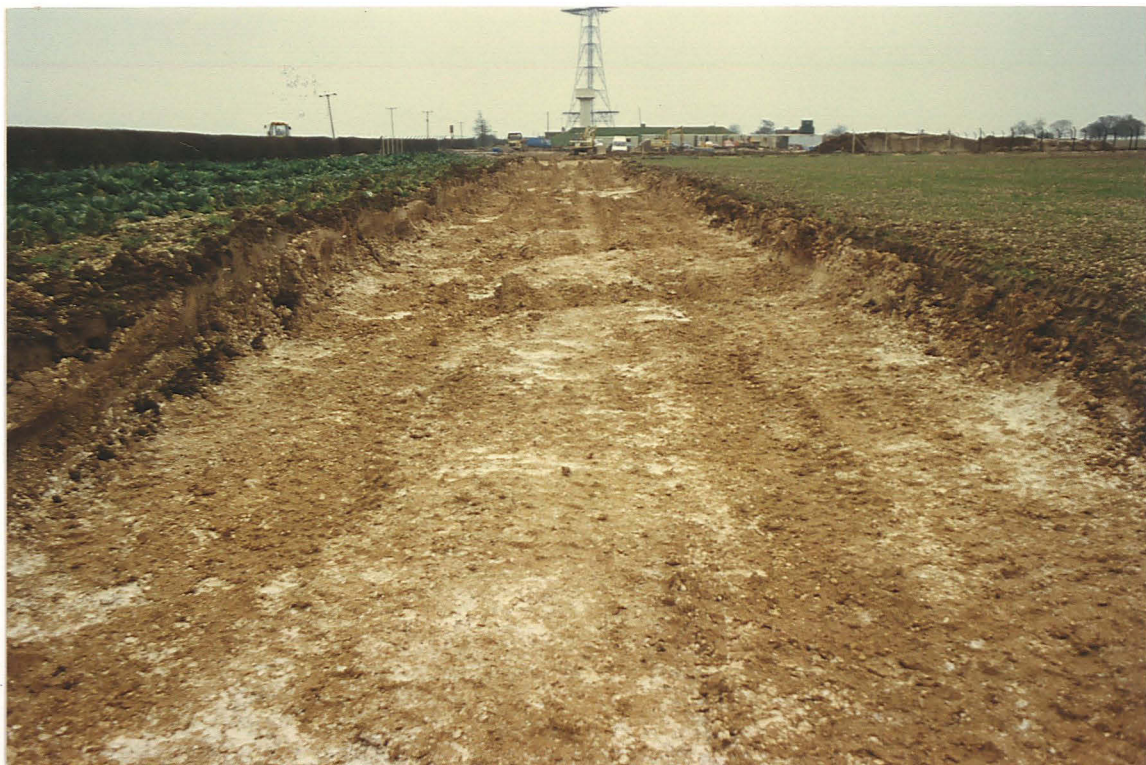
PI. 10 Vehicle ruts in temporary haul road, probably marking positions of archaeological features. Looking SW to new reservoir construction site.
