**Bassingham, 38 Water Lane**

**Archaeological Monitoring of groundworks for  
New Access Road**

**LAS Report No. 317**

**September 1998**

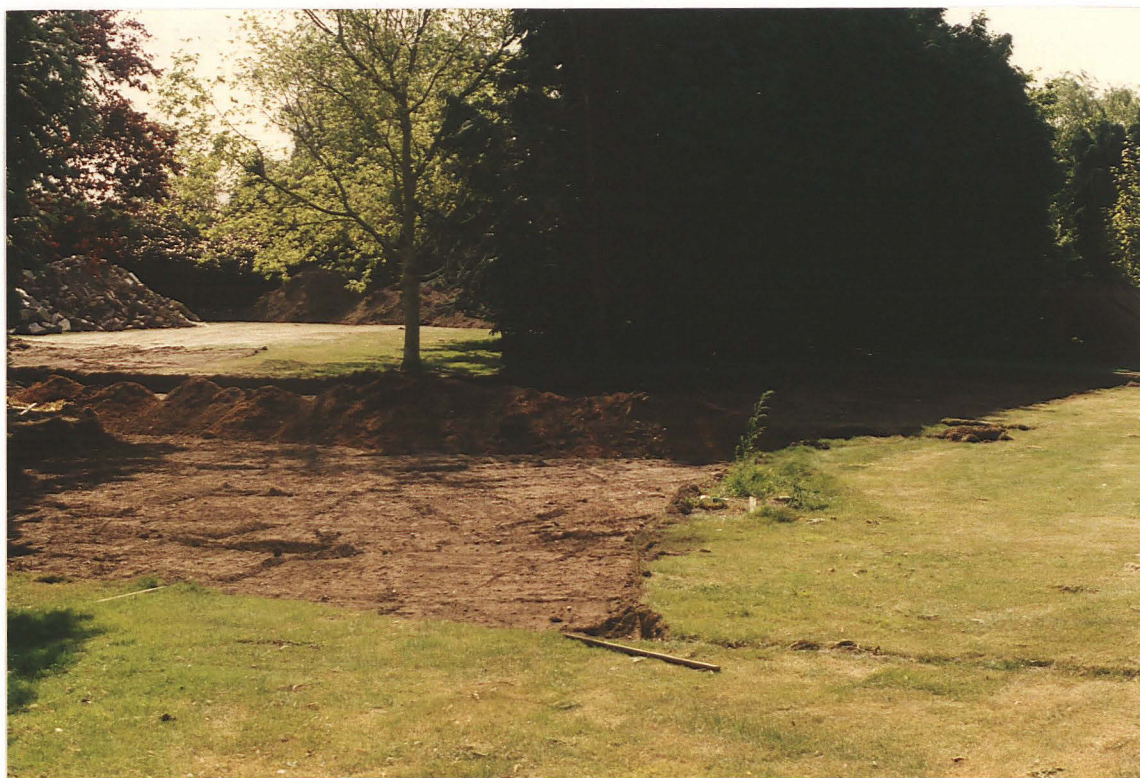
Pl. 1 The access road turning point (looking SW). The Early Saxon pot sherd was found to the left of the photograph.

One sherd of Early Saxon pottery was found in the topsoil 1 and has been identified as similar to products from the Charnwood Forest pottery production area. The sherd contains traces of chaff incorporated into the clay as temper, a feature previously only known from the Saxon site at Flixborough. Close examination of the adjacent trench did not result in the identification of any feature containing further fragments. The sherd may have been introduced during ancient manuring of the riverside field, or have spread from nearby deposits not yet identified.

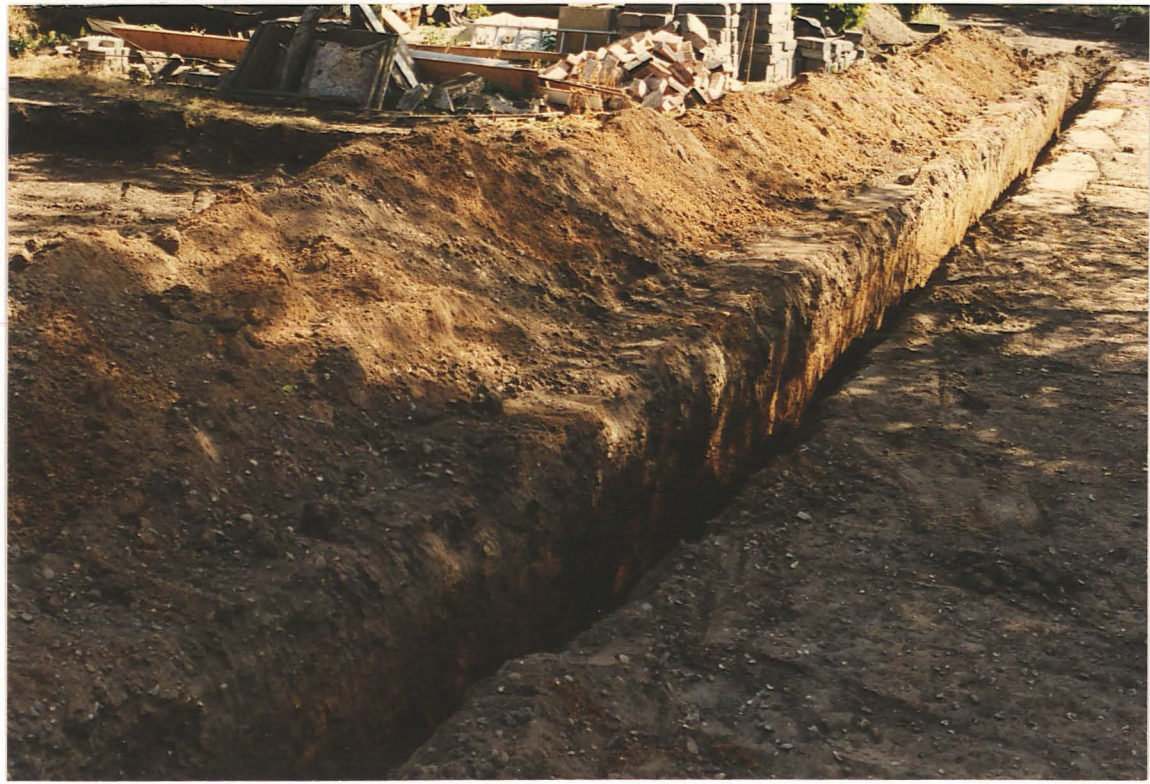
PI. 2 Dark fill of modern disturbance 2 (left foreground) and the new trench for services.

A spread of broken window glass within the turning area was readily explained as the remains of former glasshouses, and modern refuse close to the house marked backfilled pits. An 8m long (north - south) and 0.45m deep disturbance 2 was visible in the trench straddling the position of the hedgeline between the two gardens. This feature contained nineteenth century crockery fragments.

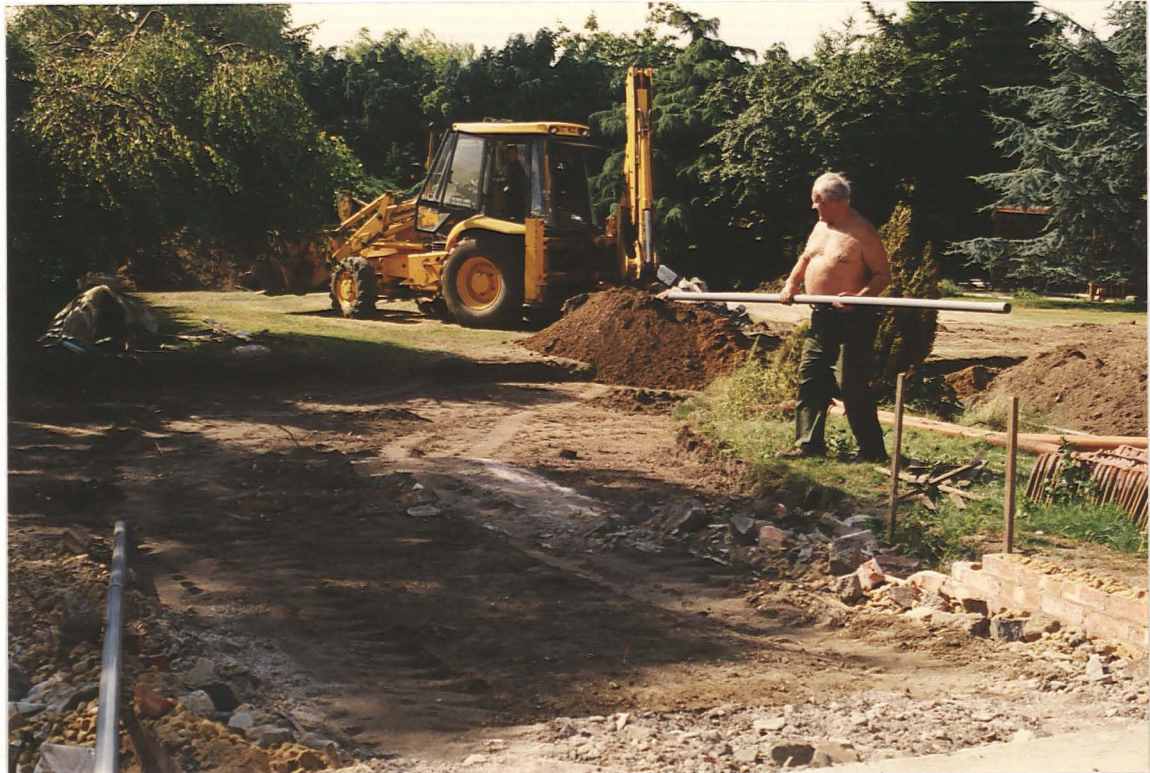
PI. 3 Excavation of the side spur from the service trench (looking west from the demolished garage).
