ARCHAEOLOGICAL PHOTOGRAPHIC SURVEY
AND WATCHING BRIEF:
LAND AT ABBEY FARM, ALVINGHAM,
LINCOLNSHIRE

Site Code:	AFA99
NGR:	TF 3675 9190 3666 9132
Planning Ref.	N/004/0447/98 L12662
LCCM Acc. No.	60.99

Report prepared for Mr A E Graves
by Mark Allen BSc AIFA

March 2001

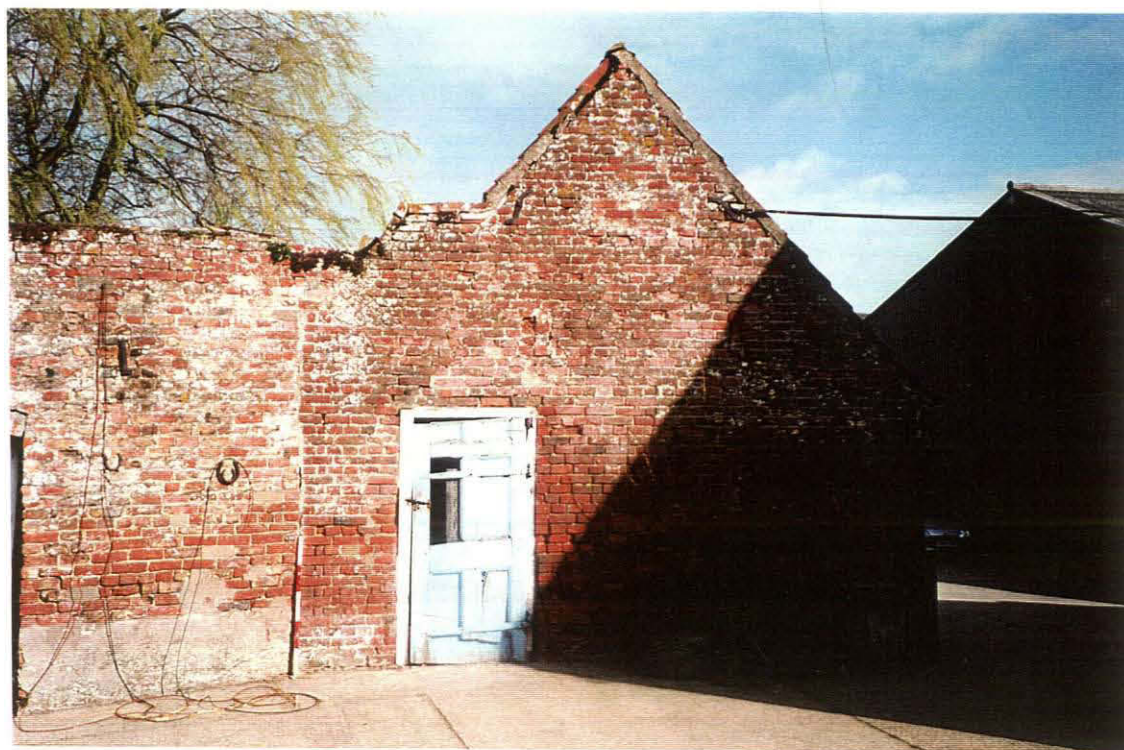
The garage was built of narrow bricks and this structure had a gabled roof (plate 1). Internally, a partition wall was made of large limestone blocks and occasional roof tile (plate 2). The walls were not finished with plaster, and the roof structure consisted of substantial wooden beams that supported ceramic pan tiles (plate 3). Externally, it was possible to judge that garage was built prior to the utility (plate 4).

P.1 South wall of garage outbuilding, looking N.

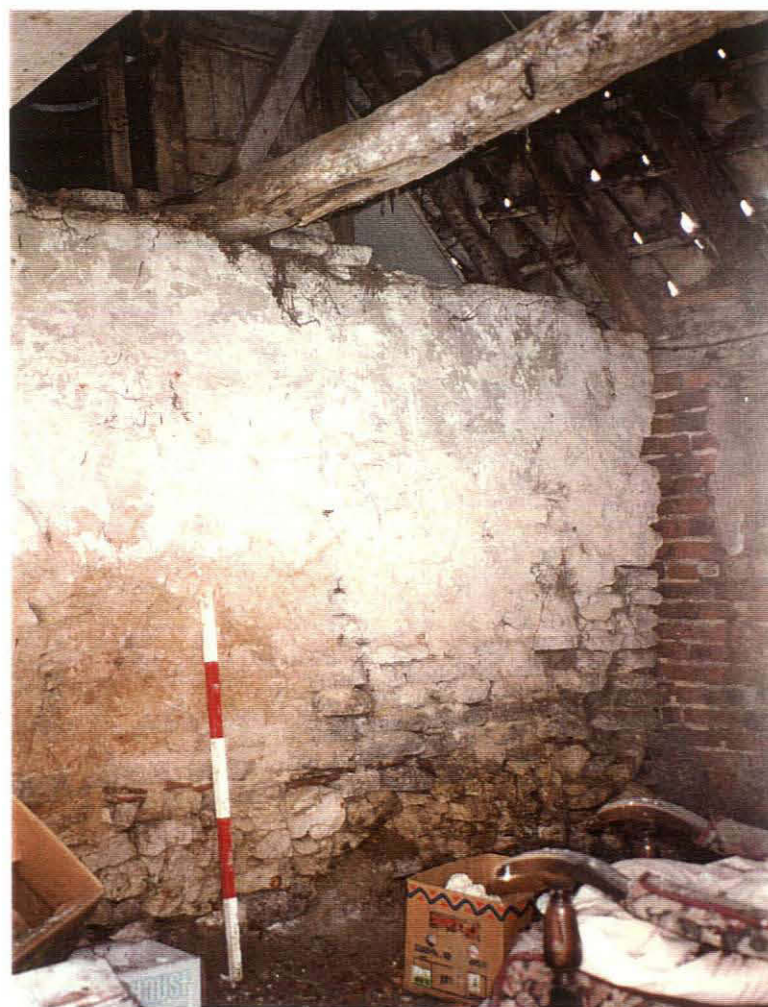
P.2 E-W limestone wall within garage, looking NE.

outbuildings were constructed. Therefore, these foundations were probably utilised to build the utility building (plates 2 & 5). The foundations were wide (0.95m), indicating that the medieval structure was considerably more substantial than the later farm buildings. Two sherds of pottery from a demolition deposit (102) may date the destruction of the building to the late 15th to mid 16th century.

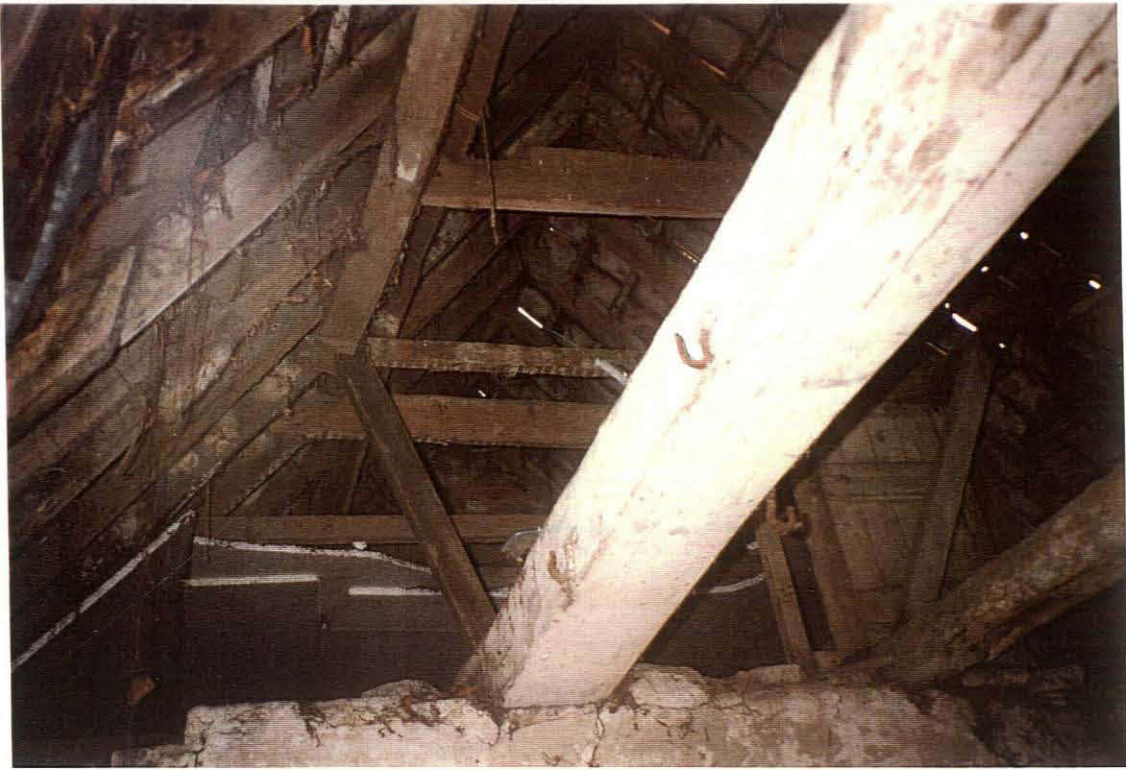
P. 3 Garage roof, looking N.

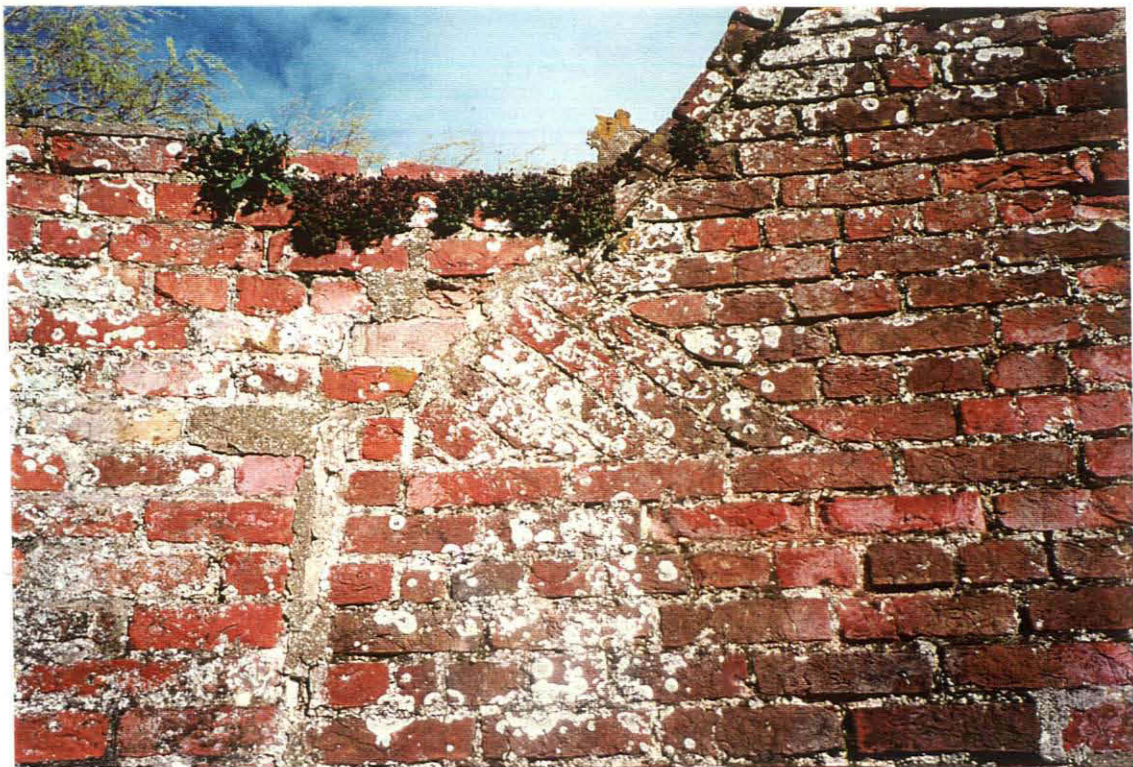
P. 4 Close-up of relationship between garage and utility, looking N.

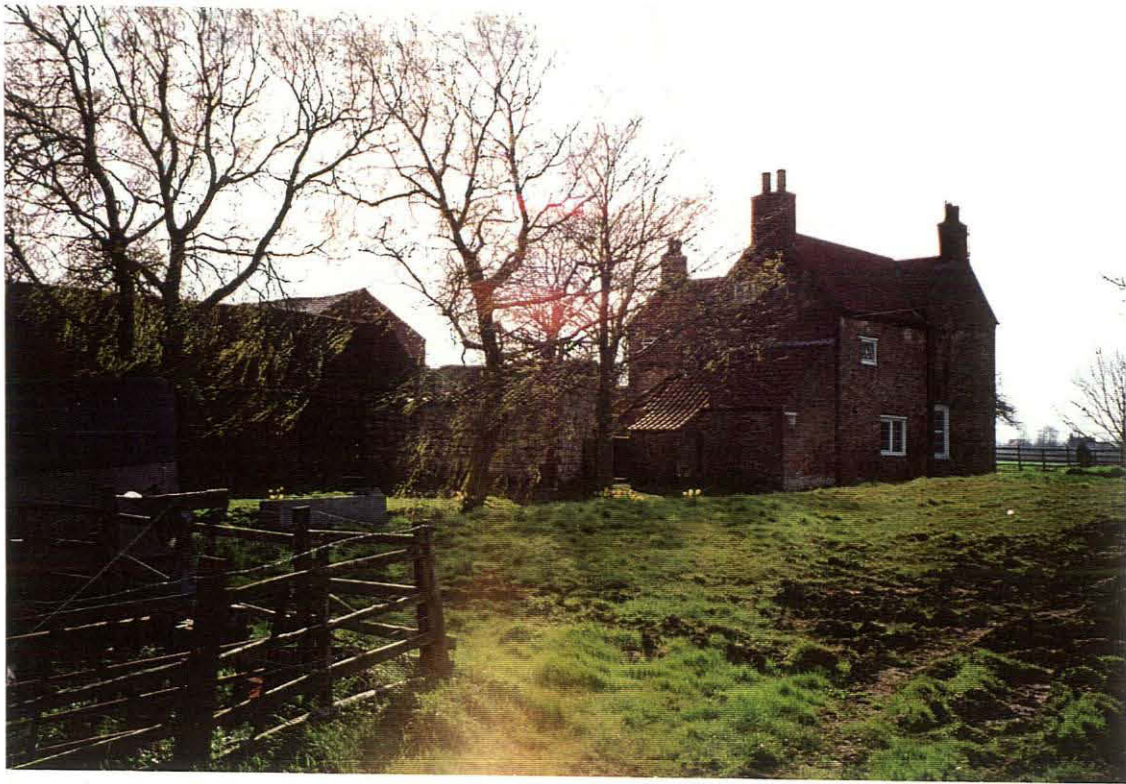
The utility was made of stone and brick. The northern (rear) and western sides were made of large limestone blocks (plate 5). The front of the building consisted of several courses of limestone (up to 0.7m high), overlain by bricks (plate 6). The limestone courses had been covered with a thin skim of mortar. The bricks were slightly thicker (?later) than those within the garage. Internally, the walls were plastered and the roof was lower, and at a lesser angle to the garage.

P. 5 Rear of utility, showing location of farmhouse, looking SE.

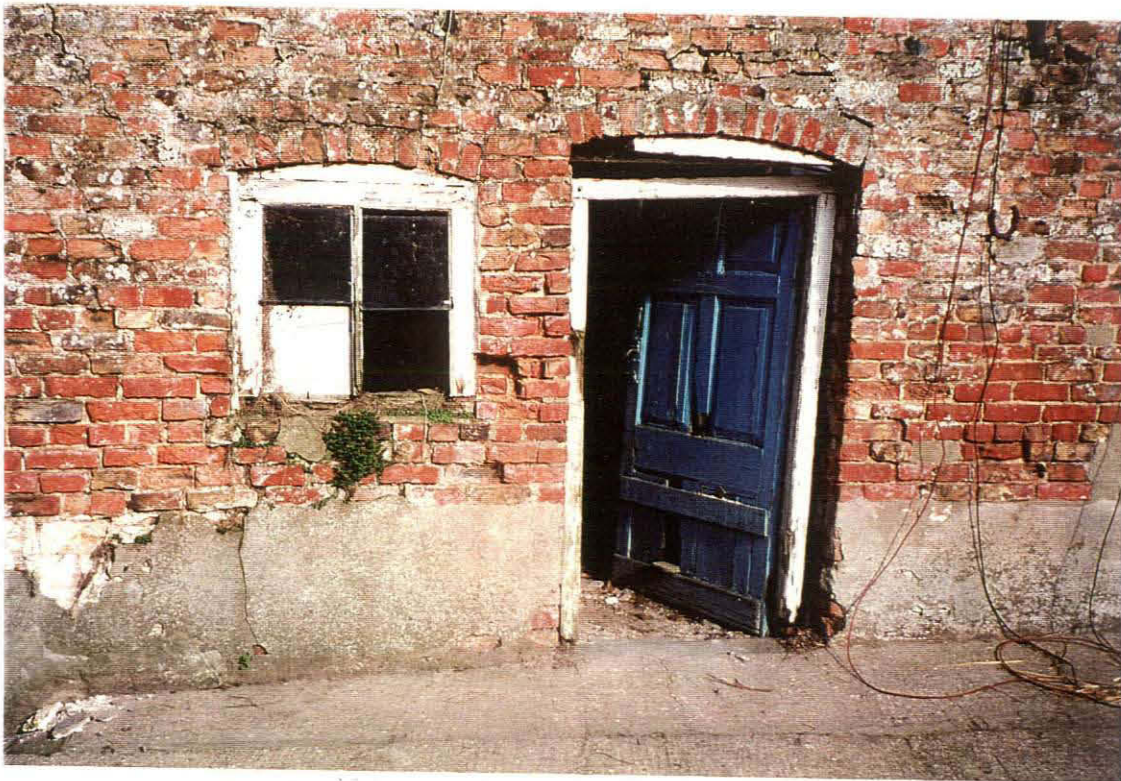
P. 6 Construction of utility, looking N.

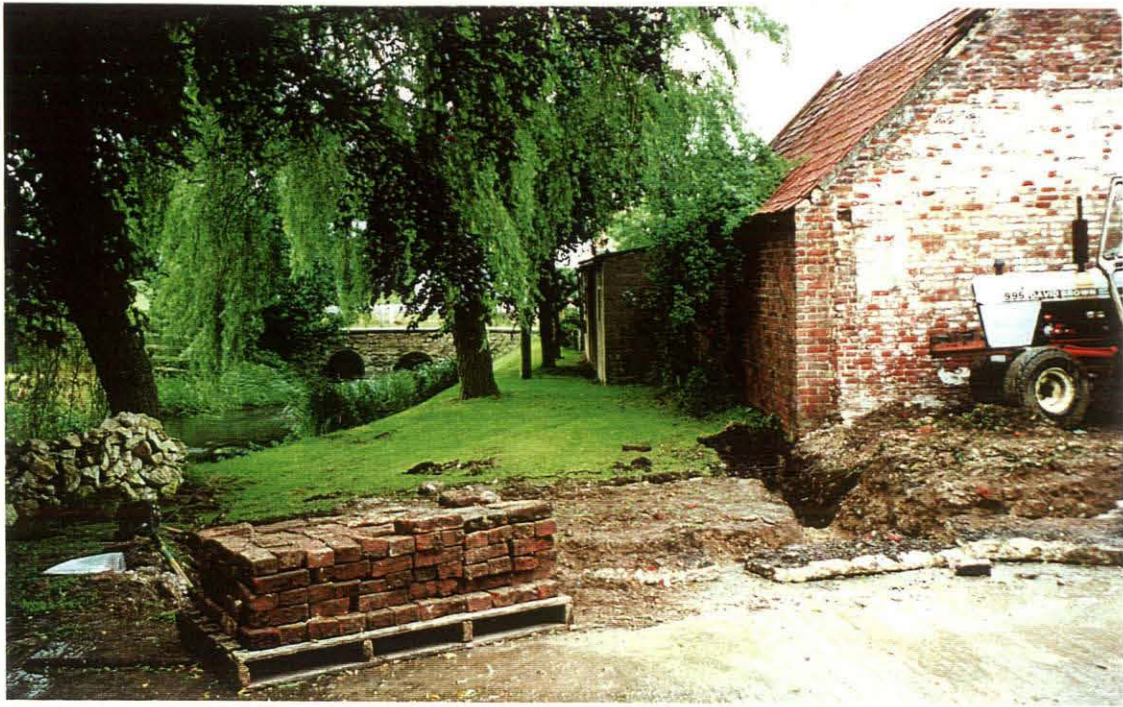
The excavation of the foundation trenches exposed a series of archaeological deposits, including stone walls and demolition layers (plate 7).

P. 7 Trench location showing stream to west, looking north.

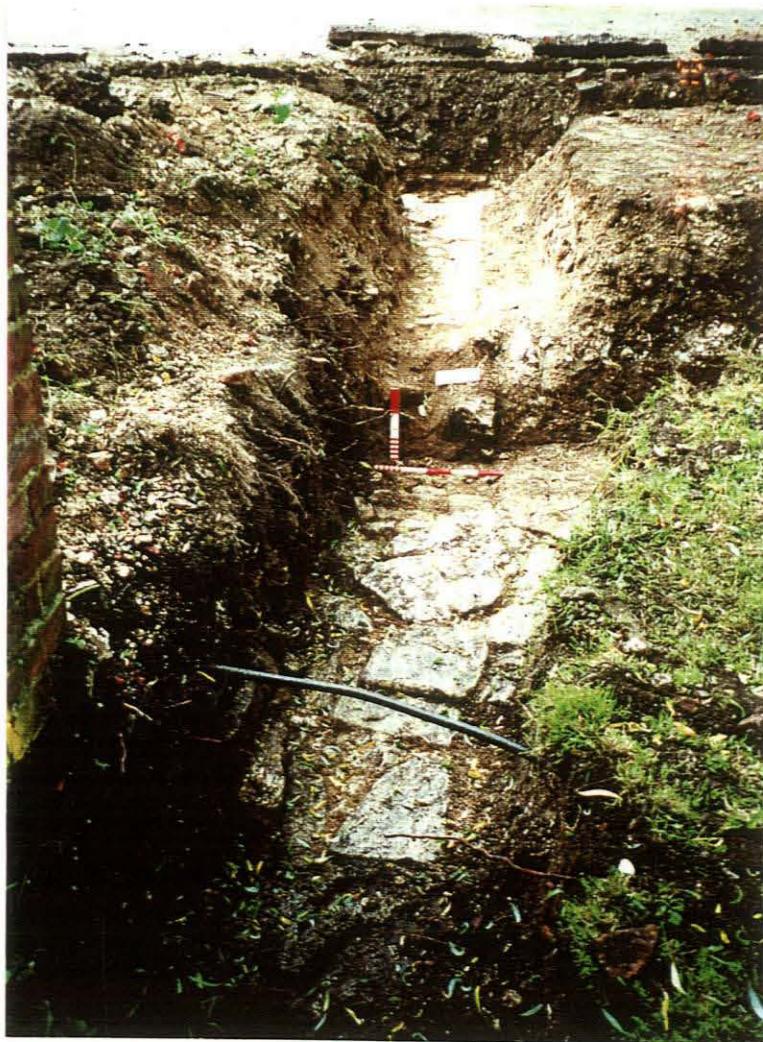
Wall 104, orientated north – south, was approximately 0.95m wide. Its internal and external faces were made of large dressed limestone blocks, with the core comprising medium and large limestone fragments (figures 2 and 3; plate 8). The bonding consisted of light yellow sandy mortar. The wall turned westwards at the southern end of the trench, forming the southeast corner of a possible structure. It seems likely this structure was associated with the Gilbertine priory.

Wall 118 (figure 2; plate 8) was located 1m north of the southeast corner of, and ran perpendicular to, wall **104**. It was orientated east-west, and it was also approximately 0.95m wide. The wall appeared to be of the same construction phase as **104**, forming another element of this structure.

P. 8 Medieval walls 104 & 118, looking south.
