**PHOTOGRAPHIC SURVEY:
HALL FARM, MAIN STREET, HONINGTON, LINCOLNSHIRE**

NGR: SK 9437 4319
Planning Reference: S/04/1622/43
LCCM Accession Number: 2007.174
Site Code: HOHA07

by Chris Clay
September 2007

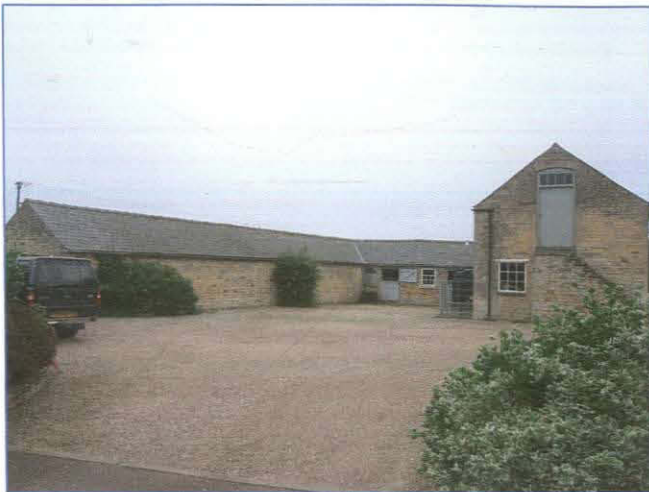
Plate 1: General view of the northern part of the barn complex, looking south-west towards granary Building A, stable block Building B, and the north wall of the cart shed Building C.

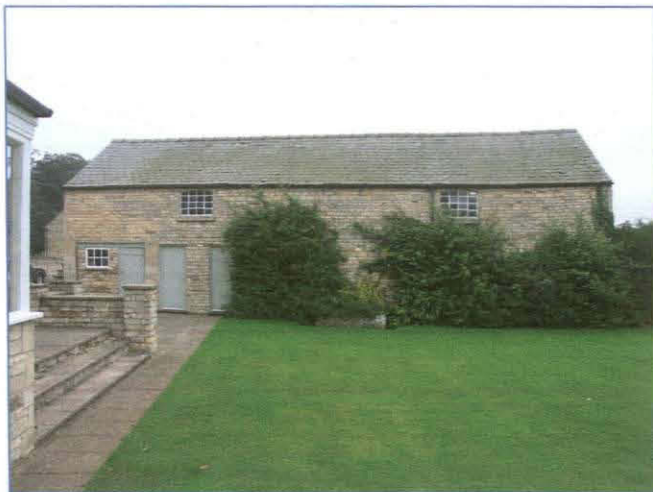
Plate 2: North elevation of granary Building A, looking south-east. The door and window at the east end of the elevation, and possibly the two adjacent doors, have replaced an opening into the cart shed.

5.2.2 Another similar opening has been partially blocked with stone in the north elevation, and replaced by three doors and a window. In the centre of this blocked opening is a pillar of ashlar blocks, which is probably an original feature. Much of the remainder of the north elevation is obscured by vegetation. A further door, which appears to be original, is evident in the west elevation.

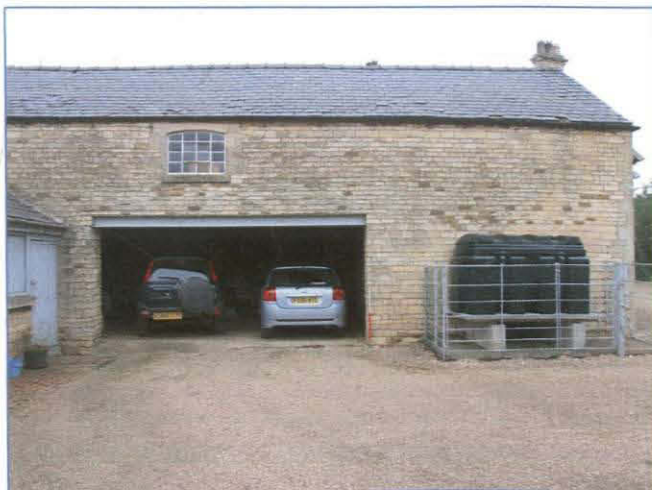
Plate 3: South elevation of the granary/cart shed Building A, looking north-north-west.

5.2.1 This building was a large two storey structure, measuring approximately 16.4m by 5.8m. It has saw tooth quoins of neatly dressed ashlar blocks on the external corners of the building. The ground floor is likely to have been used as a cart shed, as suggested by the large opening in the south elevation. It currently has a new concrete floor and is in use as a garage and store. A septic tank stands on a concrete plinth immediately to the east of this opening.

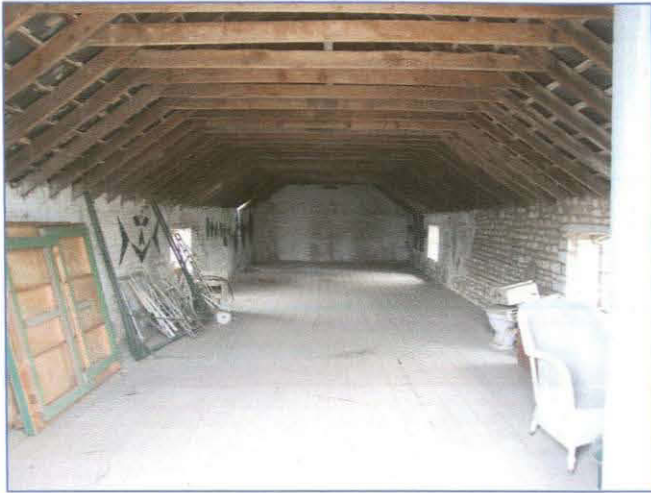
Plate 4: Upper storey of granary/cart shed, looking west-south-west.

5.2.3 Stone steps at the east end of the building allowed access to the upper storey, which was probably used as a granary or hay loft to store feed for the horses. Such an arrangement is paralleled in farm buildings of this date throughout England, with the granary close to both the farmhouse and the stables (Brunskill 2004). The upper storey has two windows in the north elevation and one in the south elevation, all with large stone sills and segmental arches of ashlar blocks and a saw tooth arrangement of ashlar blocks on each side. The interior of the building has no other features of note.

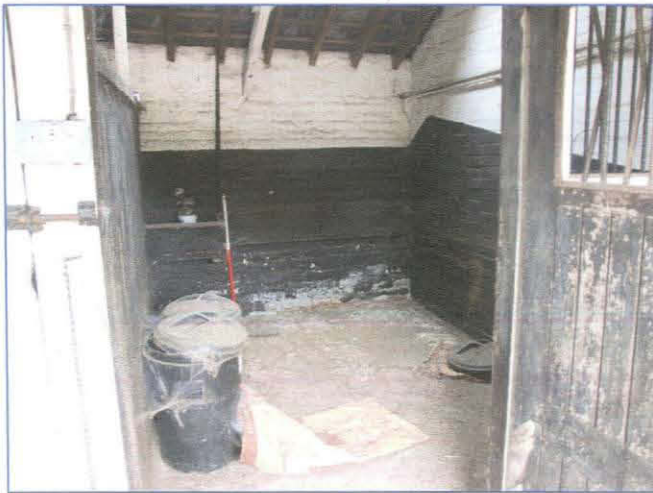
Plate 5: Interior of one of the stable blocks at the north end of Building B. Looking west.

5.3.4 The stable block comprises four stalls, each fronted by wooden panelling and a door with an iron grille. The lower parts of the walls of all four are painted black with white paint above. There are two wooden stable doors in the east elevation, each with a window to its south. The northern window has an ashlar sill and lintel and is divided by wooden mullions and transoms into six small lights (small panes of glass) in the lower part of the window and a single large light at its top. The southern window also has an ashlar sill and a semi-circular arch of ashlar blocks, and is filled with a metal grille.

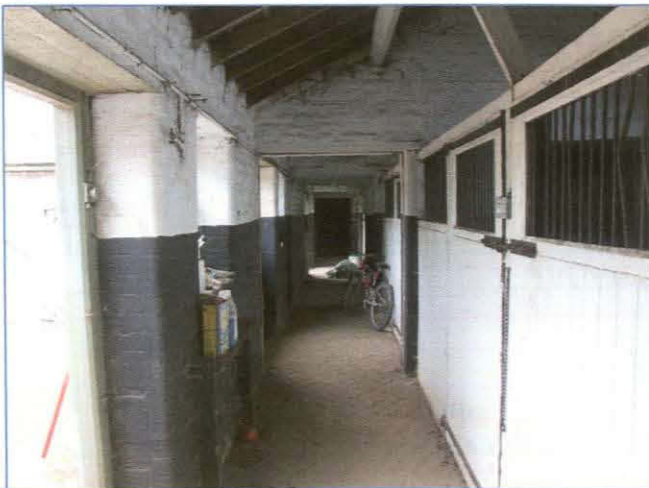
Plate 6: View along the corridor running the length of Building B. Looking south-south-east.

5.3.3 The remainder of the block comprises a single large room with a corridor running along its east side, divided into a series of bays principally by stone partitions; although the partition between the two northernmost stalls in the stable block is of wood.

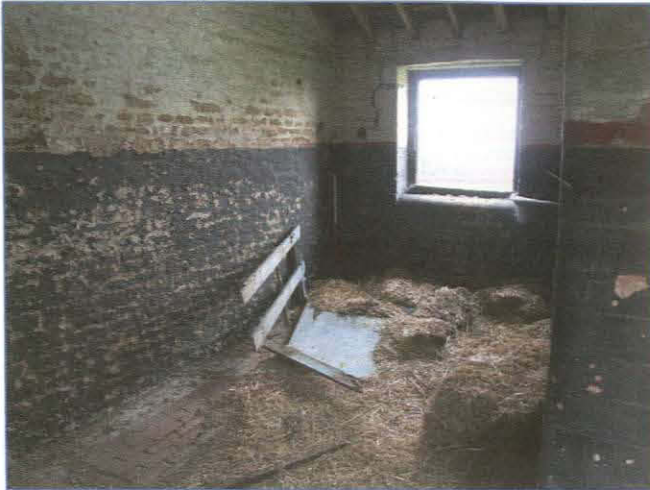
Plate 7: Possible storage room in Building B. Looking south-west.

- 5.3.6 To the south of the stable blocks is a range of four buildings, all of which open at their east ends onto the corridor that runs the length of the building. The northernmost room appears to have been used as a storage area, with a window in the west wall.

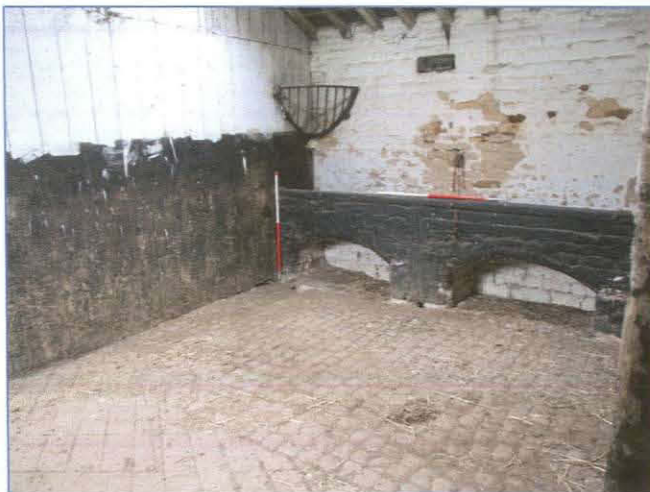
Plate 8: Room at the south end of Building B, probably used as an animal shelter/feeding room. Looking south-west towards feeding troughs on the west wall.

- 5.3.7 The remaining three rooms to the south of this are identical in form, with an arched feeding trough against the west wall. The western part of the floor in each room is of noticeably rougher construction than the eastern part, and slopes down to the east, to facilitate the clearing away of waste.

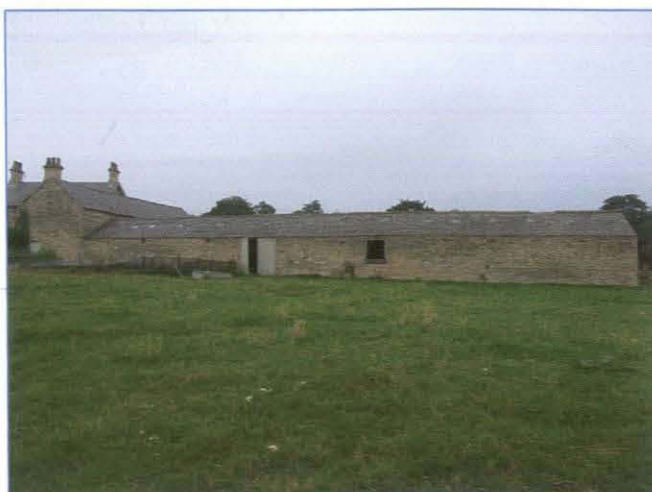
Plate 9: West elevation of Buildings A and B, looking north-east.

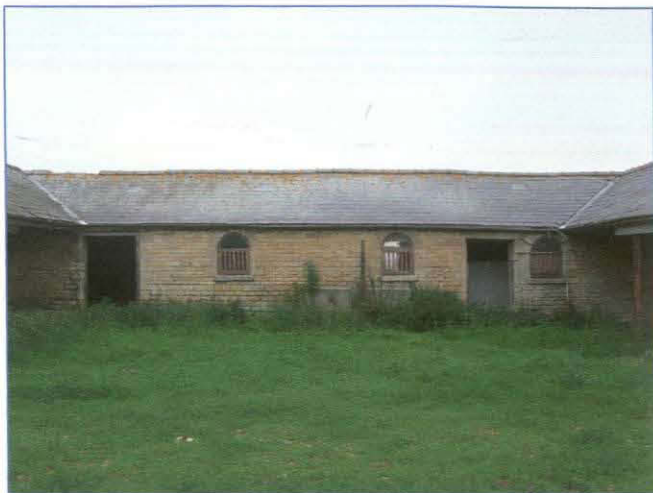
Plate 10: Southern part of the east elevation of Building B, between cart shed Buildings C and D. Looking west-south-west.

- 5.3.8 In the east elevation of this range there are two openings for doors (the doors themselves are missing), and there are four windows, all of which have an ashlar sill, with a semicircular arch of ashlar blocks. All the windows have a steel grille instead of glass in the lower part, and a semi-circular light of frosted glass in the upper part.

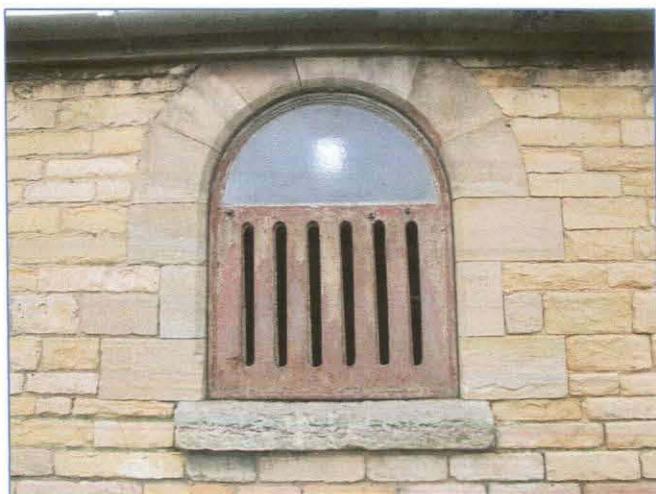
Plate 11: Detail of window in east elevation of Building B. Looking west-south-west.

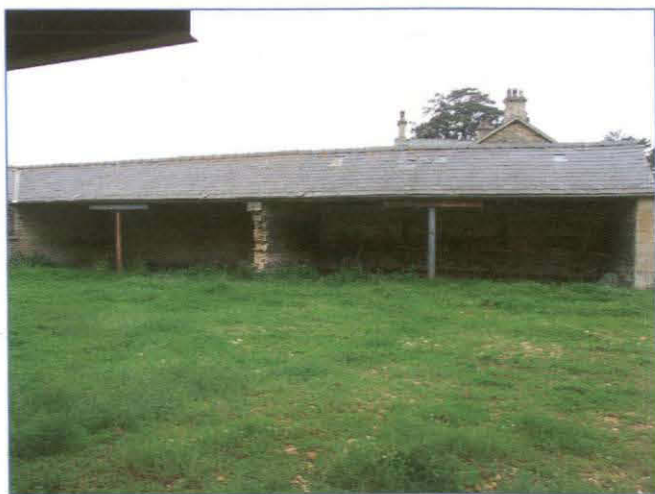
Plate 12: South elevation of cart shed Building C, looking north-north-west.

- 5.4.1 This building (along with Building D) forms one of two cart sheds extending eastwards from the east elevation of Building B. It is approximately 20m long and 4.8m wide. The building is divided into two by a central brick wall and is open on its south side apart from two steel girders supporting the roof. A stone boundary wall runs north-eastwards from the north-east corner of the building.

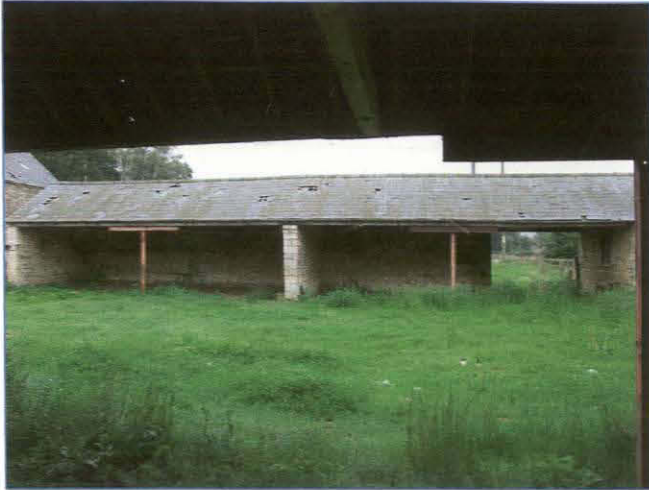
Plate 13: North elevation of cart shed Building D, looking south-south-east. Note the opening at the rear of the building allowing access to the fields beyond.

- 5.5.1 Building D was largely identical to Building C, being 20m long and 4.8m wide with a central stone dividing wall and two steel girders supporting the roof. The only major difference was that there was a further large opening in the south elevation allowing access for carts.

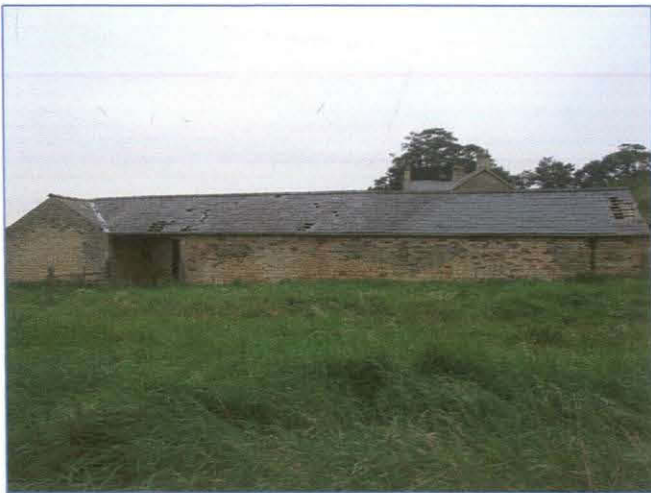
Plate 14: South elevation of cart shed Building D and Building B, looking north-north-west.

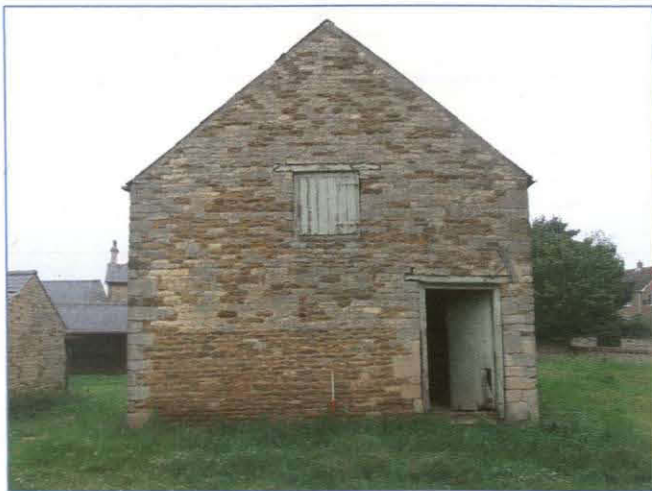
Plate 15: South elevation of threshing barn Building E. Looking north-north-west.

- 5.6.1 The final building in the complex is Building E, a large threshing barn measuring 16.8m by 6.4m. It has a stone boundary wall attached to its north-west corner, extending to the north-west. Approximately half way along this boundary wall was a repair that is likely to denote a blocked entrance. In the southern elevation is a small wooden door at ground floor level, and a square hatch or pitching hole at first floor level to allow harvested crops to be loaded directly from a cart into the upper storey of the barn.
- 5.6.2 The barn has two large doorways opposite each other in the east and west elevations of the barn. The door in the western elevation has been largely blocked, with several courses of brickwork at its base, and with wooden panelling above leaving only a small wooden door. The door in the

5.6.3 The interior of the barn is a single open room, with a wooden hayloft at the north end. It is likely that this hayloft originally extended the length of the building to form an upper storey as there is a pitching hole is visible at first floor height in the south elevation.

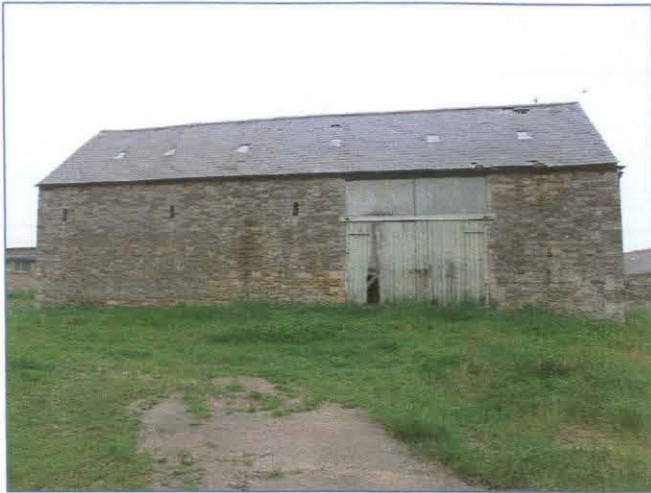
Plate 16: East elevation of threshing barn Building E. Looking west-south-west.

east elevation is a large wooden double door above which is a concrete repair. These two opposing doors are likely to represent either side of a former threshing floor, where the through flow of air was necessary to blow away the chaff, leaving the wheat behind.

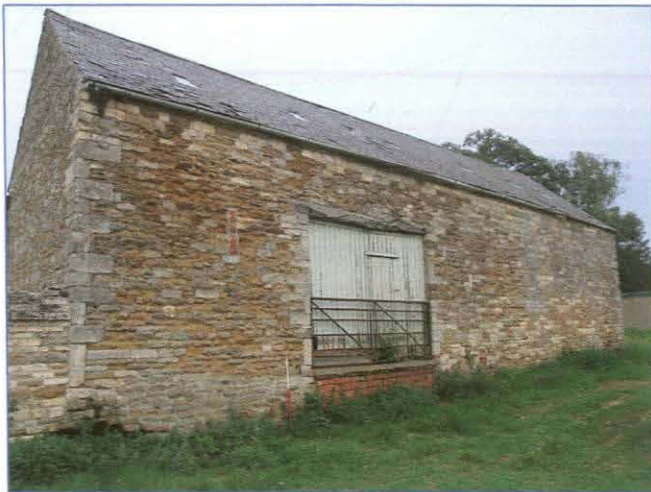
Plate 17: West elevation of threshing barn Building E. Looking east-south-east.

5.6.4 A number of ventilation slots have been blocked in the east, west and south elevations of the barn.

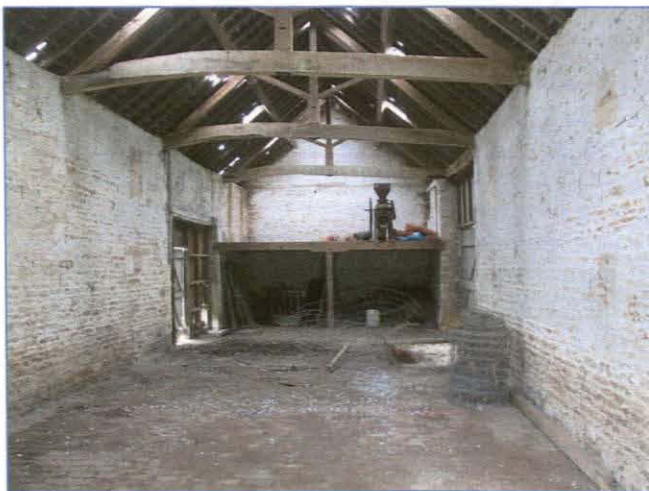
Plate 18: Interior of threshing barn Building E. Looking north-north-west.
