**ARCHAEOLOGICAL  
PHOTOGRAPHIC SURVEY OF  
BUILDINGS AT  
WEST STREET/GEORGE STREET,  
BOSTON,  
LINCOLNSHIRE**

(BWG02) APS SITE CODE  
(WSB02) CCM SITE CODE

**Work Undertaken For  
Corstorphine and Wright**

APS Report No. 120/02

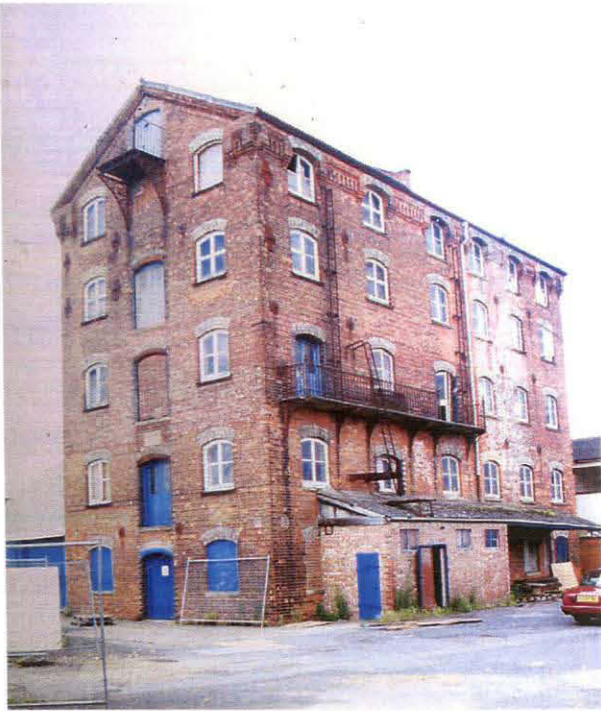
Plate 2 Mill building, south and west elevations

The western elevation is similar to the eastern, except there is no external gangway and no doors, and the lower two storeys are concealed by a modern lean-to structure (Plate 2).

The mill is a 5-storey brick-built structure with a pitched roof (Plates 1 and 2). Elongated north-south, it is six windows long and three wide and the windows and doors have segmental arches in cream-coloured brick. Some of the window-sills, particularly on the east face, are in sandstone.

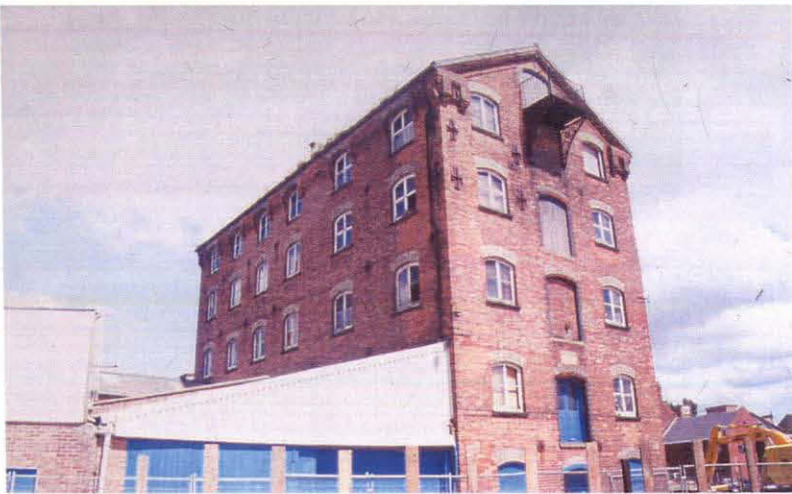
Plate 4 Detail of external walk-way, east wall of mill

At third storey level there is an external walk-way that connects two doors in the southern half of the wall (Plate 1). This walk-way has a flagstone base and is supported on decorative cast iron mounts (Plate 4).

The external, second floor, gangway provided access between the two separate parts of the building at this level. This appears to have been the only above-ground access between the two parts of the building, there being no obvious blocked or open doorways in the dividing wall. It is possible that the division of the building was for safety purposes.

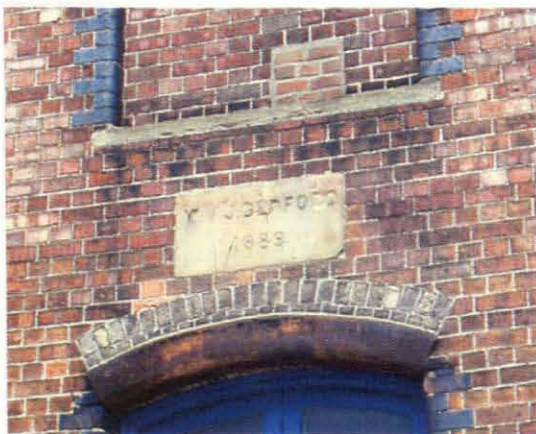
Plate 5 Mill northern elevation, lower part

The northern gable has a central doorway at second storey level and a blocked round window immediately below the roof apex (Plates 5 and 6). Otherwise, there are sets of three windows at first, fourth and fifth storey levels. At second storey level are two windows, one either side of the door. There are no windows in the third storey north wall. A cast iron wall box is set into the wall to the left of the ground floor left window (Plate 5).

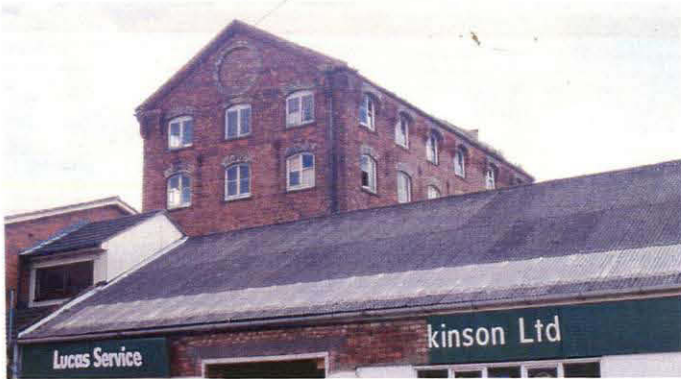
Plate 7 Mill, western elevation, showing dividing wall extending above roof line

The roof is of corrugated material and between the second and third windows from the southern end of the building there is a wall that extends upwards above the roof line (Plate 7).

The mill, elongated north-south, is divided into two parts by an east-west wall that extends across the building up to, and through, the roof line. To the north of this dividing wall the building comprises large, open floor spaces with cast iron columns supporting the upper storeys. This open-plan arrangement perhaps suggests that this part of the building functioned as a warehouse.

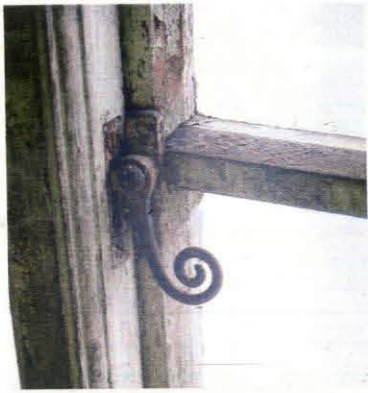
Plate 9  
Cockspur  
window catch

Windows in both parts of the building have internal catches in a cockspur or tear-drop form (Plates 8 and 9). All the windows are wooden-framed, with four lights.

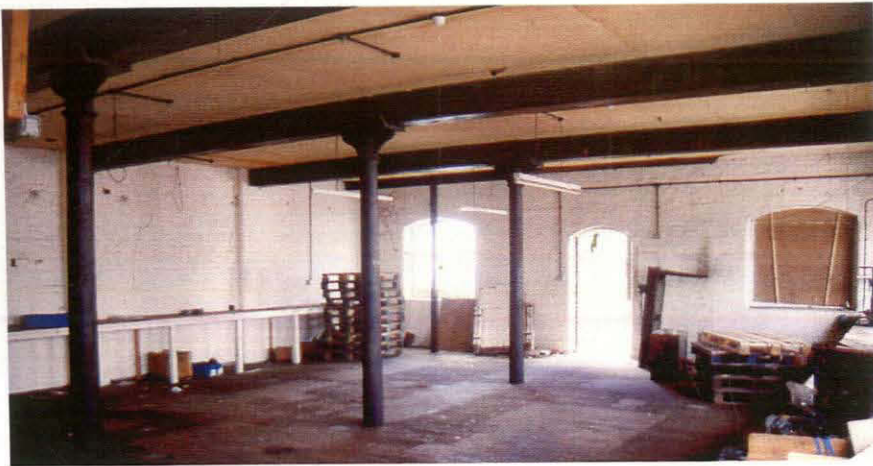
Plate 11 Mill second storey,  
northern part, showing cast  
iron columns

In the northern part of the building, each storey has cast iron columns set longitudinally down the centre of the rooms and which support the beams for the floors above (Plates 11 and 12). These

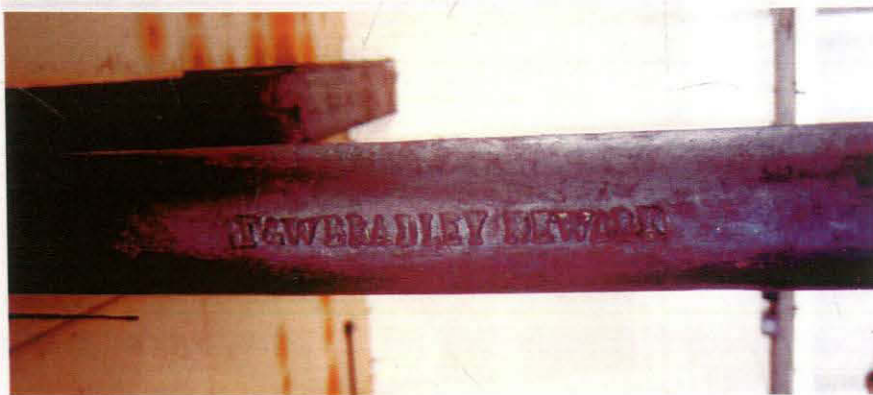
Plate 13 Detail of maker's  
name on cast iron column

columns bear the manufacturer's details 'T & W BRADLEY NEWARK' (Plate 13). Each floor of this northern section of the building is fully open, with no internal divisions except for some modern surrounds enclosing the stair well on a couple of floors. The stairway is of timber (Plate 14). Each level of the stairway in this part of the building is located at the southwest corner of the rooms.

Manufacturer's details noting 'T & W BRADLEY NEWARK' occur on the cast iron supports. These signify that the stanchions were products of the Bradley foundry, also known as the Wellington foundry, set up in 1814 on Northgate, Newark (Sheppard *et al.* 1993, 30).

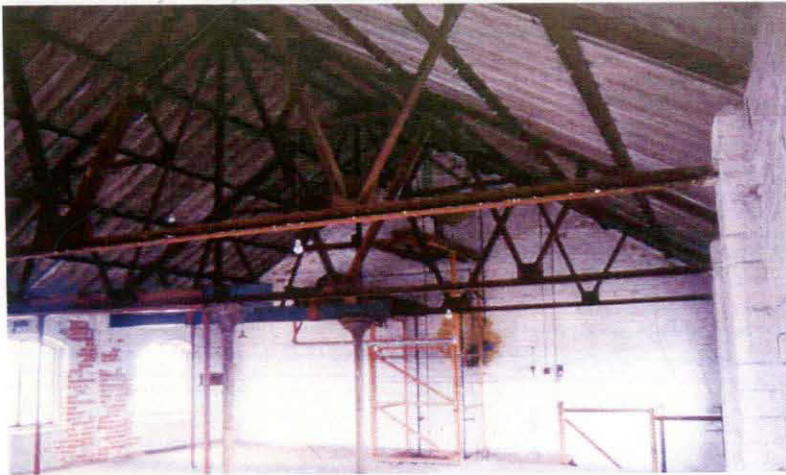
Plate 15 Cast iron roof  
trusses in northern part of mill

The upper storey is open to the roof and reveals iron/steel roof trusses (Plate 15). There is a modern, caged goods lift that runs through this part of the building and retains its driving mechanism on the upper storey (Plate 15).

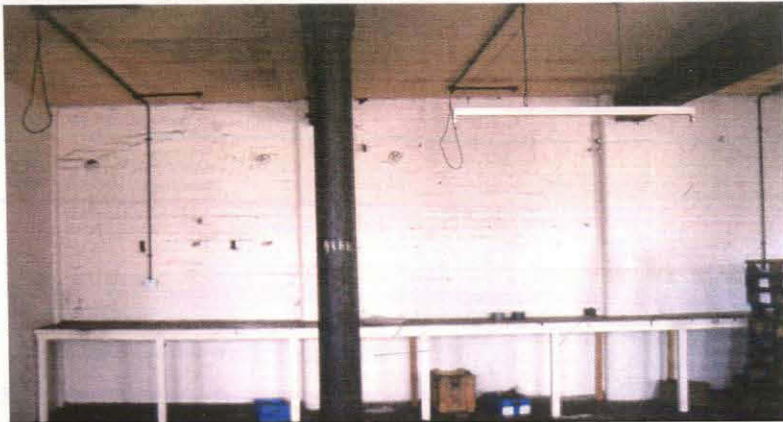
Plate 16 Mill west wall,  
showing blocked windows

Bricked-up windows, including one that was first reduced in size and then completely blocked are evident on the interior of the west wall at second storey level (Plate 16).

Some alterations to the building are evident in the form of blocked doors and windows. Many of these blockings are where recent lean-to extensions had been erected, making the openings redundant.

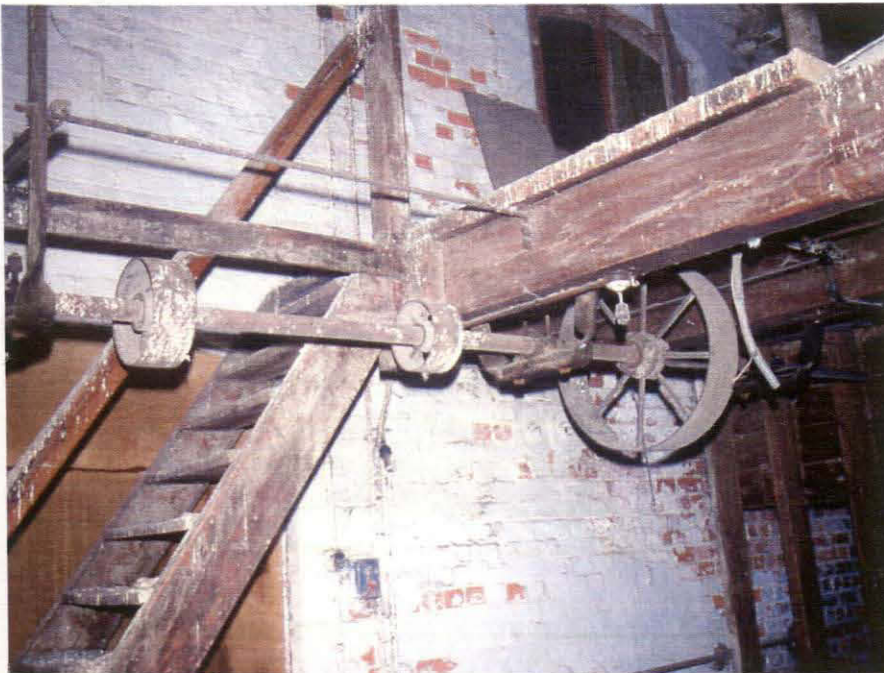
Plate 20 Detail of pulley  
wheel

On the top floor of this part of the building are the remnants of some of the mill machinery. Two lay (or line) shafts with pulley wheels are located near the ceiling (Plate 20). The lay shafts transferred power from the main drive shaft and were fitted with toothless pulley wheels. The pulley wheels would have driven belts that provided motion for ancillary machinery, such as the sack hoist. The drive belts are no longer extant.

Other than the wall boxes, the elevator ducts and the pulley wheels on their lay shafts, there are no *in situ* mechanical remains of the milling apparatus. Moreover, the mill was a steam mill and there are no clear indications of the locations of the engines that provided the steam power for the mill, nor for any chimneys for the steam engines. However, with the exception of the removal of the milling apparatus, the building largely retained its structure and form from its original construction in 1889 to the present day. The mill appears to have functioned solely as a grain mill until the buildings taken over for use as a machinery parts store.

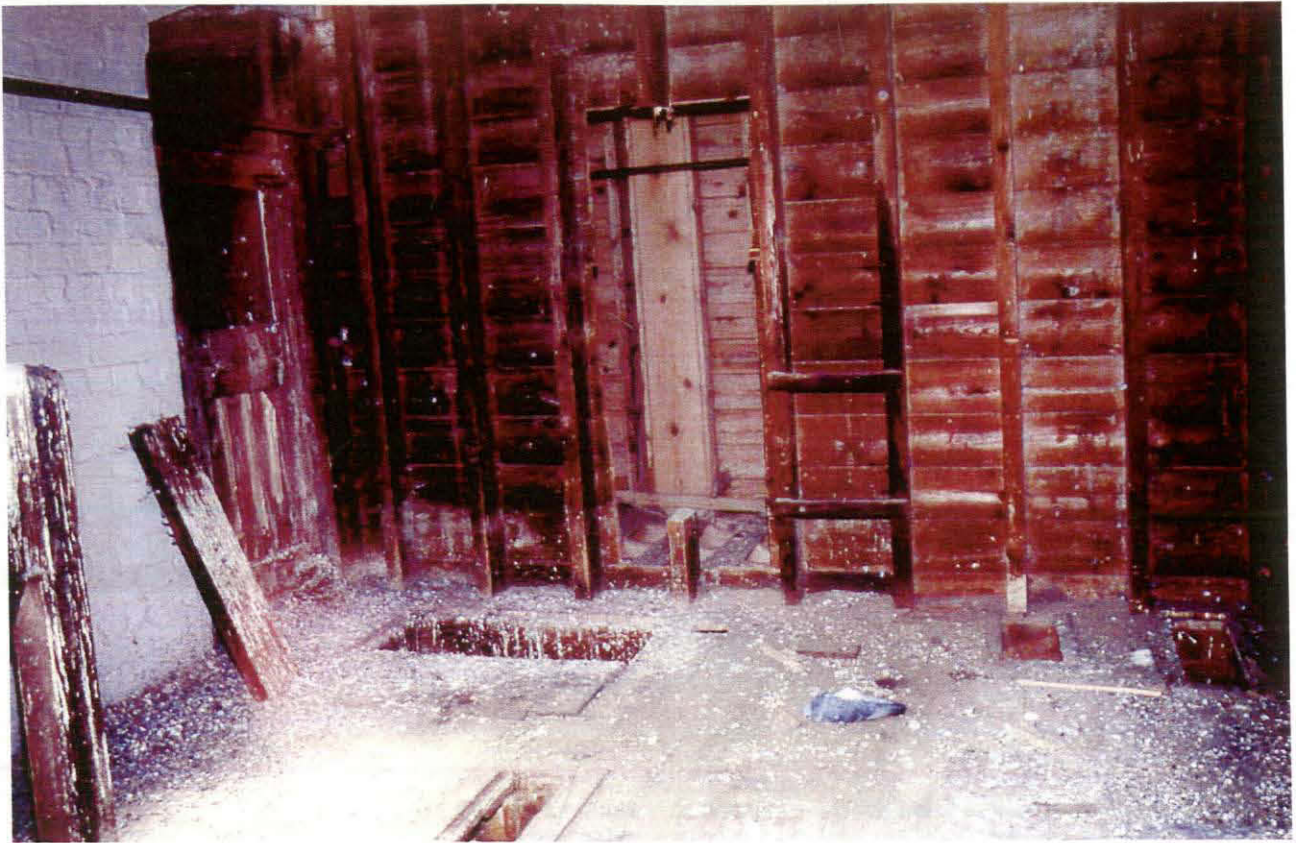
Plate 21 Mill southern part, 4<sup>th</sup> storey, showing trap door for sack hoist and elevator ducts

Trap doors for a sack hoist are evident on several levels of the southern part of the building, from the top floor down (Plate 21).

It is likely that the smaller, southern part of the building operated as the mill. This part of the building has much internal timber panelling/cladding. Passing through the floors, to storeys below, are several small ducts. These are the remnants of elevators that carried grain from the top floor through different levels of the mill to where grinding took place (cf Major 1975, pls 23, 24). Additionally, there is a sequence of trap-doors for a sack hoist, running through several levels of the building.

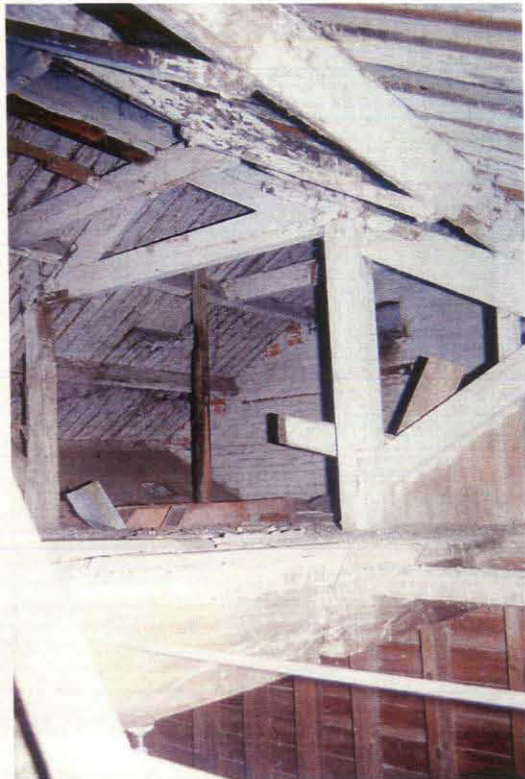
Plate 22 Queen post roof truss, mill southern part

At the very top of the southern side of the mill is an attic space. Within this attic is a displaced pulley wheel from the mill machinery. Queen post timber trusses support the attic roof (Plate 22).

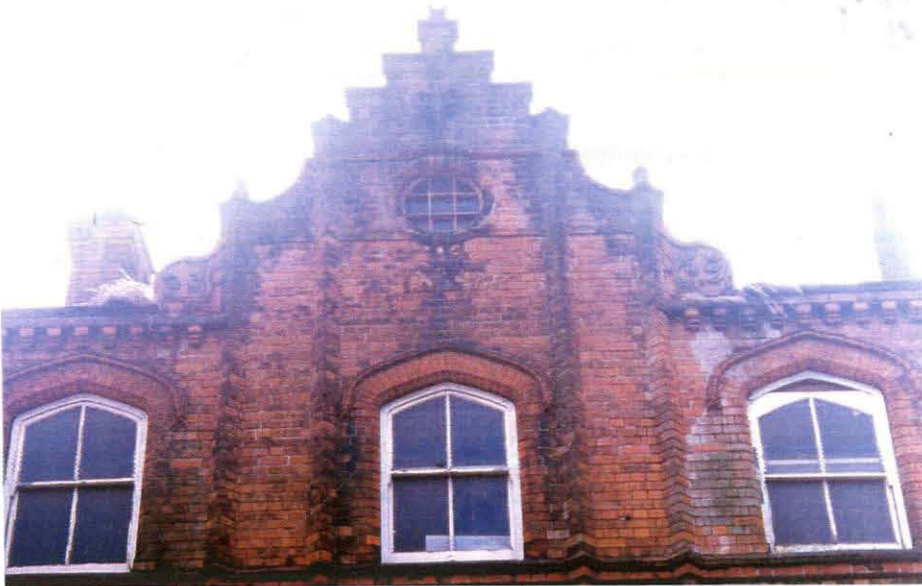
Plate 25 Boston  
Guardian, date marker in  
brick

This is a brick, three storey building of three bays. The central part of the façade extends above the eaves line to form a pseudo-gable. This is quite ornate and is in a hybrid form showing elements of shaped, Dutch and crow-stepped gables (Plates 23 and 24). The base of this is formed from large tiles moulded with floral scrollwork. A little below the apex of the pseudo-gable is a circular window and, beneath this, the construction date 1887 marked in bricks (Plates 24 and 25).

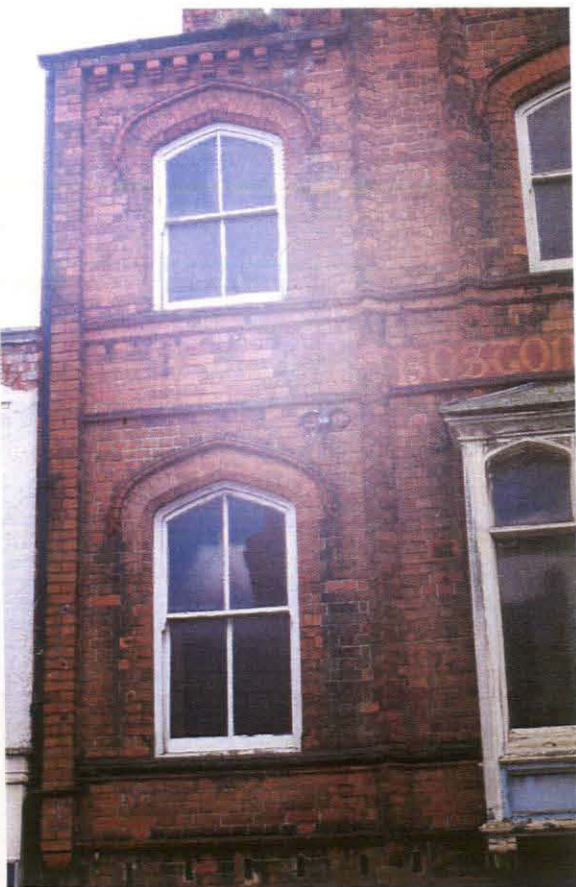
Plate 26 Boston Guardian  
building, windows with  
brick hood moulds

Below the eaves line, at second floor level, is a set of three windows with hood moulds in brick (Plate 26). These are all four-centred windows, as are those at first-floor level in the two outer bays. The central window on the first floor is an oriel window, made of wood. Above the oriel is the legend:

Located on the south side of West Street is the former Boston Guardian building. This newspaper operated between 1854 and 1958 (Wright 1986, 118). The façade of the building is quite ornate, with a hybrid shaped-cum-crow stepped pseudo-gable. This is perhaps intended to be a loose copy of the Dutch and other ornate gables evident elsewhere in Boston. An early, probable late 19<sup>th</sup>-early 20<sup>th</sup> century, illustration of the building indicates that

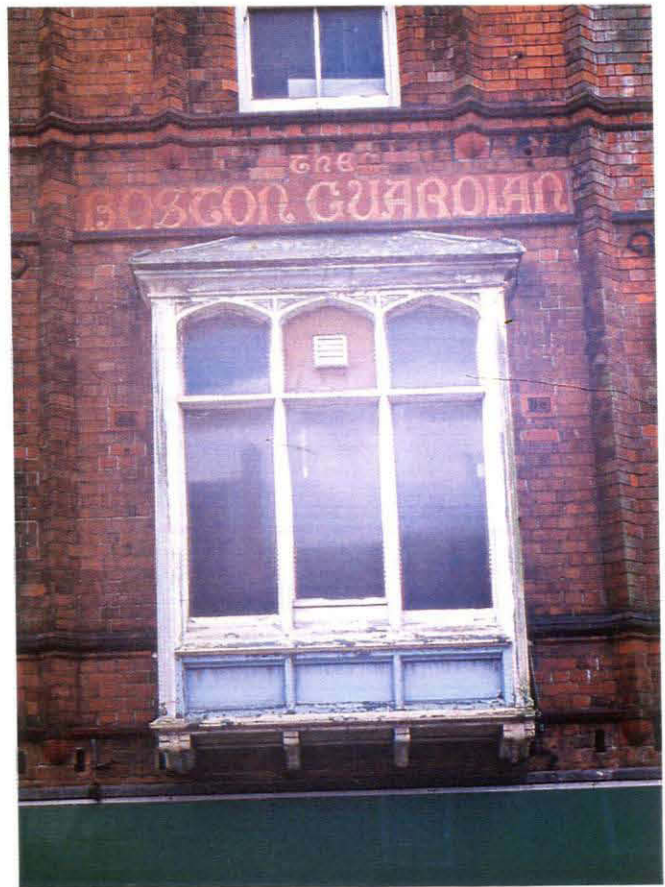
Plate 27 Boston Guardian building,  
showing name and first floor  
oriel window

The  
BOSTON GUARDIAN  
produced in ?encaustic tiles (Plate 27).
