**BUILDING ASSESSMENT AT  
10 IRONMONGER STREET,  
STAMFORD,  
LINCOLNSHIRE  
(SIS05)**

**Work Undertaken For  
John Martin and Associates**

January 2006

APS Report No. 8/06

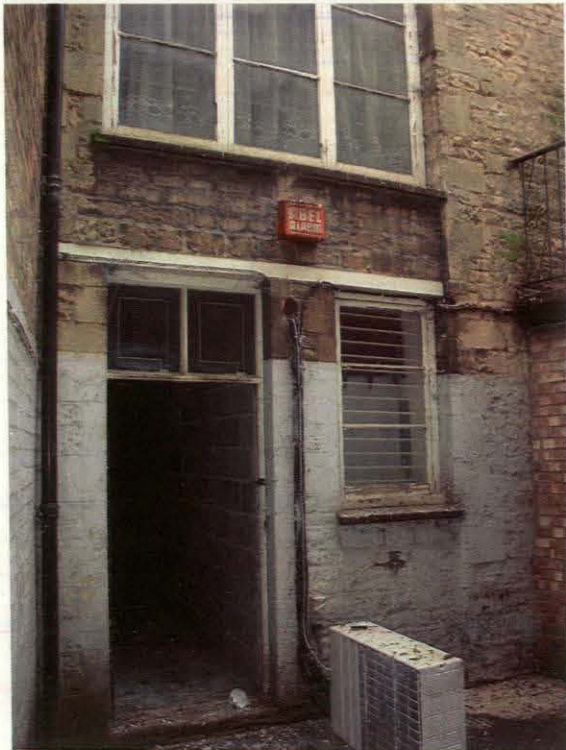
Facing the rear of 10 Ironmonger Street, the eastern elevation is predominantly of coursed limestone rubble with ashlar dressings. There is a straight join that rises to two storeys height and the façade south of this is slightly recessed (Plates 2 and 3). Within this recessed wall face are the door giving access to the structure, a narrow ground floor window and a large wide first floor window. Above the door is a rectangular fanlight. North of the straight join the elevation is mostly plain and partially obscured at ground floor level by a linking passageway. This passageway, between the assessed structure and the rear of 10 Ironmonger Street, is of late machine-made brick. There is a small window at first floor level north of the passageway.

Plate 2 Assessed Building, eastern elevation (southern part), looking west

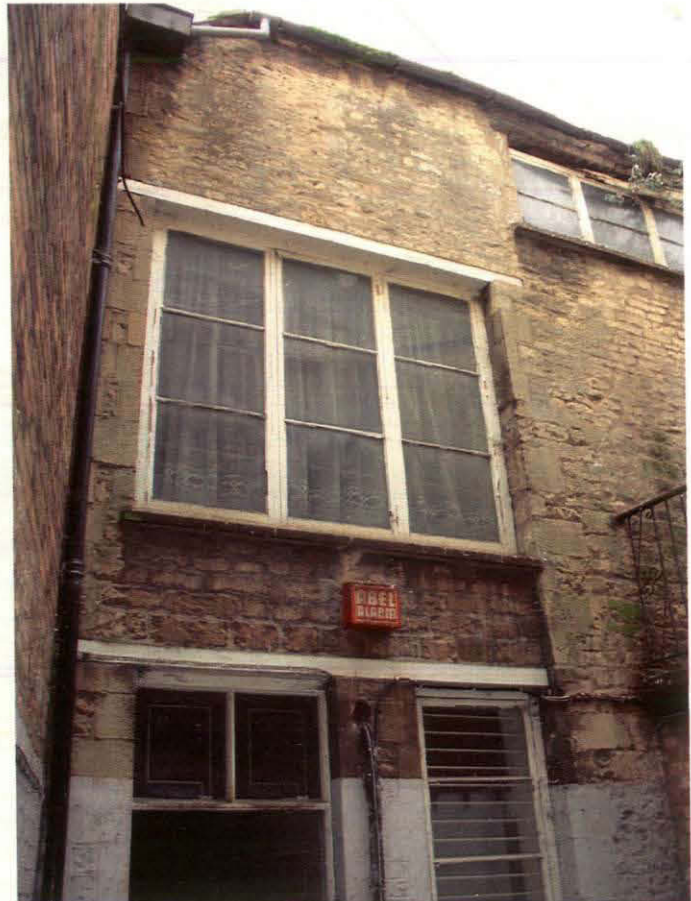
Plate 3 Assessed Building, eastern elevation, upper levels, looking west

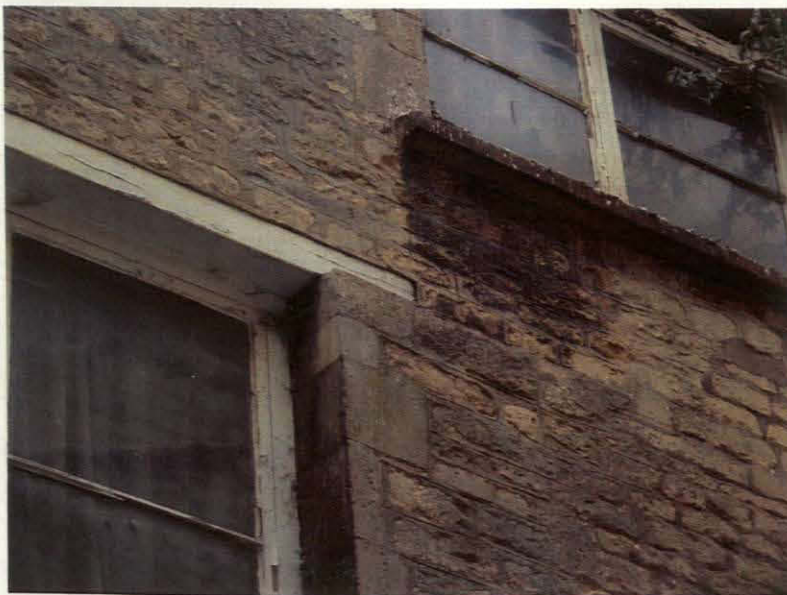
The straight join terminates directly beneath the lintel of the first floor window (Plate 4). At this point the entire 2<sup>nd</sup> floor elevation is in a single plane, with the section north of the straight join set back slightly and in line with that to the south. This section of the elevation is of coursed limestone rubble and contains a low, wide window placed just to the north of the straight join.

Plate 4 Assessed Building, eastern elevation showing straight join and offset of wall, looking northwest

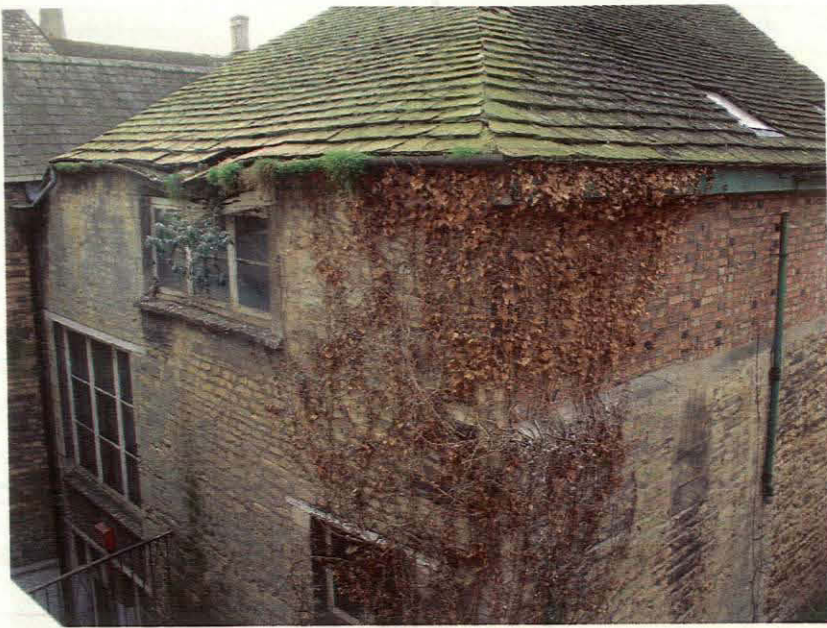
Ironmonger Street (Plate 5). This view indicated that the elevation was a plain wall of coursed limestone rubble to two storeys height, with the third storey (2<sup>nd</sup> floor) being of machine-made brick. This height raising in brick was slightly set back on the stone walling (Plate 6).

Plate 5 Assessed Building,  
eastern and northern  
elevations, looking south

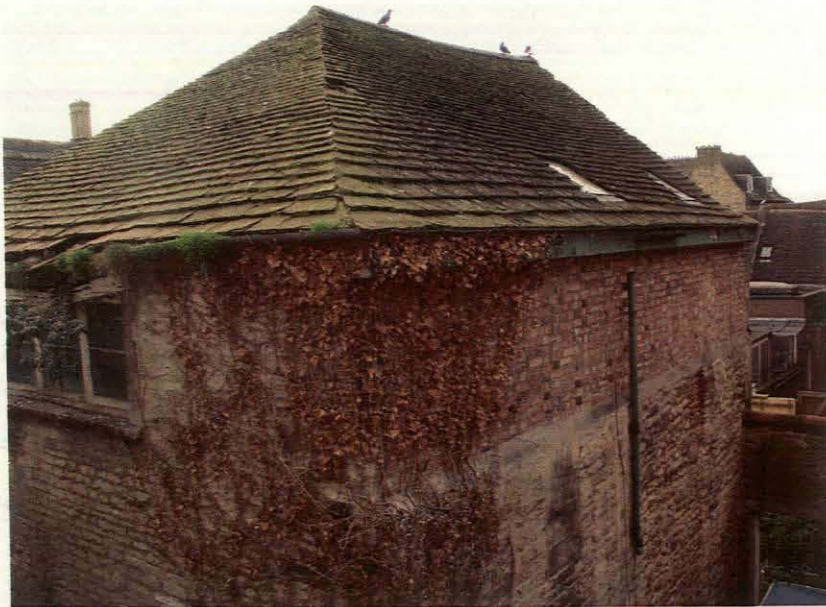
Clad with Collyweston slate, the roof is hipped (on the east side) and gabled. There are two skylights in the northern side of the roof (Plate 6).

Plate 6 Assessed Building,  
northern elevation, showing  
offset, looking southwest

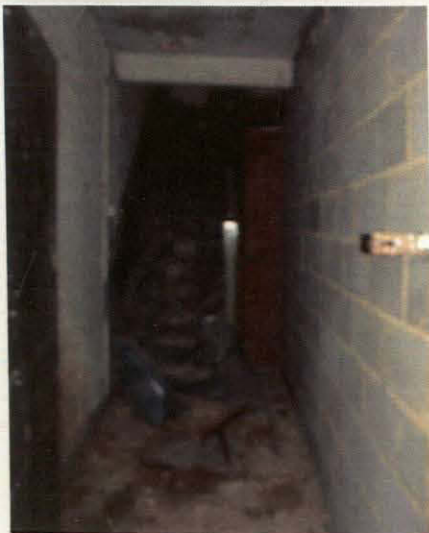
At ground floor level the only examined section of the building was the entry passage and stairwell on the south side of the building. There is modern machine-made brick dressing around the entry doorway and a recent breeze block wall forms the northern side of this passage. North of this wall is part of the Scrivens Opticians shop which is not included in the proposals for alteration and which was consequently not examined. At the end of the passage way is a set of wooden stairs up to the first floor (Plate 7).

Plate 7 Assessed Building,  
ground floor passage and  
stairwell, looking southwest

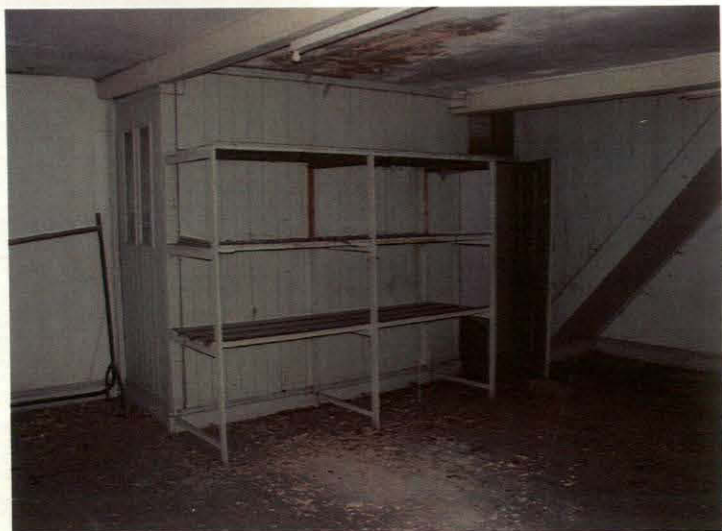
At the top of the stairs are a landing and a door giving access to the first floor room. The entire first floor is this single room, except the wooden compartment enclosing the stairwell (Plate 8). In addition to the windows in the east wall (evident from the exterior) there is a small window in the western elevation (Plate 9). Two beams cross the room north-south. These are both chamfered but straight cut.

Plate 8 Assessed Building, 1<sup>st</sup> floor, view toward stair  
compartment, looking south

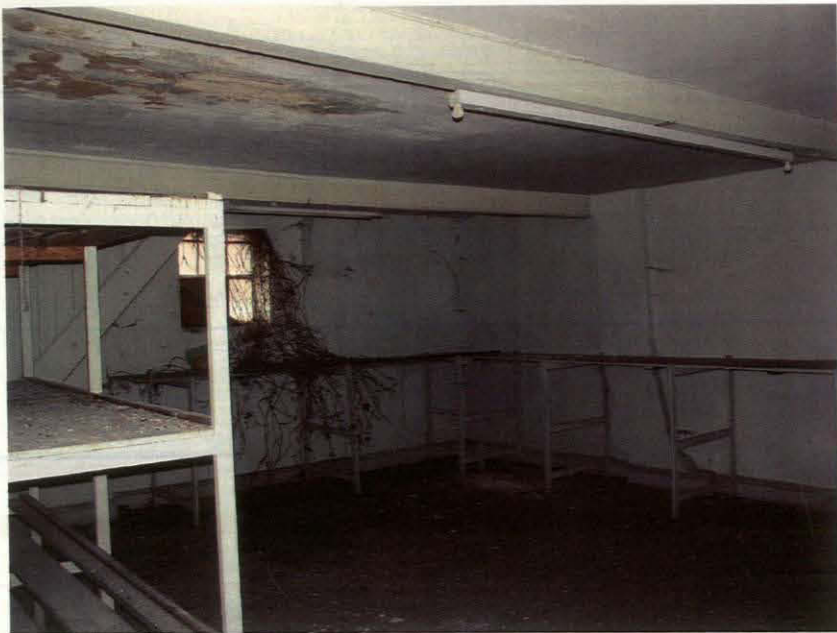
to the west of the chimney, is another projecting section. Although the west side of this is fairly vertical the eastern edge curves and narrows upwards (Plates 9 and 10). This is probably a further chimney, from a ground floor fireplace.

Plate 9 Assessed Building,  
1<sup>st</sup> floor, general view,  
looking west

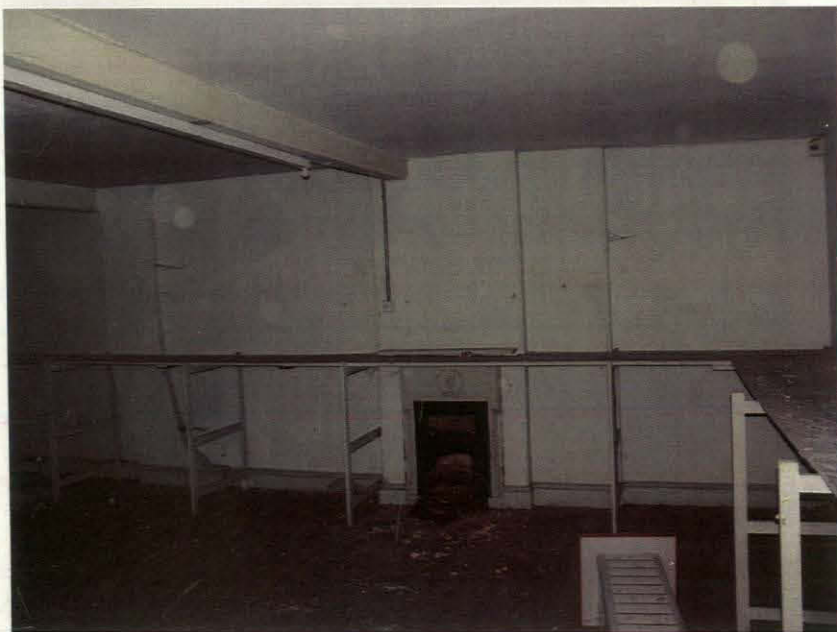
In the middle of the north wall is a cast iron fire range of perhaps late 19<sup>th</sup> century date set in a projecting chimney section. Directly alongside this to the east is another, but less prominent, projection (Plate 10).

Plate 10 Assessed Building,  
1<sup>st</sup> floor north side, showing  
fireplace, looking northwest

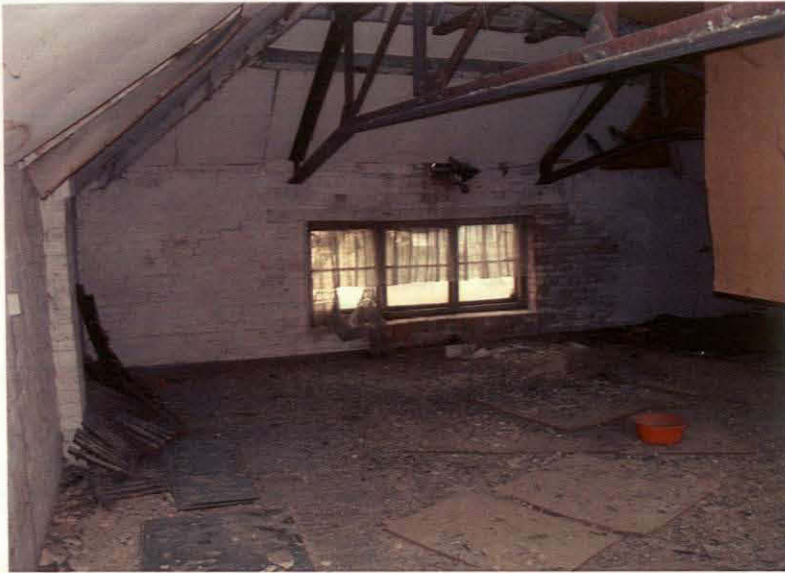
Plate 11 Assessed Building,  
2<sup>nd</sup> floor, view toward  
stairwell, looking southwest

From the landing a further set of stairs gives access to the second floor. Again a single open area, this is partially within the roof space of the building. Two steel trusses cross the room east-west (Plate 11). The walls are entirely of modern machine-made brick and incorporate plinths, some of which support the trusses or roof joists. In addition to the window in the east wall (Plate 12), evident from the exterior, there is a window in the western elevation (Plate 13). Just north of this western window, but close to the floor and partially covered by one of the brick plinths, is a recessed area, apparently a blocked window (Plate 14).

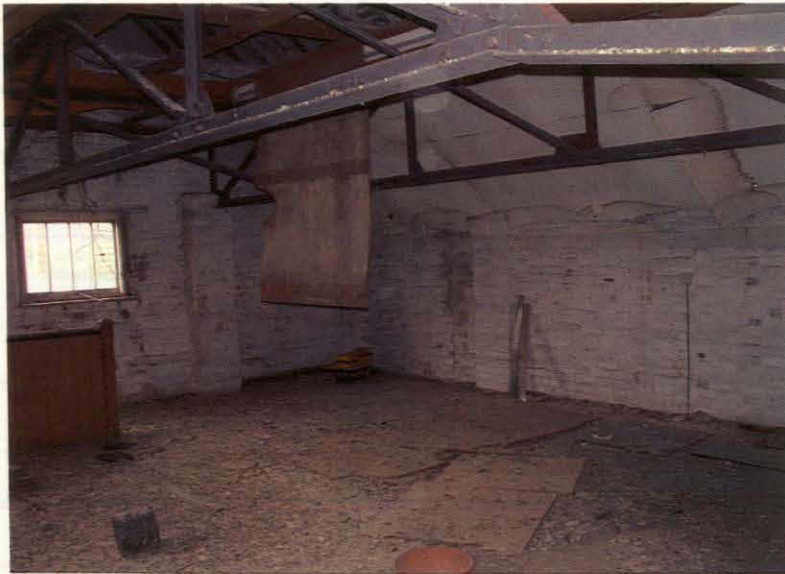
Plate 12 Assessed Building, 2<sup>nd</sup> floor, general view, looking east

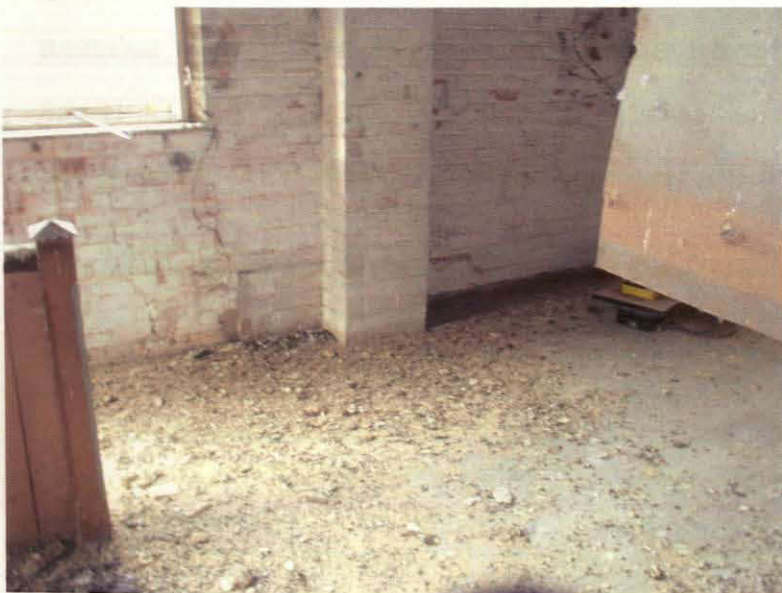
Plate 14 Assessed Building, 2<sup>nd</sup> floor, west side, showing blocked window crossed by floor and plinth, looking west

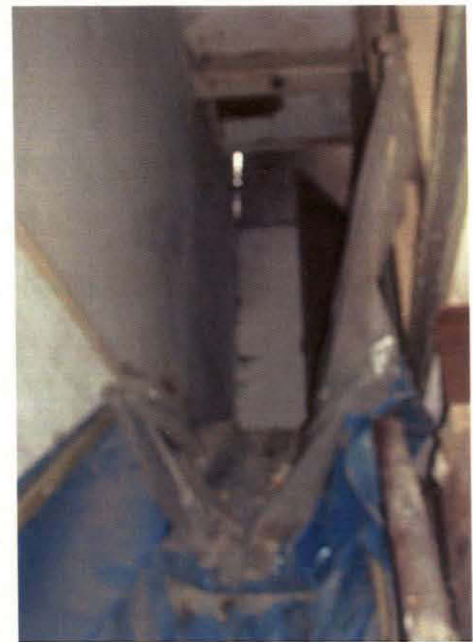
In the lower part of this second floor, the western elevation is separating from the south wall, resulting in a prominent crack at the junction through which daylight is visible (Plate 15).

Plate 15 Assessed Building, stairwell up from ground floor, showing separating walls, looking west
