**SURVEY OF BUILDINGS AT  
THE COTTAGE,  
35 HIGH STREET,  
OSBOURNBY,  
LINCOLNSHIRE  
(OHS 07)**

Work Undertaken For  
Mr A Joy

March 2007

A.P.S. Report No: 38/07

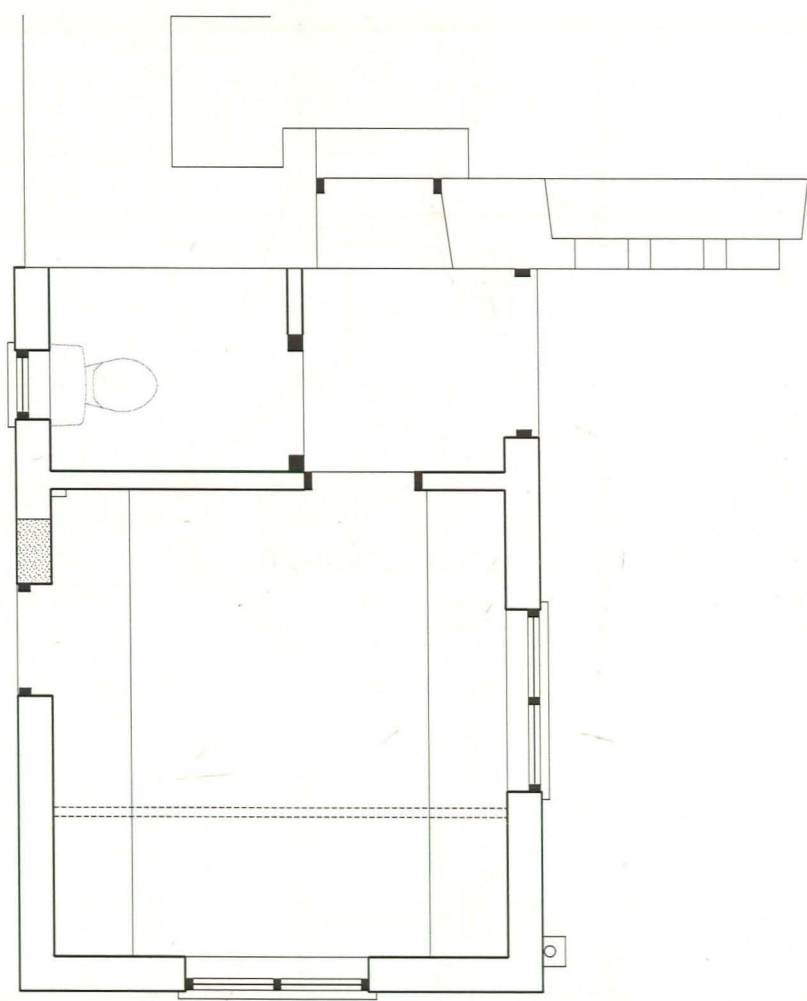
Figure 3 - Plan of the recorded building

The double-door facing west enters a rectangular lobby with access into the main building and to a toilet (Plate 5; Fig. 3) and a washroom. The floor is of quarry tiles and the walls are painted white.

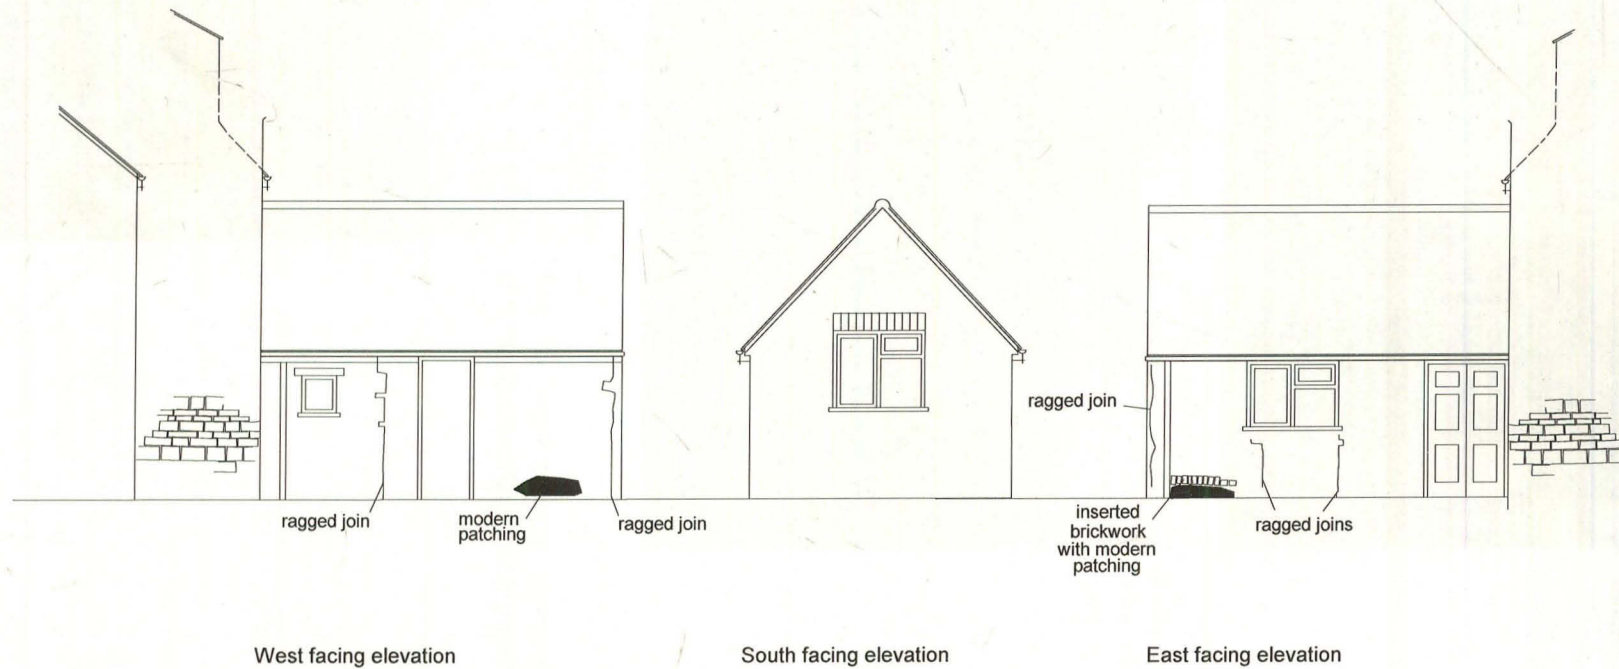
Figure 4 - Elevations of the recorded building

lies close to the southern edge of the structure and there is an area of recent patching close to ground level. North of this door is a small window with wooden lintel (Plate 2; Fig. 4).

The south facing gable end is plain and dominated by a central window which has a soldier course (upright bricks) across the lintel (Fig. 4). The bricks in this elevation are slightly larger and can be seen to tie in with the west and east facing walls. This would suggest that the gable end had been rebuilt.

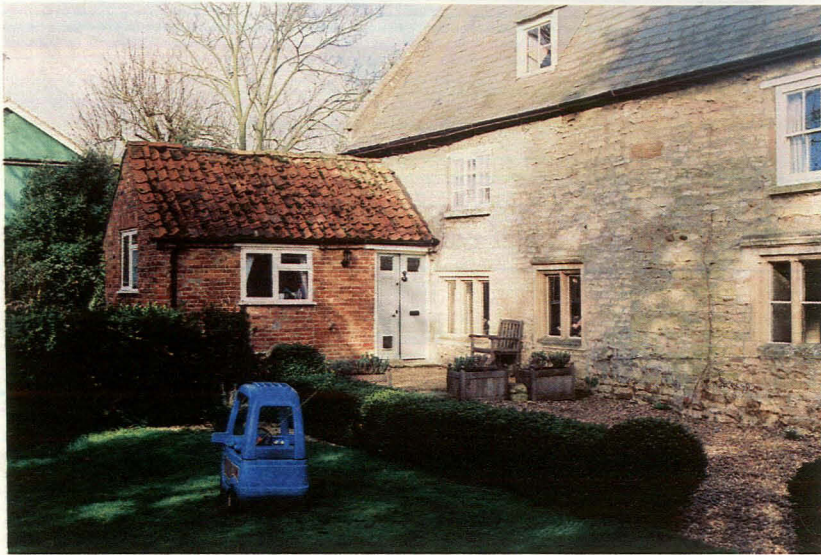
The recorded structure forms a rectangular extension to the rear (south) of the house and is located at the southwest corner (Plate 1).

Plate 1 - View showing the relationship between the extension and principal building at 35 High Street, looking northwest

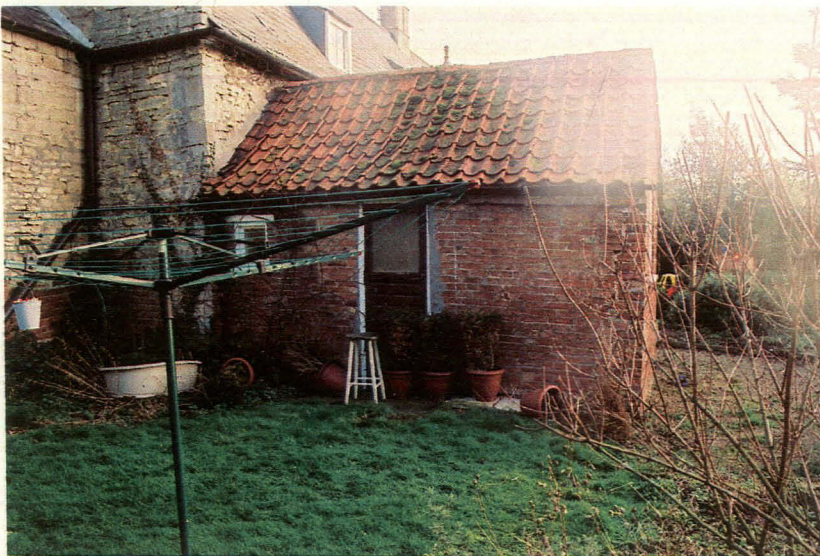
The west facing range has a central door which has been narrowed as evidenced by a ragged joint to the north. A ragged joint

Plate 2 - The west facing elevation showing narrowed doorway, looking east

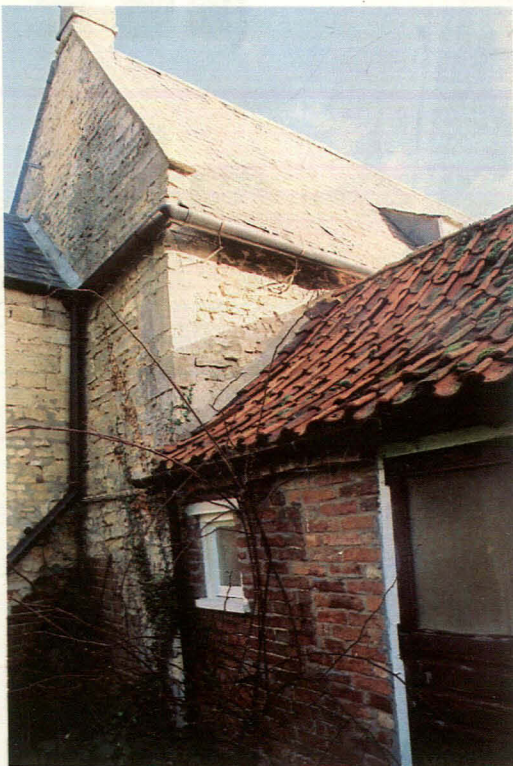
Plate 3 - Detail showing relationship between the extension and principal building, looking northeast

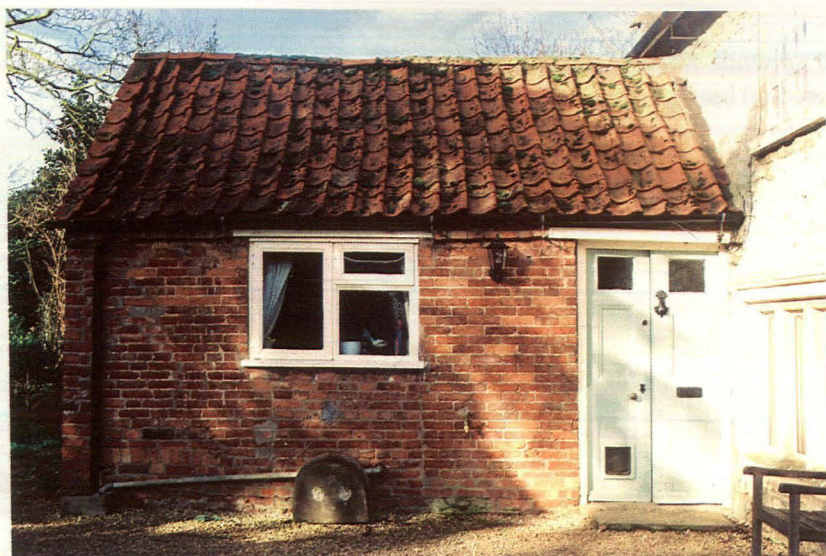
The east elevation has a double-door adjacent to the older cottage with a large window to the south. Ragged joints below the window suggest the window has been replaced or that the opening was formerly a door (Plate 4). Another ragged joint marks the rebuild of the south gable end. Close to the ground towards the south is a line of inserted headers above recent patching which may suggest that this feature ran through the width of the building.

Plate 4 - The east facing elevation showing modern patching to left of picture and ragged joins below the window, looking west

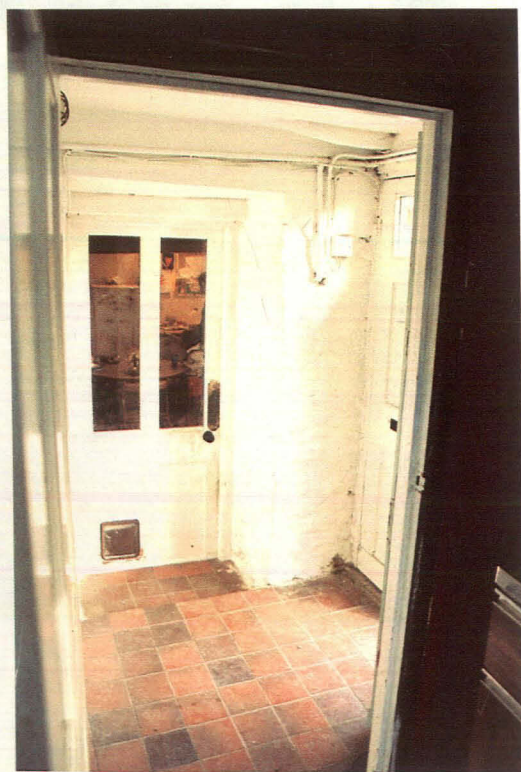
Plate 5 - View showing the lobby area, with door to main cottage in the background, looking north

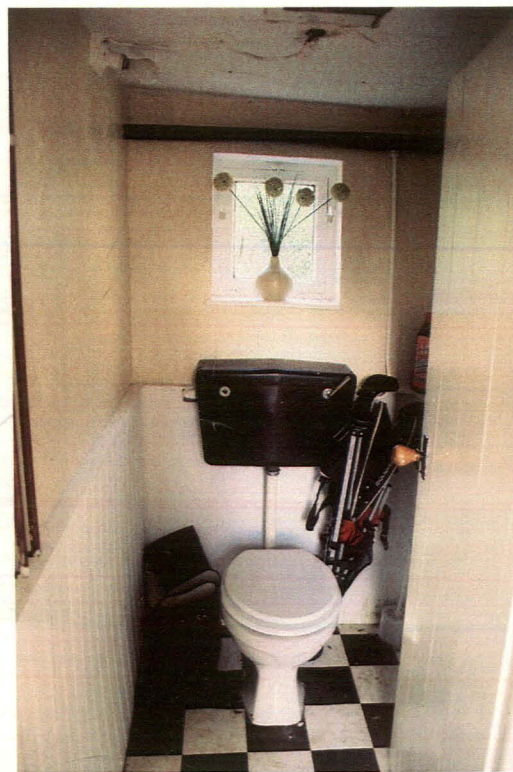
The small toilet room has wooden panelling around the lower half (Plate 6). There is a suspended plywood ceiling. The floor is of vinyl tiles.

Plate 6 - View showing the small toilet, looking west

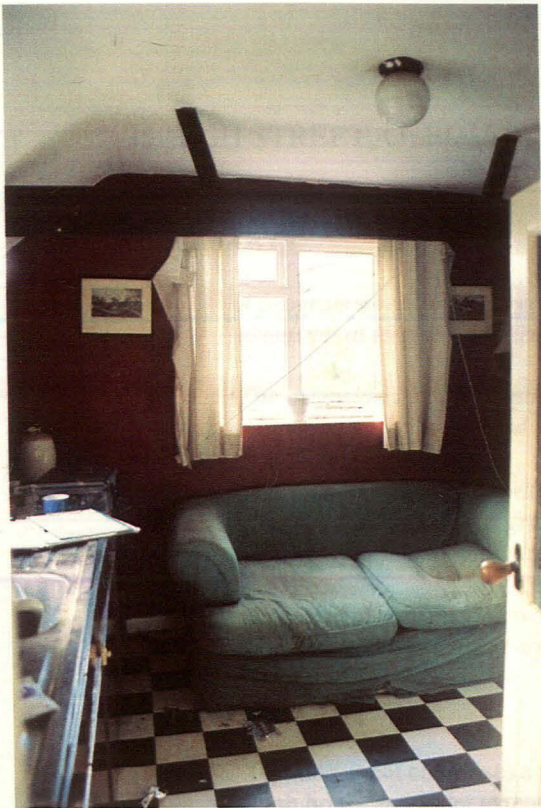
The largest room is in the southern part of the building (Plate 7). This has a similar vinyl tile floor to that in the toilet. The ceiling is higher, exposing a tie-beam with metal clasps (Plate 8) and the slope of the roof. The tie-beam supports two raking struts.

Plate 7 - View showing the larger room within the extension with exposed tie-beams and raking struts, looking south

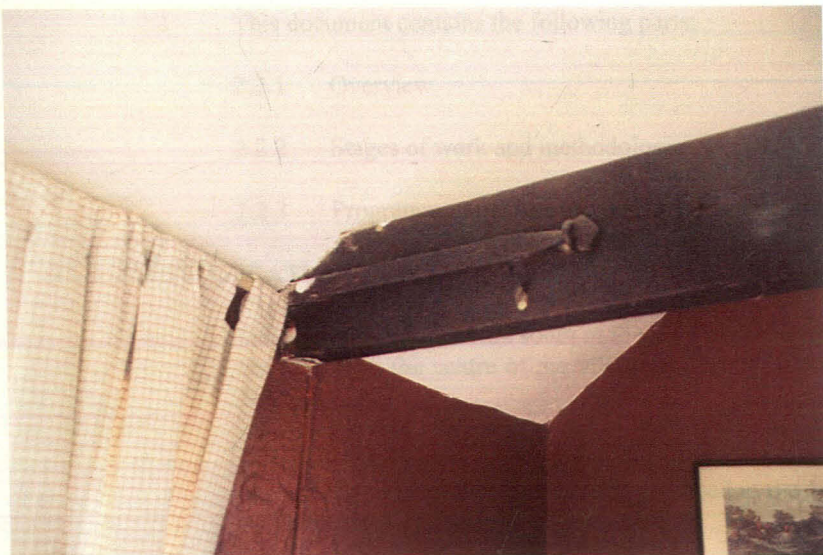
Plate 8 - Detailed view of the tie-beam showing metal clasp
