**Cowbit Signal Box, Spalding
Building Survey**

**LAS Report No: 860
September 2005
(Revised November 2006)**

Cowbit Signal Box, Lincolnshire Building Survey

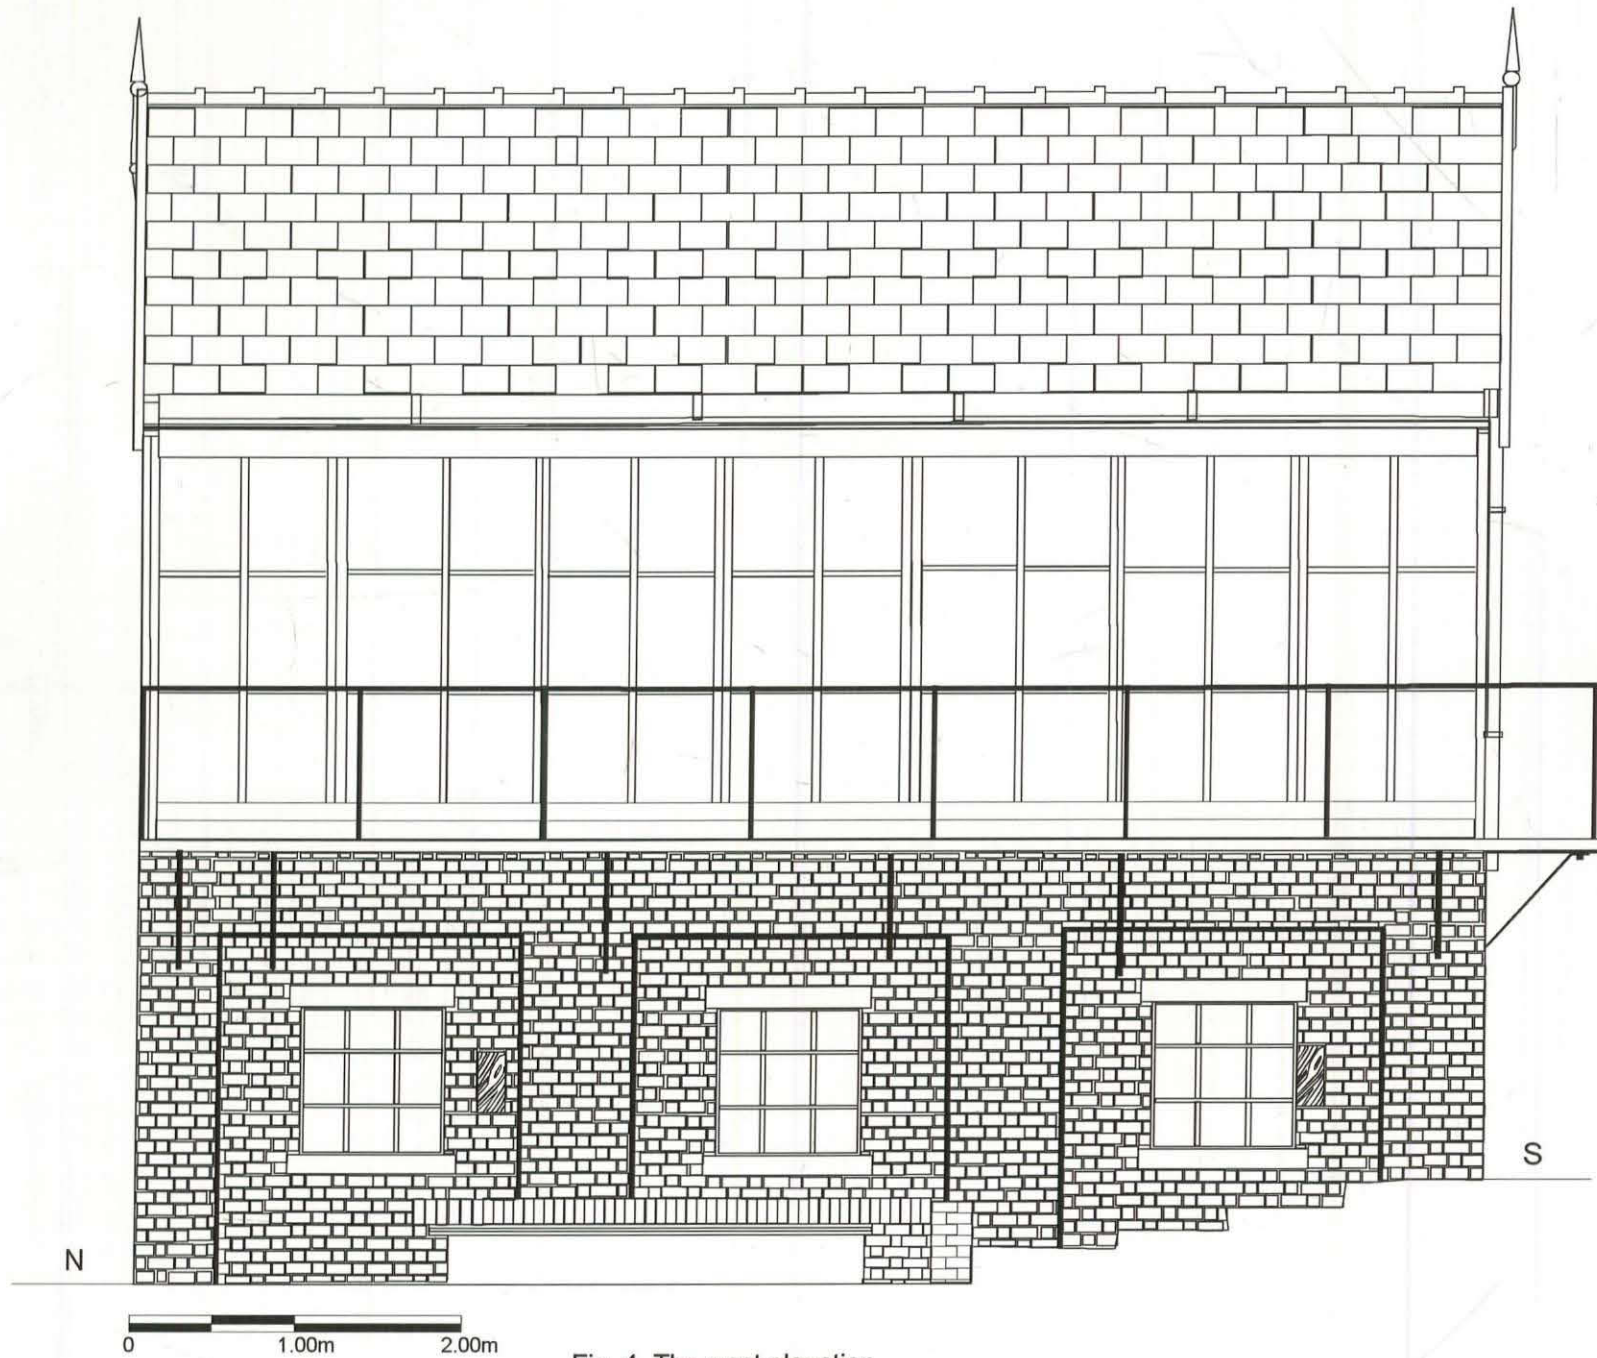
Fig. 4 The west elevation

The western elevation faces the railway line with the platform and station building in front of it. It has a brick lower floor and glass fronted upper floor (Pl. 3 and Fig. 4). There are three ground floor windows in recessed brick panels defined by projecting pilasters. The windows have nine small panes and all have sandstone lintels and painted sandstone sills.

The upper storey comprises seven glazed panels, each one with six panes. The panels at each end slide open giving access to the balcony which runs the full length of this elevation and continues around the south and western sides of the building. The pine plank walkway is supported on six cast-iron brackets with cast-iron railings. The planks are secured to the frame with large bolts (Pl. 4).

Two large oak timbers protrude through the wall at ground level. These timbers are the ends of the lever frame that holds the internal signalling mechanism (Fig. 4). Corresponding ends can be seen in the eastern elevation.

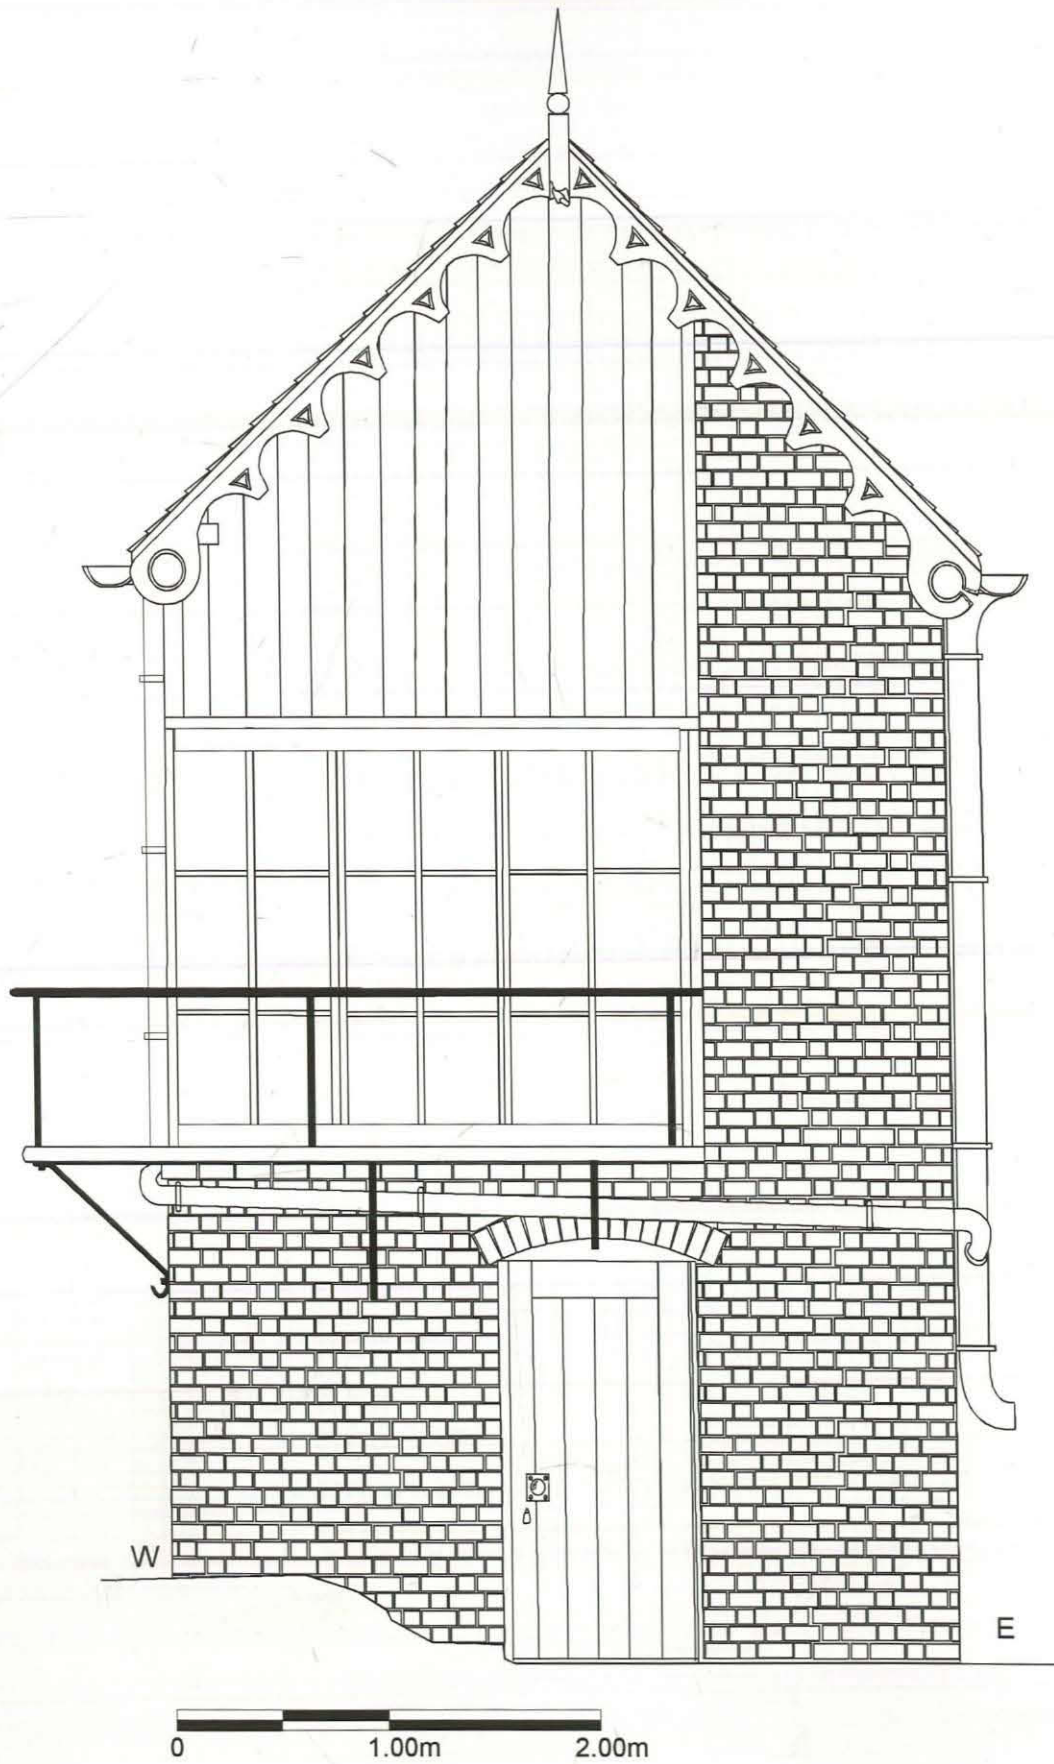
Fig. 5 The south elevation

The lower part of the south gable and the upper east side is constructed in brick. The remainder of the upper floor comprises three window panels, the same size as seen on the west elevation, each one separated into six single panes (Pl. 5, Fig. 5). The windows do not slide or open. The first floor balcony continues around the south side of the building, to the end of the windows. Above the windows pine tongue and groove panelling runs to the apex of the roof. The ornate fretted pine bargeboards (fixed beneath the eaves of a gable to cover and protect the rafters) each consist of six semicircular sections with triangular spacings and circular terminals. The terminal to the east shows slight damage due to shrinkage and cracking in the wood. The finial is also damaged with the entire lower half missing.

A drainpipe runs beneath the balcony connecting the downpipe on the west elevation to that on the east. A single door at ground level provides the only access to the interior of the building. The door lintel is of common red brick stretchers. The only furniture on the door is a bakelite knob, brass key escutcheon and swing cover. A series of steps lead up the slope from the doorway, towards the platform, to the west. These have been buried, but continue around to the western side of the building.

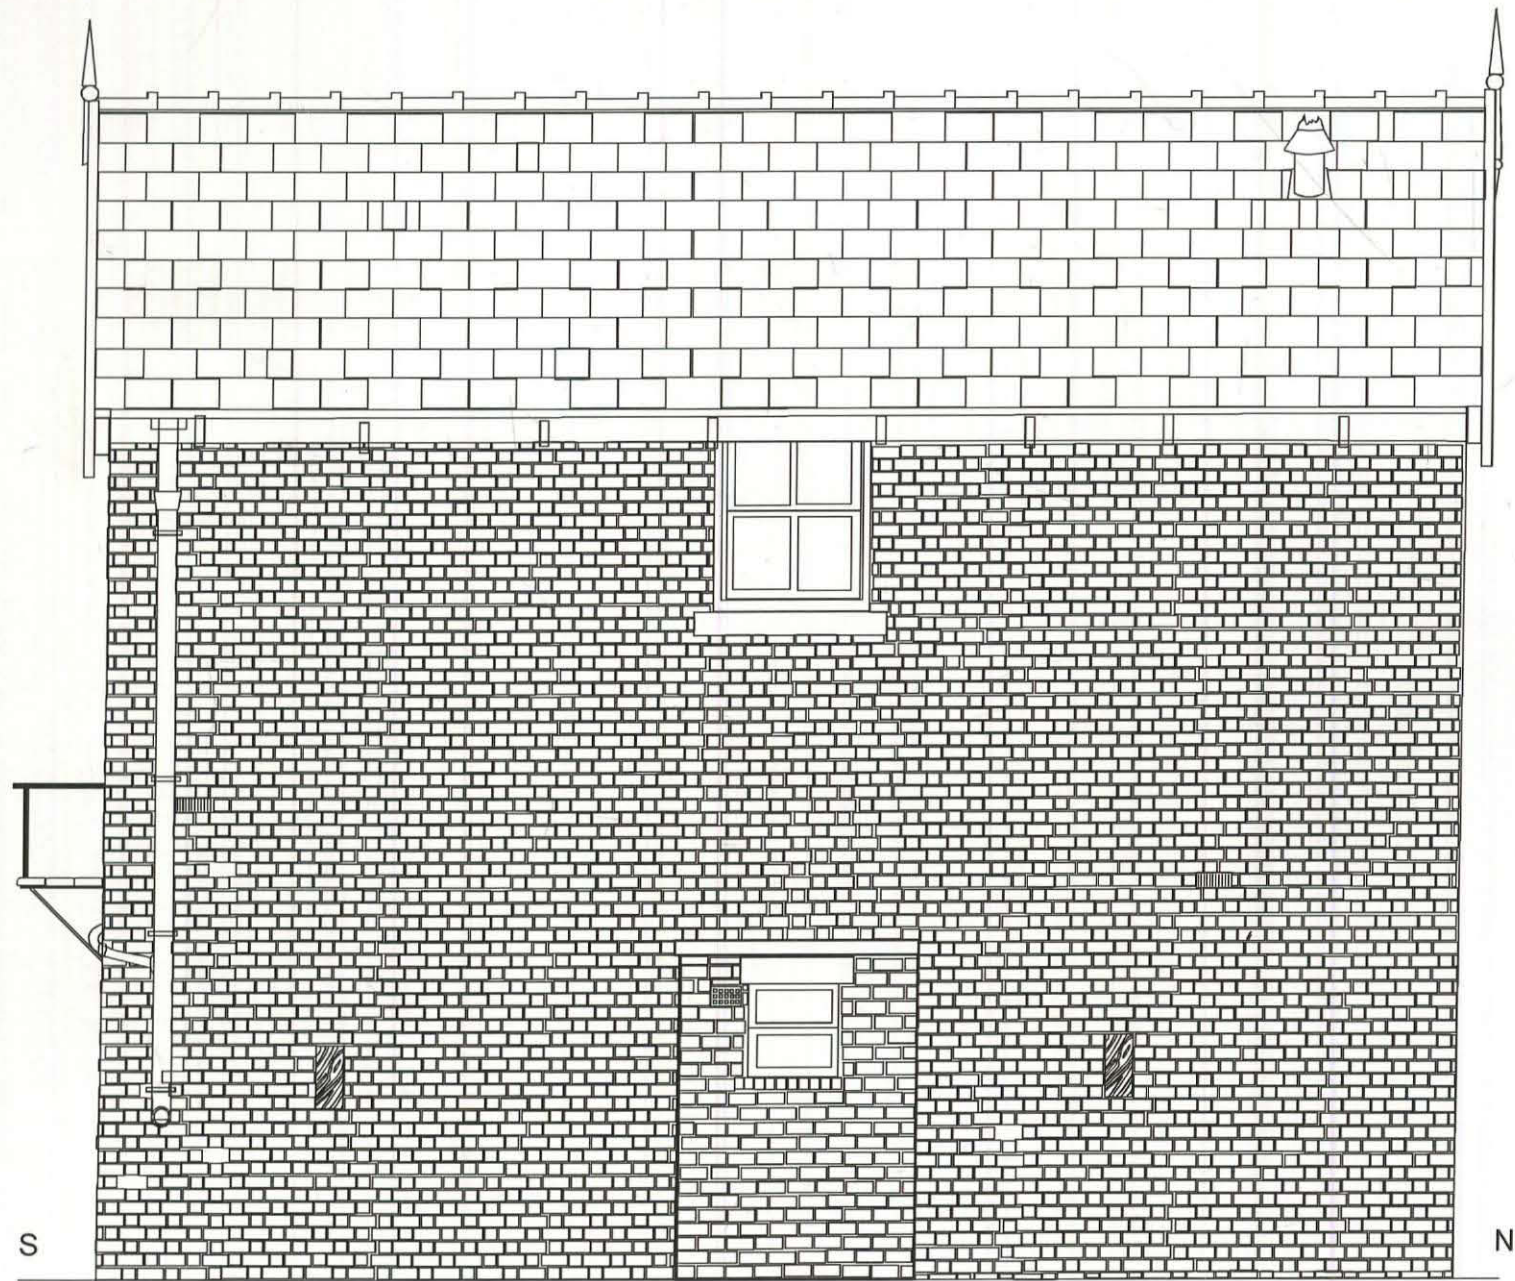
Fig. 6 The east elevation

This elevation forms the rear of the building and is of brick construction throughout (Pl. 6). There are two cast iron air vents incorporated into the courses (Fig. 6). There is a small four-pane window in the centre of the elevation just below the eaves. It has a vertical sliding sash pine frame in good condition that opens from the bottom upwards. The lintel and sill are sandstone, painted grey to match the window surround. The lintel and sill do not show any tool marks, but the underside of the lintel has regular circular scoring indicating it has been sawn using a machine-operated circular saw.

The rainwater guttering and drain pipe are cast iron. The downpipe runs down the southern corner of elevation and is linked to the downpipe on the west elevation by a single pipe which crosses the south gable just above the door lintel.

Two large wooden beams protrude through the wall of the lower floor. These beams are the ends of the oak frame that holds the internal lever mechanism; corresponding beam ends can be seen in the western elevation (Fig. *).

The gutter boards are of pine in good condition with the cast iron guttering attached by eight iron brackets, as on the west elevation. Although the guttering is overgrown with moss and weeds it is in surprisingly good condition with no apparent cracking.

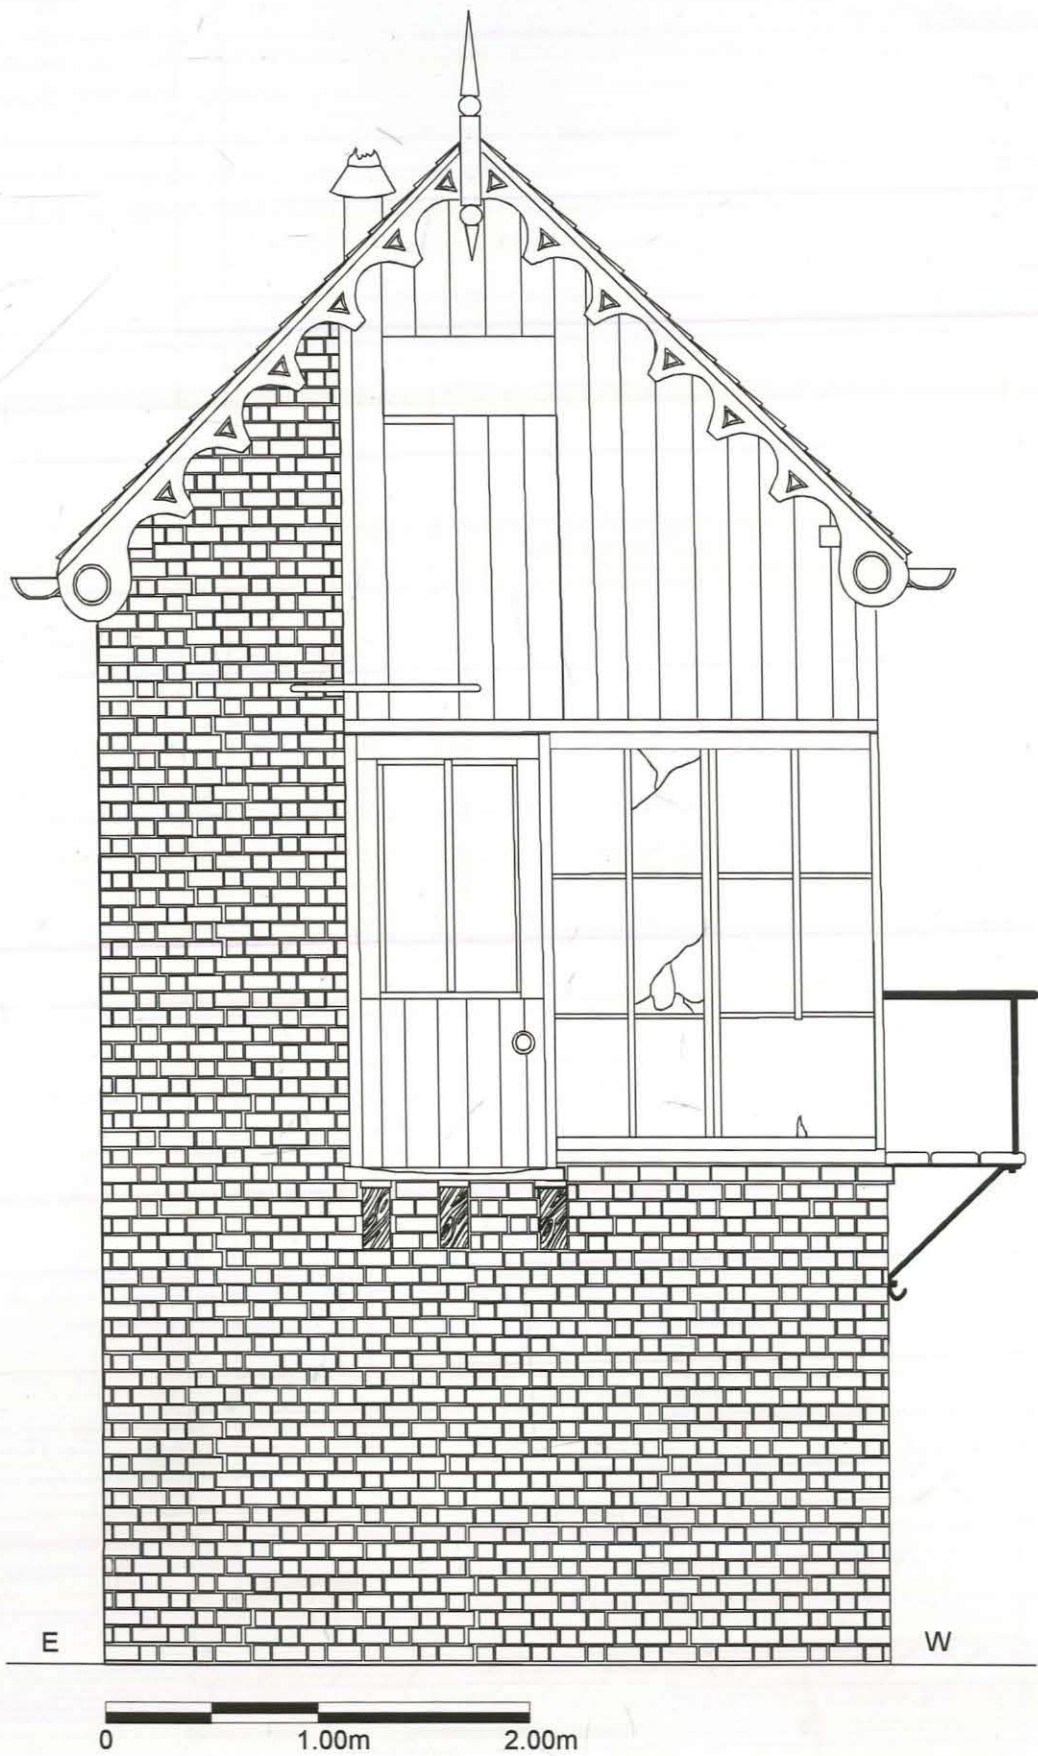
Fig. 7 The north elevation

The north elevation is almost a mirror of the south gable in construction with the lower half and west side of the upper storey being built in brick (Pl. 7, Fig. 7). There are two window panels on this elevation with six panes in each. The windows do not slide or open and several are cracked or broken. The sill is supported by a slightly protruding row of brick stretchers. Above the windows pine tongue and groove panelling runs up to the ridge. Some of the panelling is missing, exposing the reverse of the interior panels. A tongue and groove pine door, with glass upper panels, is located immediately to the west of the windows, and originally provided access to the first floor. The door has a bakelite knob and brass keyhole escutcheon. At the time of the survey the door was not in use as the wooden staircase that led up to it from ground level had been removed. The only surviving evidence for the staircase is the sawn off ends of three pine joists that protrude through the wall beneath the first floor door. The balcony does not continue round this elevation, presumably because the staircase would have been in the way

There is a small three-pane window above the door inside the building, but this has been boarded over on the exterior. The bargeboards and finial are identical to those on the south elevation but are in better condition.

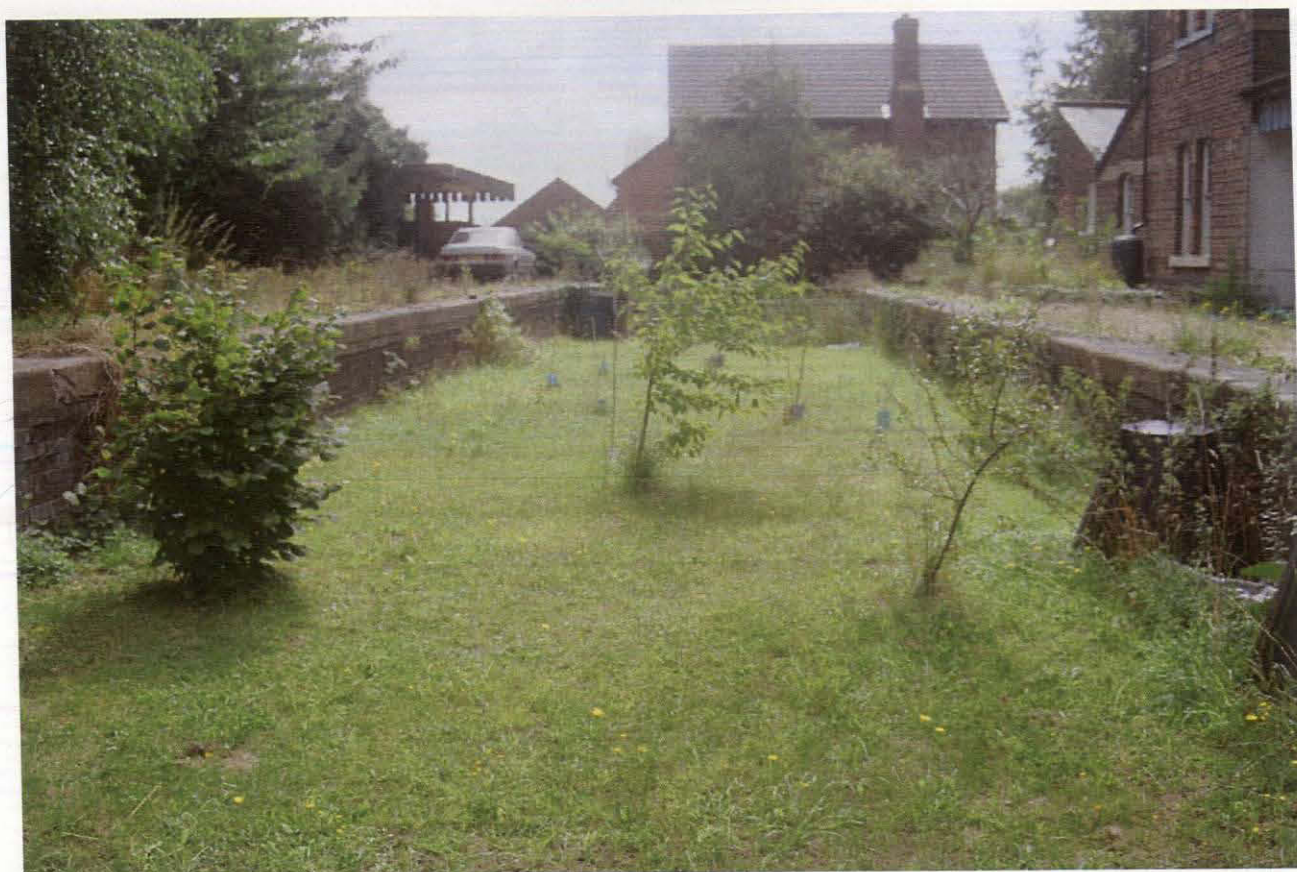
Immediately to the west of the signal box the original station building has been converted into housing and stands on the western side of the platform. The track between the two platforms now forms a turfed area and sunken garden (Pl. 1). The platform is mostly overgrown, but in the areas where grass and weeds do not occur it can be seen that the platform is paved with blue engineering brick faced along the edge with granite blocks. Both sides of the platform still survive and are constructed from red brick.

Pl. 1 The former railway line and station platforms to the immediate west of the signal box

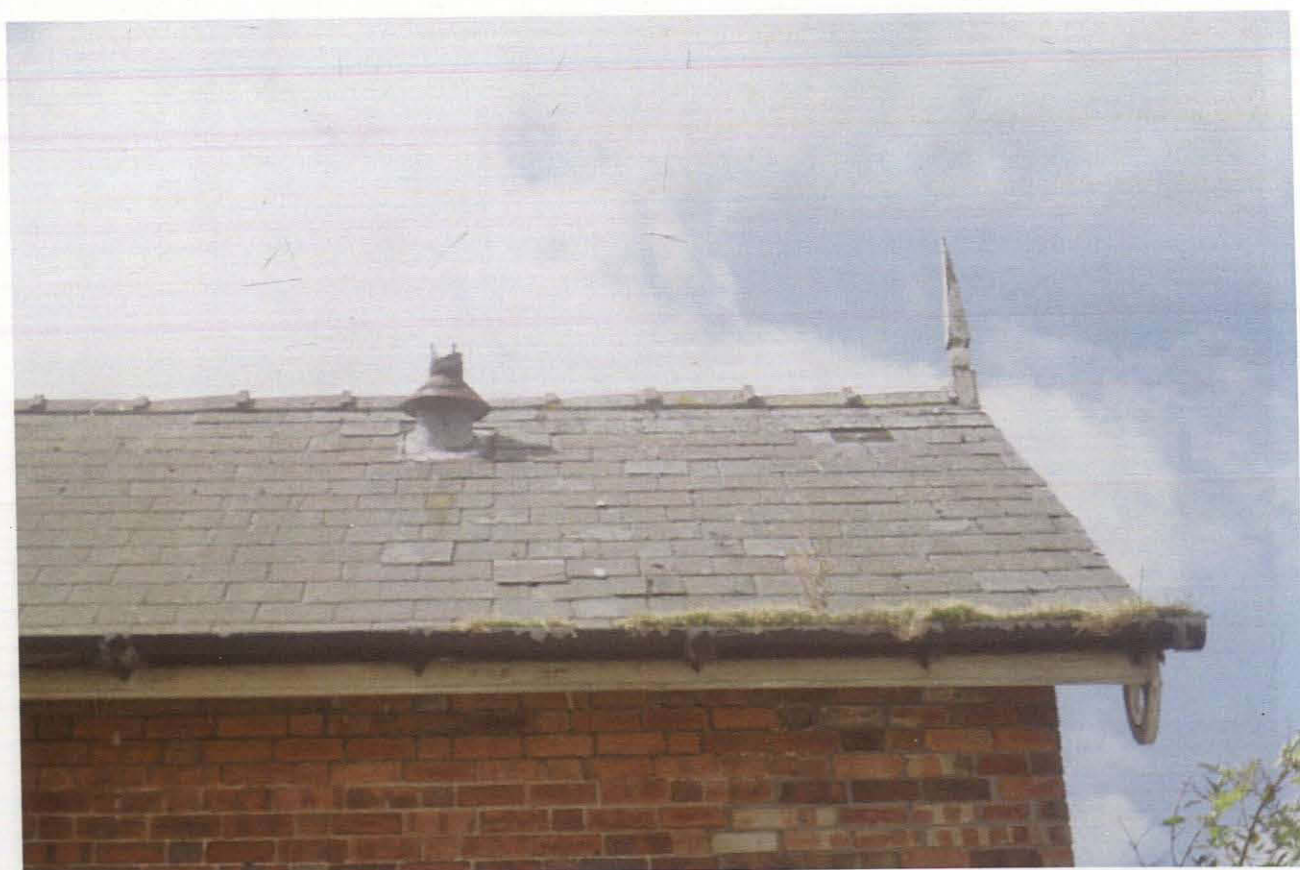
Cowbit signal box is now in a neglected condition, but appears structurally sound and still retains many original features, both internally and externally. The building is an ivy covered two-storey construction with a brick lower floor and a half-brick, half-timber upper floor. The brickwork is in Flemish bond. The Welsh slate roof appears to be in good condition, with the exception of several slates that have slipped. The interlocking blue ridge tiles are all present and are typical of those found on many 19th century buildings. A single galvanised steel chimney flue protrudes through the roof on the eastern side with lead flashing forming a seal. The chimney coating has weathered away leading to rust and rapid deterioration of the flue itself (Pl. 2).

Pl. 2 The roof, finial, guttering and chimney flue on the eastern side of the signal box

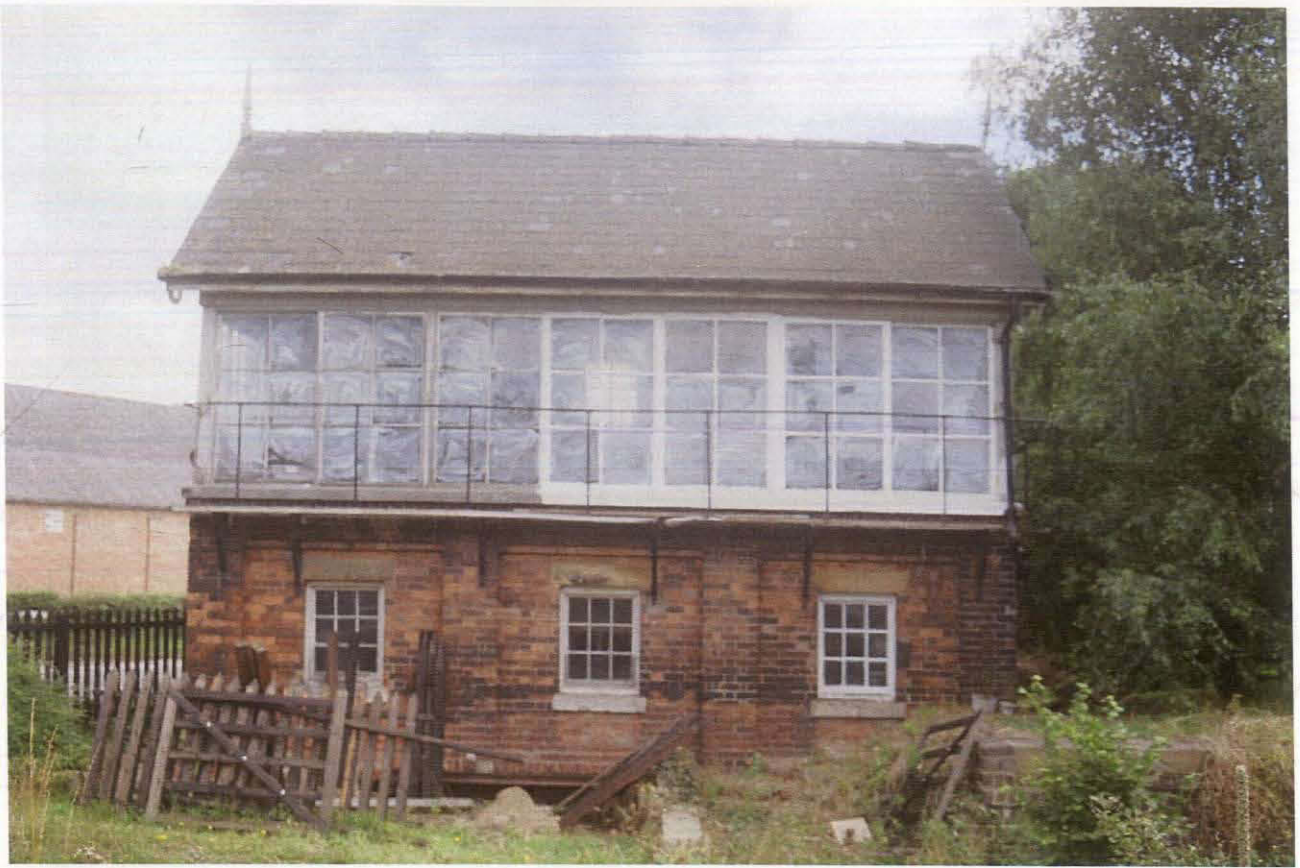
Pl. 3 The west elevation

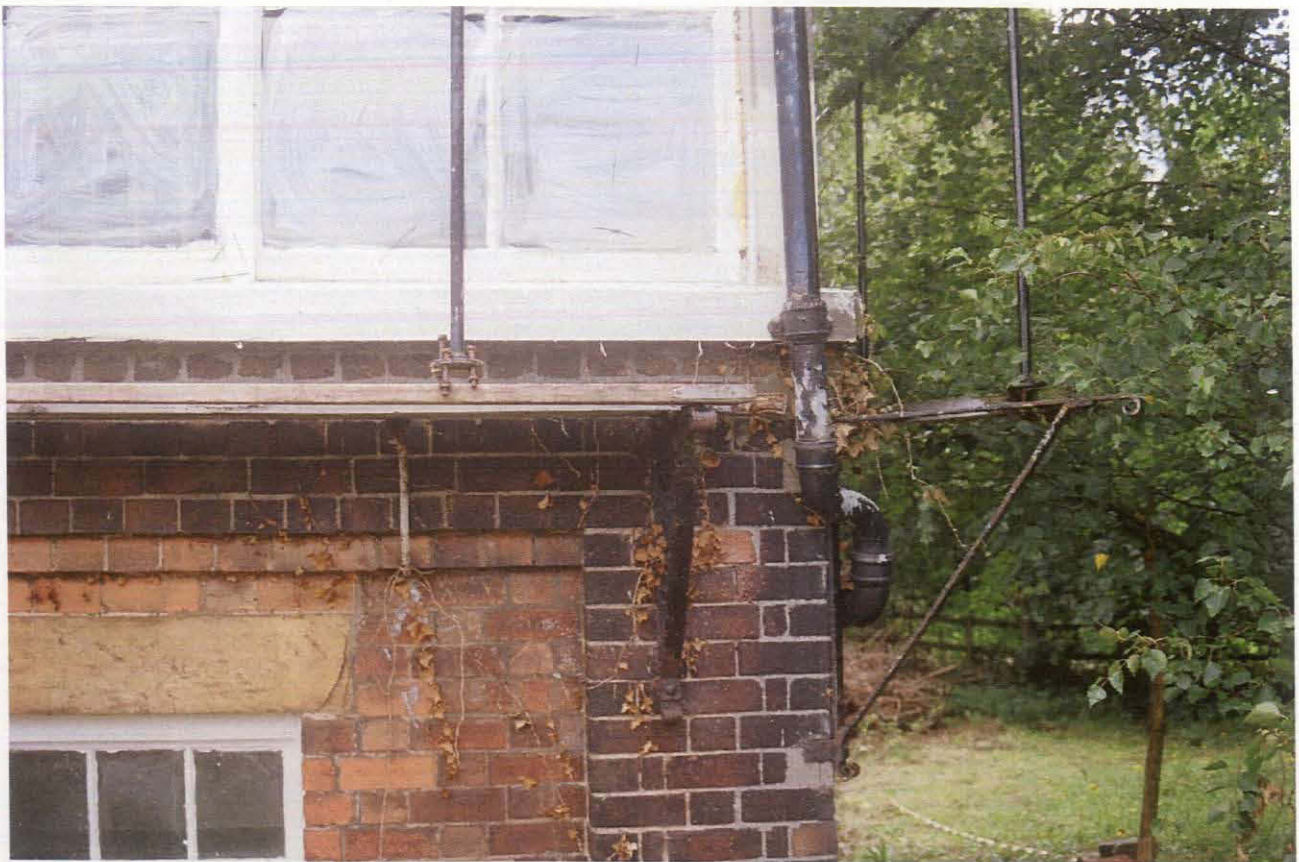
The gutter boards are of pine in good condition with the cast iron guttering attached by eight cast-iron brackets. The down pipe at the south end of the elevation turns along the south gable just below the platform to meet the downpipe on the east elevation (Pl. 4).

Pl. 4 The west elevation detail showing the cast iron down pipes, recessed window, glazing and balcony on the south-western corner of the building.

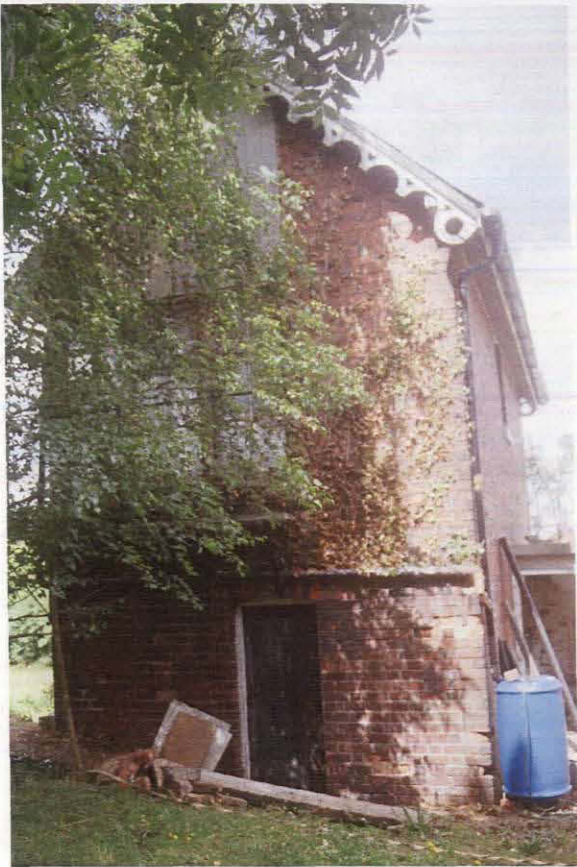
Pl. 5 The south elevation

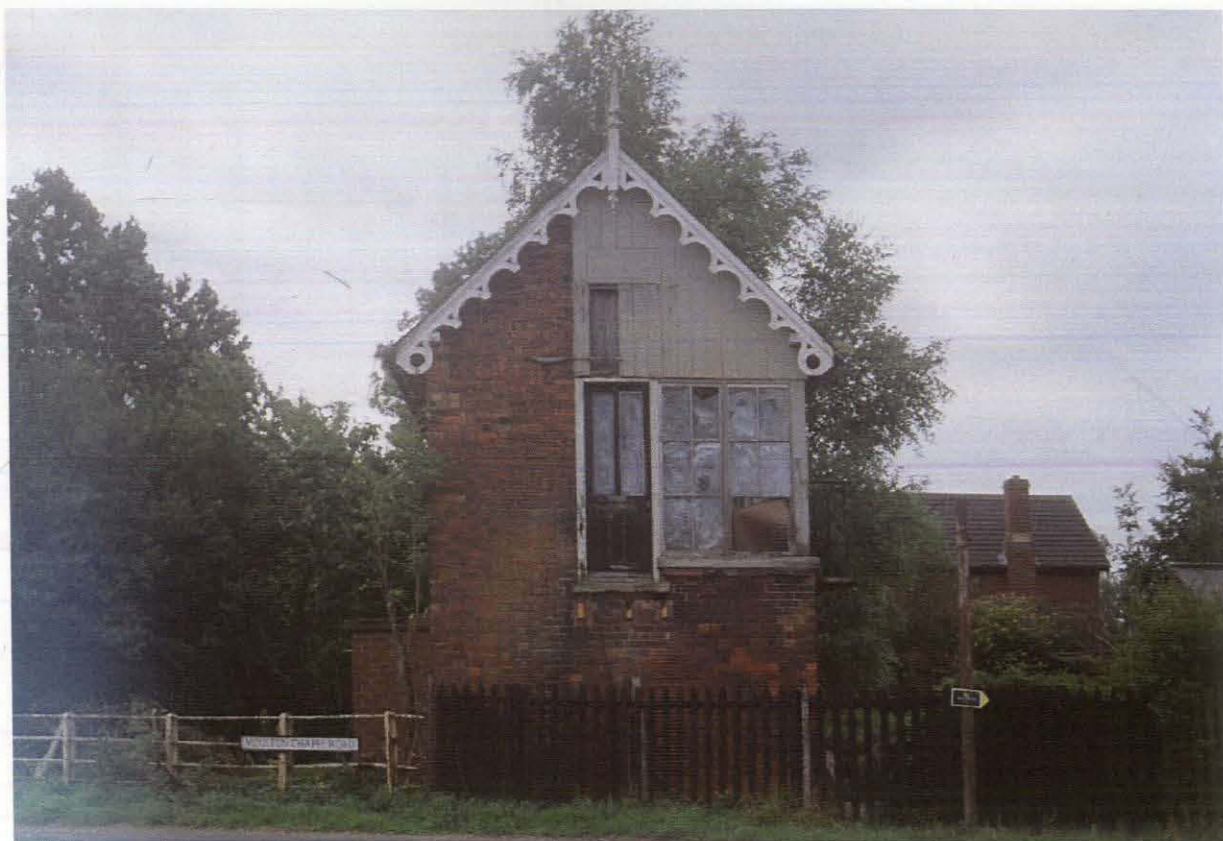
Pl. 7 The north elevation

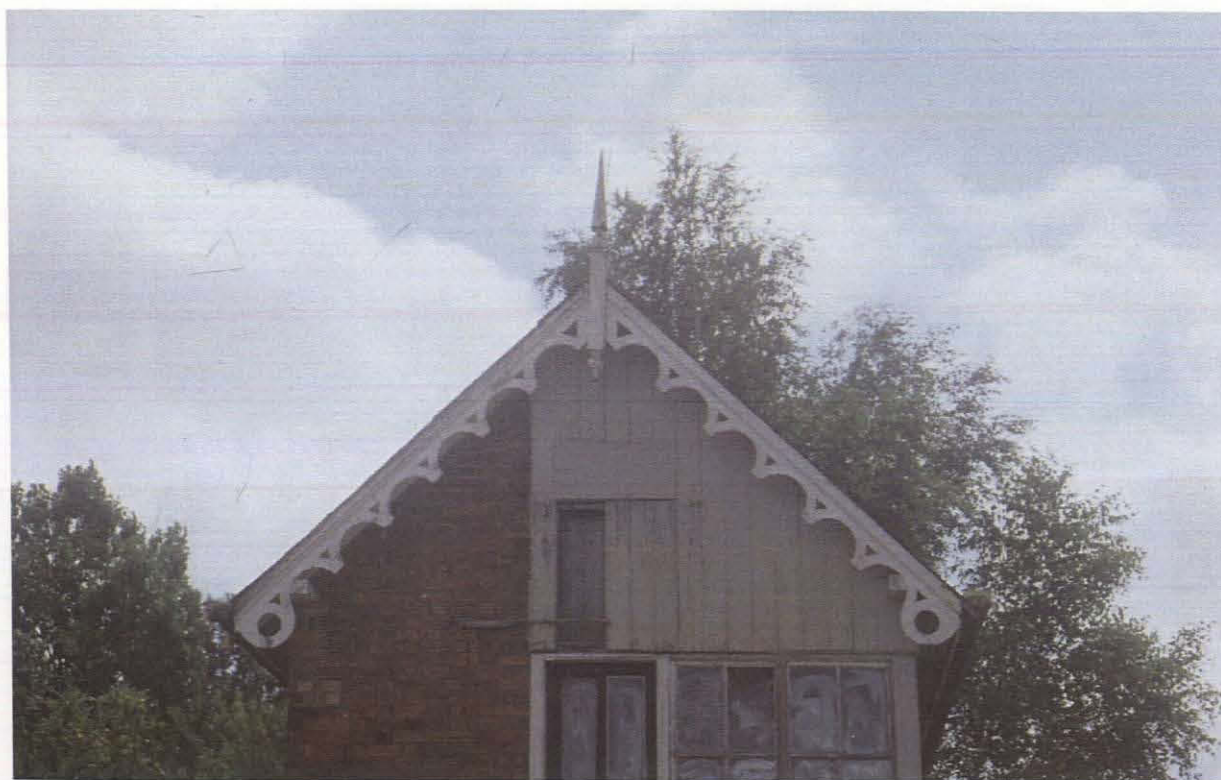
Pl. 8 The north elevation, detail of the bargeboards and finial

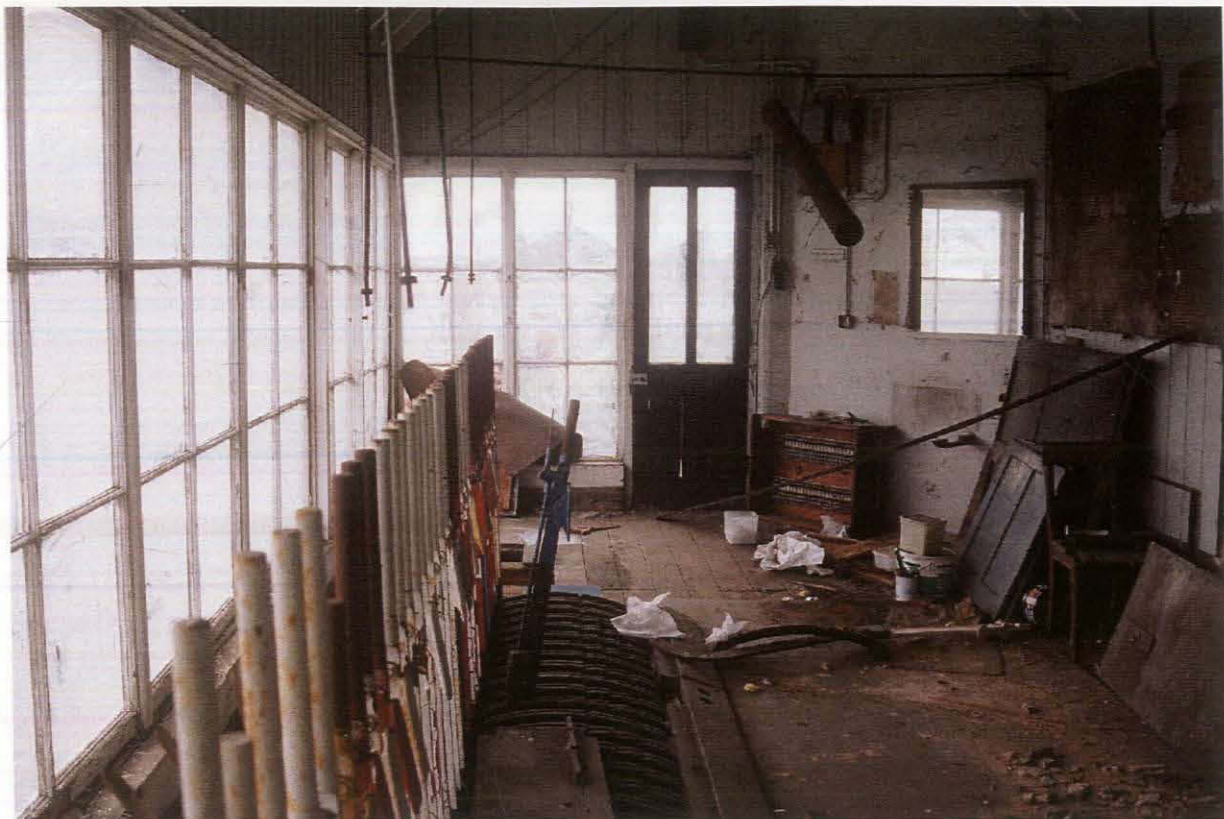
The main feature of the upper floor is the signalling lever grid (Pls 9, 12-14). This consists of a cast iron tappet lock frame that holds thirty-five full length large catch-brake levers spaced at c.0.10m intervals with 1.25m appearing above the grid (Fig. 9). The levers retain full and free movement although the cables linking them to the mechanism below are now gone. They are still painted in their various signal recognition colours. The four blue levers would have been for either the locking bars or the facing point blocks, the yellow lever would have operated the clearance bars, the signals with interlocking facility would have been changed by the three red and white striped levers with all other standard signals being operated by the five red ones. The detonators that would warn oncoming trains of workmen on the line would have been fired by pulling the levers with the black and white chevrons. The direction of the chevrons indicates the line they are connected to, the chevrons point upwards for the up line and downwards for the down line. The lever painted in yellow and blue is of unknown usage. The remaining twenty levers are painted in white indicating that they are spare levers. This would have been due to the fitment of a standard model lever set, rather than a purpose-built set with fewer levers for a smaller signal box. This was common practice as a large number of spare levers would allow for future expansion on the railway with the addition of new track or signals.

Pl. 9 The first floor with the signaling levers in the foreground, looking north

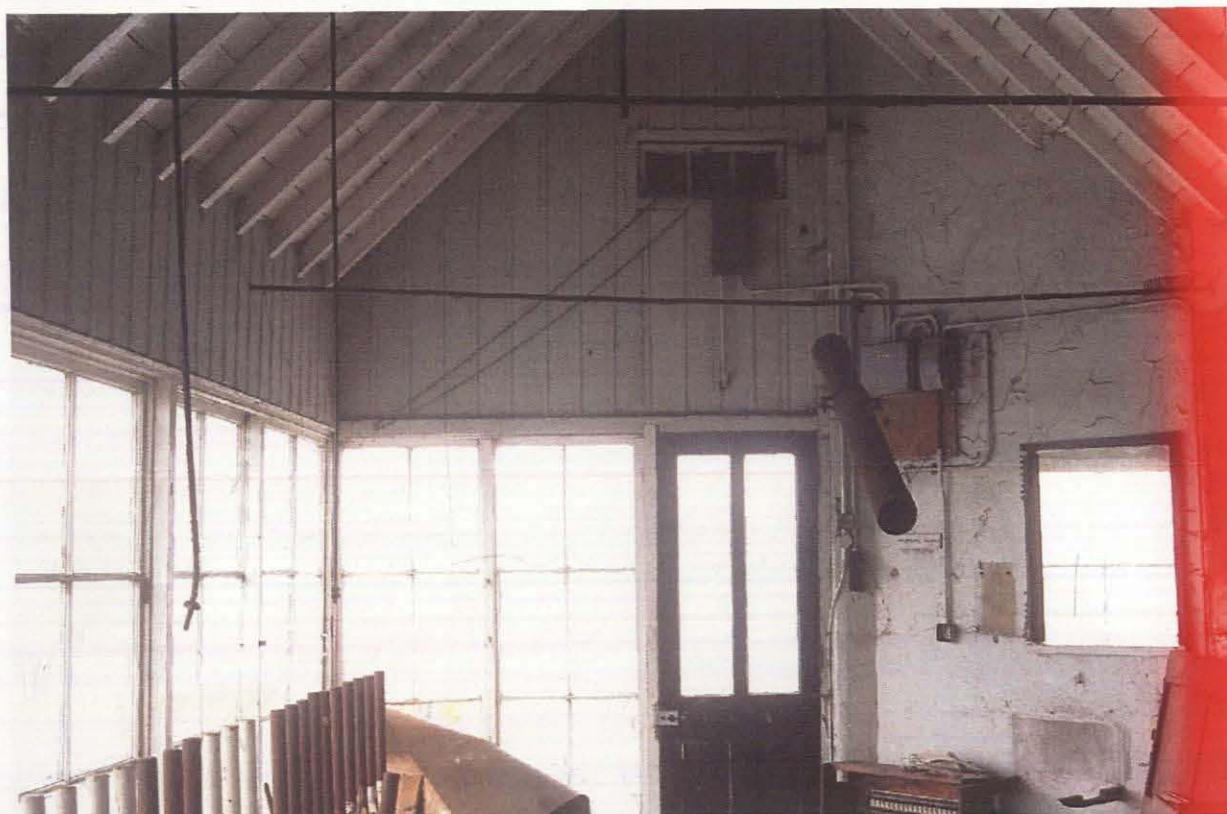
Access to the first floor is currently via a ladder through a hole made by the removal of two of the pine floor boards (Fig. 9). The first floor interior extends to the apex of the roof with no loft or ceiling. The north, west and south walls within the apex of the roof space is panelled with pine tongue and groove planking similar to that on the exterior of the building. The lower parts of the north, east and south walls, where not glazed or panelled, are plastered (Pl. 9). The plaster is in good condition although its covering of light blue paint is flaking. The angle between the northern and eastern walls is filled with the flue for the ground floor fireplace which exits through the galvanised chimney noted from outside. There is no built-in fireplace on the first floor. However, section of cast iron flue is suspended from the roof on three pieces of threaded bar. The presence of the internal flue suggests the presence of a wood burning stove at some time (Pl. 10). However, with the exception of the flue there is no sign of a stove ever having been present. The roof consists of exposed rafters 0.39m apart with tongue and groove panelling between. Each of the rafters is identical (Pl. 10). A small three-panelled window was noted above the door in the north wall. The window opens inwards and is operated by a string attached to the catch (Pl. 10). This window has been boarded over on the outside.

Pl. 10 The first floor detail of internal panelling and rafters, looking south

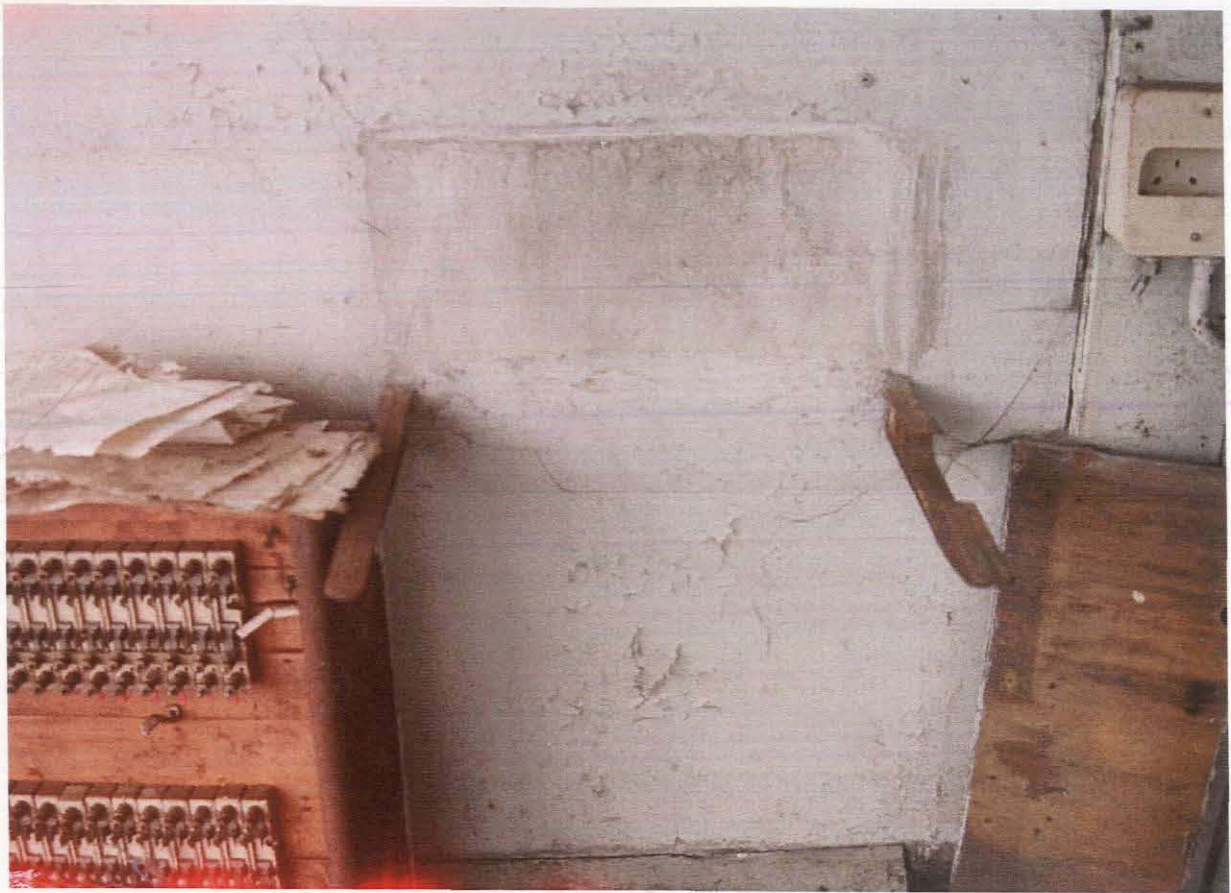
A pair of cast-iron brackets is set into the chimney breast on the eastern wall of the first floor. The brackets are 0.25m long and 0.55m apart (Pl. 11). The most likely use for the brackets would be to support a large ceramic Belfast sink. There is no evidence for taps, so the facility would have been

more a washstand than a plumbed in sink with running water. Modern trip switches, metal trunking and several redundant fuse boxes appear on the north wall.

Pl. 11 The sink brackets and various fuse boxes in the south-west angle

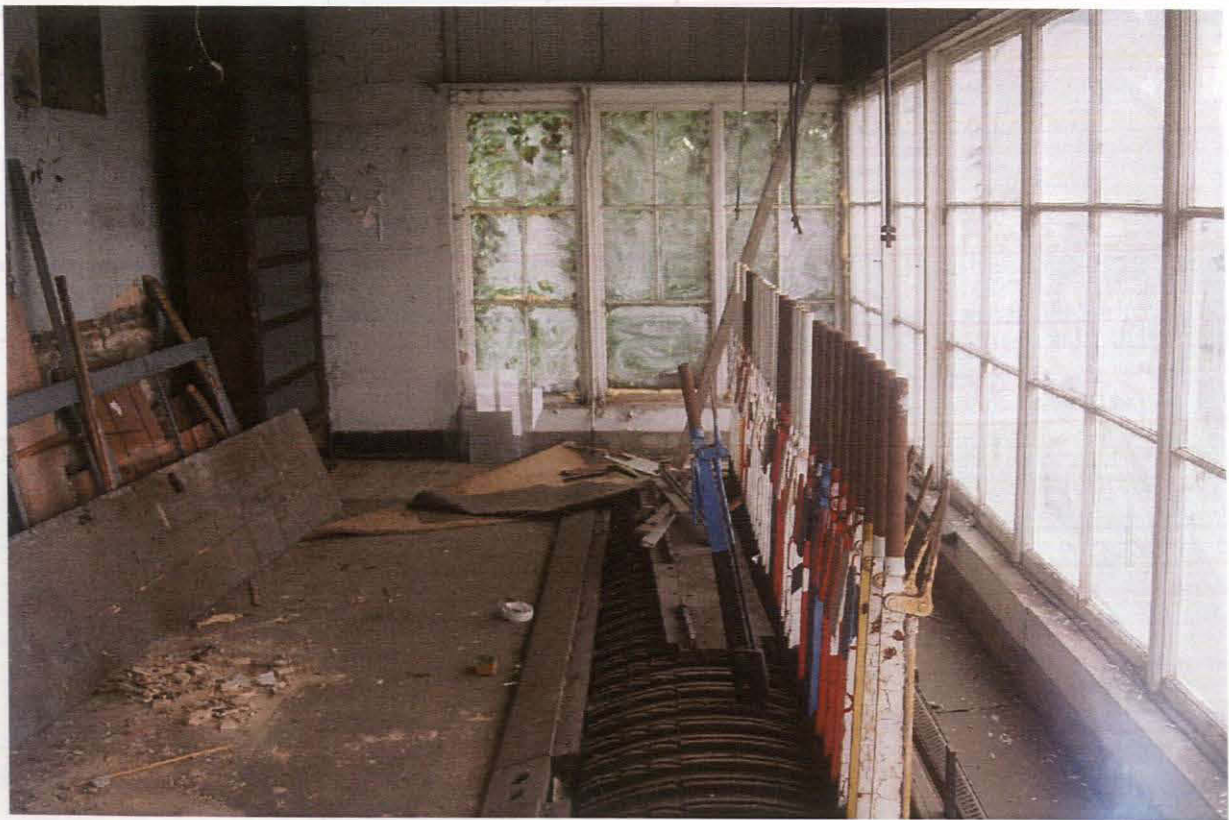
A single dark-stained, glass-fronted pine cabinet in the south-eastern corner of the upper floor is the only surviving furniture (Fig. 9). The cabinet is 2.75m high, 1.85m wide and 0.60m in depth (Pls 12 and 13). The body of the cabinet has eight glass-fronted sections with two small cast-iron handles screwed onto the front of each section. This cabinet is standard railway furniture and would have contained charts, posters and other official railway information.

Pl. 12 The signaling levers with the chart cabinet in the south-east corner, looking south.
