**Cowbit Signal Box, Spalding
Building Survey**

**LAS Report No: 860
September 2005
(Revised November 2006)**

Cowbit Signal Box, Lincolnshire Building Survey

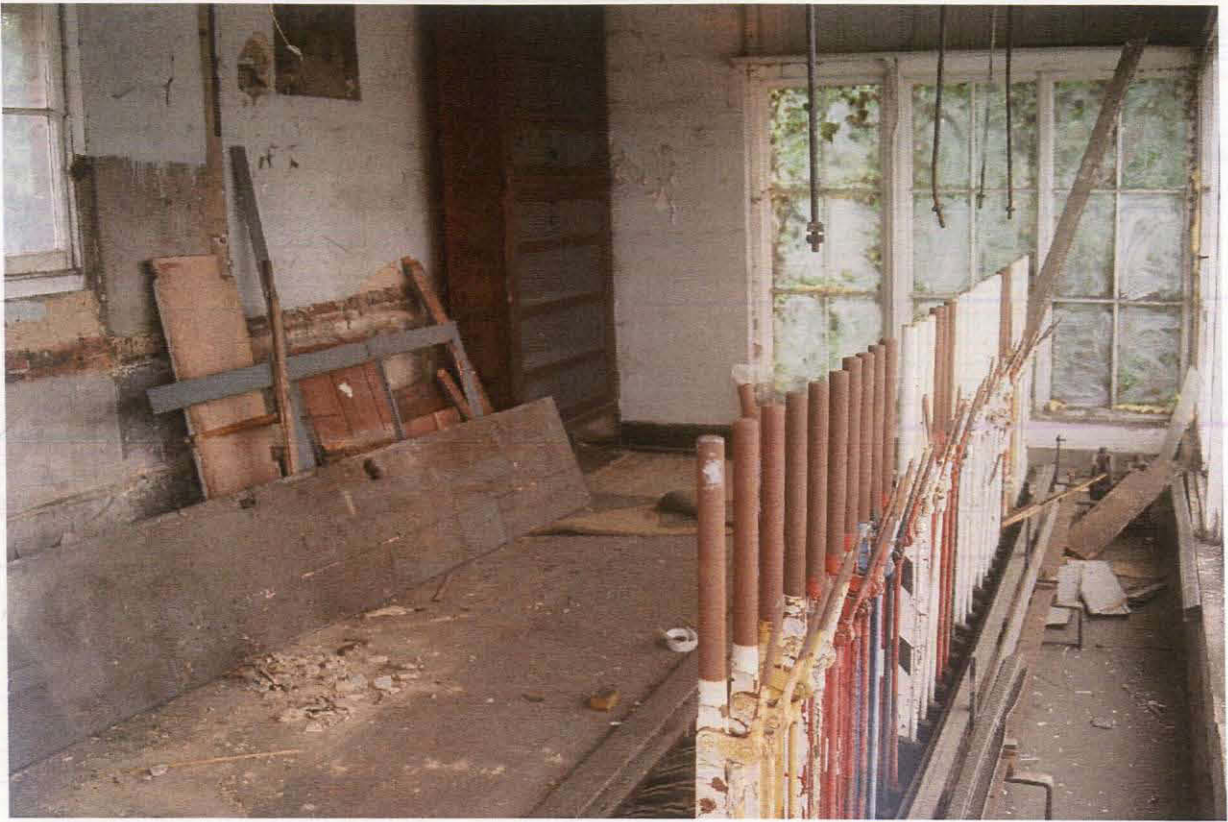
A single dark-stained, glass-fronted pine cabinet in the south-eastern corner of the upper floor is the only surviving furniture (Fig. 9). The cabinet is 2.75m high, 1.85m wide and 0.60m in depth (Pls 12 and 13). The body of the cabinet has eight glass-fronted sections with two small cast-iron handles screwed onto the front of each section. This cabinet is standard railway furniture and would have contained charts, posters and other official railway information.

Pl. 13 General view Looking south-east across the first floor

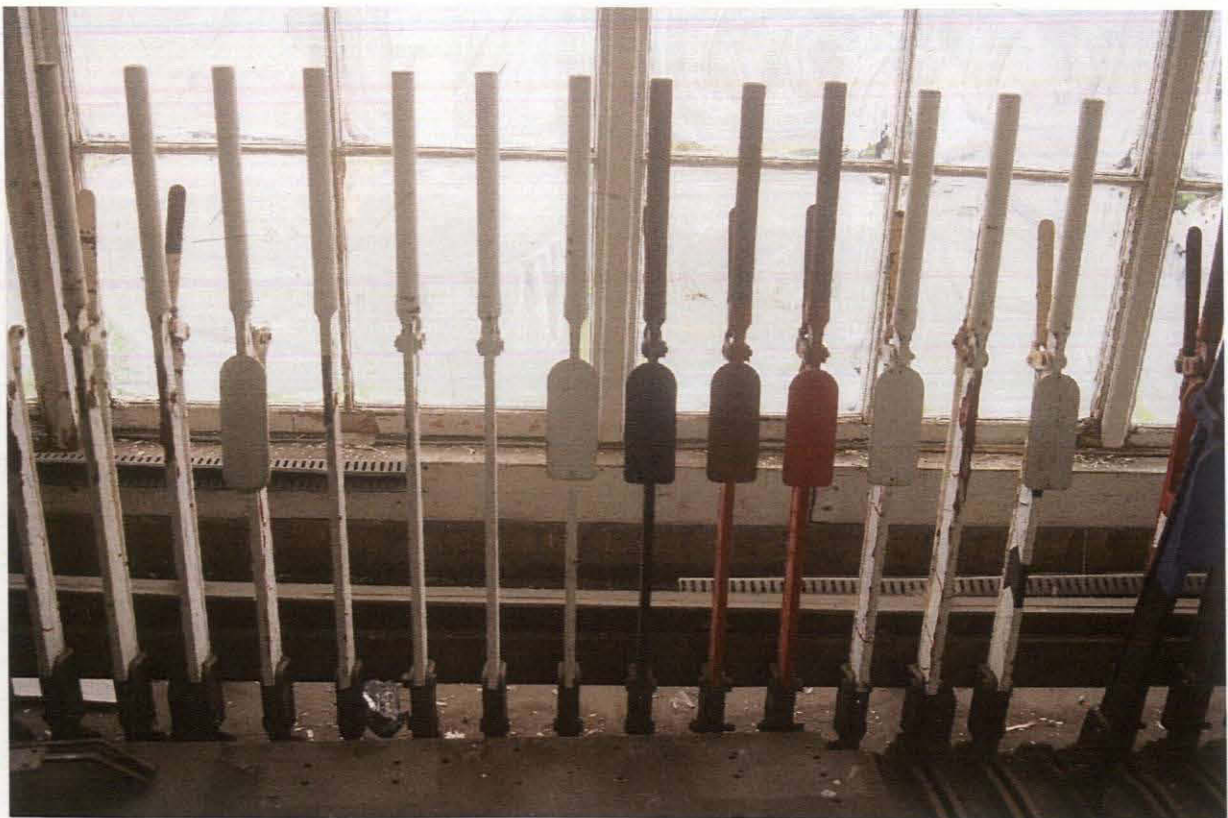
The main feature of the upper floor is the signalling lever grid (Pls 9, 12-14). This consists of a cast iron tappet lock frame that holds thirty-five full length large catch-brake levers spaced at c.0.10m intervals with 1.25m appearing above the grid (Fig. 9). The levers retain full and free movement although the cables linking them to the mechanism below are now gone. They are still painted in their various signal recognition colours. The four blue levers would have been for either the locking bars or the facing point blocks, the yellow lever would have operated the clearance bars, the signals with interlocking facility would have been changed by the three red and white striped levers with all other standard signals being operated by the five red ones. The detonators that would warn oncoming trains of workmen on the line would have been fired by pulling the levers with the black and white chevrons. The direction of the chevrons indicates the line they are connected to, the chevrons point upwards for the up line and downwards for the down line. The lever painted in yellow and blue is of unknown usage. The remaining twenty levers are painted in white indicating that they are spare levers. This would have been due to the fitment of a standard model lever set, rather than a purpose-built set with fewer levers for a smaller signal box. This was common practice as a large number of spare levers would allow for future expansion on the railway with the addition of new track or signals.

Pl. 14 The levers

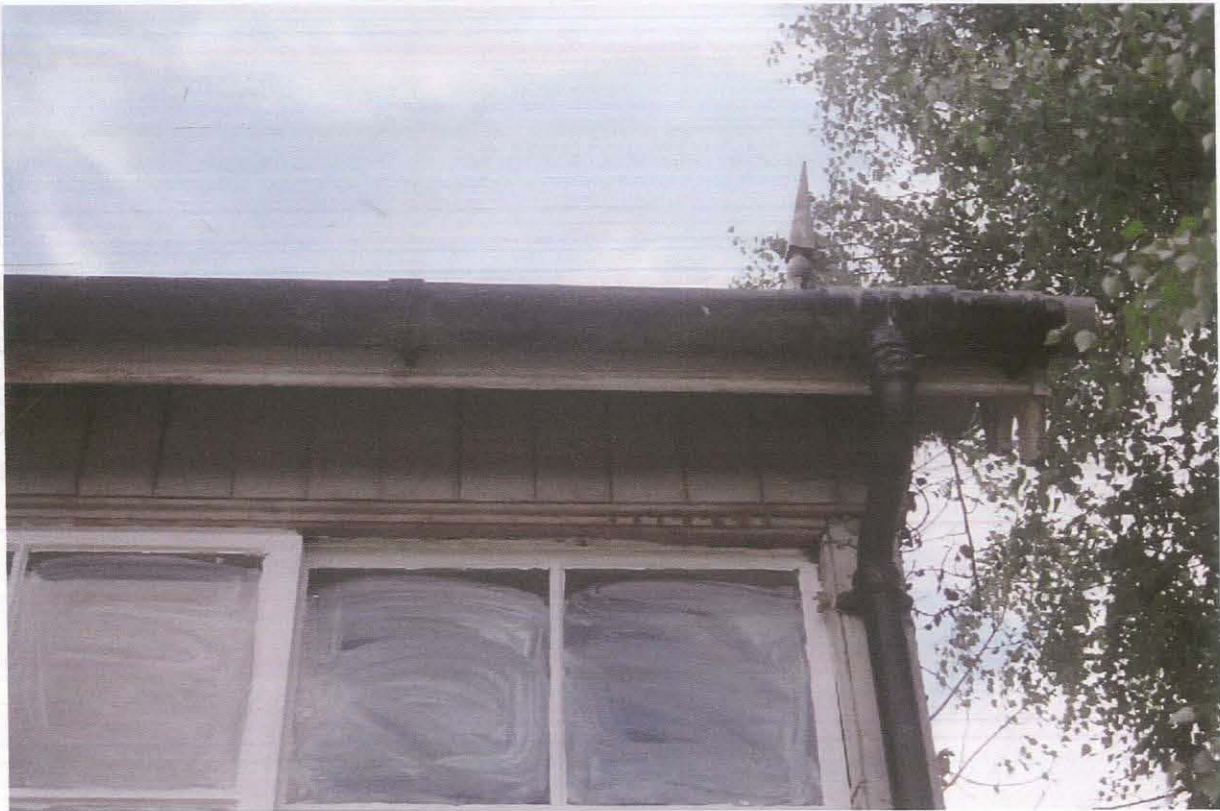
Pl. 11 A detail view of the south western corner of the signal box showing the cast iron guttering and the eaves of the roof

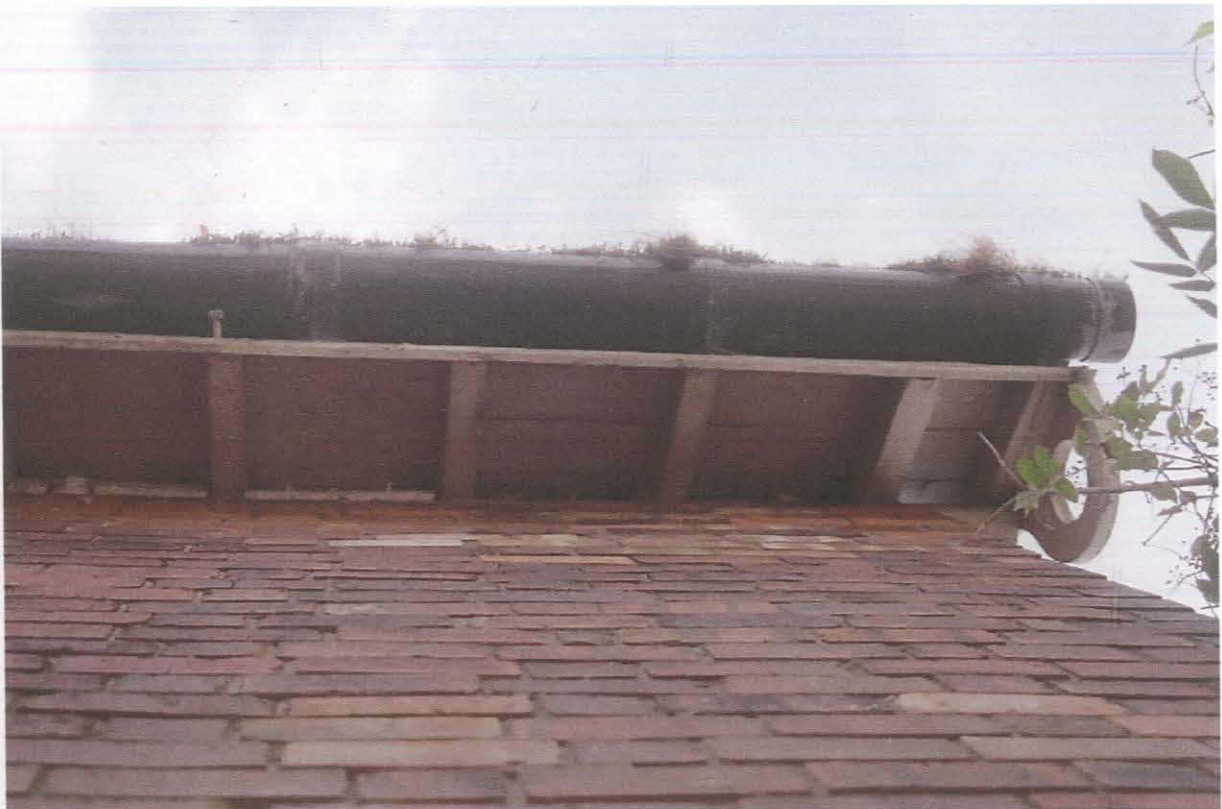
Pl. 12 A detailed view of the underside of the eaves on the north-eastern corner of the building

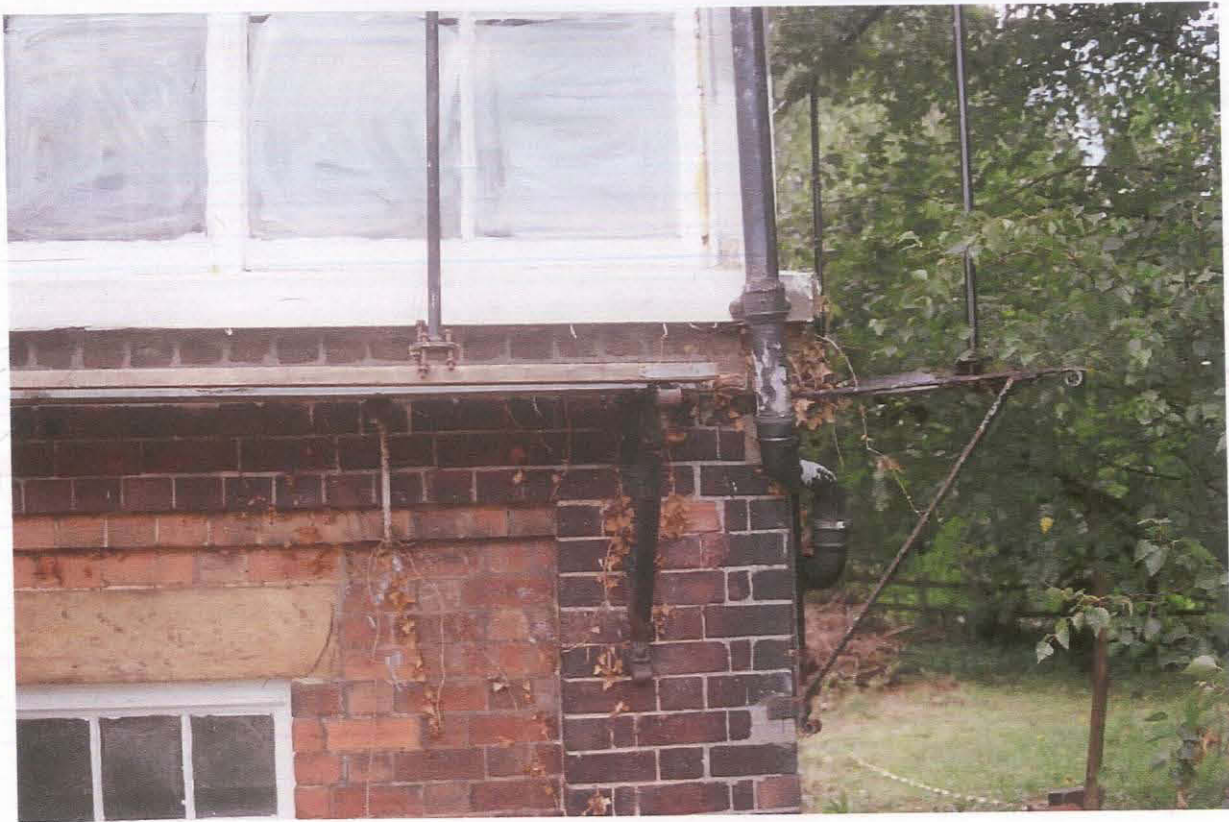
Pl. 13 A view showing the cast iron down pipes, recessed window, glazing and balcony on the south-western corner of the building.

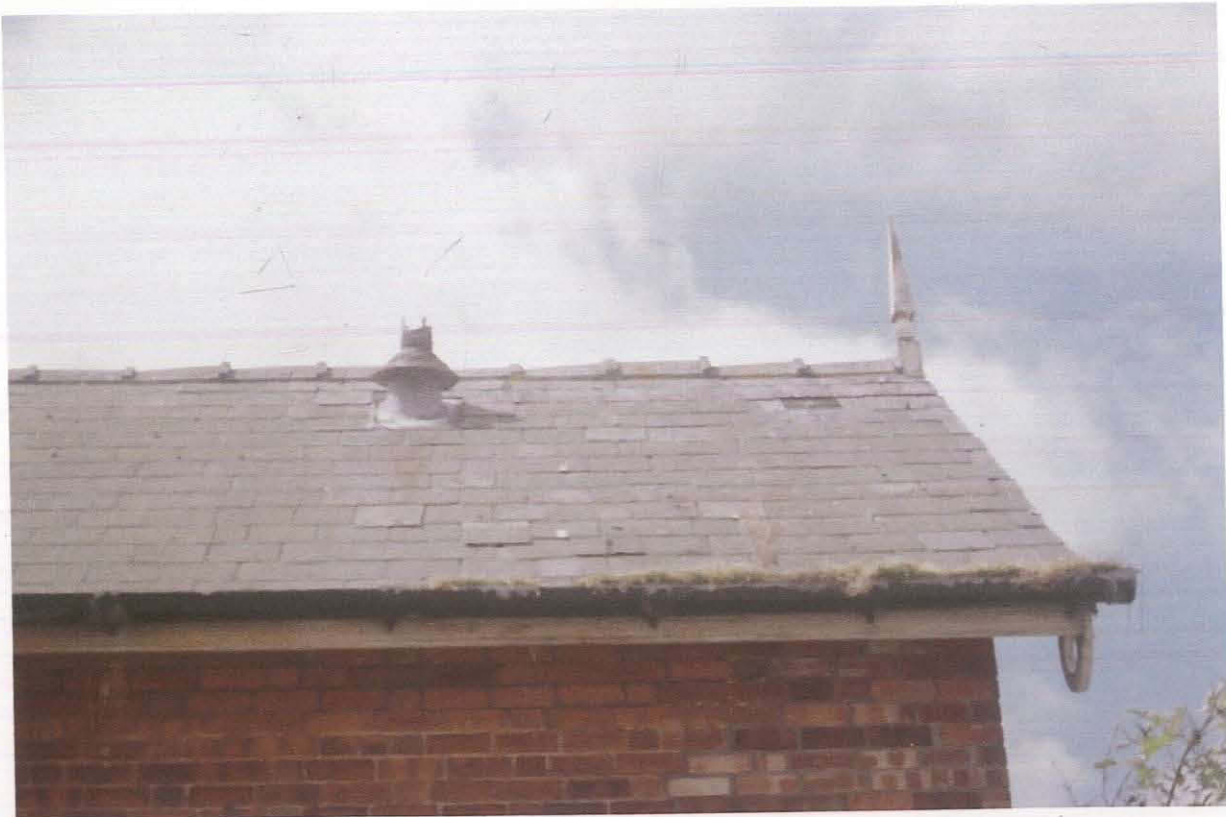
Pl. 14 The roof, finial, guttering and chimney flue on the eastern side of the signal box

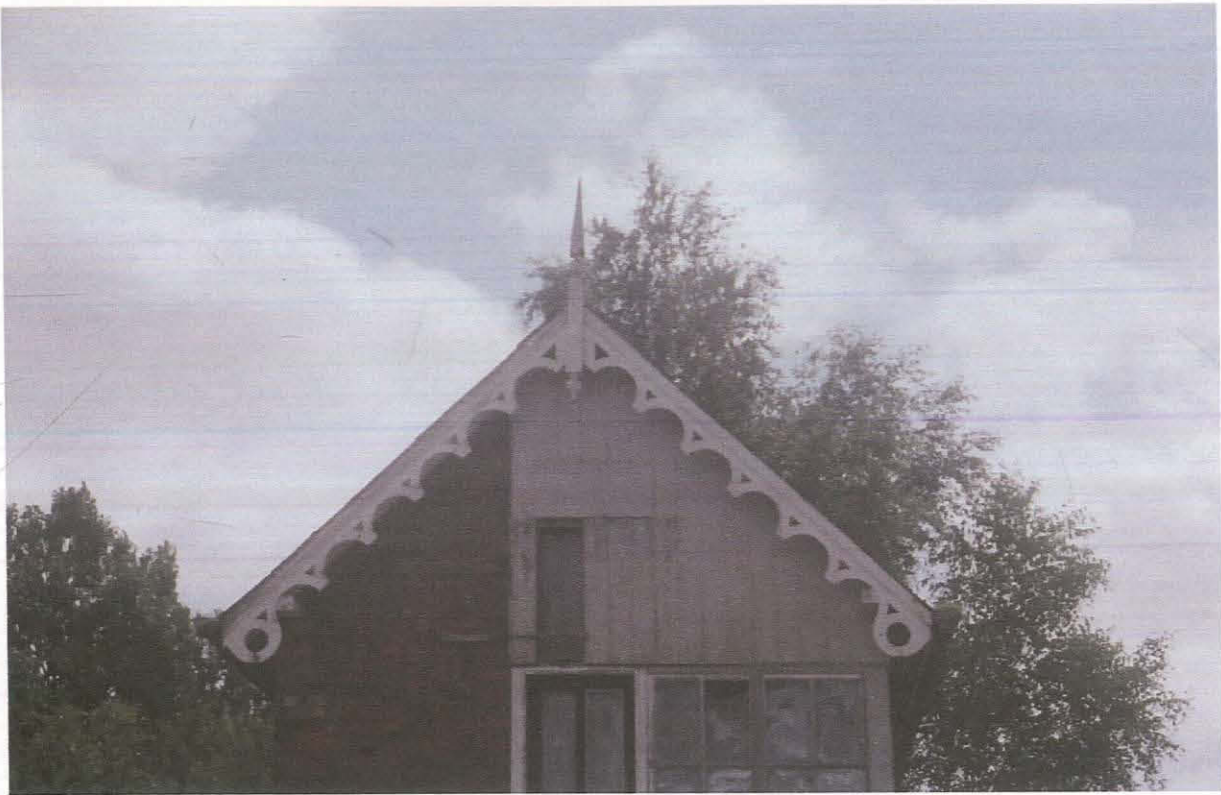
Pl. 15 Detail of the ornate gable end and tongue and grove planking on the northern face of the building
