**LEVEL I SURVEY OF
EASTFIELD BARN
FRIESTON ROAD
HOUGH-ON-THE-HILL
LINCOLNSHIRE
(HEB05)**

Work Undertaken For
Living Spaces (Lincoln) Ltd

A.P.S. Report No. **120/05**

Eastfield Barns,
Thompson's Lane
Hough-on-the-Hill
HEB05

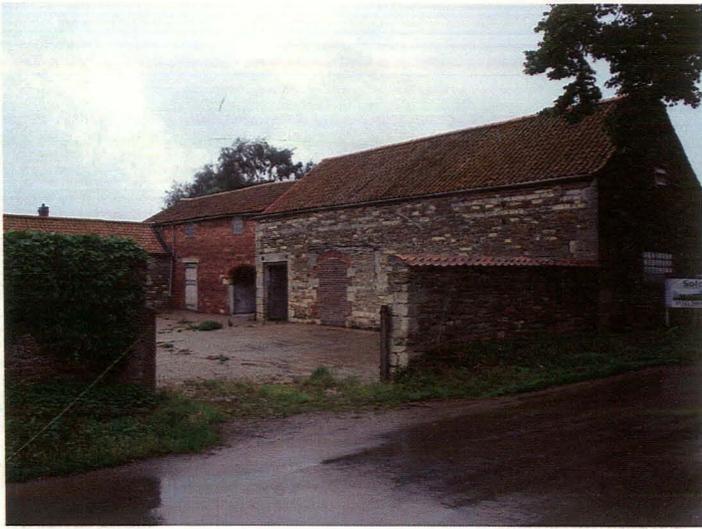
Plate 1 Eastfield Barns, looking north

The recorded Eastfield Barns, broadly form an U-shaped arrangement of farm outbuildings (Plates 1 and 2), once owned by Eastfield Farm immediately to the north. During recording of the farm buildings at least four phases of development were noted (Figure 5). The farm buildings are broadly described below by phase

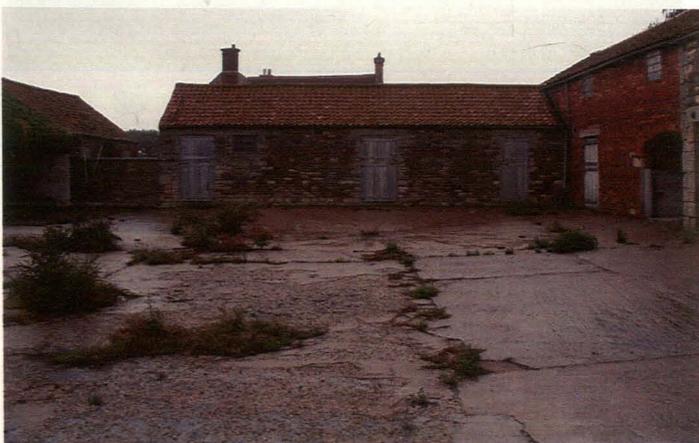
Plate 4 Northern Barn, looking northwest

The earliest farm buildings at the site are the elongated north-south aligned (Plate 3), referred to as the western barn for the purposes of this report, and the smaller rectangular, southwest-northeast aligned barn (Plate 4), referred to as the northern barn. Both of these barns appear on an earlier plan of Hough-on-the-Hill, dated 1850. There are no earlier maps or drawings depicting buildings on the site.

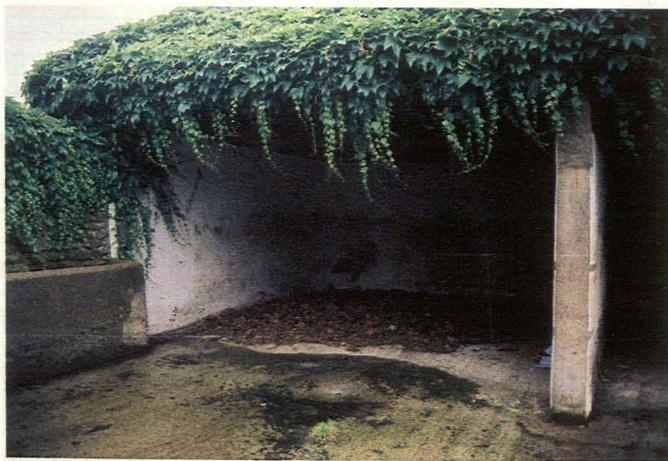
Plate 7 Southeastern cell of northern barn (example of), looking south

The building is divided into six cells, the northern one (Plate 6) of these being separated from the farmyard by a stonewall, with access only provided from Eastfield Farm. The five cells fronting onto the farmyard are all open fronted, with gates/doors having been removed (Plates 7 and 8). The cells are partitioned by inserted breezeblock walls rendered with concrete. There is concrete flooring throughout, and each of the cells has a small basin, with the addition of a water tank in the northernmost.
