**The Engine Shed and Lincoln Centre for the  
Performing Arts Building, Brayford Campus  
University of Lincoln, Lincoln  
Archaeological Building Recording and  
Environmental Assessment**

**Report**

**LAS Report No. 1083**

**October 2008**

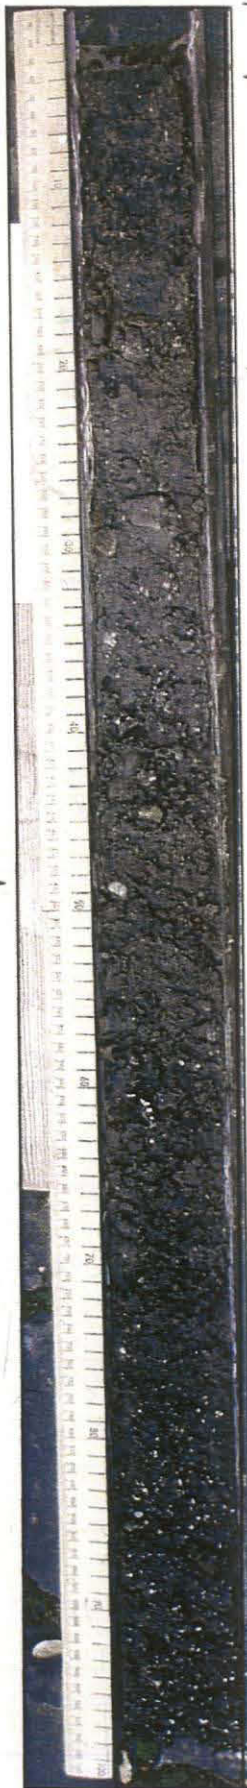
APPENDIX 1. Lincoln University Engine Shed Cores and logs  
BH1 Core 1 (220cm-320cm)

4cm-20cm Firm 5YR 3/1 very dark grey sandy silty layer with ochreous staining and inclusions of fragmented brick, coal and clinker; sub-angular gravel (= 20mm x 10mm) and smaller angular gravel inclusions (= 5mm x 5mm). Industrial rubbish/dump deposit mixed with the sandy silt – most probably active dumping to make ground.

Shoe sample 348cm-350cm: 10YR 2/1 black peat with wood/root wood inclusions.

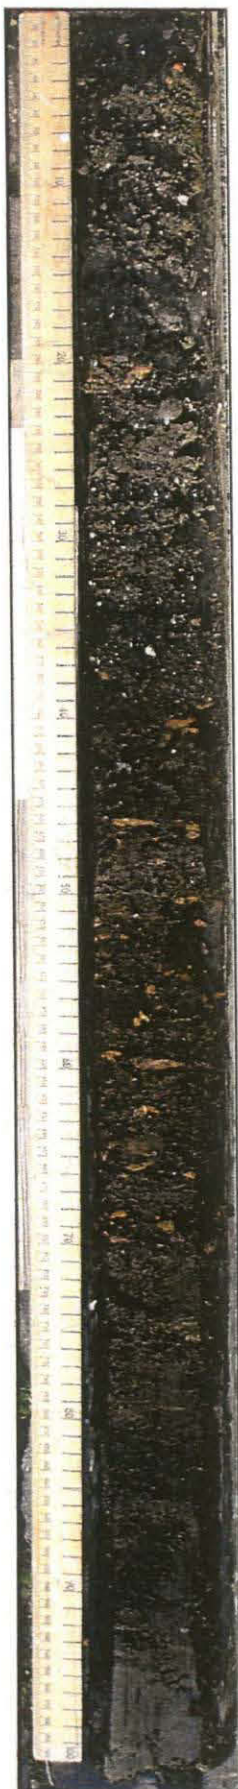
Lincoln University Engine Shed – BH1 Core 2 (320cm-440cm)

**0cm-26cm** Firm 5YR 3/1 very dark grey sandy organic mollusc shell-rich silt with inclusions of pebbles (= 25mm x 18mm), angular and sub-angular limestone gravel (= 5mm x 5mm), fragments of brick and coal. Industrial rubbish has been dumped into the natural organic shell-rich silt to make ground. The initial interpretation of this deposit was that it was 'slip down' but the underlying deposit (see 26cm-39cm) indicates a definite phase of dumping.

**26cm-39cm** Firm 5YR 2.5/1 black organic mollusc shell-rich silt with inclusions of small brick fragments (= 6mm x 4mm) – less concentrated than the overlying deposit (0cm-26cm), with a greater concentration of mollusc shell and crushed mollusc shell than the overlying deposit (mollusc shell sampled at **37cm**).

**39cm-72cm** Firm YR5 3/2 dark reddish brown peat with well-preserved and semi-degraded organic matter – wood/root wood and twigs. This deposit is indicative of an open and wooded boggy area – most probably scrubby alder carr.

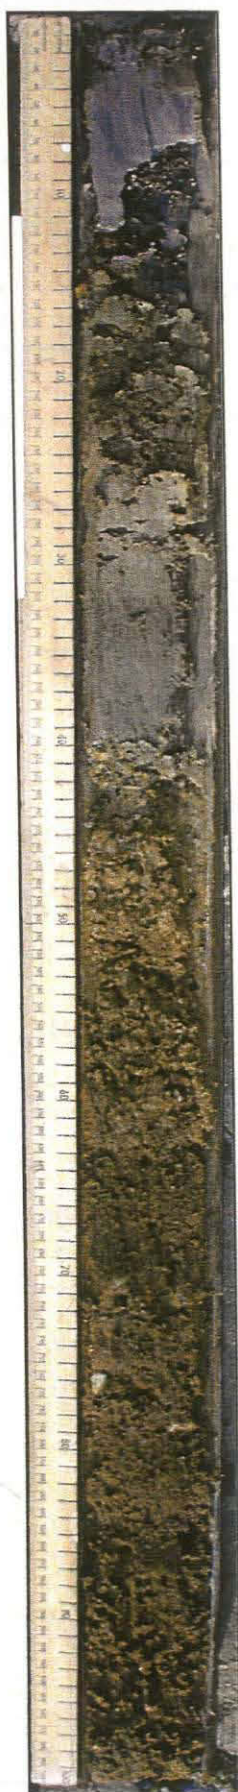
Lincoln University Engine Shed – BH1 Core 3 (440cm-540cm)

15cm  
Top of clay  
horizons

12cm-15cm Firm 5YR 3/1 very dark grey clay with 5YR 4/4 reddish brown mottling (ochreous staining), inclusions of mollusc shells but less abundant than in the overlying deposit (7cm-12cm).

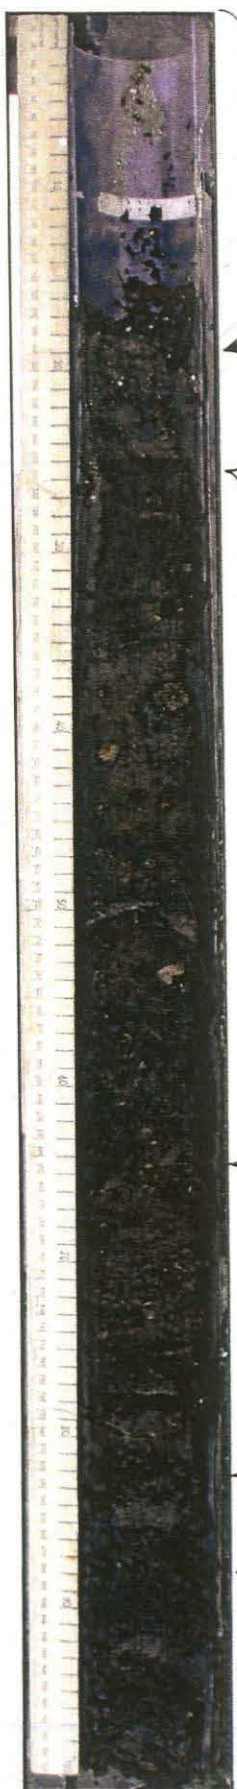
Lincoln University Engine Shed – BH2 Core 2 (330cm-430cm)

0cm-19cm Missing.

19cm-26cm Firm 5YR v3/c1 very dark grey silt with inclusions of fragmented brick (= 1mm x 1mm) and brick dust, and sub-angular quartz gravel (= 1mm x 0.5mm). The absence of mollusc shells in this deposit suggests this layer may be contaminated with 'slump'.

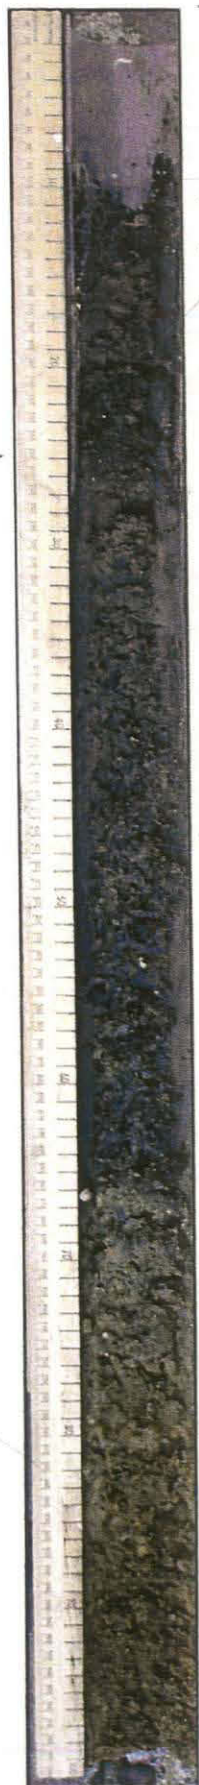
Lincoln University Engine Shed – BH2 Core 3 (437cm-520cm)

0cm-11cm Missing.

11cm-13cm Firm 5YR 3/1 very dark grey silt with fragmented brick (= 2mm x 1.5mm) and lime mortar.

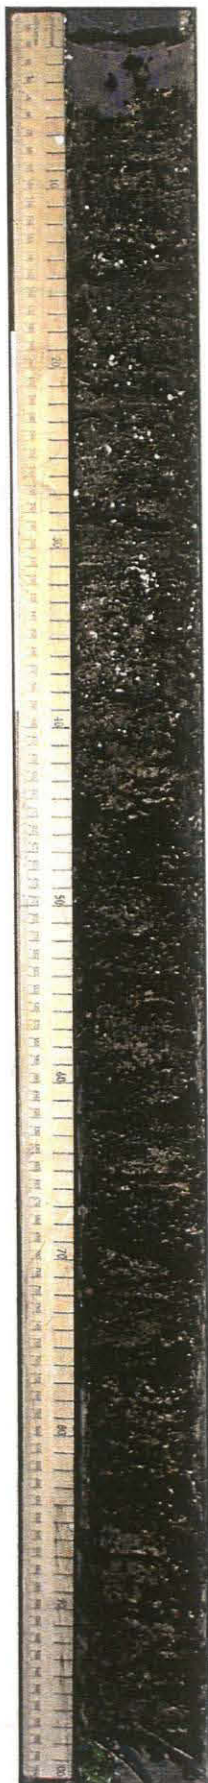
Lincoln University Engine Shed – BH3 Core 2 (300cm-400cm) [Note: No Core 1]

0cm-5cm Missing.

5cm-12cm Firm 5YR 3/1 very dark grey silt with inclusions of brick dust.

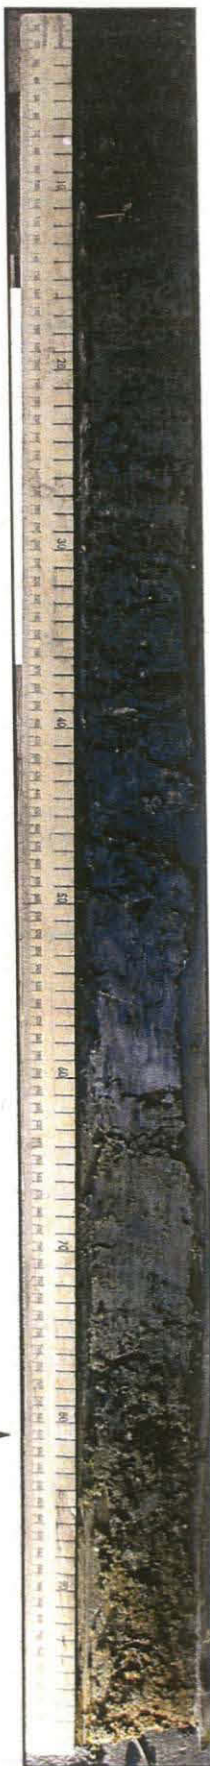
Lincoln University Engine Shed – BH3 Core 3 (400cm-500cm)

**0cm-3cm** Firm 5YR 2.5/2 dark reddish brown peat.

**3cm-11cm** Firm 5YR 3/2 dark reddish brown peat with wood/root wood.

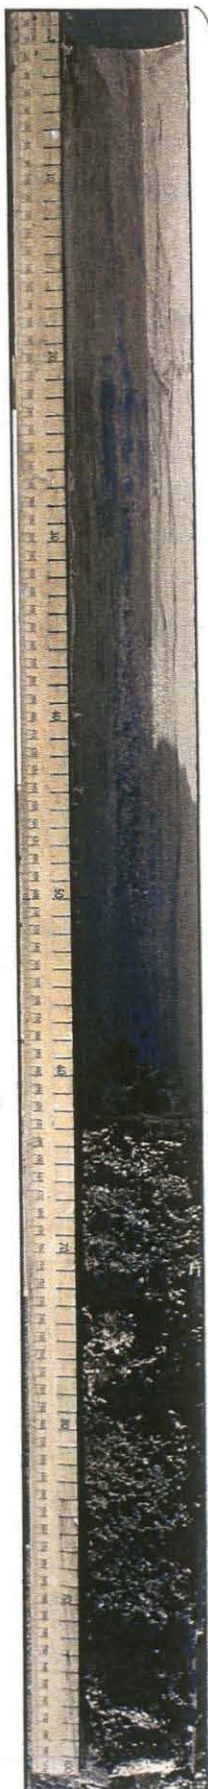
Lincoln University Engine Shed- BH4 Core 1 (200cm-290cm)

0cm-62cm Missing

62cm-64cm Firm 5YR 4/3 reddish brown sandy silt with inclusions of brick fragments (= 5mm x 3mm).

92cm-100cm Firm 5YR 5/1 grey silty sand with inclusions of angular limestone (80mm x 60mm), brick fragments (= 3mm x 1.5mm), and oyster shell at 97cm. Dump/rubbish deposit.

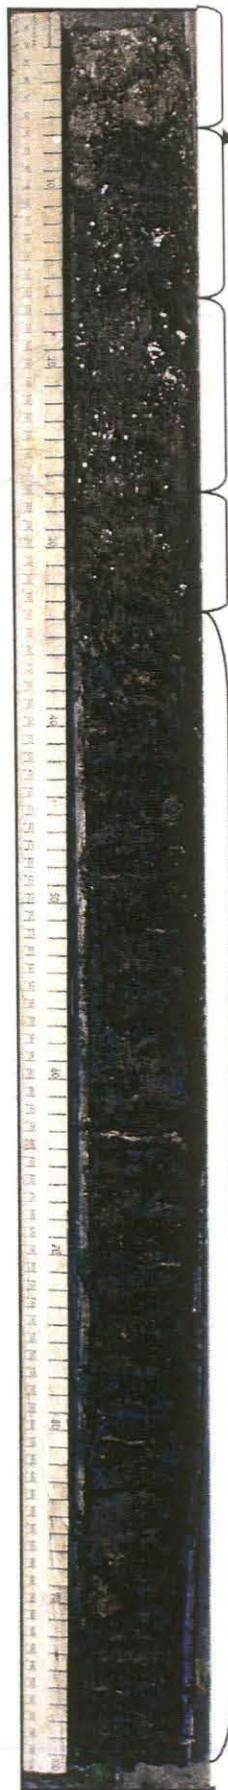
Lincoln University Engine Shed- BH4 Core 2 (300cm-400cm)

**0cm-7cm** Firm 5YR 5/1 grey silty sand with inclusions of limestone (= 40mm x 30mm), brick fragments (= 4mm x 3mm), oyster shell and post-medieval pot sherd at **6cm** (sampled). Dump/rubbish layer.

**7cm-16cm** Firm 5YR 2.5/1 black mollusc shell-rich silt.

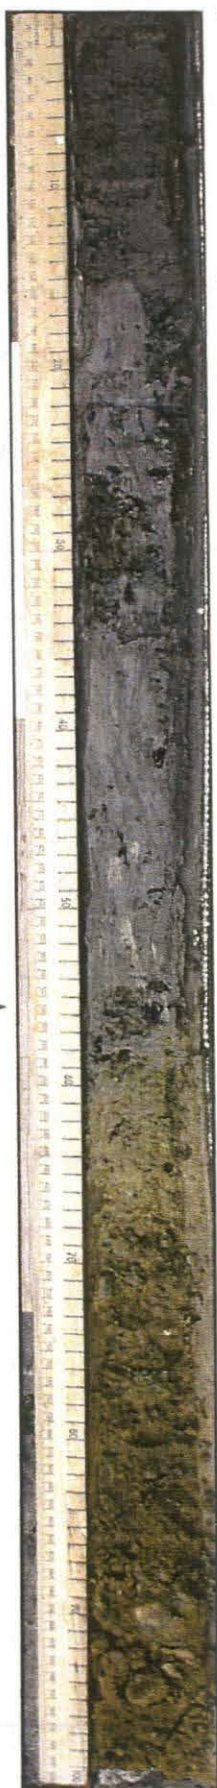
Lincoln University Engine Shed- BH4 Core 3 (400cm-500cm)

**0cm-15cm** Firm 5YR 2.5/2 dark reddish brown clayey peat with organic matter i.e. reed (*Phragmites*) stem fibres and root fibres.

**15cm-57cm** Firm 10YR 5/1 grey clay with organic matter i.e. well-humified wood/root wood and charcoal at **56cm** (sampled).

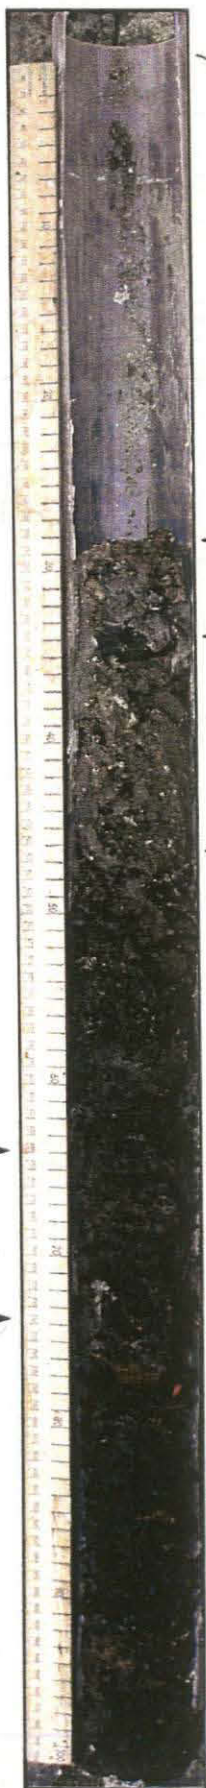
Lincoln University Engine Shed – BH5 Core 1 (210cm-310cm)

0cm-29cm Missing.

29cm-34cm Firm 10YR 3/1 very dark grey sandy silt with inclusions of ash, rounded and broken pebbles (= 5mm x 4mm), and coal (= 3mm x 2.5mm). Dump/rubbish deposit most probably associated with use of the site as a locomotive shed. **Note:** This deposit has a strong smell of hydrocarbons.

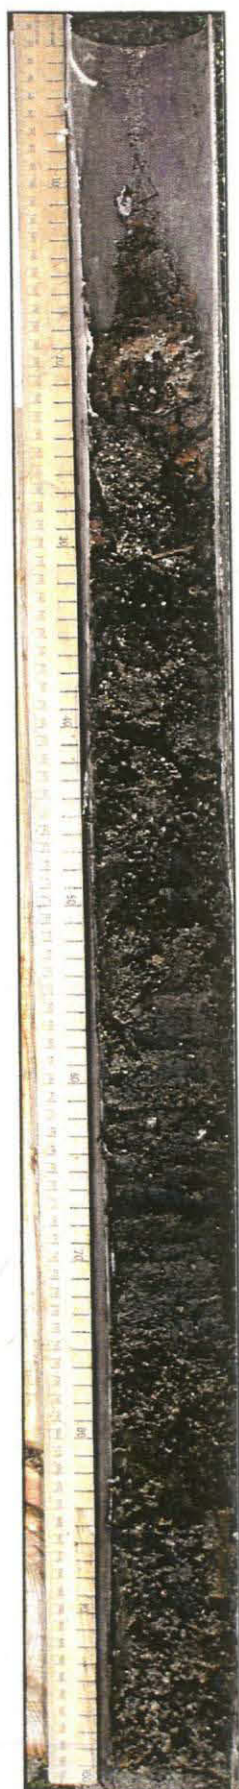
Lincoln University Engine Shed – BH6 Core 1 (150cm-250cm)

0cm-18cm Missing.

18cm-23cm Loose 2.5YR 3/4 dark reddish brown sandy clayey silt with inclusions of brick fragments (= 15mm x 10mm) and brick dust and sun-angular gravel (= 10mm x 8mm).

23cm-34cm Loose 5YR 3/1 very dark grey sandy mollusc shell-rich silt with inclusions of brick fragments (= 15mm x 8mm) and brick dust. Dump/rubbish layer to make ground.

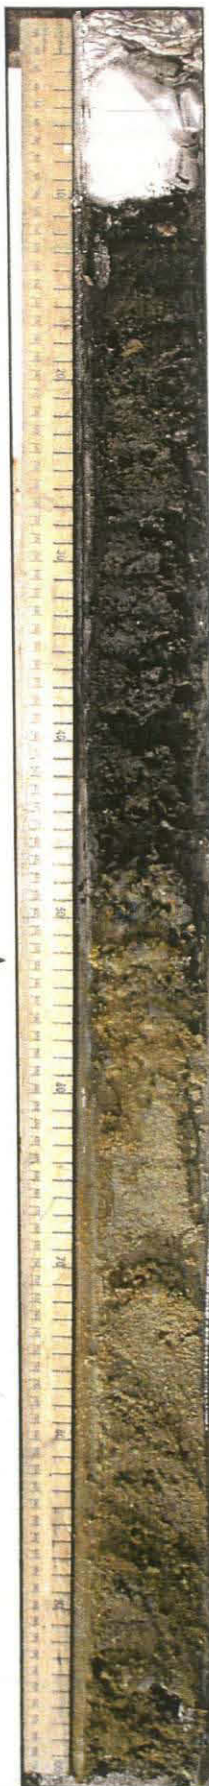
Lincoln University Engine Shed – BH6 Core 3 (350cm-440cm)

0cm-10cm Missing.

10cm-20cm Firm 7.5YR 2.5/1 black peat with small twigs and wood/root wood.

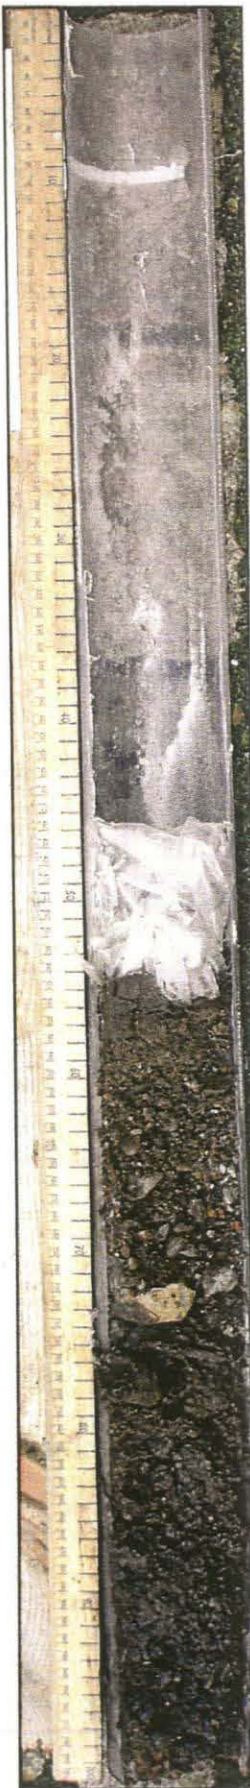
Lincoln University Engine Shed – BH7 Core 1 (300cm-373cm)

91cm-100cm Firm and moist 10YR 2.1/1 black silty sandy with inclusions of stones (= 60mm x 30mm), angular and sub-angular gravel (= 4mm x 2mm), and brick fragments (= 60mm x 35mm). **Note:** This deposit has a strong smell of hydrocarbons most probably associated with the use of the site as a locomotive shed.

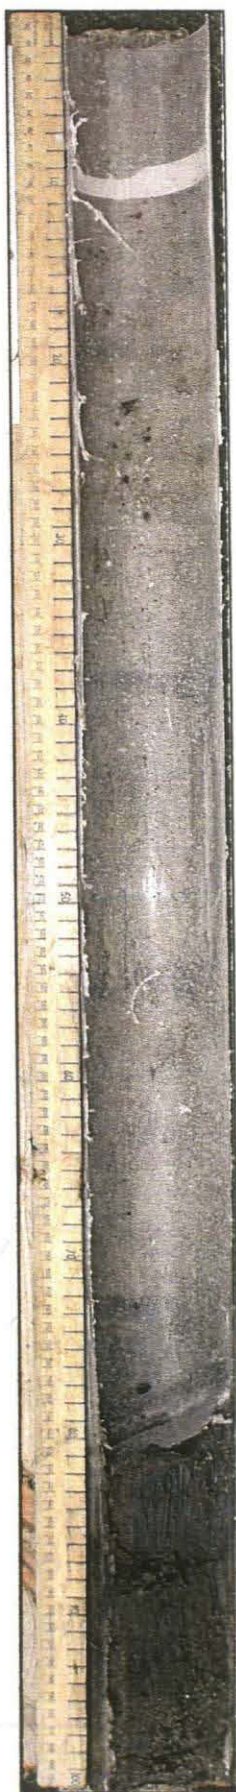
Lincoln University Engine Shed – BH7 Core 2 (380cm-460cm) [Bottom]

**80cm-87cm** Soft 10YR 3/1 very dark grey silty sludge. **Note:** This deposit has a strong smell of hydrocarbons and probably associated with the use of the site as a locomotive shed.

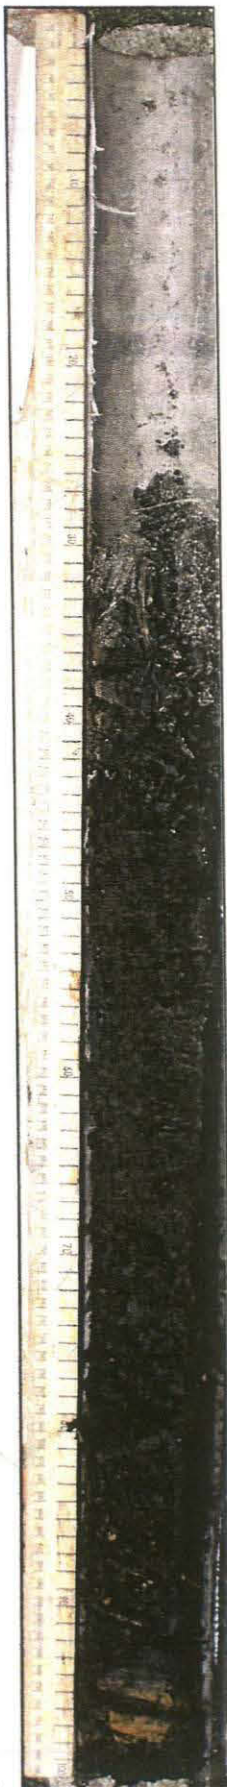
Lincoln University Engine Shed – BH8 Core 1 (250cm-350cm)

**0cm-30cm** Missing.

**30cm-35cm** Loose 10YR 3/1 very dark grey silt and compressed wood.

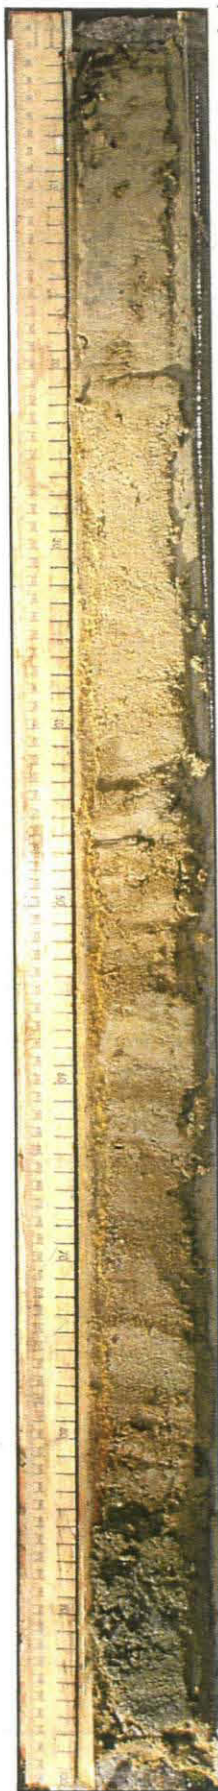
Lincoln University Engine Shed – BH8 Core 2 (250cm-440cm)

0cm-2cm Missing.

2cm Top of sand horizons.

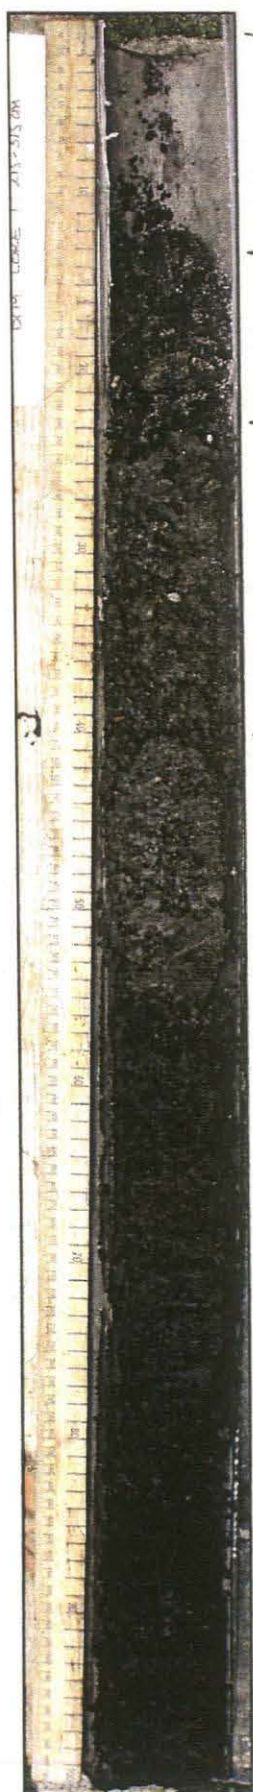
Lincoln University Engine Shed – BH9 Core 1 (215cm-315cm)

**0cm-14cm** Missing.

**14cm-23cm** Loose 10YR 3/1 very dark grey sandy silt with inclusions of quartz pebbles (= 4mm x 3mm), angular limestone gravel (= 2mm x 2mm), fragments of brick (= 4mm x 2mm). Dump/rubbish deposit to make ground.

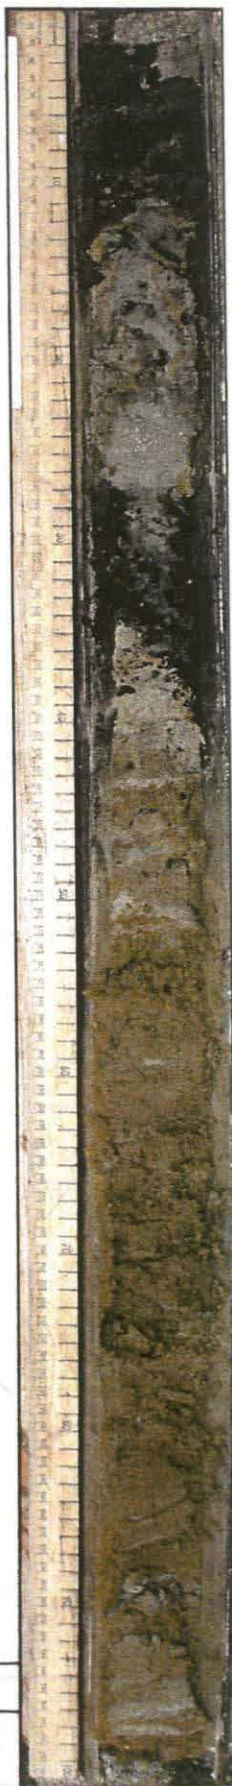
Lincoln University Engine Shed – BH9 Core 3 (415cm-490cm)

0cm-4cm Missing.

4cm-6cm Firm 10YR 3/1 very dark grey silt. Possible slump

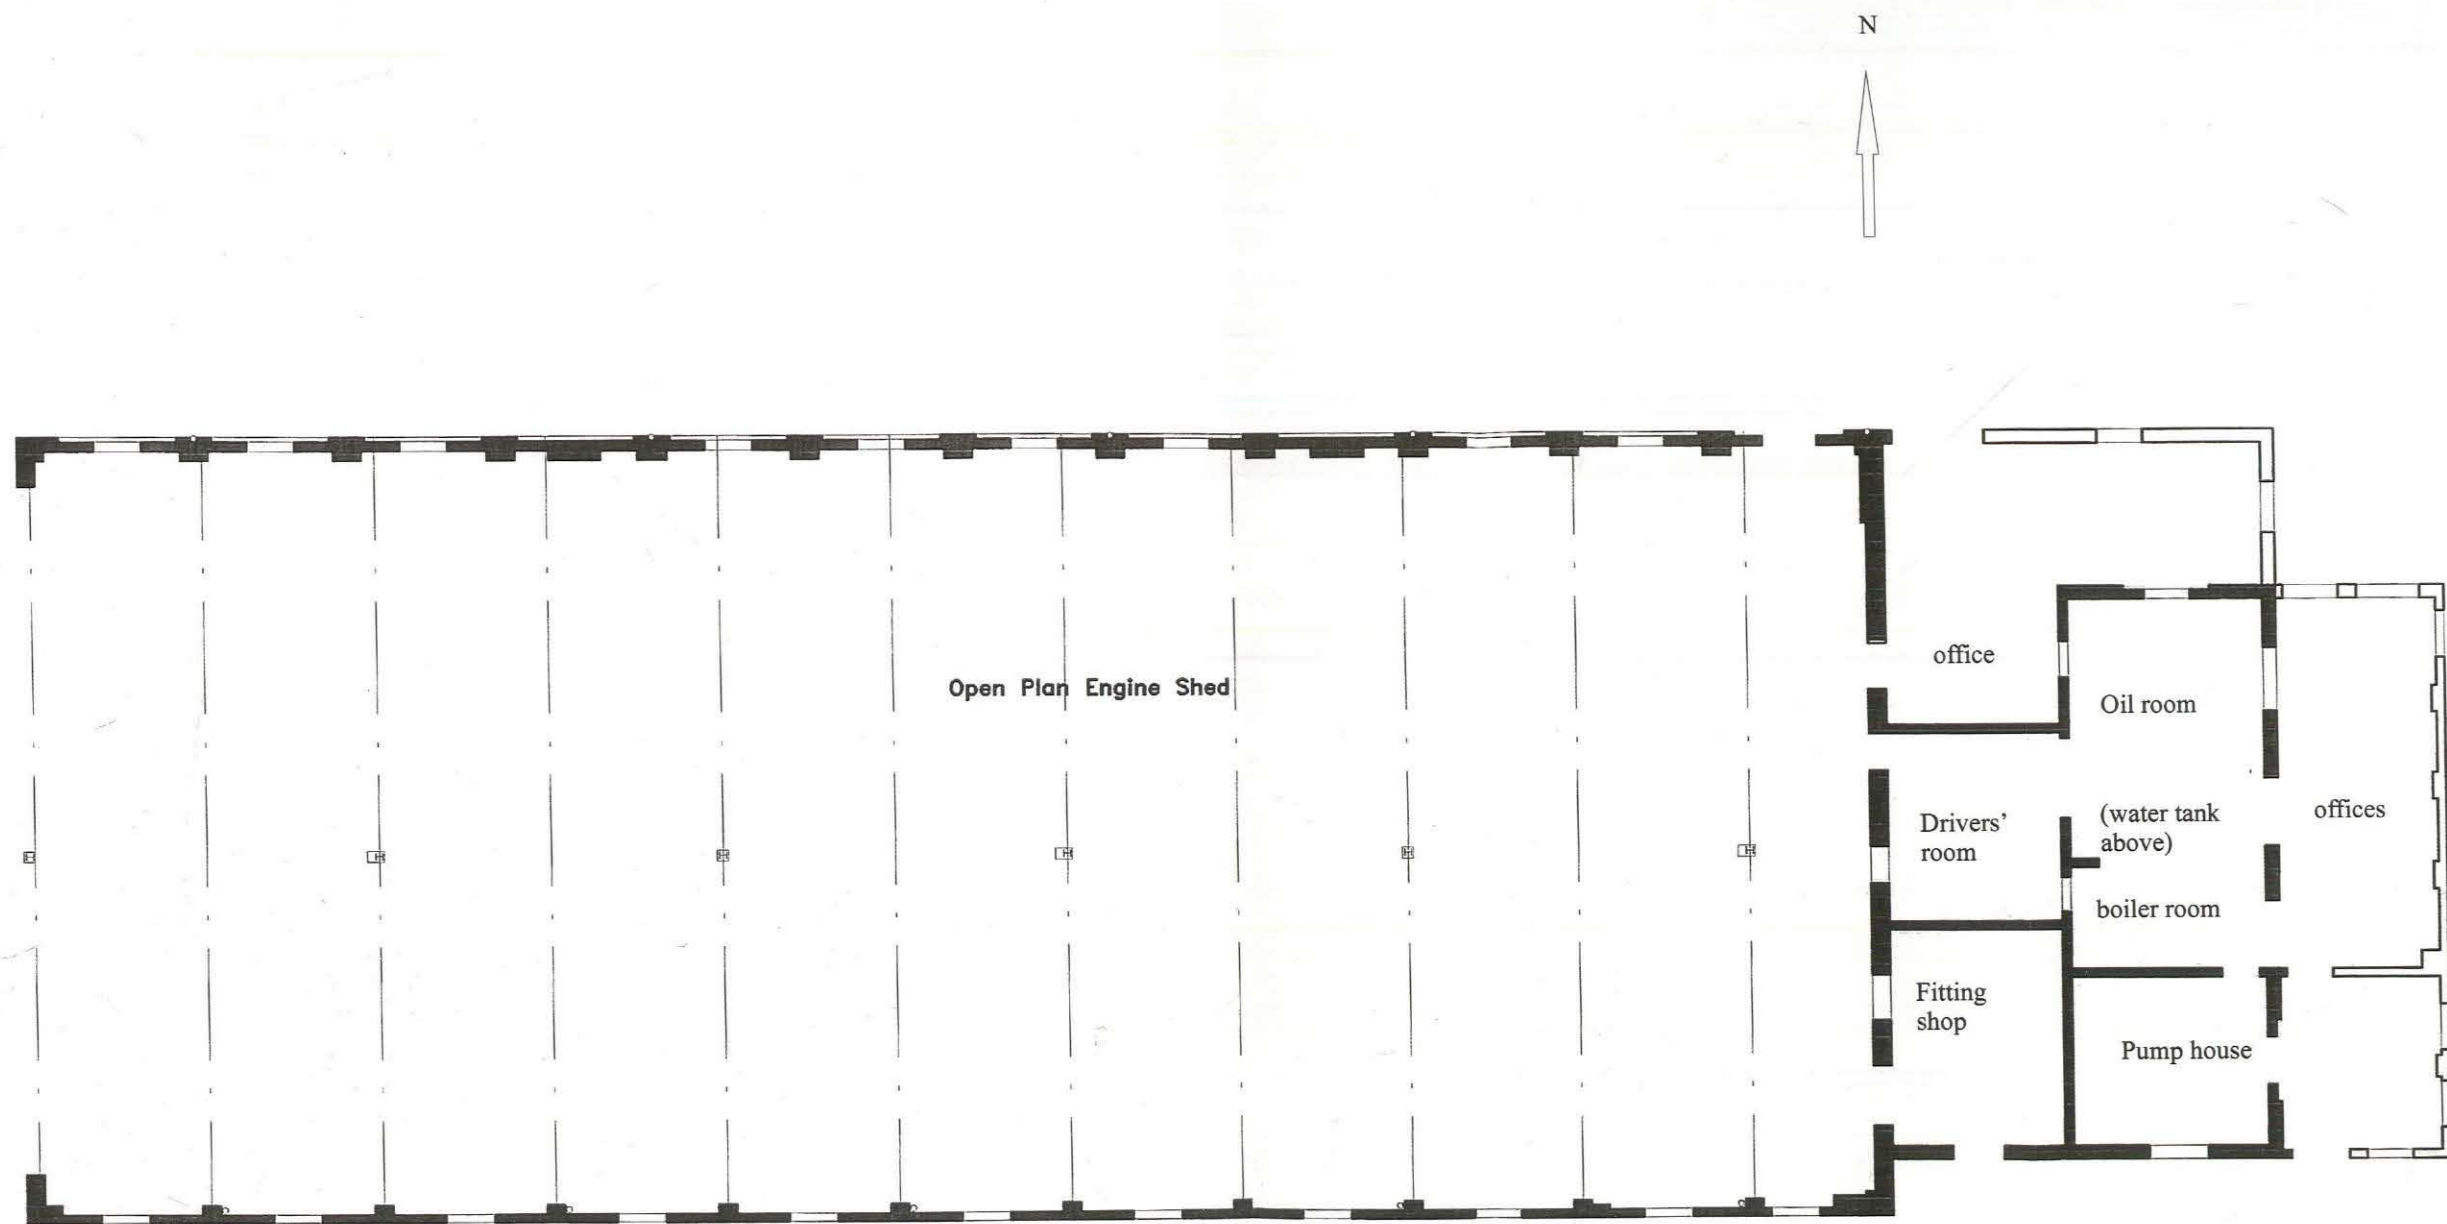
Fig. 3 The engine shed, Holmes Yard, Lincoln. Ground plan

Site investigations were carried out in May 2005 by Solmek comprising a series of six boreholes and six test pits (see Fig. 3). The ground disturbance was found to exceed the proposed foundation depths in TP 11 and 13 and the watching brief was abandoned (Pl. 33).

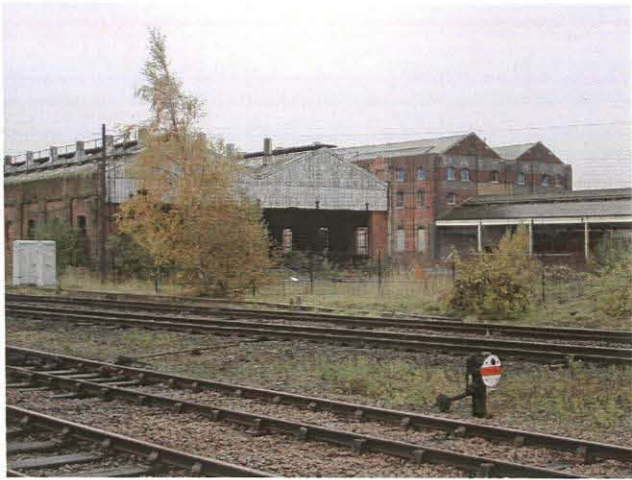
Pl. 3 General view of the engine shed W and N elevations (looking SW)

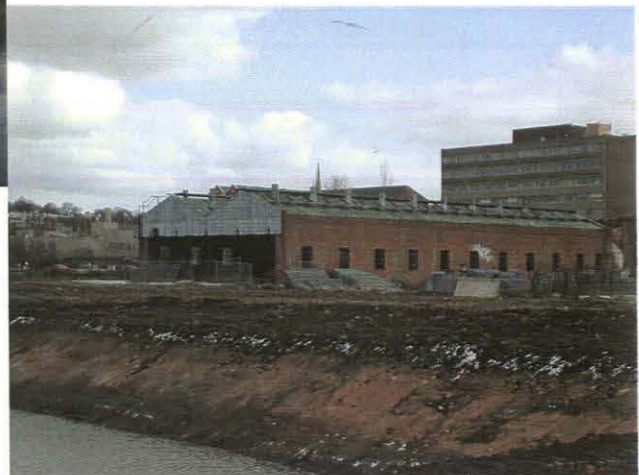
Pl. 6 General view of the engine shed S and W elevations (looking NE)

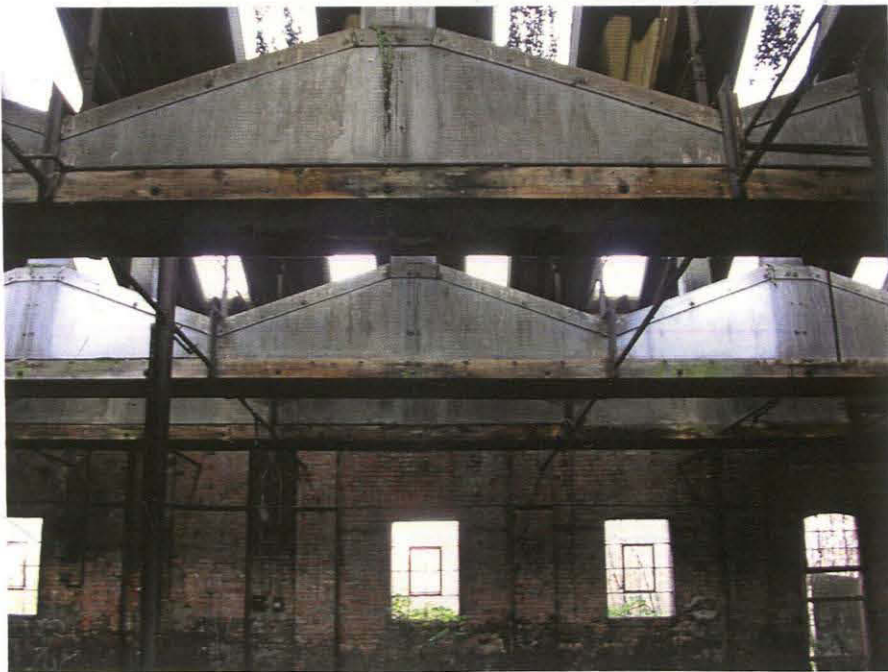
Pl. 10 Engine shed interior, detail of ventilation hoods

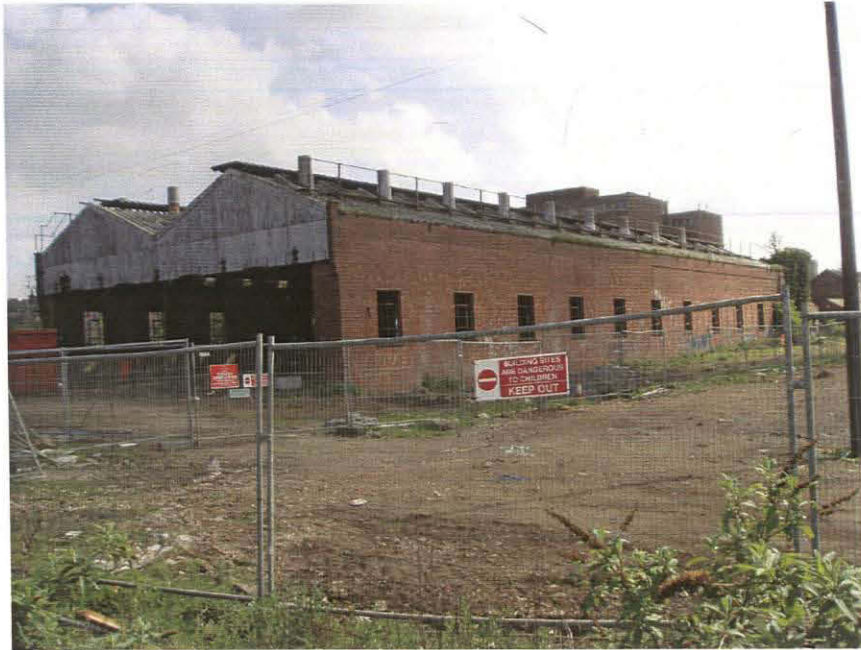
Pl. 11 Engine shed S elevation

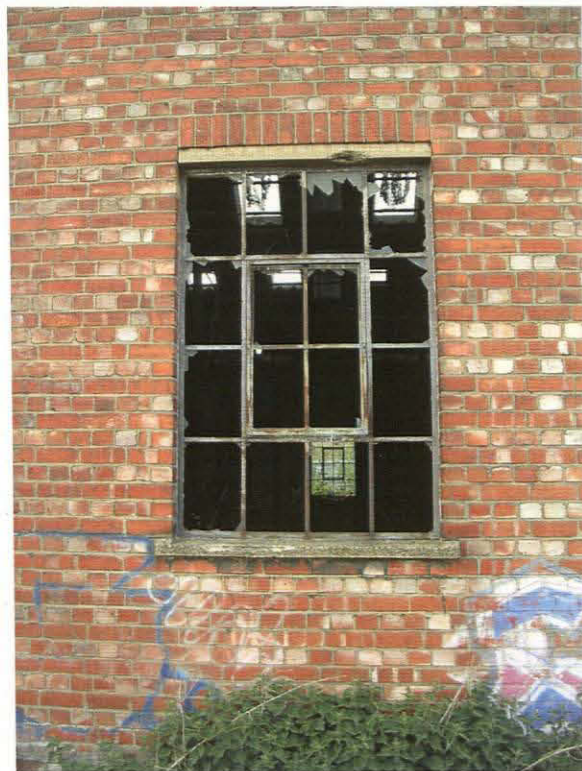
Pl. 12 Engine shed S elevation, window

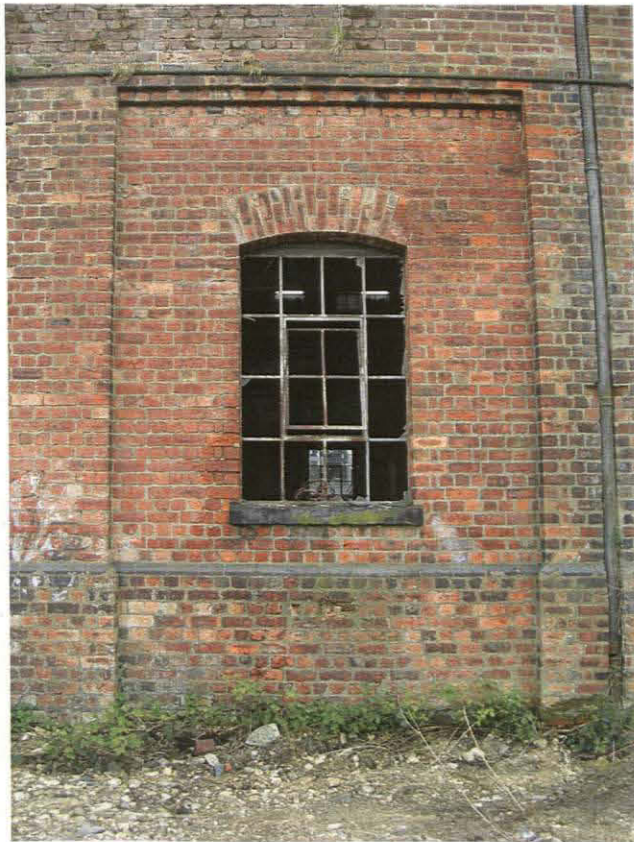
Pl. 14 Engine shed N elevation, window

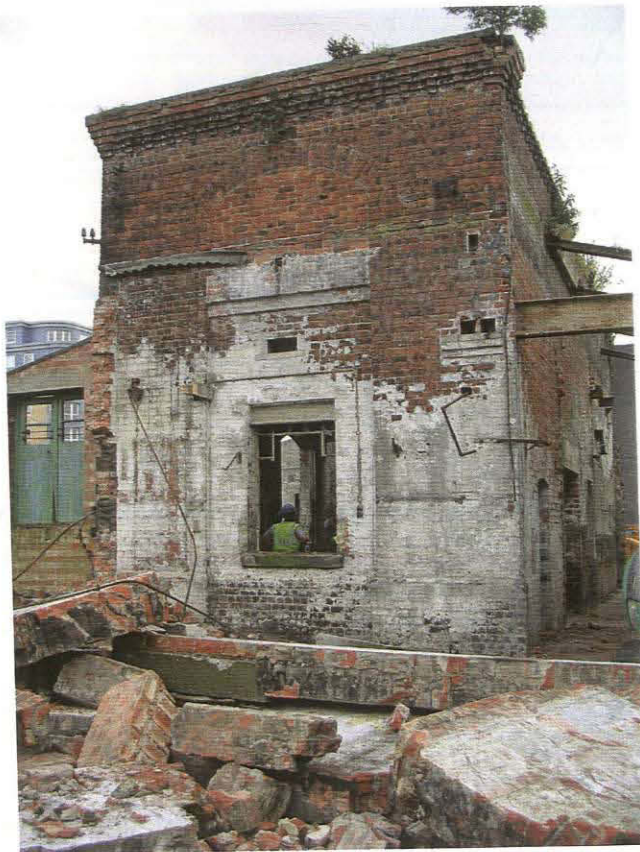
Pl. 17 Water tower after demolition of the north extension, looking south

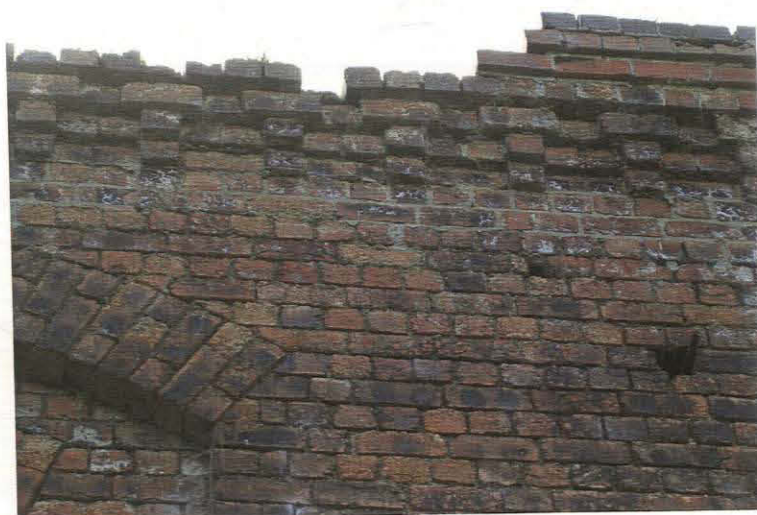
Pl. 18 Water tower , detail of decorative brickwork

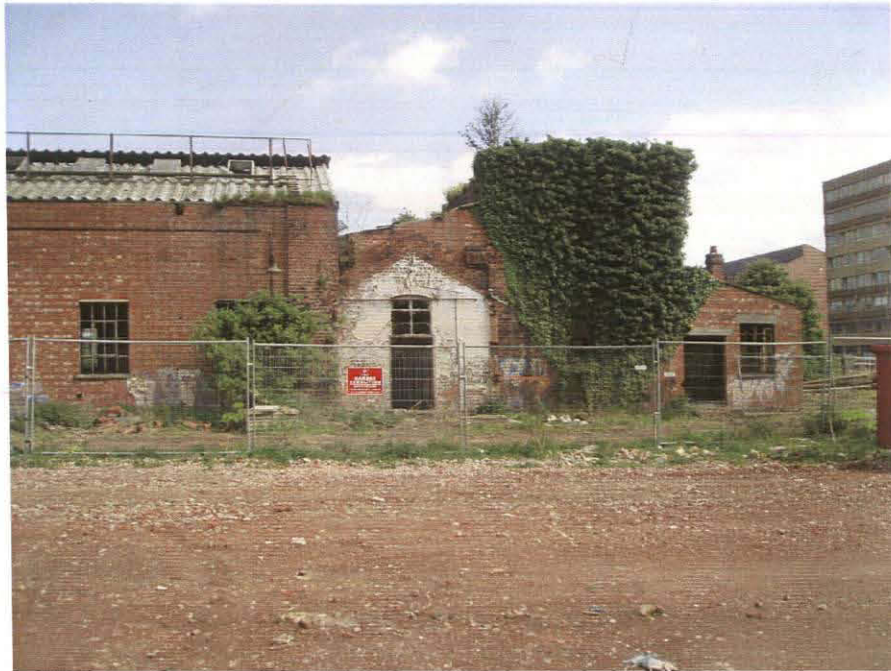
Pl. 19 Water tower, west and east extensions, south elevation

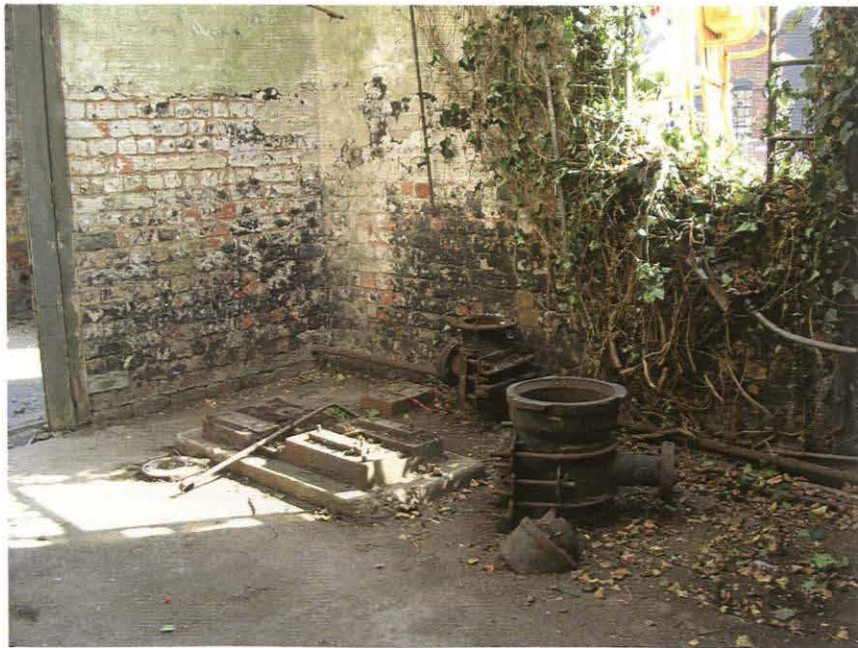
Pl. 28 Water tower interior, pump room fittings in the floor, looking S.

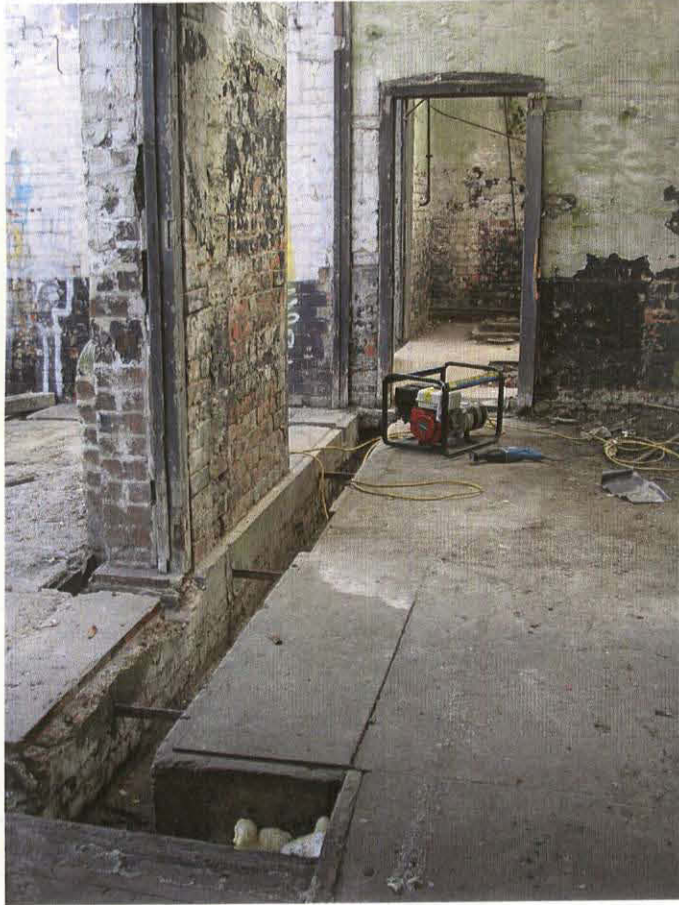
Pl. 29 Water tower interior, boiler room, looking N.

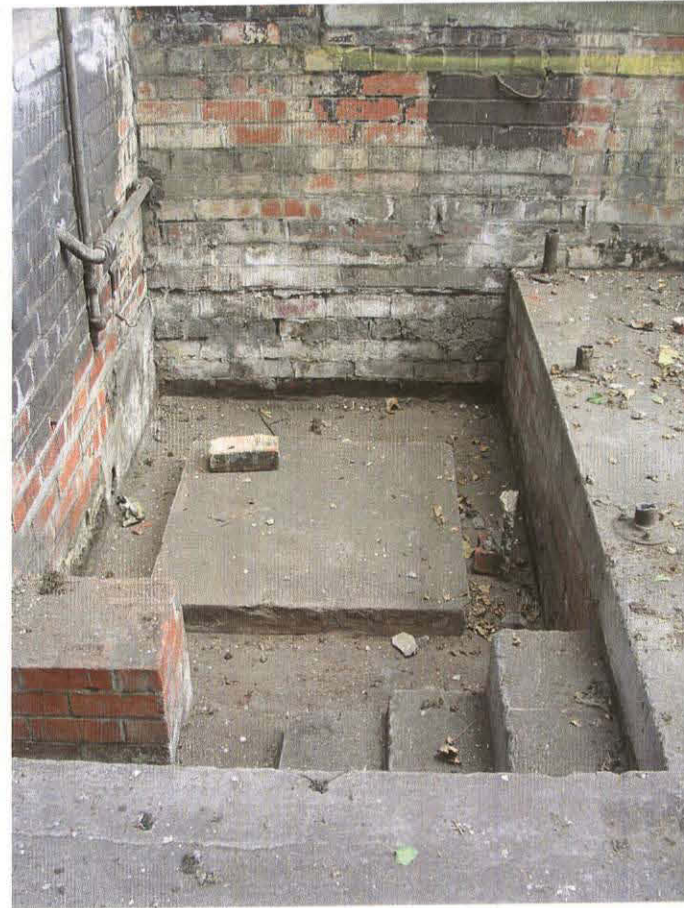
Pl. 30 Water tower interior, boiler room tank base, south end of the room

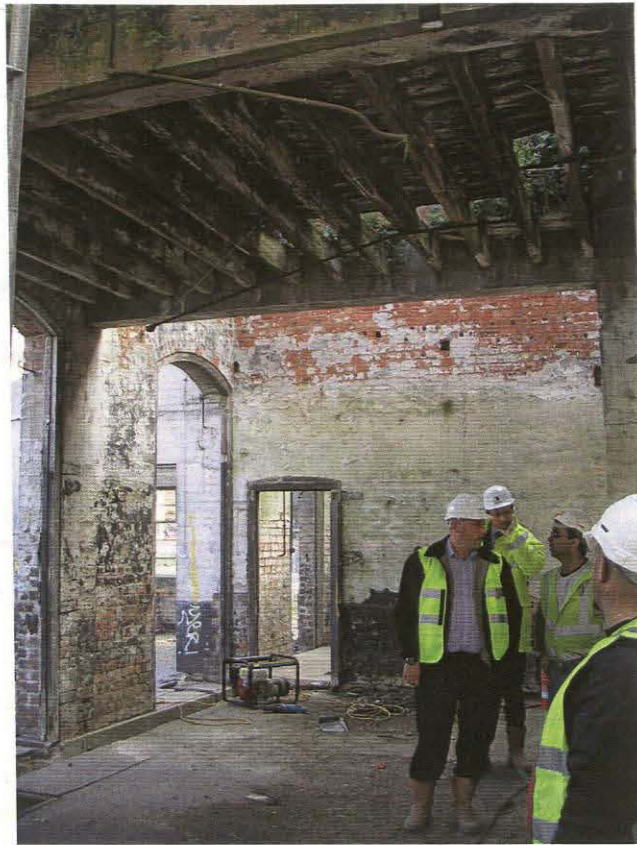
Pl. 31 Water tower interior, boiler room looking N

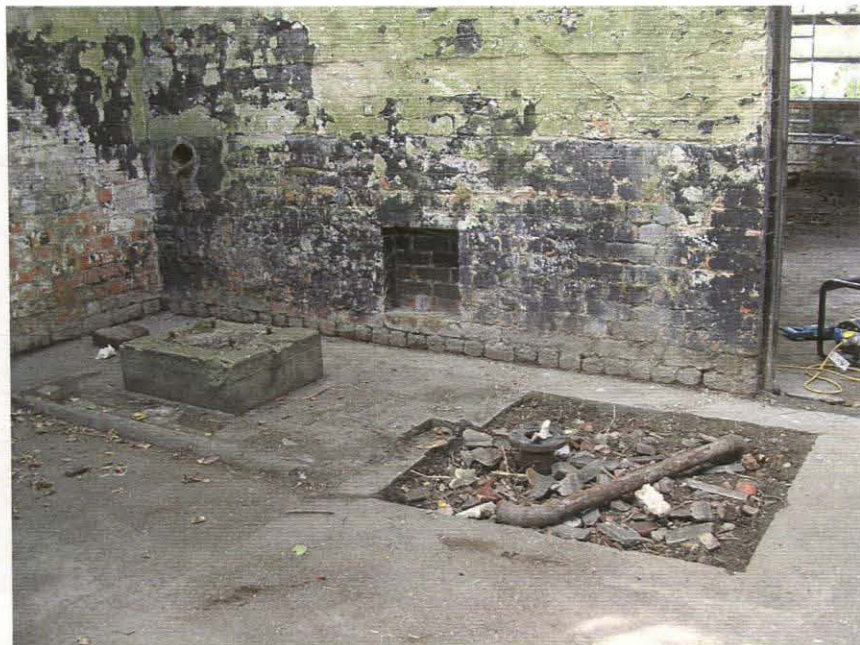
Pl. 32 Water tower interior, oil room, tank base at S end of room

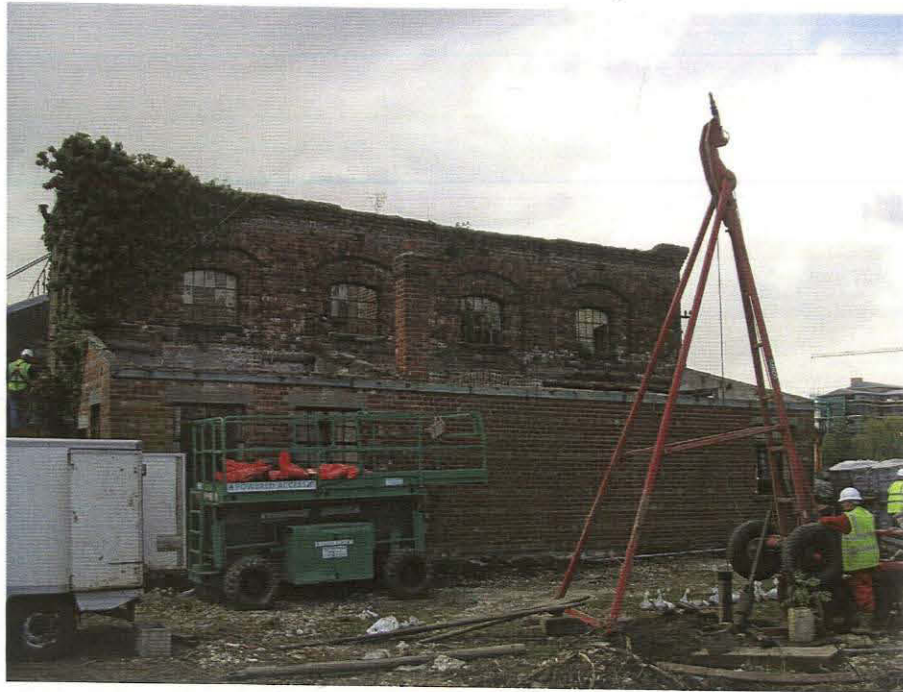
Pl. 33 Piling in progress to east of the water tower, looking NW.

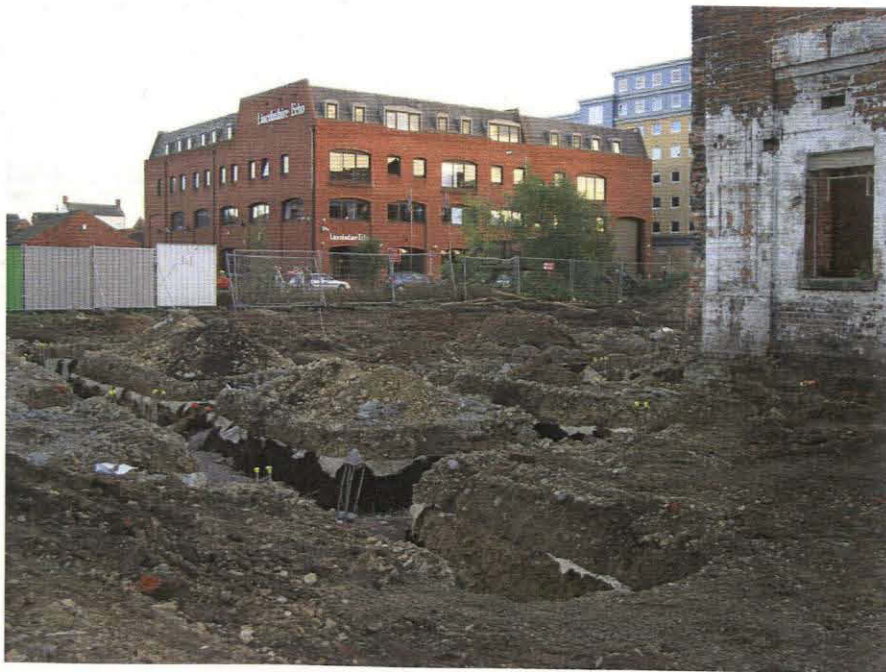
Pl. 34 Groundworks north and east of the water tower (looking south-east)

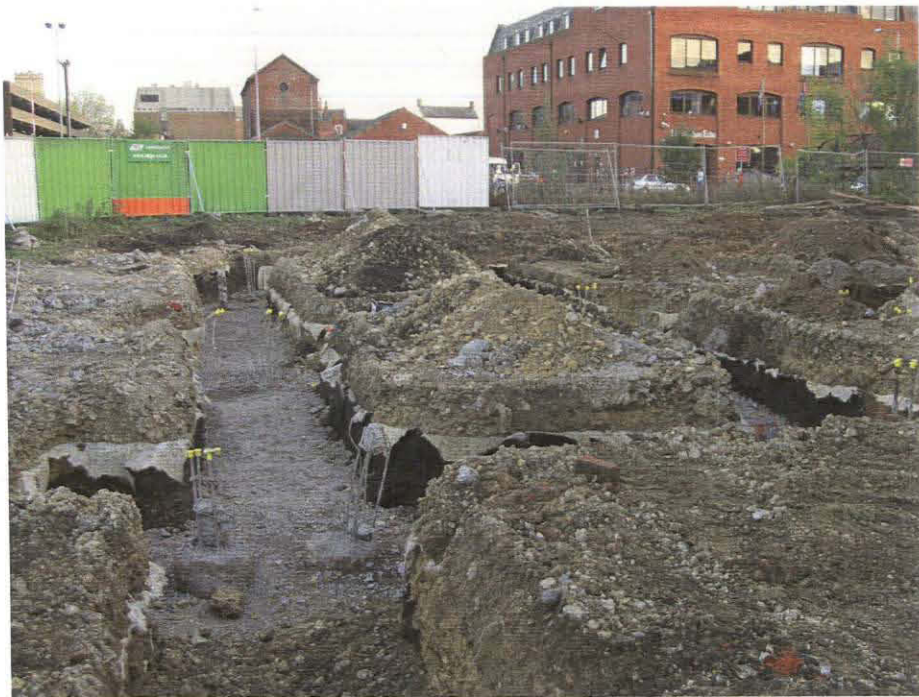
Pl. 35 Groundworks north and east of the water tower (looking east)

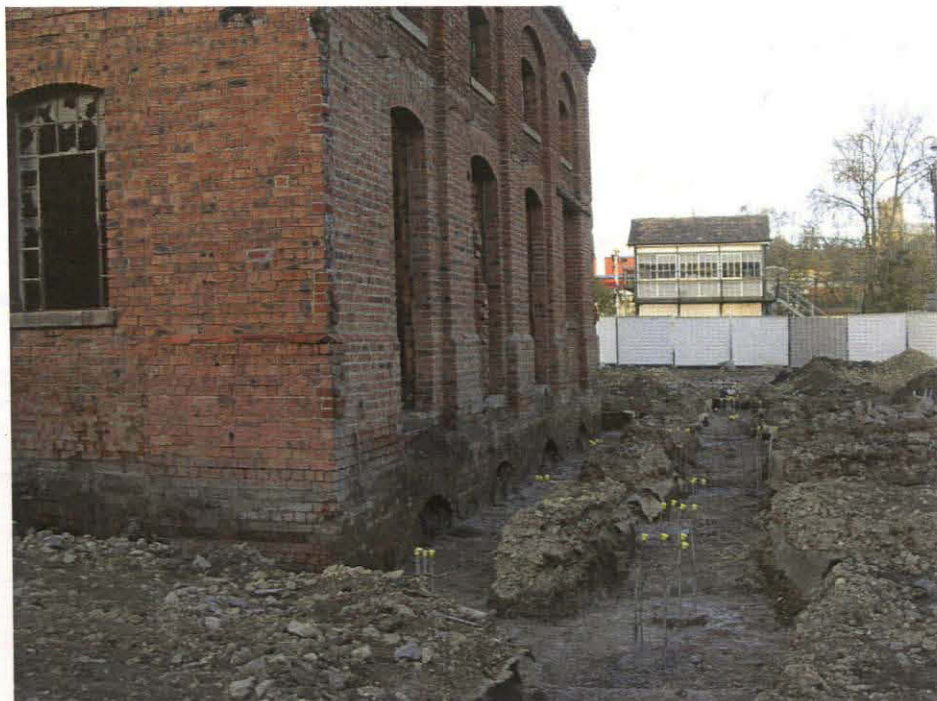
Pl. 36 Groundworks east of the water tower (on site of the east extension, showing the brick relieving arches at ground level (looking north)

and poured the concrete foundations. To the east of the water tower, the uppermost 0.4m of deposits remained visible in the trench faces, overlain by a textile membrane and covered by recently redeposited material. Only a very dark brown peaty material was visible (Pls. 34, 35). The peaty material was not present within \*m of the building and in this position a brown mixed fill is suspected to mark the position of a construction trench for the water tower. An offset brick foundation course was visible to the north of the water tower wall. Four open relieving arches were visible in the brickwork below the east elevation (Pl. 36).
