**The Engine Shed and Lincoln Centre for the  
Performing Arts Building, Brayford Campus  
University of Lincoln, Lincoln  
Archaeological Building Recording and  
Environmental Assessment**

**Report**

**LAS Report No. 1083**

**October 2008**

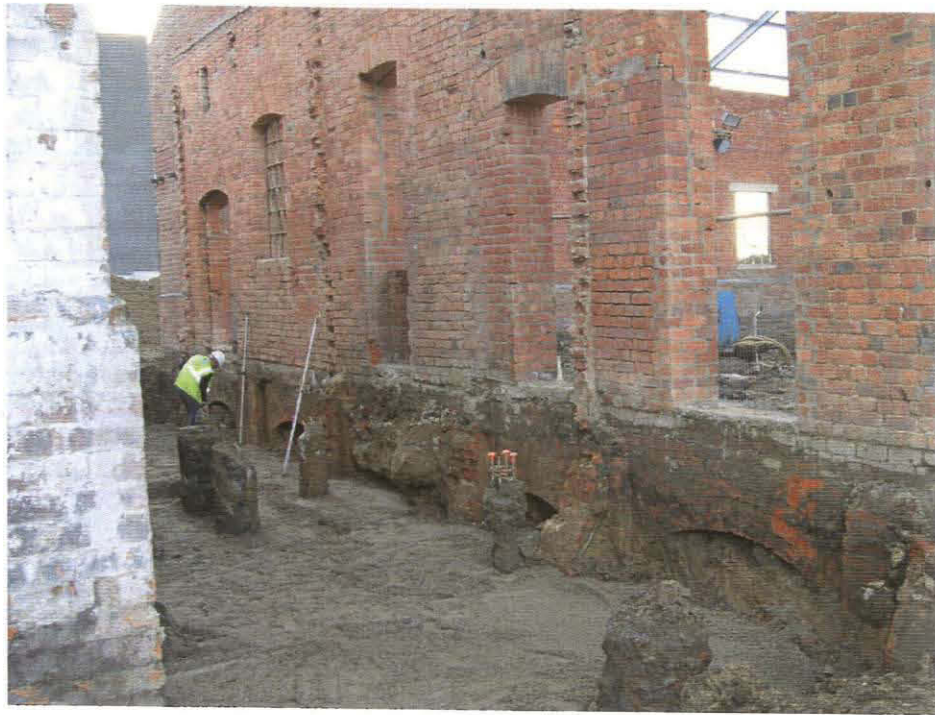
Pl. 37 Groundworks west of the water tower (on site of the west extension, showing the brick relieving arches at ground level (looking north)
