**SURVEY OF BUILDING AT
THE FORGE,
94 MAIN STREET,
EWERBY,
LINCOLNSHIRE
(ETF05)**

Work Undertaken For
G. Hunter and M. Harrold

December 2006

A.P.S. Report No. 192/06

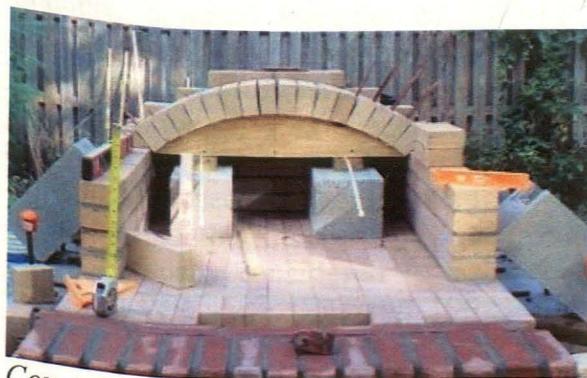
Both the ashbox and the baking area of the oven have domed tops. It seems likely that these were moulded on a support of sand, or possibly using a wooden template/former. Modern domed-roof bread or pizza ovens are constructed using wooden or metal templates. This doming of the roof was to radiate heat evenly on the items being cooked.

Construction of modern oven using wooden template.

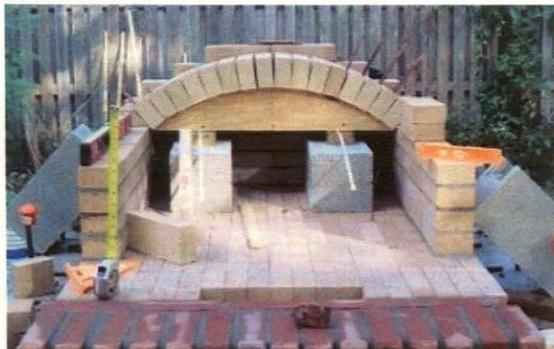
Both the ashbox and the baking area of the oven have domed tops. It seems likely that these were moulded on a support of sand, or possibly using a wooden template/former. Modern domed-roof bread or pizza ovens are constructed using wooden or metal templates. This doming of the roof was to radiate heat evenly on the items being cooked.

Construction of modern oven using wooden template.

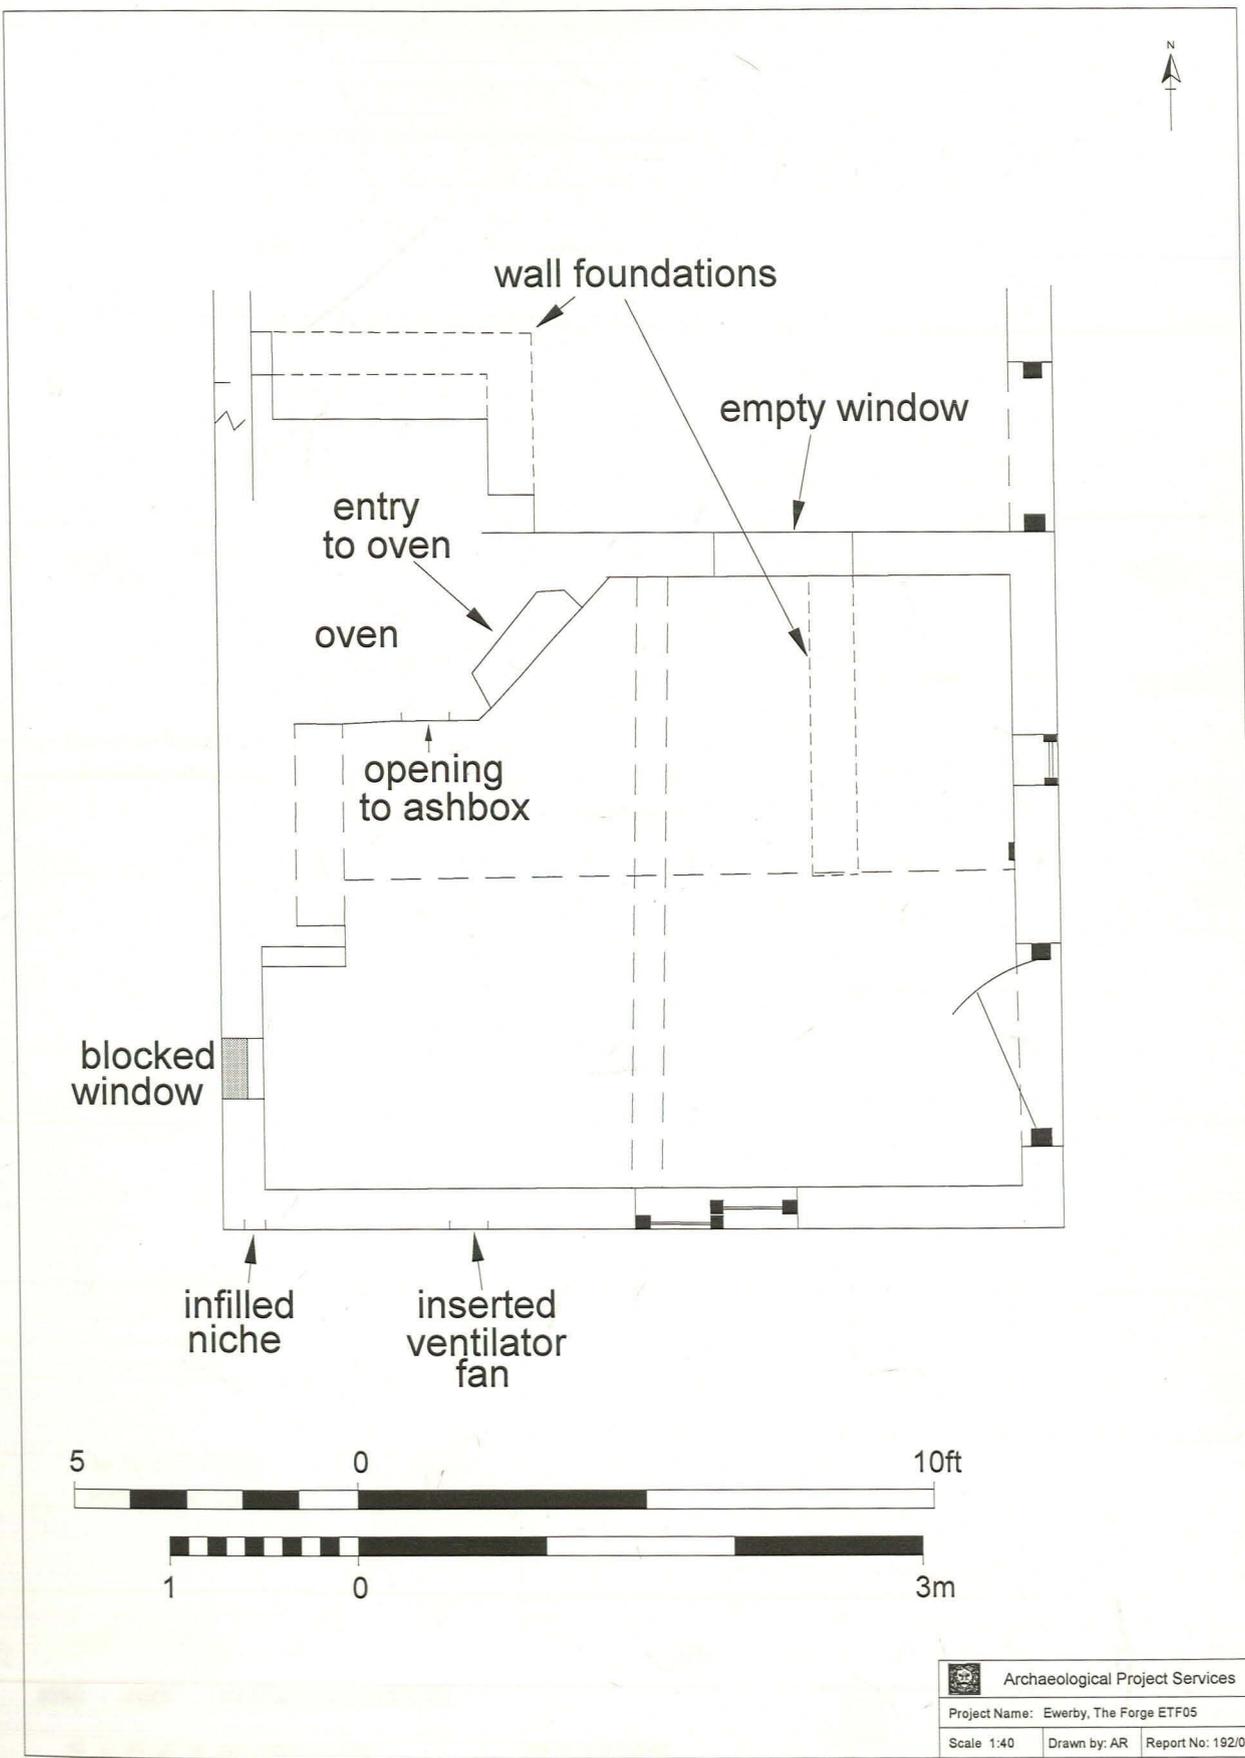
Figure 4 Plan of Examined Building

A single room, the kitchen has a concrete floor and is crossed by a central tie beam aligned north-south. In the northeastern corner is a toilet and alongside this a foundation for a removed wall around the WC.

- the production of a dimensioned plan (Fig. 4)
- drawings showing the location of significant structural detail and also section drawing showing vertical relationships (Figs. 5 and 6)
- a written record of the building's type, materials, possible dates and development sequence, form, function, past and present use and use of its parts, and details of the relationship of the building to its setting
- general photographic views of the exterior of the building and the overall appearance of principal

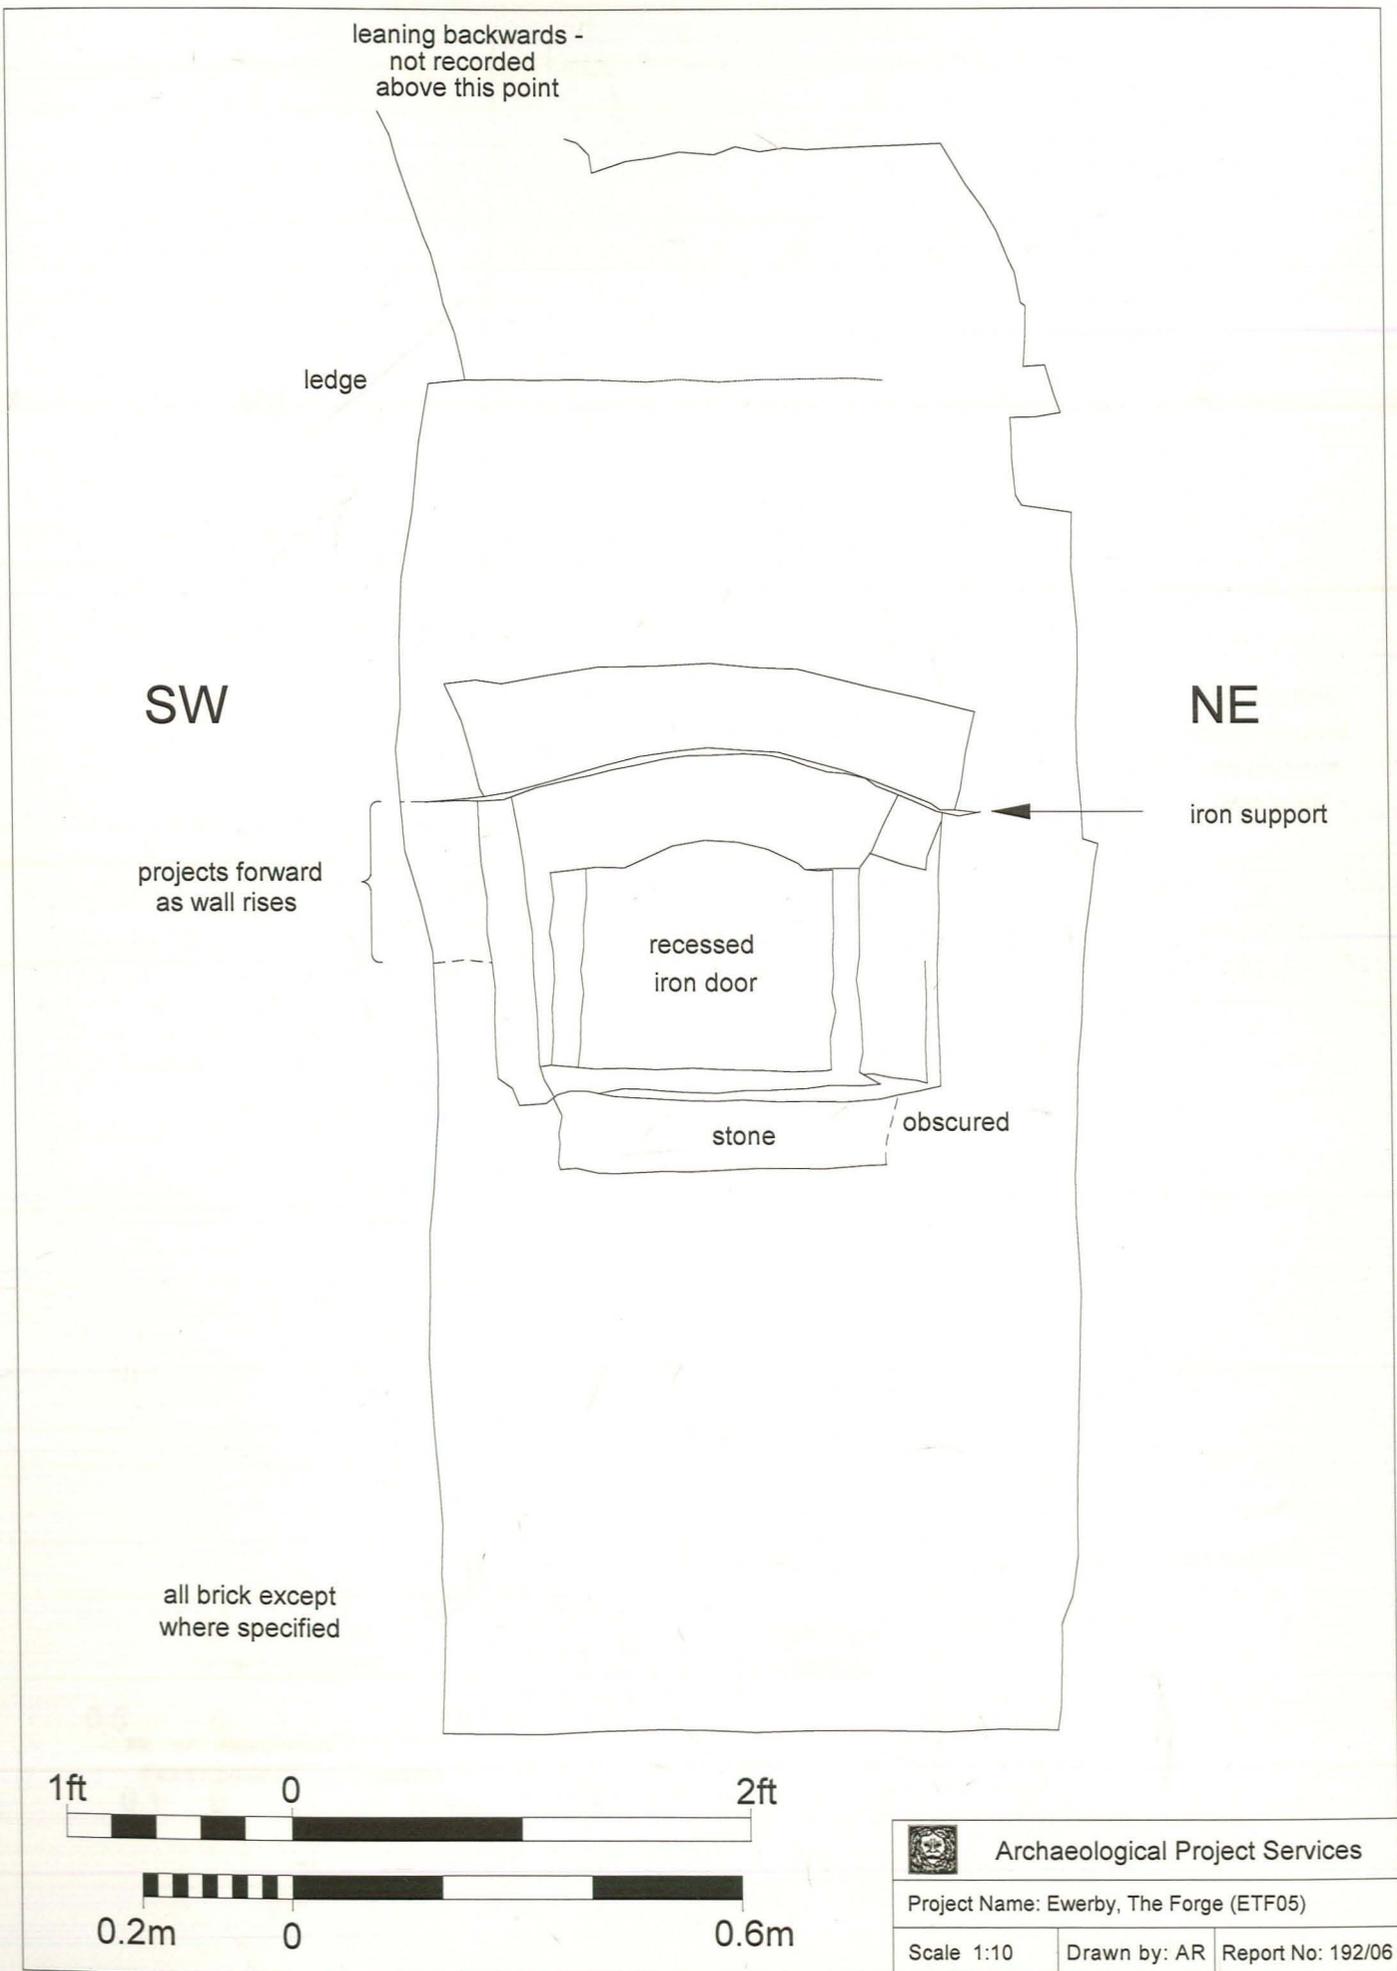
Figure 5 Front Elevation of Oven

The canted face of the oven contains a recess that has an arched front supported by a cast iron bar. There is a stone sill at the front of the recess and immediately behind this an opening down into an ashdrop below the oven (Plate 13). Within the back wall of the recess is a cast iron door which opens into the domed oven (Plate 14).

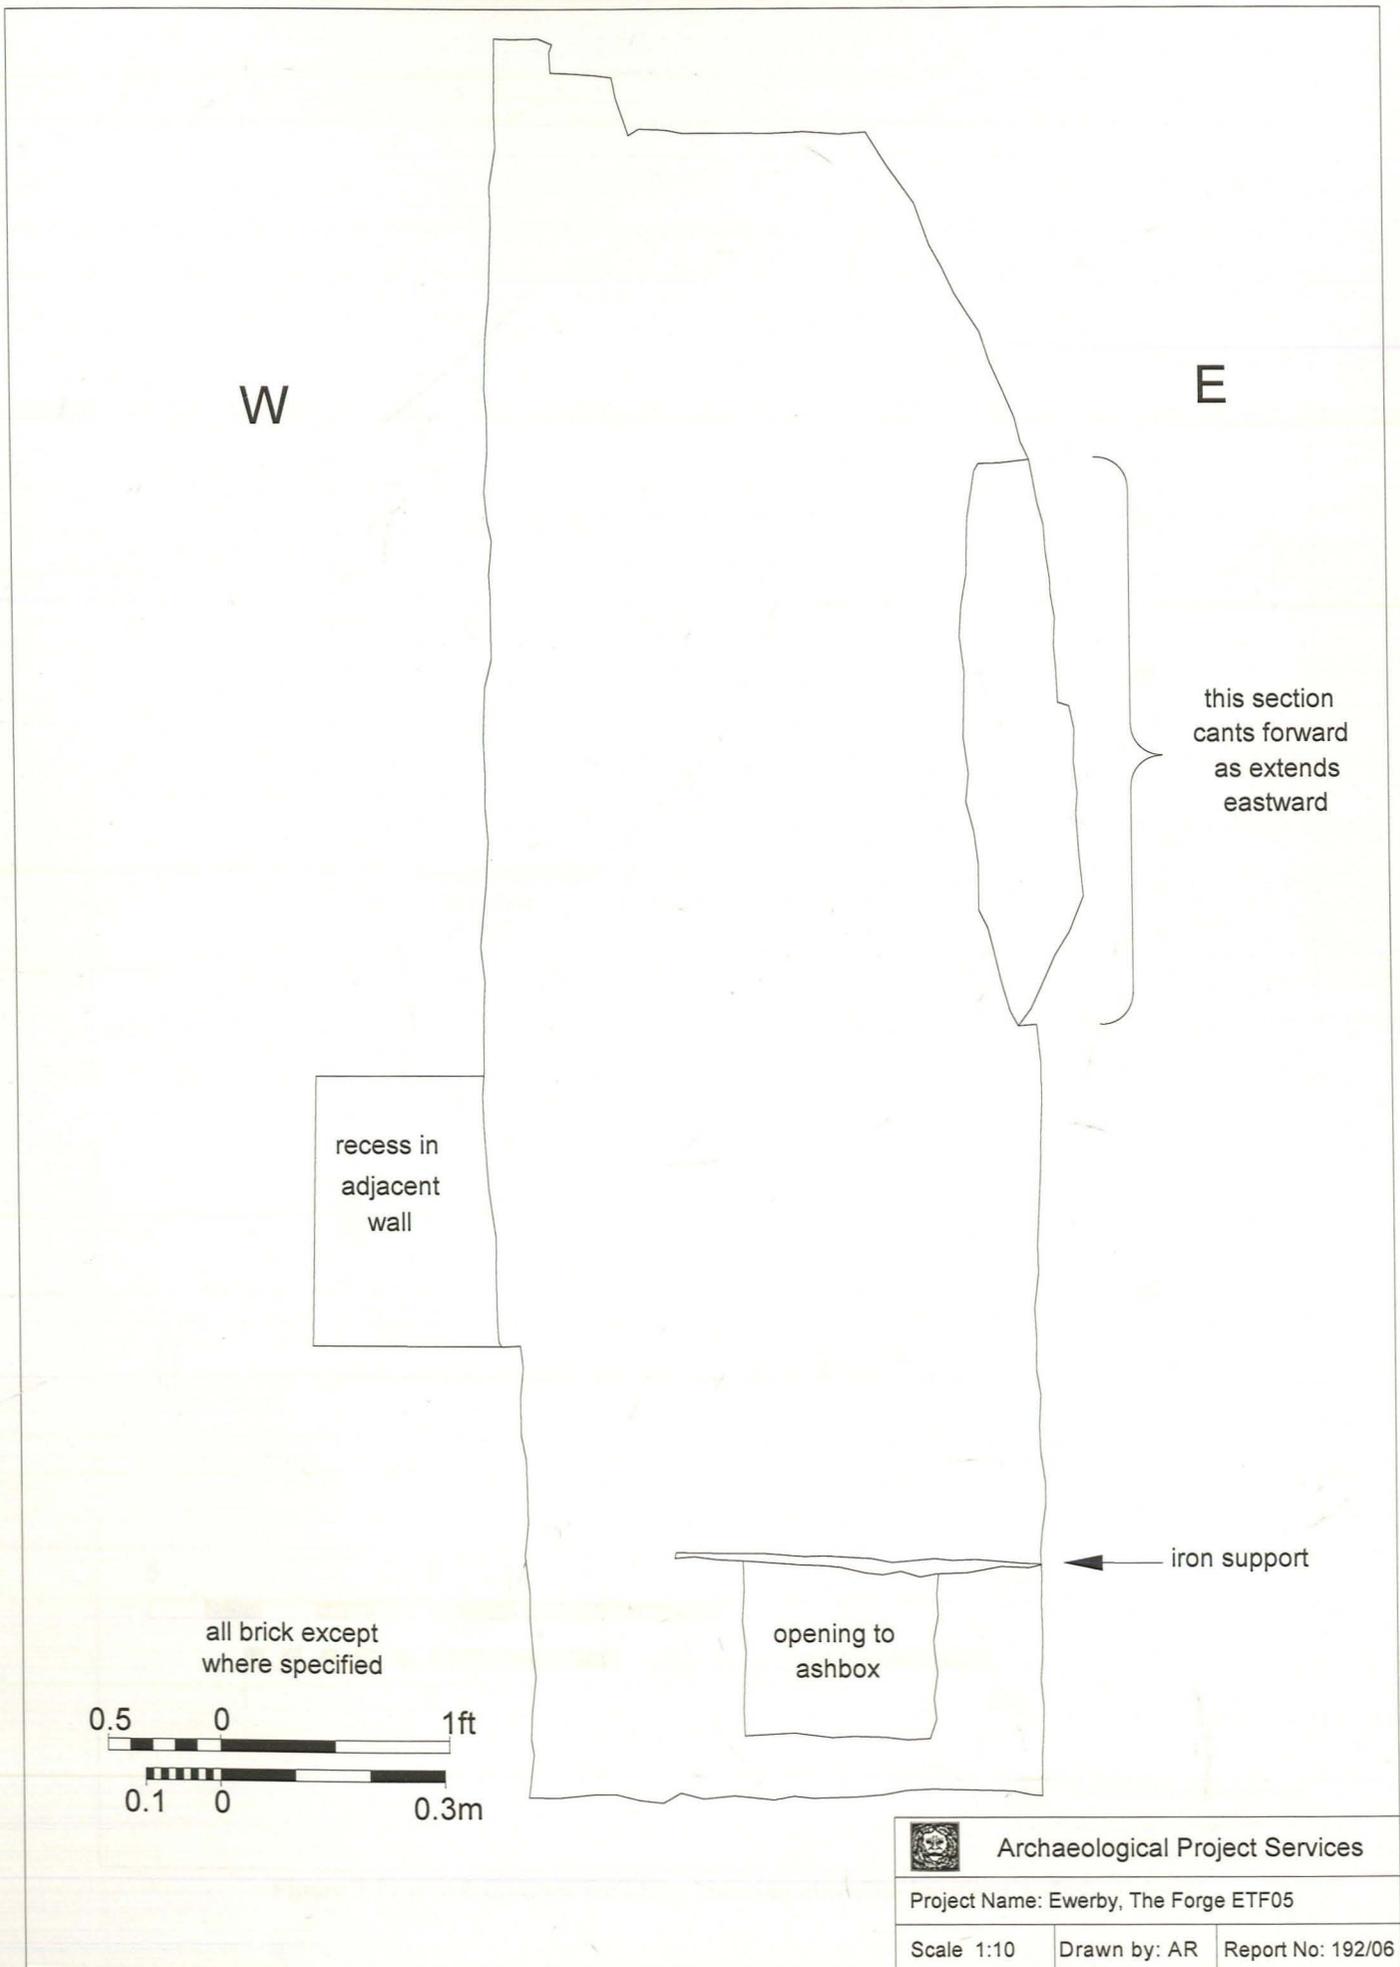
Figure 6 South Side Elevation of Oven

Low in the south wall of the oven is the raking-out opening to the ashbox, which has a cast iron bar lintel (Plate 15). Dismantling of the oven revealed that the ashbox had a brick-built domed roof (Plate 16).

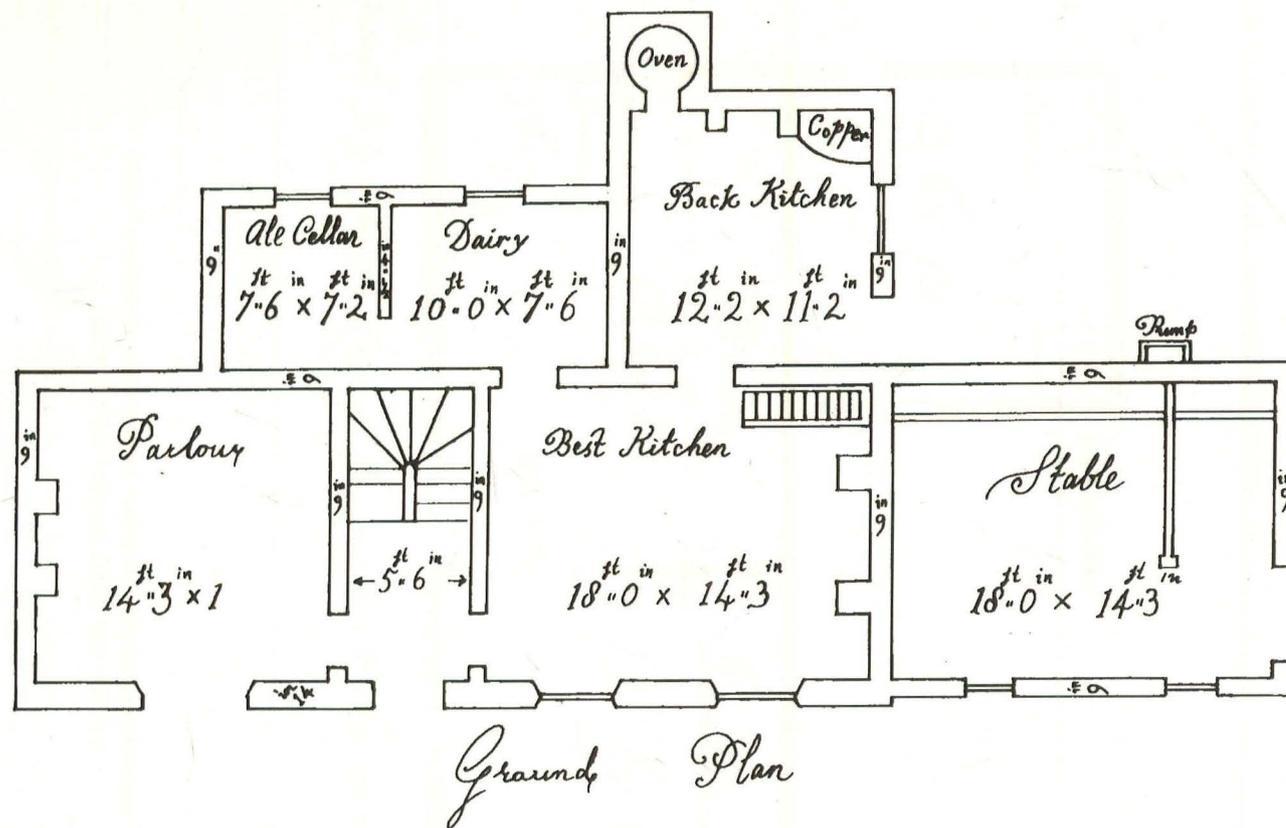
Figure 8 Plan of Building at Hough-on-the Hill, showing kitchen arrangements

A mid 19th century farmer's house at Hough-on-the Hill, about 20km west of Ewerby, was designed with two kitchens, one described as 'best' and the other the back kitchen. In one rear corner of the back kitchen was a circular oven, the greater part of which projected out to the rear of the room, while in the other back corner was a copper boiler (LA 3BNL.29). Although forming part of the same building as the house, this back kitchen at Hough-on-the Hill is very similar in format to the detached kitchen at Ewerby, particularly with the oven projecting beyond the room (Fig. 8). This may imply that the detached structure at Ewerby also served a subsidiary function, comparable to the back kitchen at Hough.

Mr Thos. Lord's House at Hough, 1843 (Lincolnshire Archives Office 3 BNL.29)

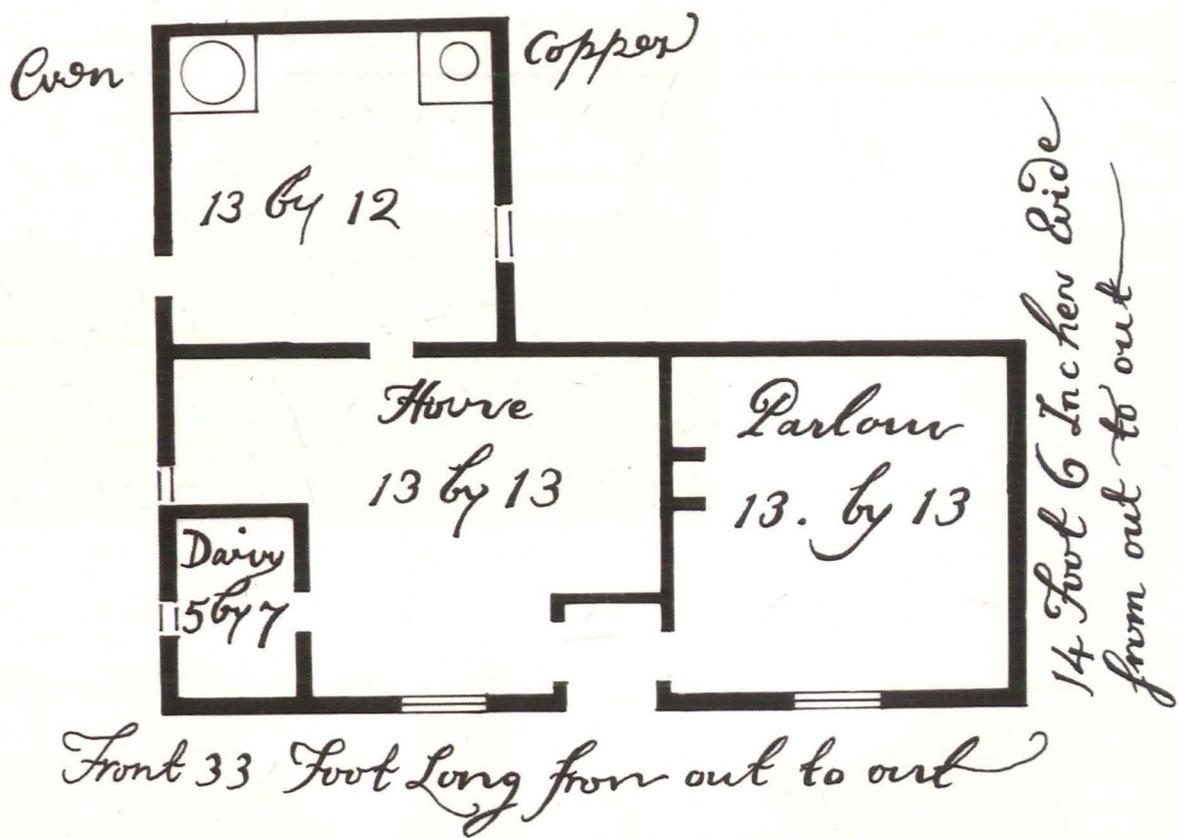
Figure 9 Plan of Building at Saxilby, showing kitchen arrangement

Plans made for a small farmhouse at Saxilby, near Lincoln, in 1764 (LA Mon 8/51/12) depict a similar arrangement to that at Hough-on-the-Hill. At Saxilby, the farm building had an L-shaped arrangement, with the attached kitchen to the rear of the house and parlour. As at Hough, the oven and boiler occupied opposite corners at the rear of the kitchen (Fig. 9).

Plan of a small farmhouse to be built at Saxelby for Lord Monson, 1764
(Lincolnshire Archives Office Mon 8/51/12)

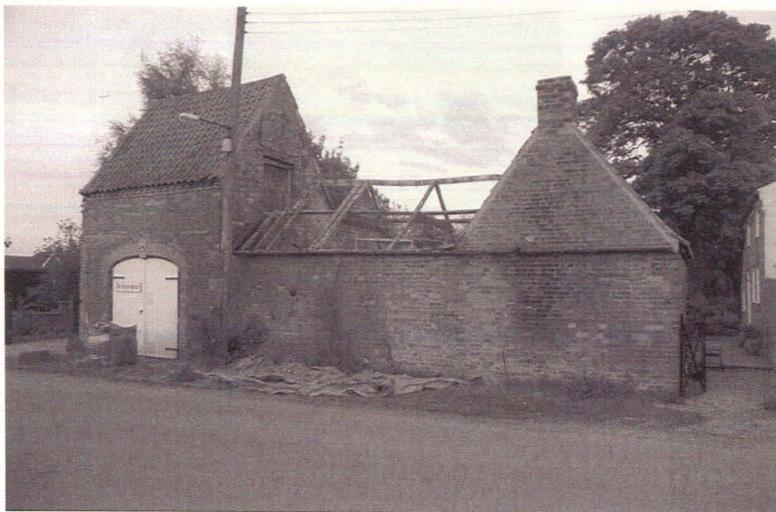
The recorded structure is part of a range of outbuildings located immediately to the northwest of the present residential house (Figs. 3 and 4; Plate 1).

Plate 1 General Site View, showing recorded building (right end of range), with house on extreme right, looking east

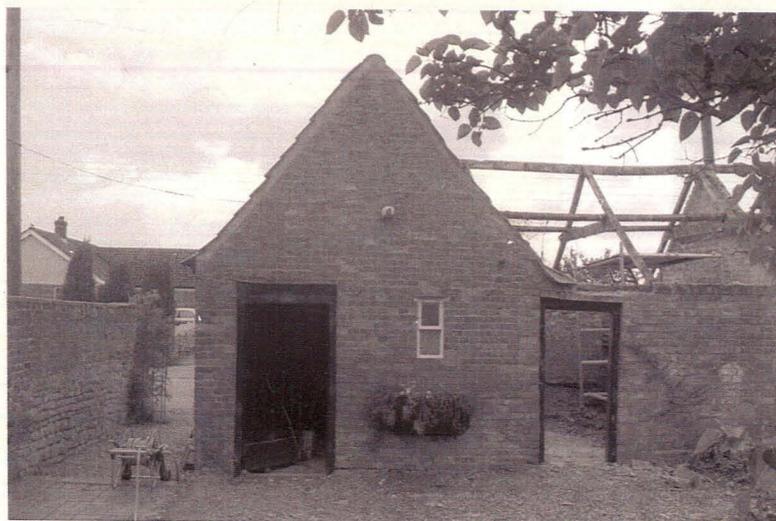
Forming the frontage of the room, the eastern gable contains a planked doorway of fairly recent date and a small modern top-pivoting sash window (Plate 2). Both openings have timber lintels. Directly north of the gable is the doorway to the next room which houses part of the oven structure. The junction between the two rooms is effectively marked by a straight join.

Plate 2 Recorded building, east gable, looking west

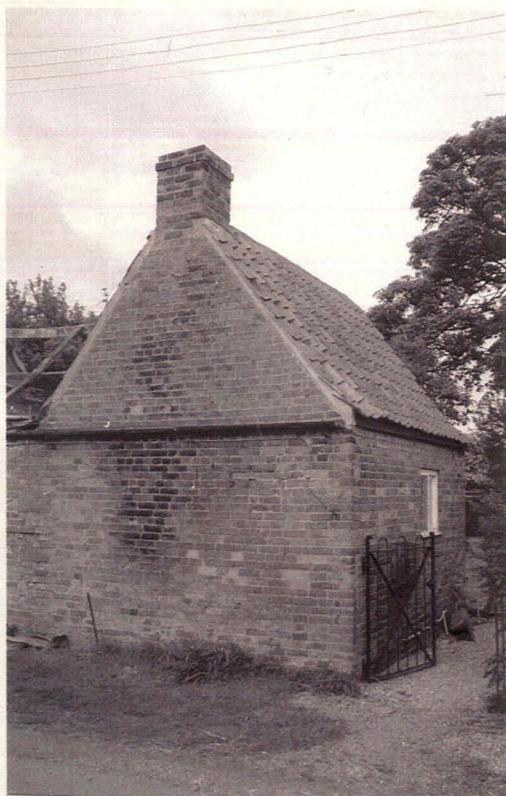
The southern elevation (Plates 3 and 4) contains a Yorkshire sliding sash window and a recent inserted ventilator fan. At the western end is a pair of straight joins

The western gable is mostly plain, though there is an infilled window with a timber lintel toward the southern end (Plate 3). In addition, the western wall extends northward beyond the limit of the gable, and there is a straight join about 1m north of the end of the gable (Plate 5). There is no obvious joining between the wall of the recorded room and that to the north though the brick bonding changes, in a very irregular way, from English garden wall bond in the recorded structure to English bond in the wall extending to the north.

Plate 3 West and South elevations, looking northeast

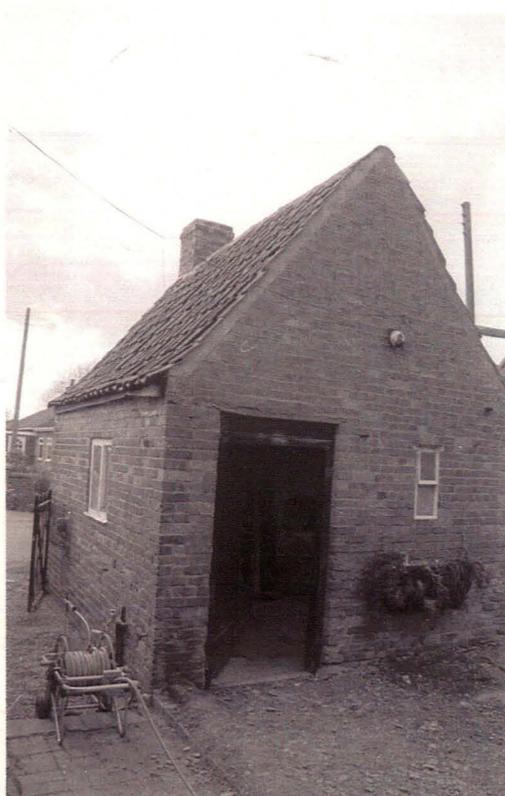
Plate 4 East and South elevations, looking northwest

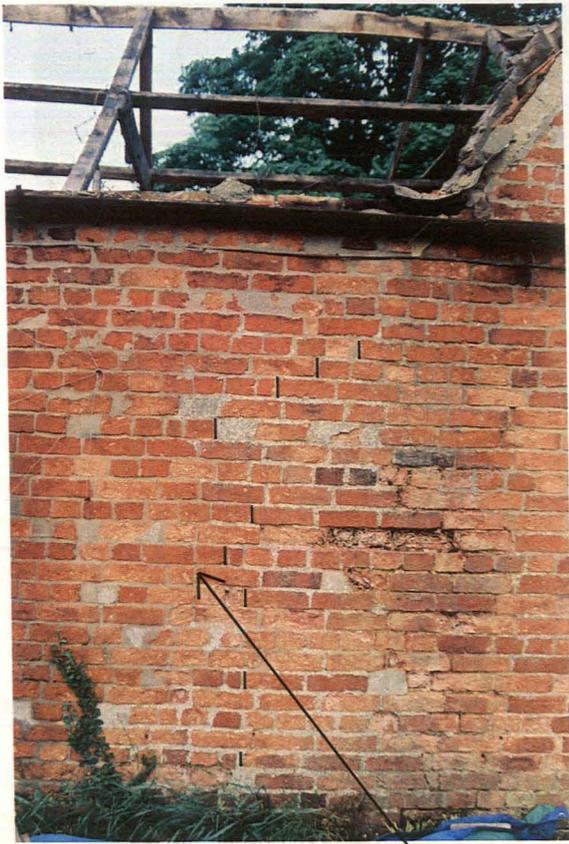
Plate 5 West elevation of recorded building and next to north, showing straight joint, looking east. Note also changes in brick-bonding (vertical lines)

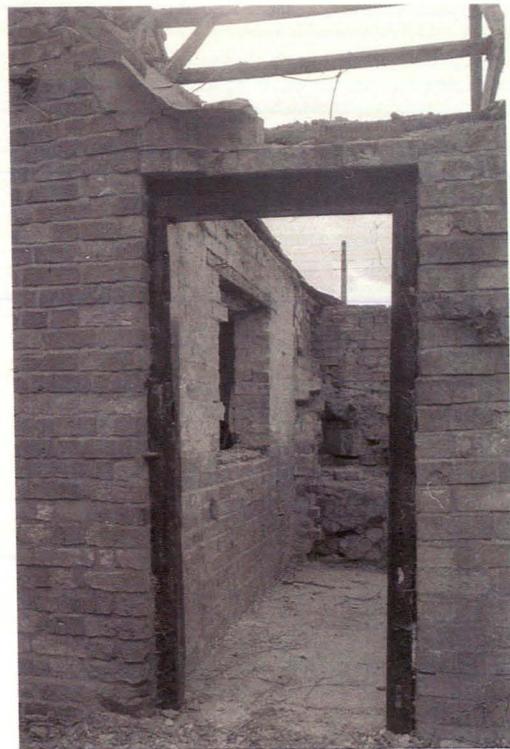
The northern wall of the kitchen is now an internal divide between this room and the next (Plate 6). In the eastern part of the elevation is a former window with a timber lintel, the glazing removed. At the western end of the elevation, and projecting northward from it, is part of the oven (Plates 7 and 8). This has partially collapsed but the oven base, part of the domed roof, and remnants of retaining walls on the east and north side of the oven are evident. At its western end, the northern retaining wall was keyed in to the western wall of the complex.

Plate 6 North elevation, through doorway of room to north, looking southwest

next) is a window. However, being now on an internal wall this window is redundant. This suggests the room to the north is a later addition. Confirmation that the kitchen and adjoining room are of different building phases is provided by the straight join in the eastern elevation, above the door to the room to the north. Additionally, although there is no obvious straight or ragged joins between the buildings in the western elevation, the brick bonding alters from the kitchen to the room to the north, this change reflecting the different phases of construction. Cartographic evidence confirms that the kitchen building was originally free-standing, but other structures were added on its northern side during the second half of the 19th century.

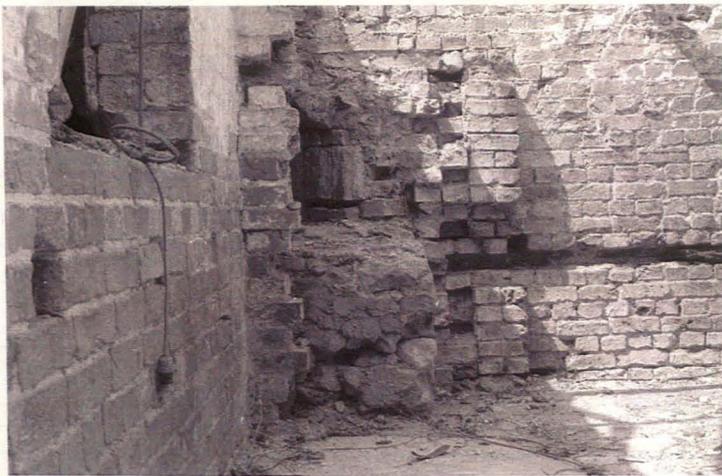
Plate 7 East side of rear of oven, looking west

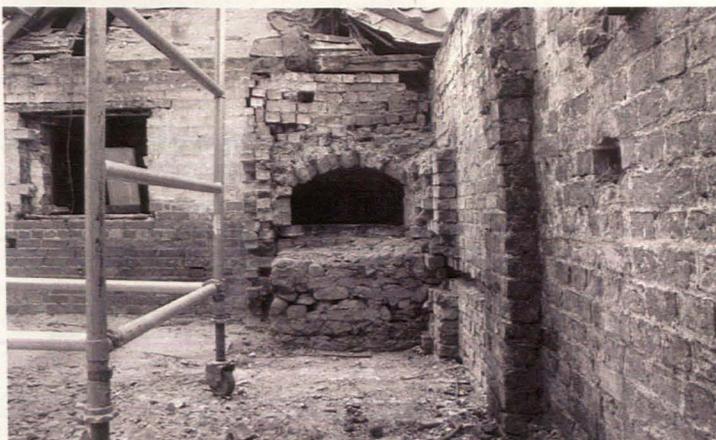
Plate 8 North side of rear of oven, looking south

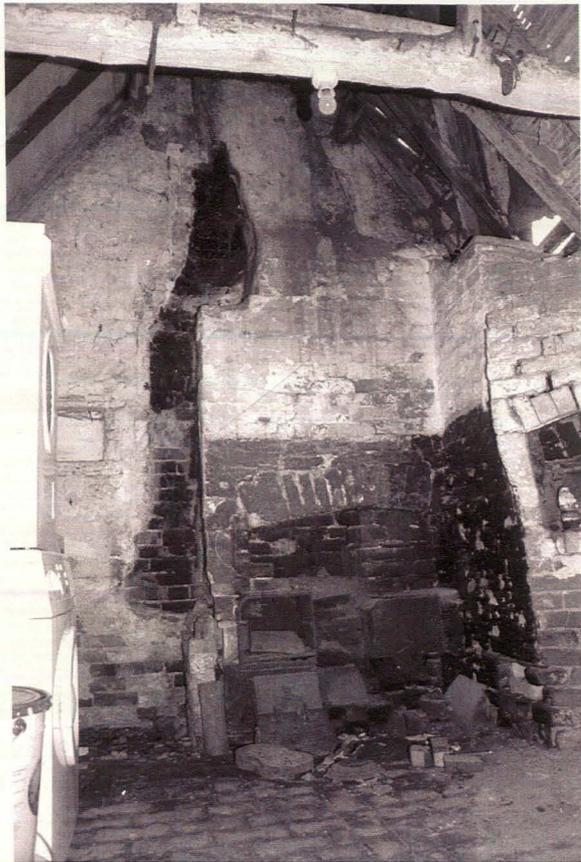
In the middle of the western wall is a projecting hearth containing a cast iron range, with a chimney above (Plate 9). On the south side of this hearth, marking its southern wall and also part of the western wall of the room, is a sooted area that terminates at an opening in the chimney (Plate 10).

kitchen, directly north of the hearth with cast iron range, is an oven that projects in to the room. This slightly overlaps the brick arch of the hearth range (Plate 9). Extending about 1m into the room, the oven has a canted front that reaches a further 0.6m along, and butts against, the north wall of the room (Plates 11 and 12).

Plate 9 Interior, hearth and range with oven on right, looking west

Against the rear wall of the room is a hearth with cast iron range and a separate oven. The hearth and range are probably 19th century – a kitchen grate with iron oven was patented in 1780 (Wedd 2002, 181). Sooting on the walls alongside the hearth and its chimney, particularly on the western wall of the room, indicate the facility previously extended further to the south, but that this extension has since been removed. The sooting pattern, which also occurs on the south wall of the existing hearth, and an opening in to the side of the chimney, suggests that this now-removed section was a later addition to the main hearth.

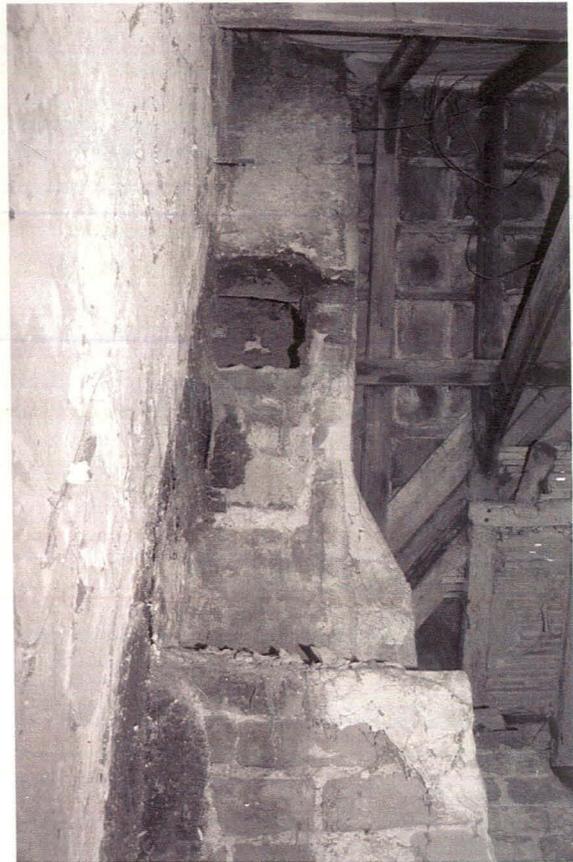
Plate 10 South side of chimney of hearth, showing opening into chimney, looking north

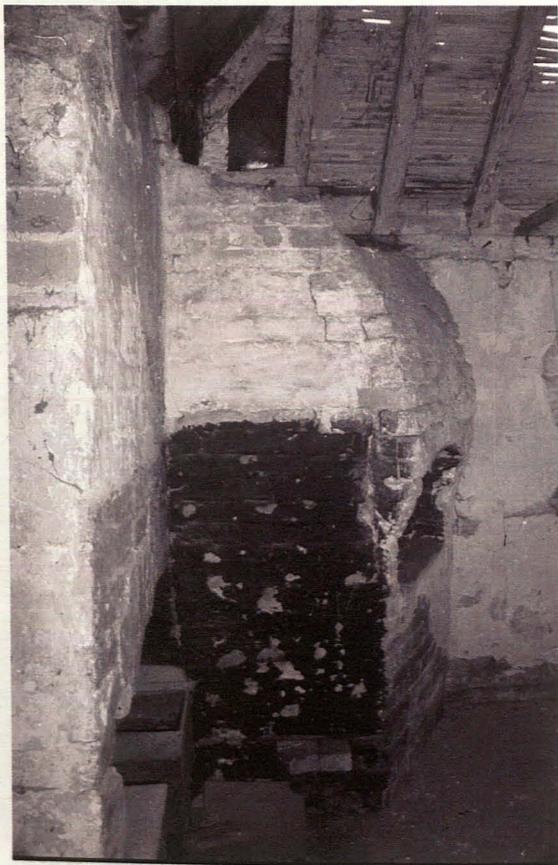
Plate 11 South side of oven, looking north

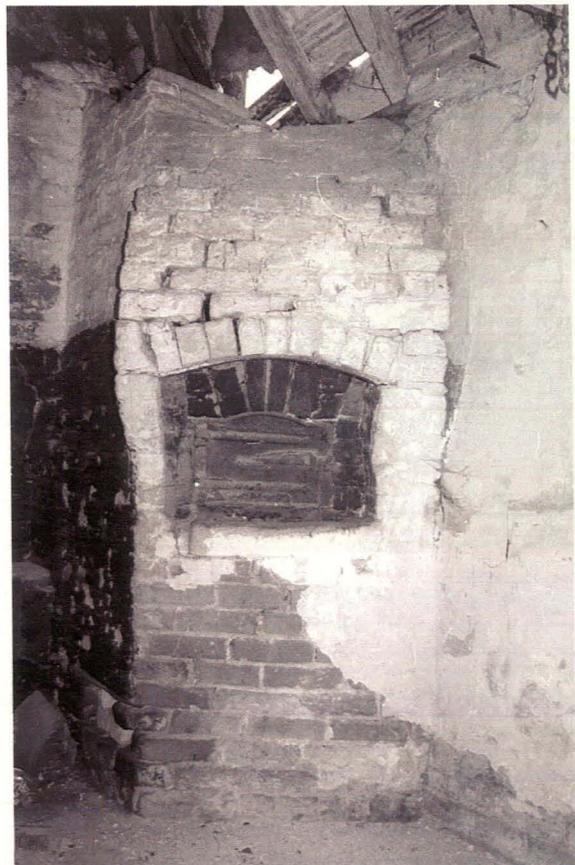
Plate 12 Front, east elevation of oven, looking northwest

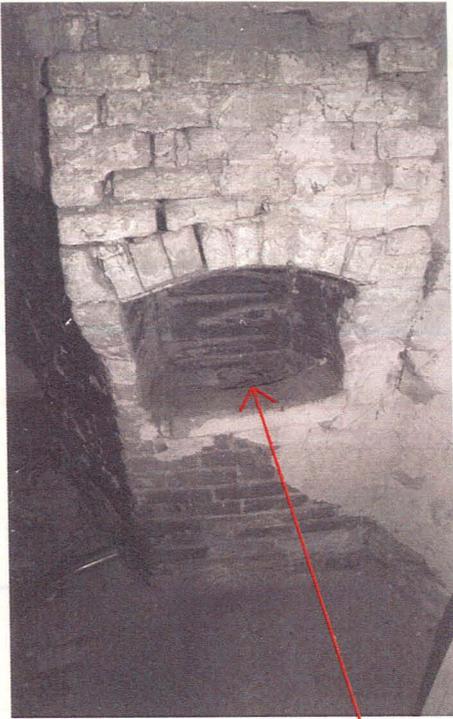
Plate 13 Front of oven, showing ashdrop in front of oven door, looking northwest

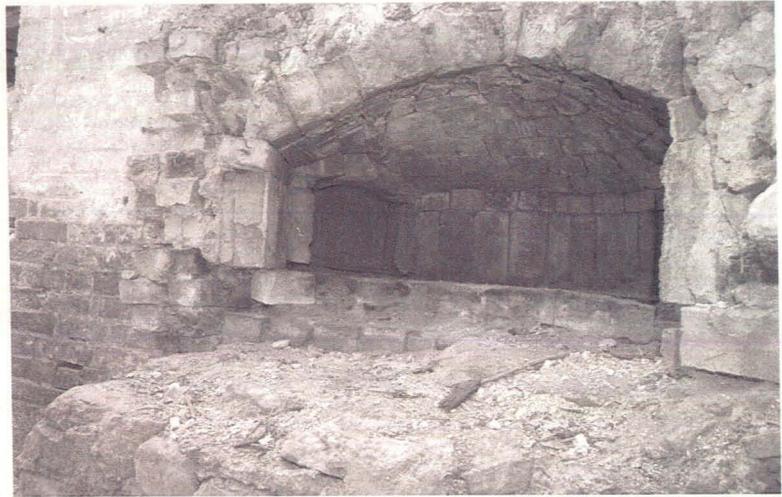
Plate 14 Interior of oven, from rear, looking southeast

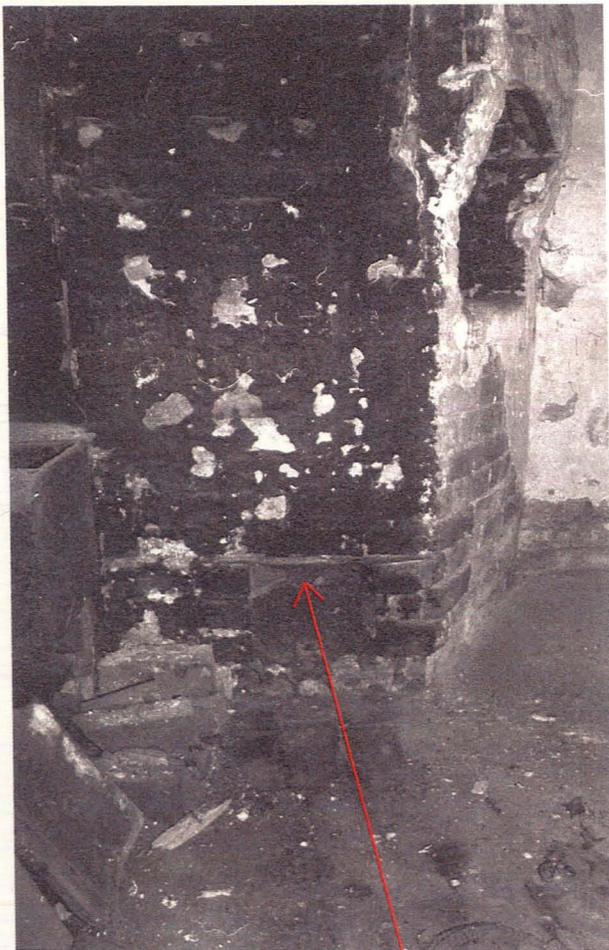
Plate 15 South side of oven, showing cleaning-out duct for ashbox

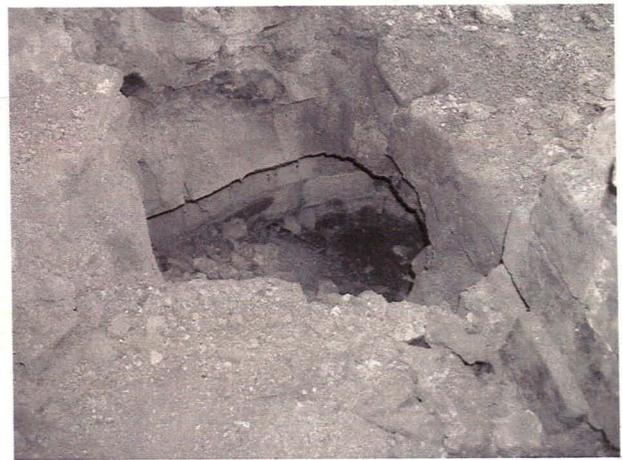
Plate 16 View into ashbox of oven, showing its domed roof, looking west
