**HISTORIC BUILDING SURVEY OF  
THE FORMER METHODIST CHURCH  
AND SCHOOL,  
WEST STREET/MILL LANE,  
BRANT BROUGHTON,  
LINCOLNSHIRE  
(BBMC06)**

Report Compiled by  
Gary Taylor BA(Hons) MA

A.P.S. Report No. **80/06**

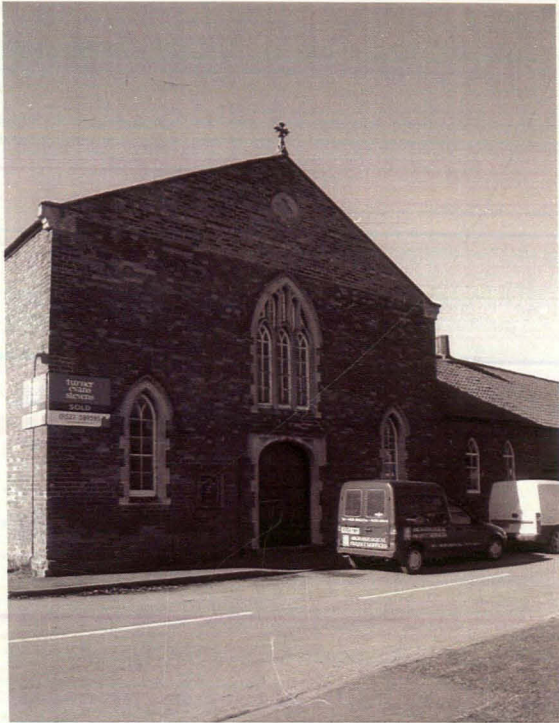
Plate 1 General Site View, showing recorded church (left) and school (right), looking southwest

The recorded structures form an L-shaped arrangement of buildings located at a street corner (Figs. 2 and 3; Plates 1 and 2).

Surmounted by a stone cross, the northern gable contains the main entry to the church, a centrally-located double door (Plates 1 and 6). A boot-scraper is set into the pavement adjacent to the door. Flanking the door are two single-light Gothic Revival windows, while above the entry is a large three-light Gothic Revival window. High in the gable is another quatrefoil panel, though this is uninscribed.

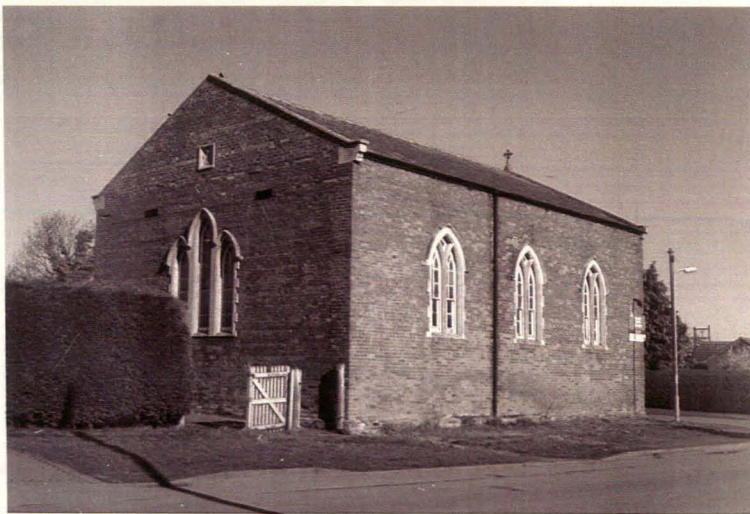
Plate 2 General Site View, showing church, looking northwest

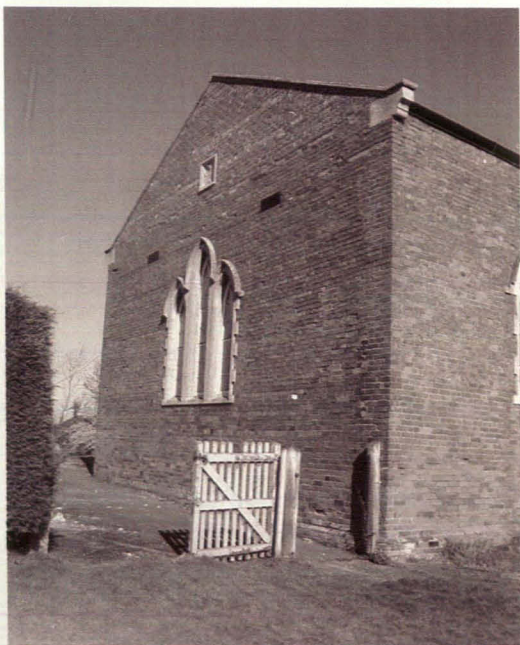
Plate 3 South Gable of church, looking northwest

Centrally-located within the south gable is a three-light Gothic Revival window (Plate 3) and, above this, a quatrefoil stone panel inscribed 'A.D. 1858' (Plate 4). Alterations in the brickwork on the level of the window apex may indicate the building was raised in height. High in the gable is a brick inscribed 'I.S.'

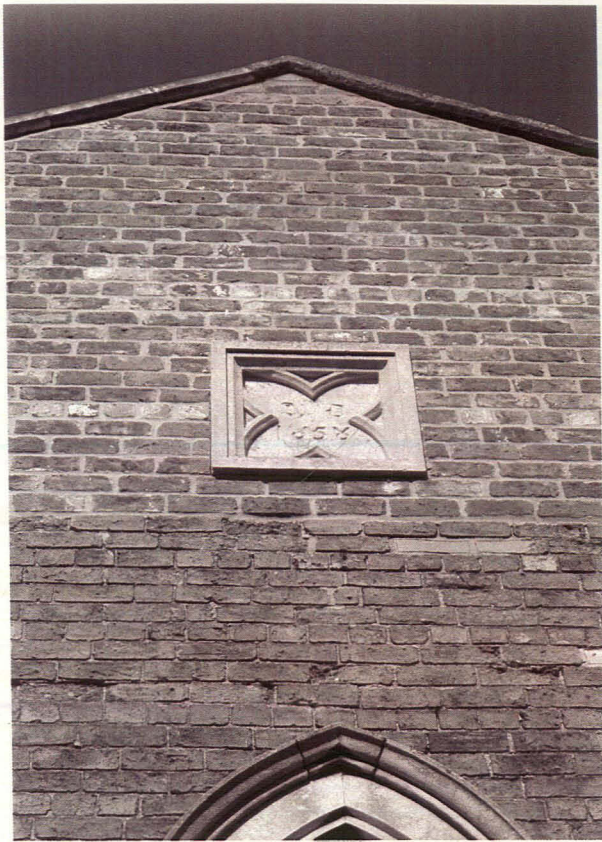
Plate 4 Detail of datestone in south gable of church, looking north

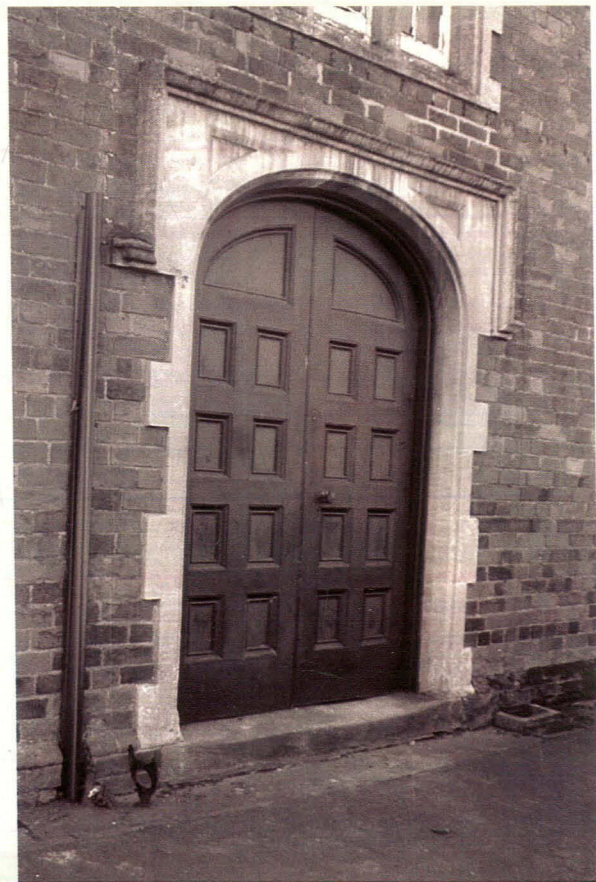
Plate 6 North Gable of church, detail of main doorway, looking southwest

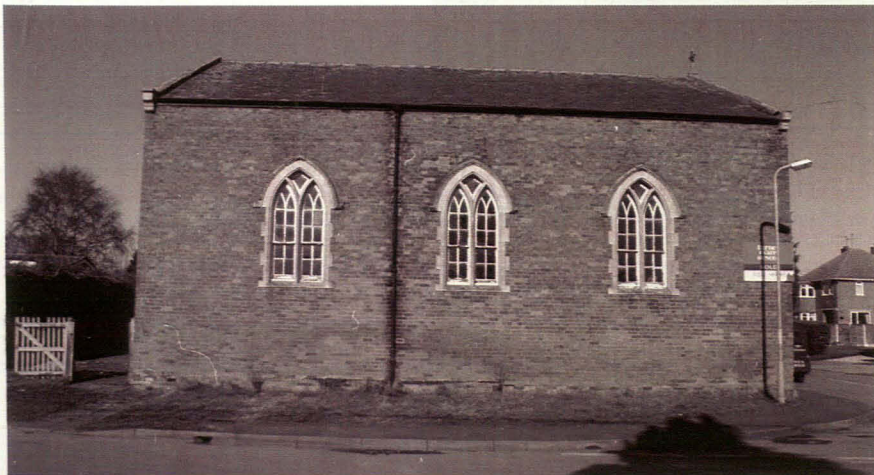
Plate 5 Eastern elevation of church, looking west

In the eastern elevation is a sequence of three Gothic Revival windows, each with two-lights (Plate 5).

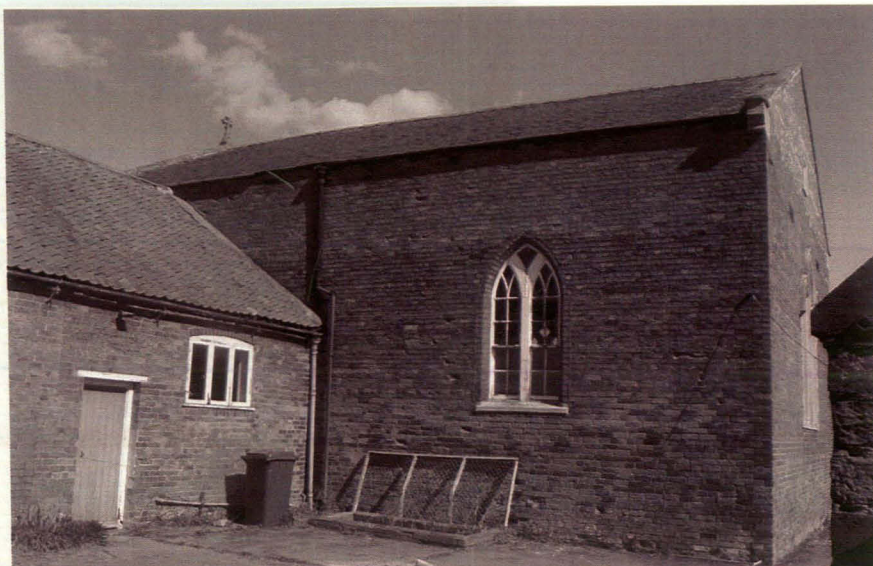
Plate 7 Western elevation of church, looking east

light Gothic Revival window (Plate 7). Alterations in the brick by the window apex suggests the building was raised in height.

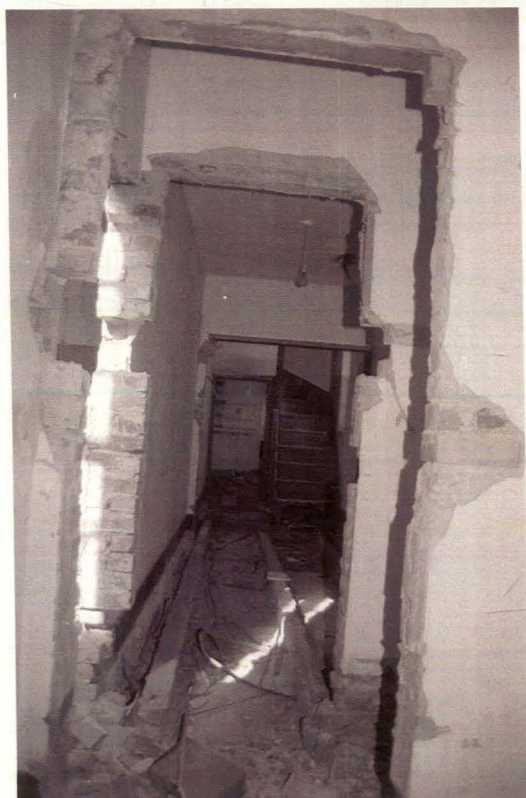
Plate 8 Passageway in northern part of church, looking west

The main doorway in the northern gable gives access to an east-west passage running the width of the church (Plate 8). At the eastern end of the passage are two small compartments, while the western end of the passage gives access to the stairs up to the upper storey, and a doorway to the adjacent school room. Two doorways on the south side of the passage give entry to the main body of the church.

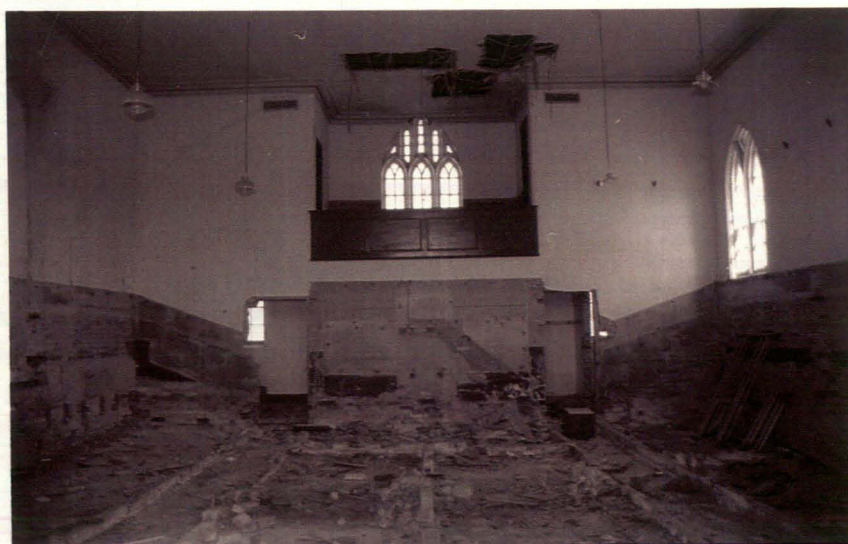
Plate 9 Church interior, showing scars of removed pulpit and first floor gallery, looking north

The church is a large open space, two storeys high (Plate 9). As noted above, this is essentially empty and lacking fixtures and fittings. However, scars on the east and west walls indicate the pews were surrounded with panelling and the pews to the rear, south side, of the church were raised or raked (Plate 10). On the north wall are scars of a raised pulpit and steps up to it (Plate 9). High on the south wall is a marble memorial plaque dated 1846 (Plates 11 and 12).

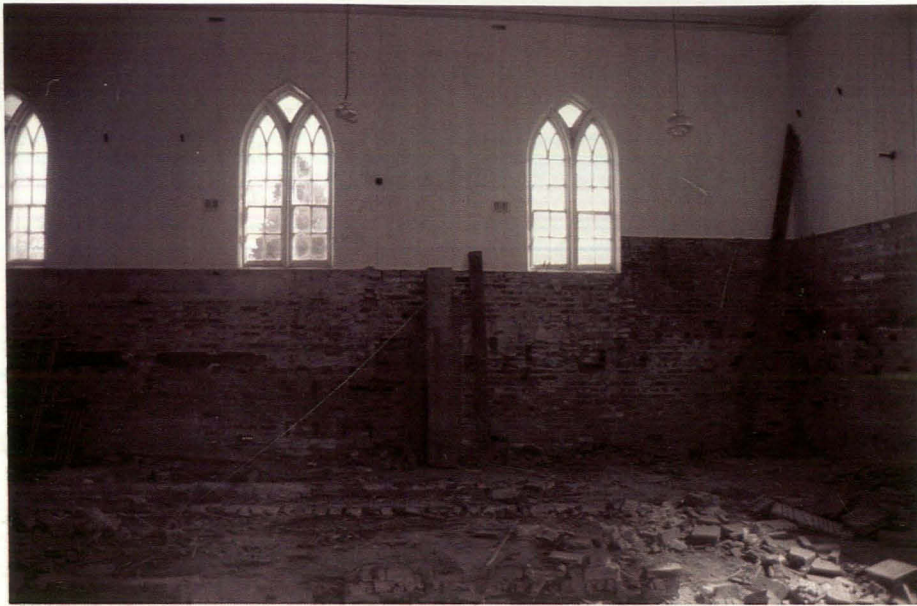
Plate 10 Church interior, east side, showing scars of removed panelling and pews, looking east

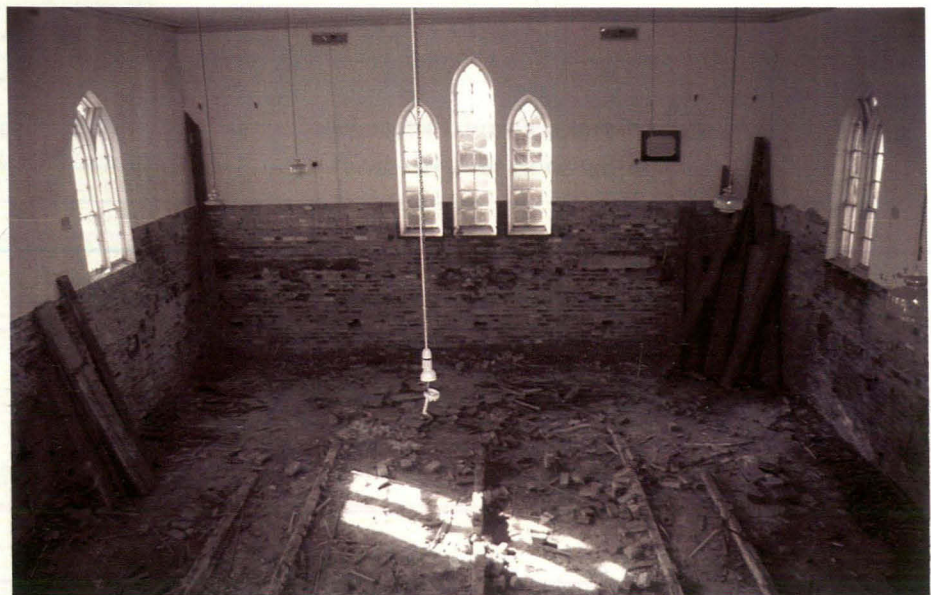
Plate 11 Church interior, south side from gallery, looking south

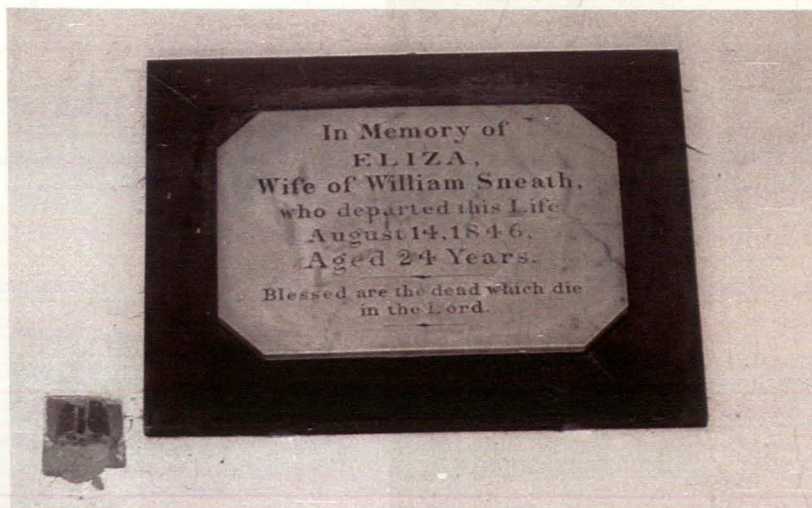
Plate 12 Detail of memorial plaque on south wall of church, looking south

On the south wall is a memorial dated 1846, perhaps removed from the earlier chapel and incorporated in the new church when it was built.

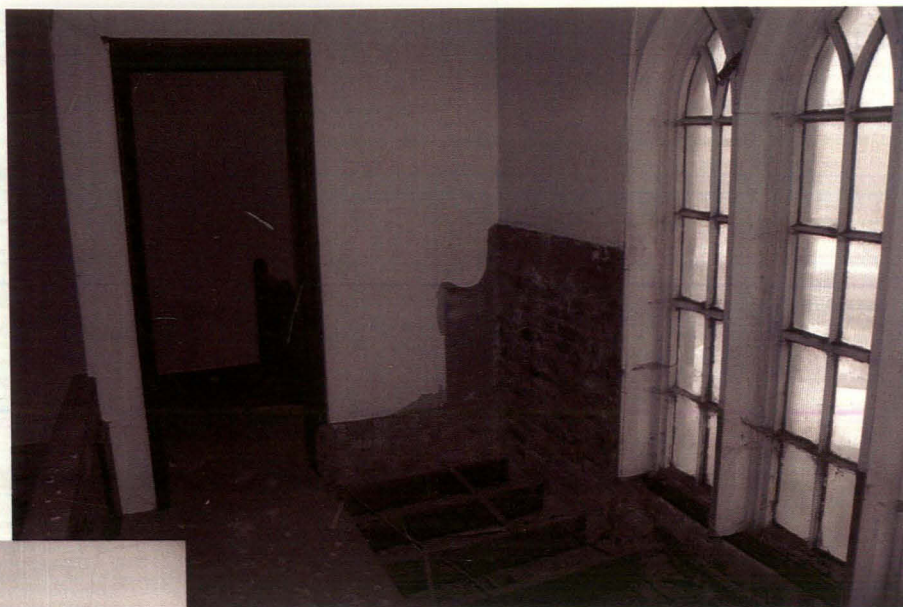
Plate 13 Church interior, first floor gallery, showing scars of removed pew, looking northwest

From the passageway on the north side of the church are steps that lead up to a first floor gallery, above and just behind the ground floor pulpit area (Figs. 5 and 6). As on the ground floor, the gallery has been stripped of its fixtures, though scars indicate a row of pews were located here (Plate 13).

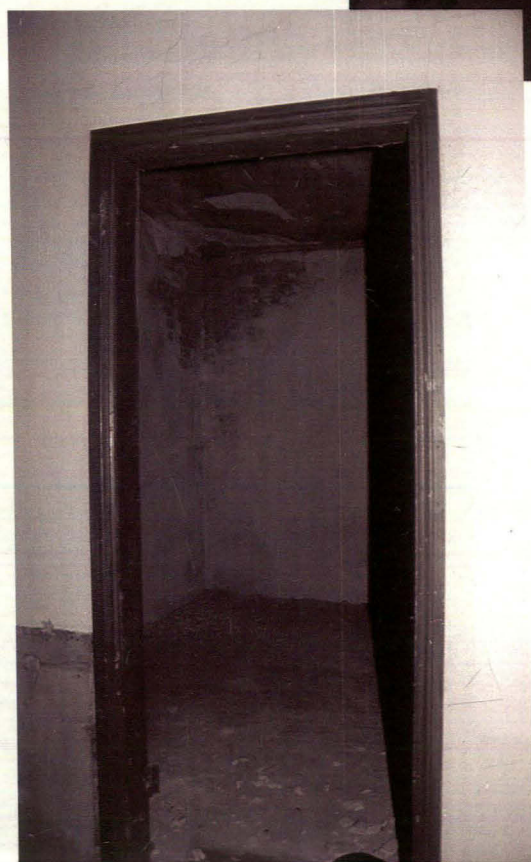
Plate 14 Church interior, store room off first floor gallery, looking east

illumination (Plate 14). A trap door in the ceiling of this possible store gives access to the roof space. Queen post roof trusses are evident, with modern timber braces added at right angles to, and linking, the trusses (Plate 15).

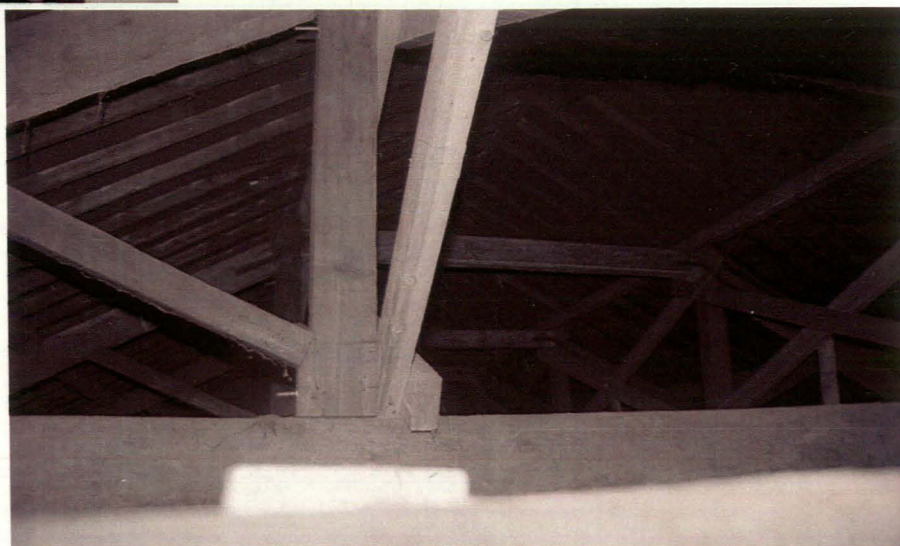
Plate 15 Timbering in roof space above church, looking south

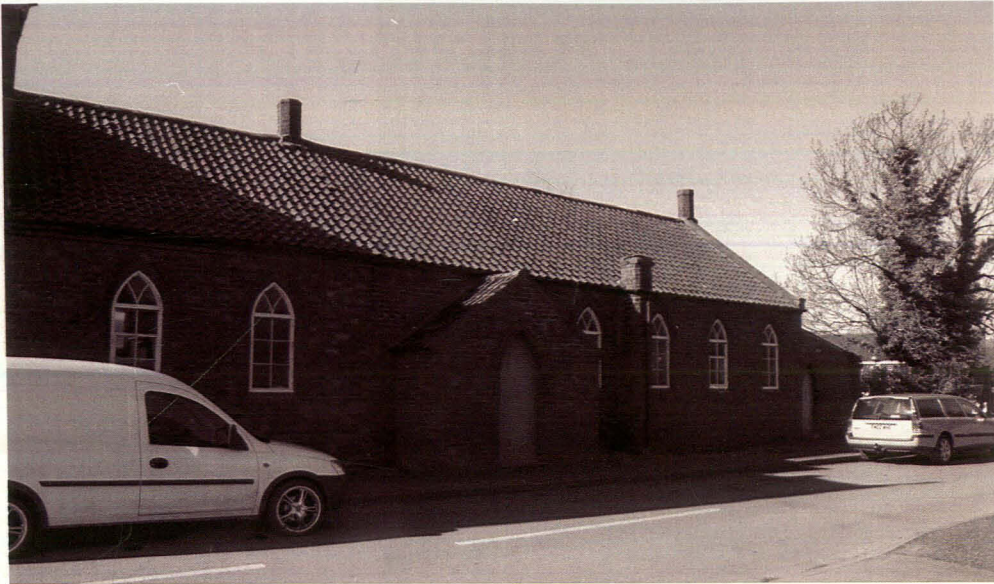
Plate 16 School northern elevation, looking southwest

Extending westwards along Mill Lane from the church, the school is a single storey structure. The northern elevation, proceeding from the church (Plate 16), contains two single light windows with pointed arch brick hood moulds, then a straight join (Plate 17). West of the straight join is a porch containing a single door with an arched brick hood mould. To the west of the porch is a row of four further windows with brick pointed arch hood moulds. Between the first two of these west of the porch is a projecting chimney. Two further chimneys are located in the roof apex, one above the straight join and the other at the western gable. Both chimneys are of brick and octagonal in plan.

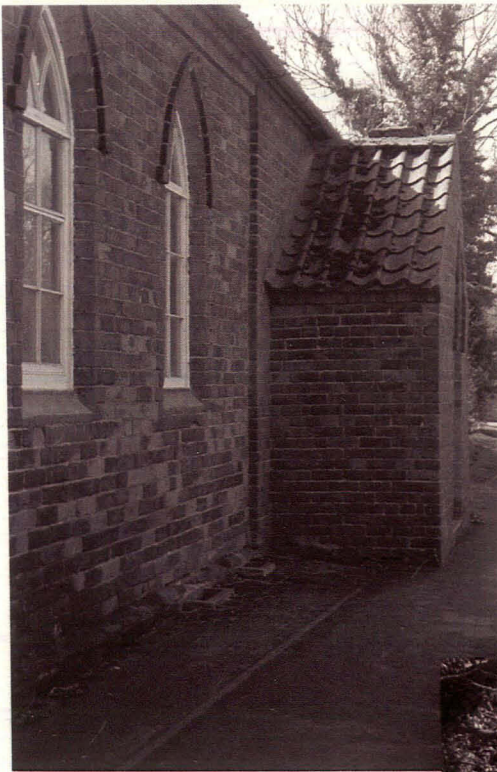
Plate 17 School north side, showing straight join between chapel and school, looking west

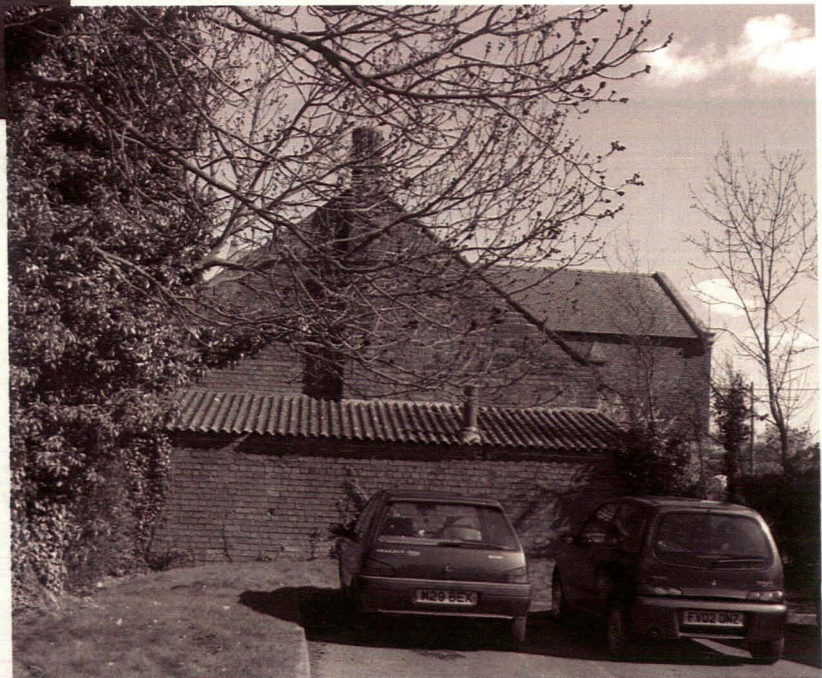
Plate 18 School western elevation and lean-to, looking east

The western gable of the school is largely obscured by a lean-to (Plate 18), though within the lean-to are scars of a blocked doorway and possibly a blocked or removed fireplace (see below).

Located at the western end of the complex and built against that face of the school is a small lean-to. Doorways are located in the northern and southern elevations (Plates 26 and 27), the entry on the north having an arched hood mould of brick, while the western elevation is plain. A ceramic pipe, functioning as a chimney or vent, exits from the roof (Plate 18).

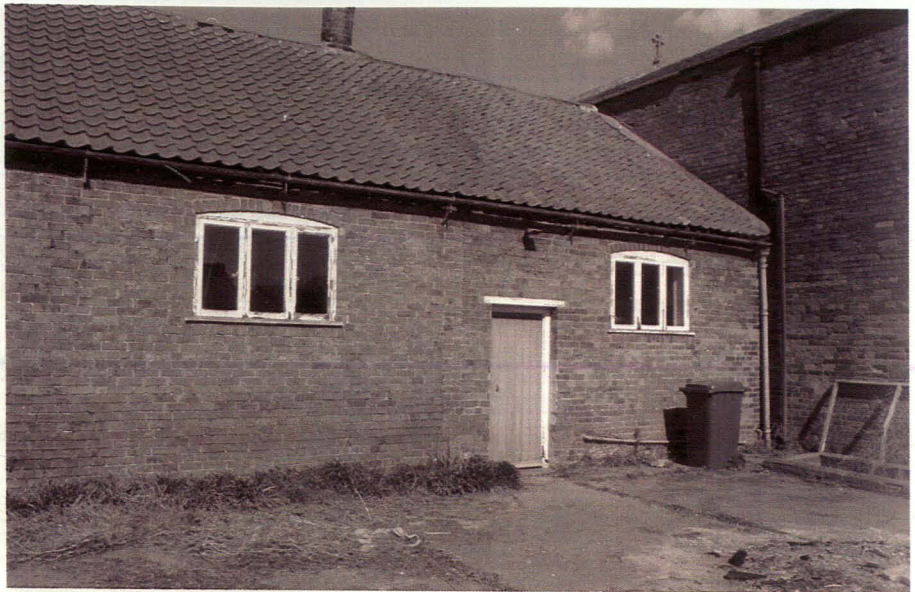
Plate 19 School/  
chapel south  
elevation, looking  
northeast

In the southern elevation of the school are four windows with segmental heads of brick rubbers. Between the third and fourth windows from the western end is a single door. Just west of the door is a staggered straight join, the upper part of this being to the east of the lower section (Plate 19).

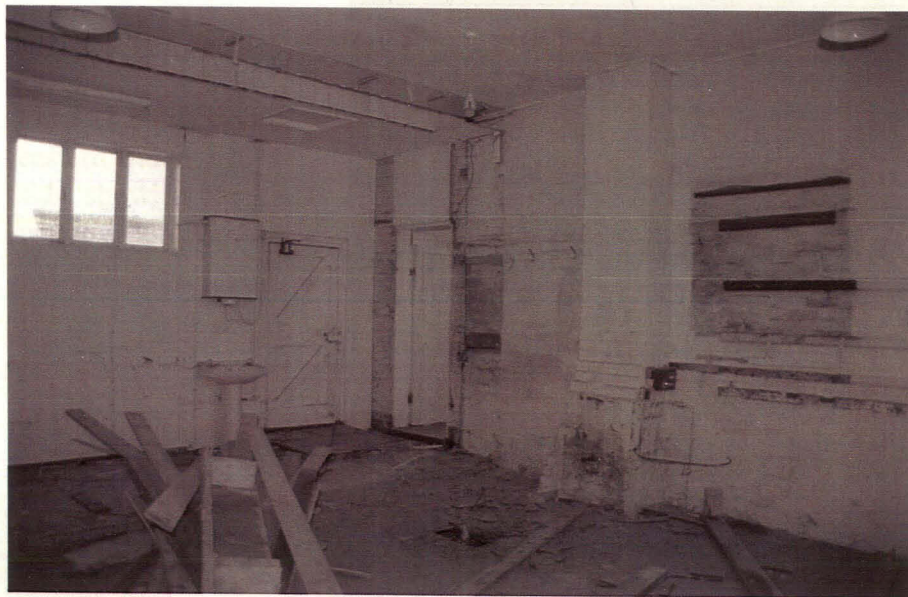
Plate 20 Chapel/  
school interior,  
looking  
southwest

In the centre of the west wall was a blocked fireplace with chimney above (Plate 20). At the north and south ends of this wall are doors to the main school room, to the west.

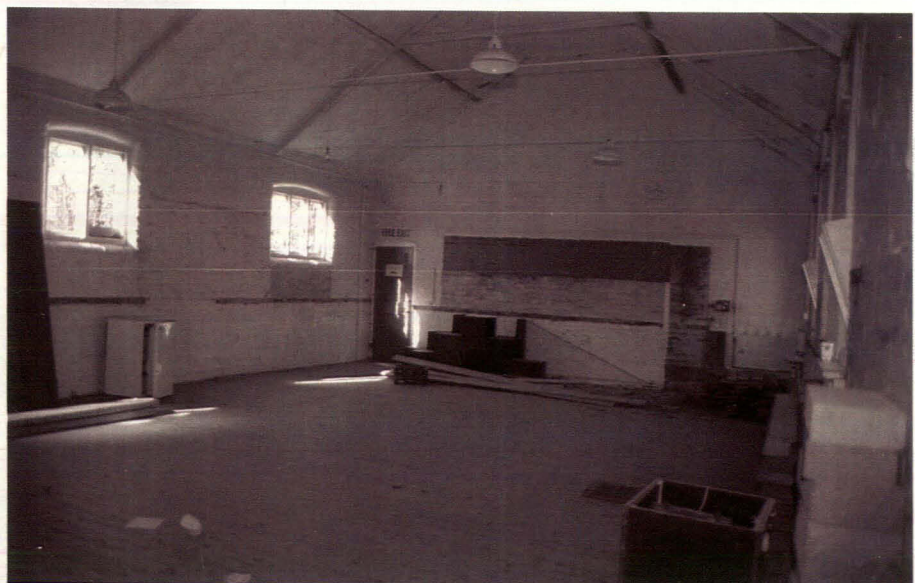
Plate 21 Main  
Schoolroom  
interior, looking  
west

The main school room is mostly open to the roof (Plates 21 and 22). Four windows are located in the northern elevation and three in the south wall, those in the south edged with bullnose bricks. There is a door at the southern end of the west wall. A segmental arch at the northern end of this wall marks the position of a blocked door, more evident on the outside of the wall, within the lean-to (see below).

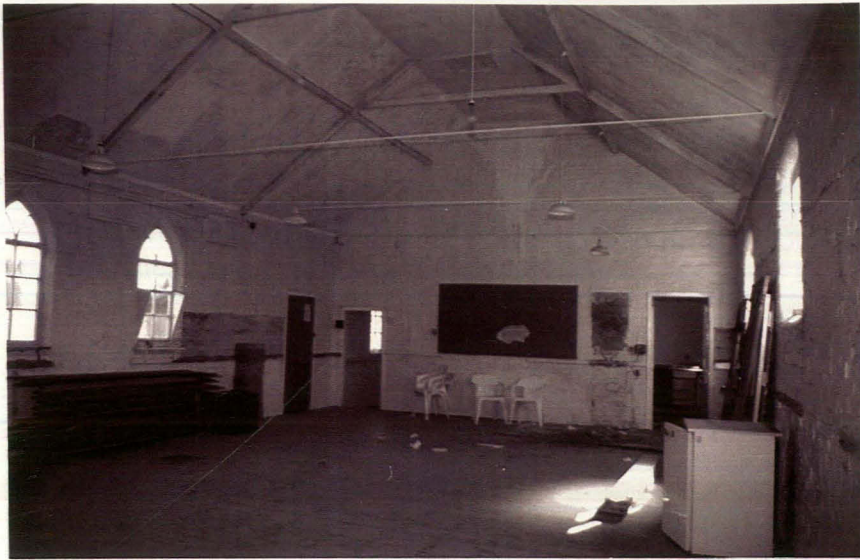
Plate 22 Main  
Schoolroom interior,  
looking east

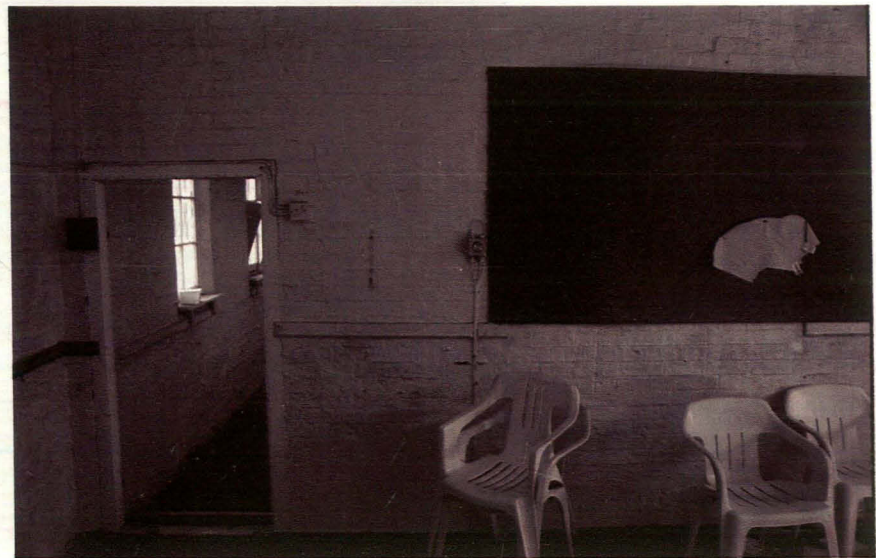
Plate 23 Schoolroom,  
eastern end, north  
side, showing blocked  
window, looking east

At the northern and southern ends of the east wall of the school room are further arches, probably marking blocked windows or doors (Plates 23 and 24). However, there are no obvious straight joins below the arches to determine what form of opening they originally topped. In the middle of the wall is a single straight join, possibly for a window, though there is no obvious other side to this.

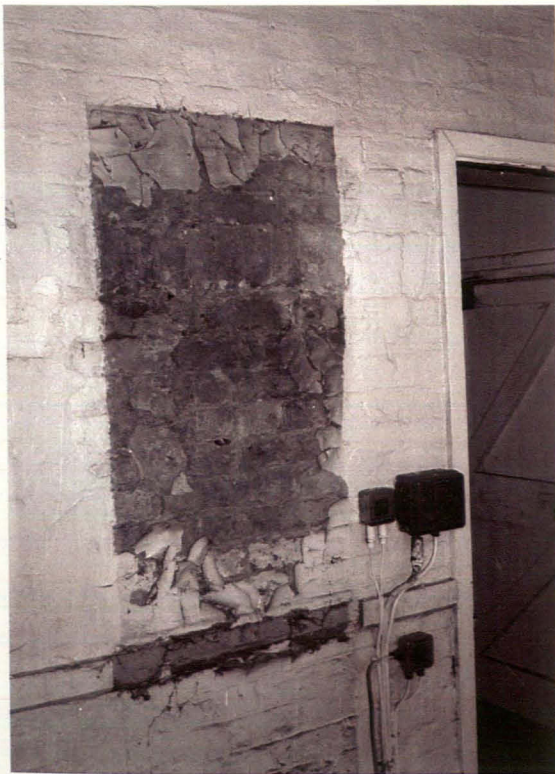
Plate 24 Schoolroom, eastern end,  
south side, showing blocked  
window, looking southeast

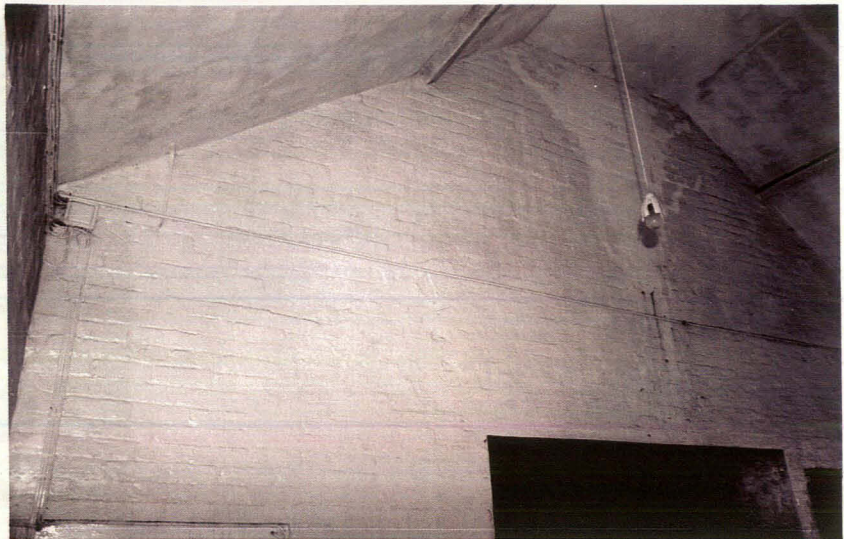
Plate 25 Schoolroom,  
eastern end, showing  
alteration in brick  
indication earlier lower  
eaves line, looking  
southeast

Alterations in the brickwork of the eastern wall indicate an earlier, lower eaves line (Plate 25). There are similar alterations in the brickwork in the south wall but no obvious corresponding change in the north.

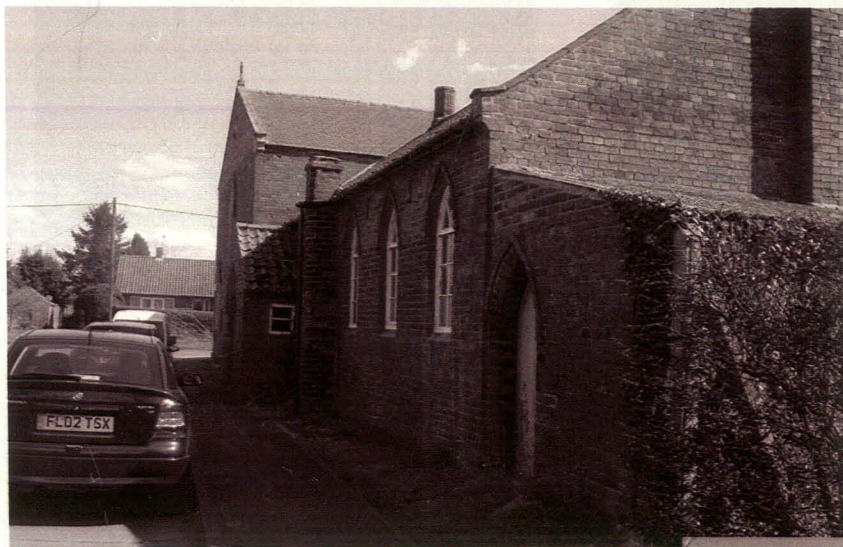
Plate 26 School and lean-  
to, north side, looking  
southeast

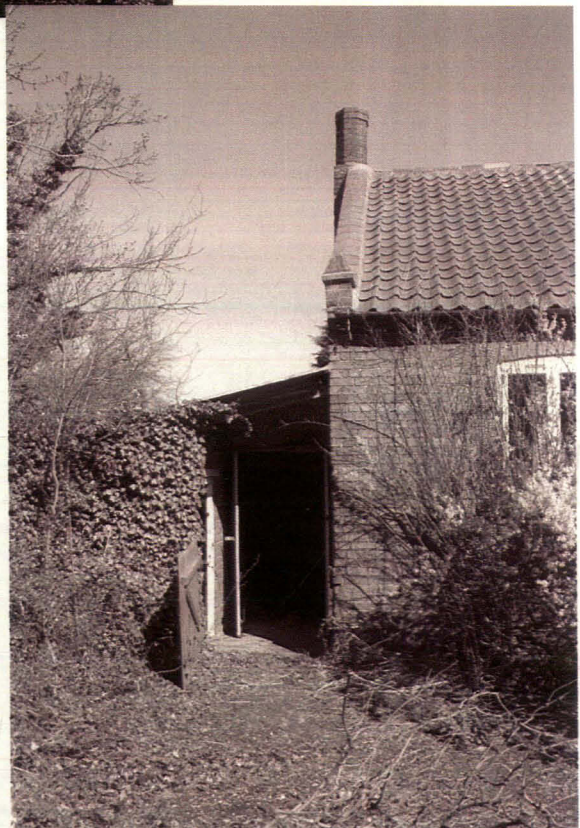
Plate 27 Lean-to, south side, looking  
north

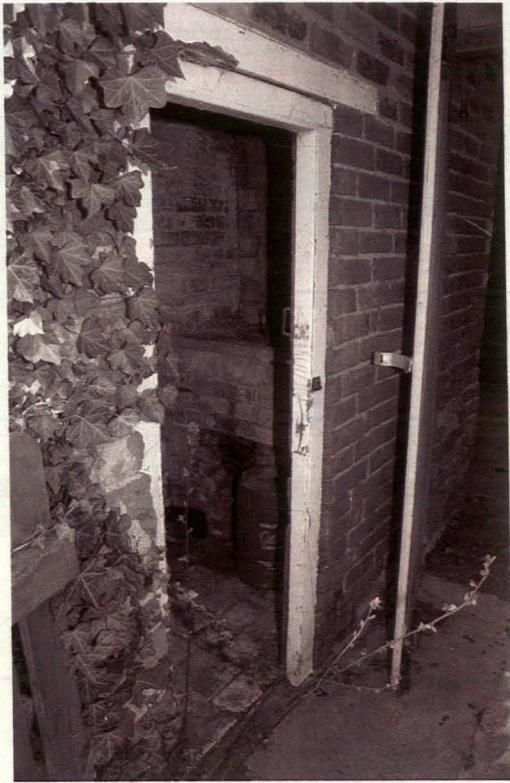
Plate 28 Lean-to, boiler house and boiler hearth, looking northwest

Internally, the lean-to is divided in to two, with a small room in the southwestern corner of the building housing a boiler hearth and floored with quarry tiles (Plate 28). The remainder of the lean-to is fairly plain and floored with concrete (Plate 29). In the southwestern corner of the main compartment are some partial straight joins that perhaps define the location of a removed hearth. Above these straight joins in the very corner of the building is a projecting area of bricks that seem to be the remnants of a chimney (Plate 30). At the northern end of the east wall are straight joins that define a blocked doorway, partially evident on the interior of the school wall (Plate 31). Just south of this blocked doorway are straight and ragged joins that perhaps represent the location on an infilled fireplace. There are also scars of a wall, only about 1m high, having divided the main compartment in to two narrow north-south elongated sections (Plate 29). At the southern end of the eastern wall is a door to the adjacent school room.

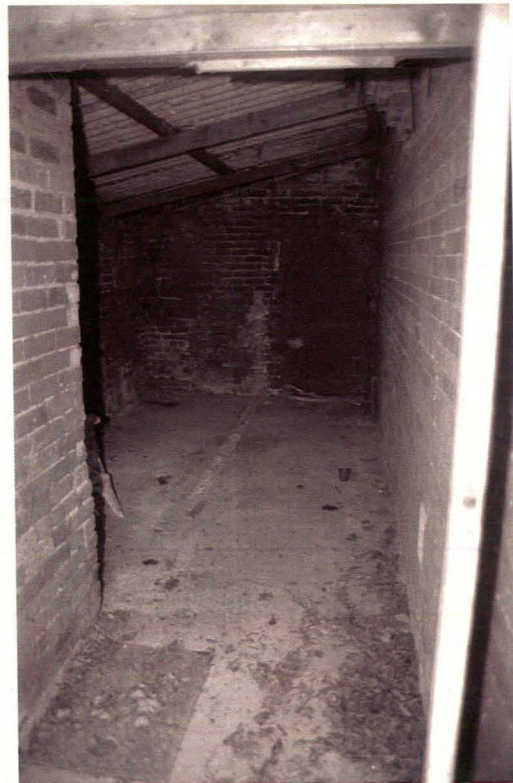
Plate 29 Lean-to, main room, showing wall scar on floor, looking north

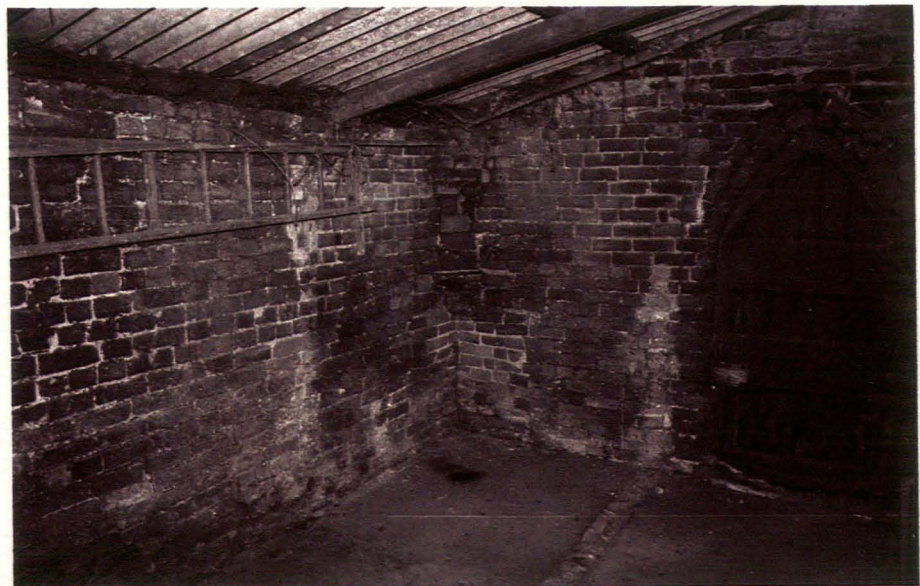
Plate 30 Lean-to interior, northwest corner, showing straight joins and possible chimney remnants, looking northwest

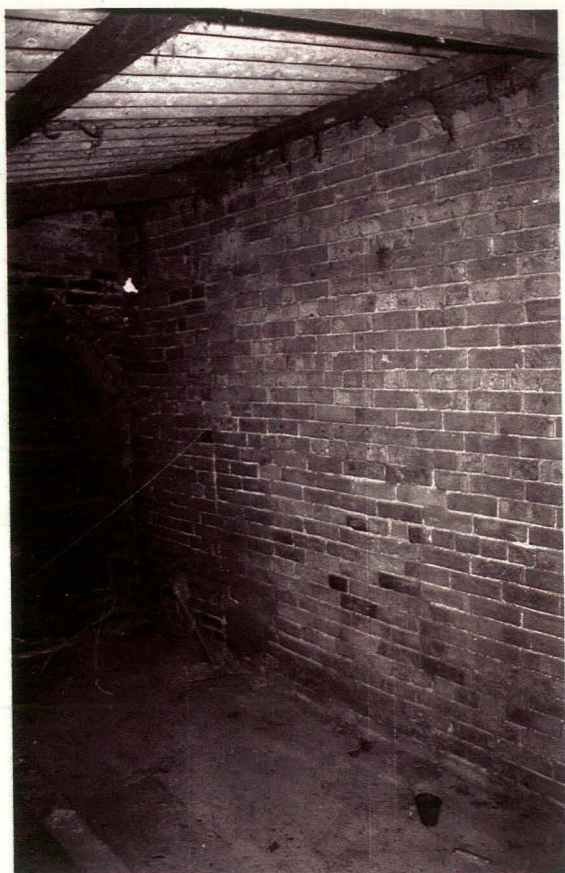
Plate 31 Lean-to interior,  
northeast corner, showing  
blocked door, looking northeast
