**HISTORIC BUILDING SURVEY
OF THE
FORMER QUARRINGTON PRIMARY SCHOOL
GRANTHAM ROAD,
SLEAFORD,
LINCOLNSHIRE
(SLQS09)**

Work Undertaken For
Sankate Homes Ltd

January 2009

APS Report No. 8/09

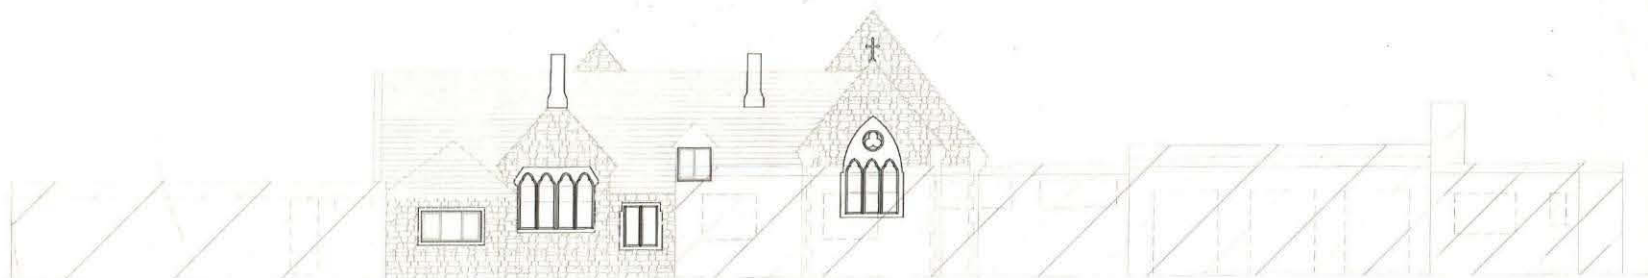
Figure 9 Eastern Elevation of School Buildings

The eastern, chancel, gable is surmounted by an ornate cross finial (Fig. 9; Plate 6). The elevation contains a three-light mullioned window with a trilobed light above.

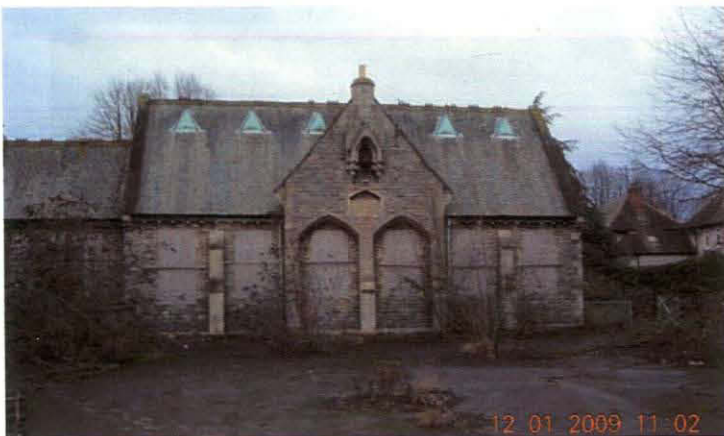
Plate 3 Northern elevation, looking south

The northern façade is one storey tall with the nave having a higher roof than the chancel (Fig. 6; Plate 3). Additionally, the northern wall of the chancel is stepped back from the wall of the adjacent nave.

There are eight sets of 2-light mullioned windows, 6 in the nave section and 2 in the chancel wall. Between these windows are buttresses. The central part of the nave elevation is formed by a gable that contains two sets of windows and which is supported by three of the buttresses. Above and between the windows in this gable is an inscription plaque reading:

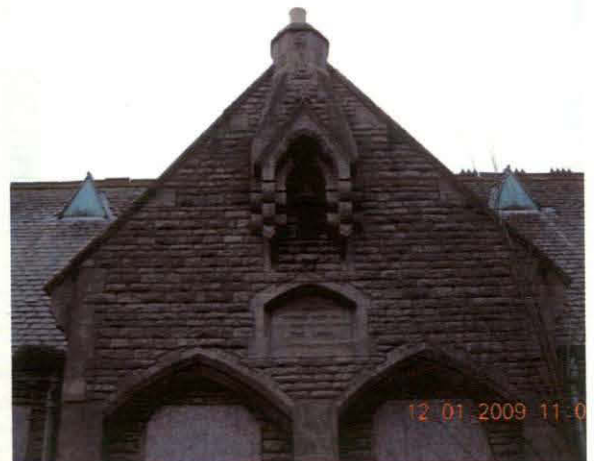
Plate 4 Detail of bell cote and inscription panel, looking south

Above this panel is a bell cote with elaborate, chevroned corbels (Plate 4). This bell cote in turn supports an octagonal chimney stack.

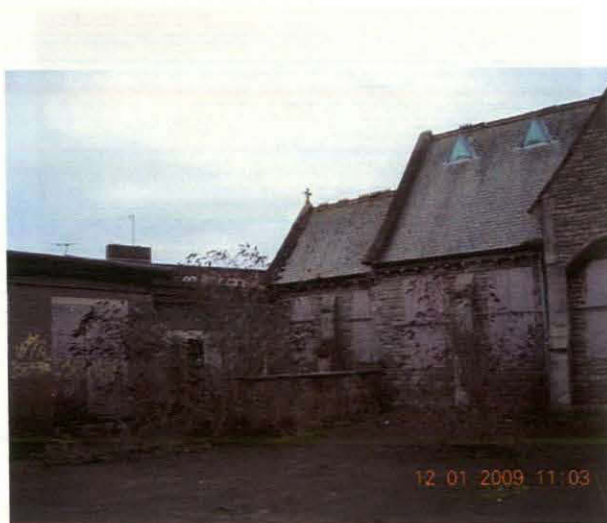
Plate 5 Western elevation of chapel, looking east

The western, nave, elevation is a gable and contains a large transomed four-light mullioned window, with two trilobed lights and a 5-lobed light above, all within recessed circular frames (Fig. 7; Plate 5).

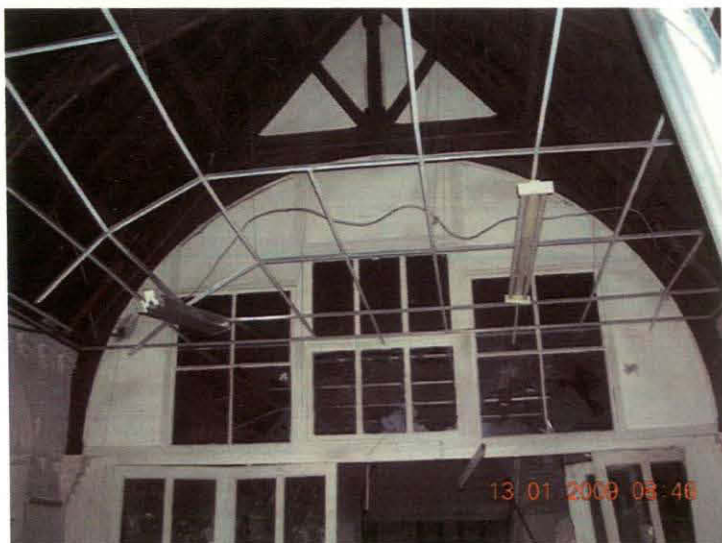
Plate 7 Nave interior, showing roof truss and inserted modern partition, looking east

The nave (Room 1) is of 6 bays and the chancel (Room 2) of 2, the bays separated by arched brace roof trusses (Fig. 5; Plate 7). These trusses are carried on wall posts that are supported by brick corbels. The wall posts vary between the nave and chancel. Those in the nave are rectangular sectioned, chamfered and with short runs of pyramidal projections (Plate 8). In contrast, those in the chancel are in the form of chamfered rectangular block fronted by a circular sectioned column with capital and base (Plate 9). On top of the arch braces is a collar that carries a king post with inclined side braces. The nave previously had a modern suspended ceiling, but this was recently removed.

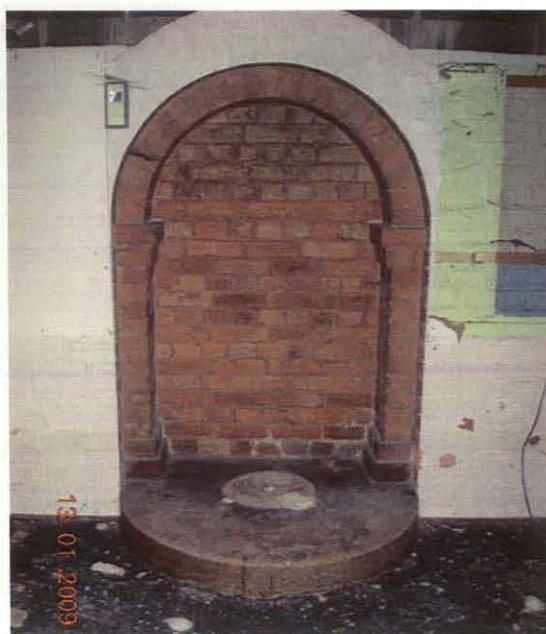
Plate 10 Plinth base of removed font, looking south

Along the side walls of both nave and chancel are two rows of brick dentilation, one at the eaves and the other level with the arch spring of the windows. At the western end of the nave, below the central window, is a semi-circular plinth with a hole in the centre. This is probably the base for a removed font (Plate 10).

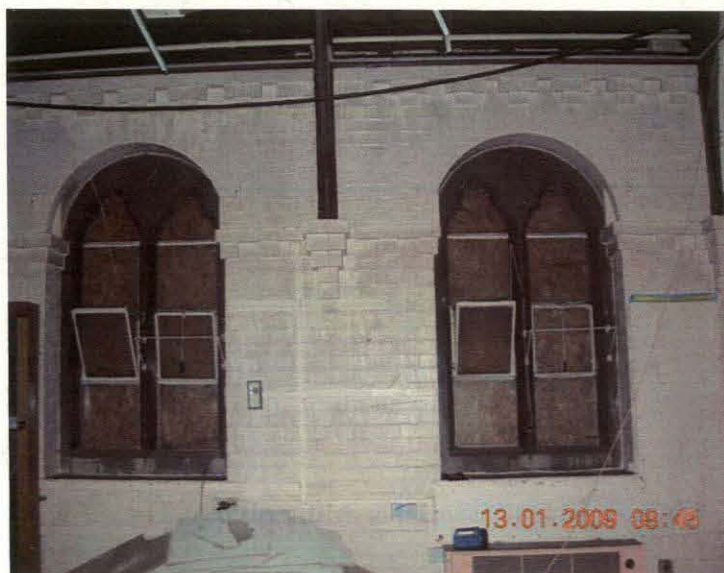
Plate 11 Nave windows, looking north

All of the windows are recessed. The reveals of the windows in the side walls have semi-circular arches (Plate 11) while those in the opposed gables have pointed arches.

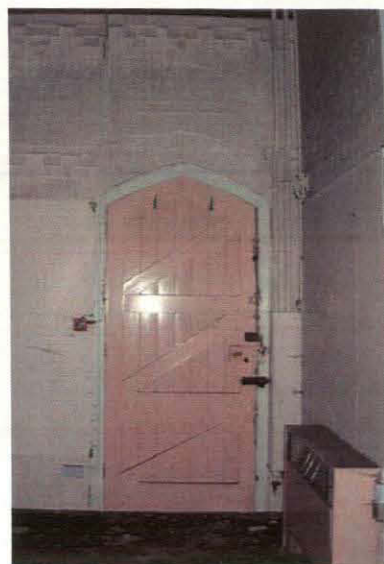
Plate 12 Door in southwestern corner of nave, showing brick arch over, looking south

There are doors to the nave in its southwest and southeast corners. Both doors have 2-centre arched tops. However, high in the walls above these doors are semi-circular arches of brick (Plate 12).

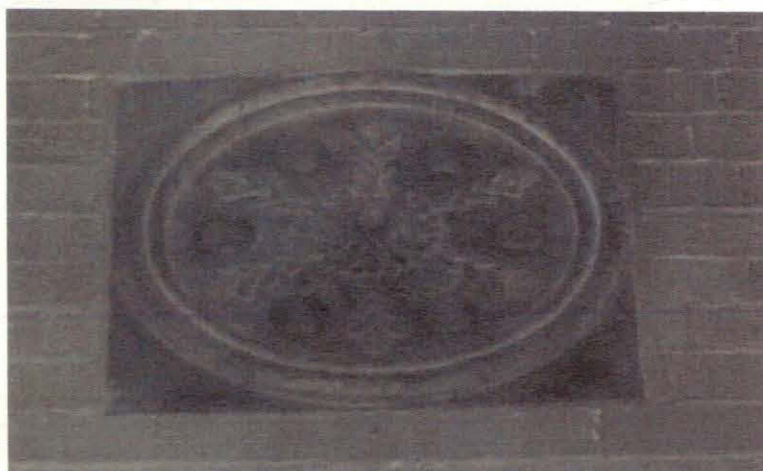
Plate 13 Roundel over chancel arch, looking east

At the eastern end of the nave, above the chancel arch (Plate 14), is a decorative stone roundel carved with a 6-pointed foliate pattern (Plates 13).

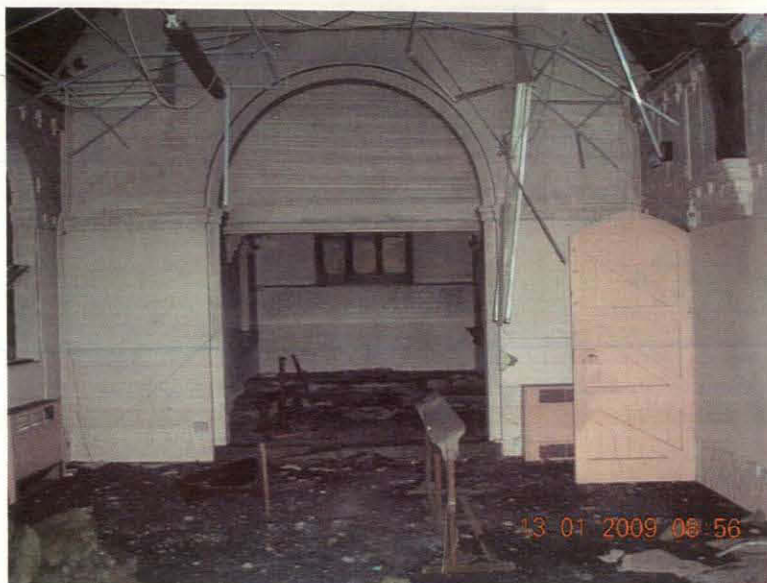
Plate 14 Chancel arch, looking east

At the eastern end of the nave is the chancel arch, with the chancel beyond (Room 2). A modern vertical rolling partition is attached to the chancel arch. This allowed the more sacred area of the chancel to be closed off from mundane activities occurring in the nave/school room. While the present partition is clearly recent, perhaps dating from the 1960s-70s, it is possible that it replaced some other means of separating the chancel and nave/school room.
