**HISTORIC BUILDING SURVEY
OF THE
FORMER STATION HOUSE AND GOODS SHED,
AT THE FORMER RAILWAY STATION,
STATION ROAD,
HOLBEACH,
LINCOLNSHIRE
(HOSR09)**

Report Compiled by
Gary Taylor BA (Hons) MA MSc

APS Report No. 73/09

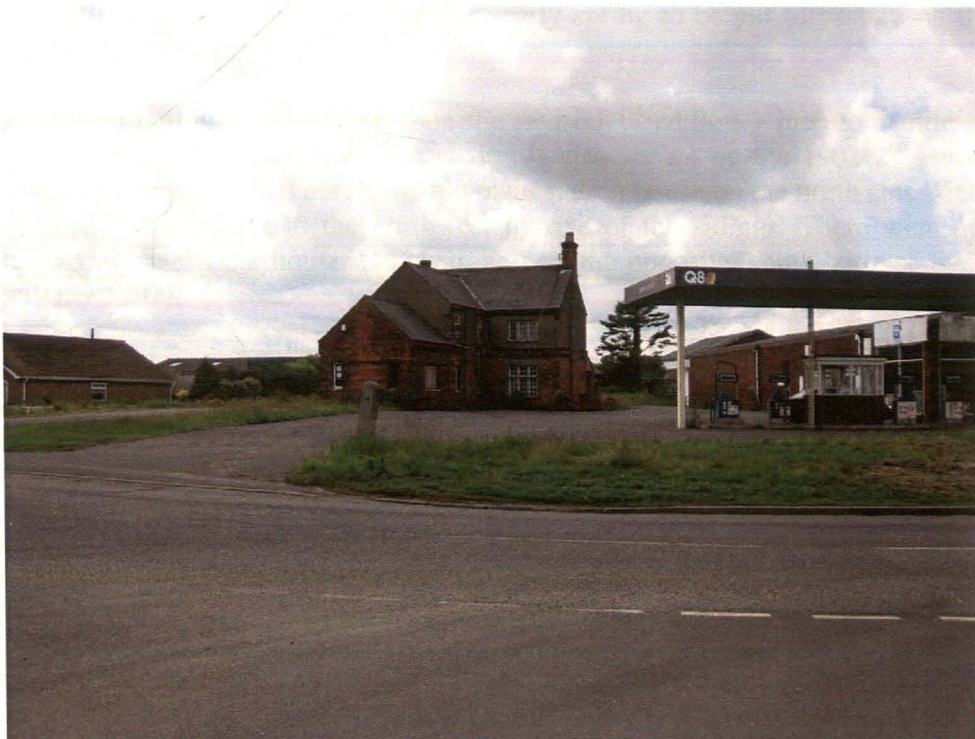
Plate 1
General
site view of
the station
house,
looking
southwest

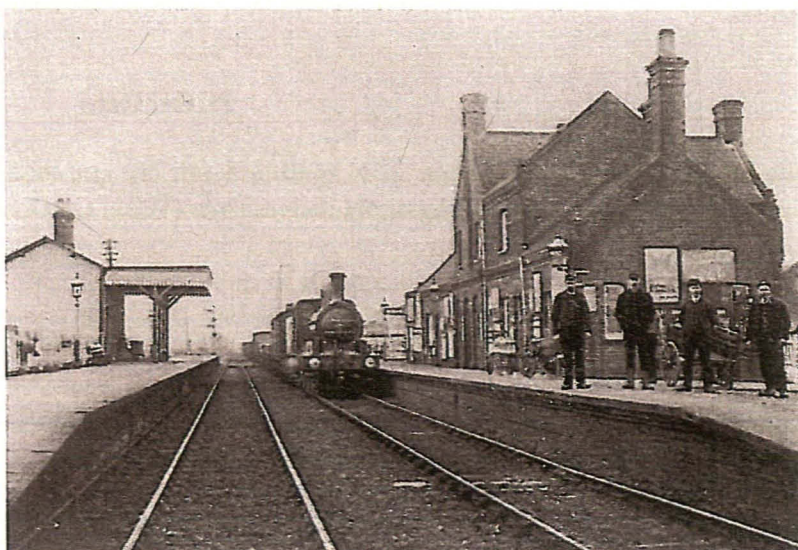
Plate 2
Holbeach Station House,
c. 1906

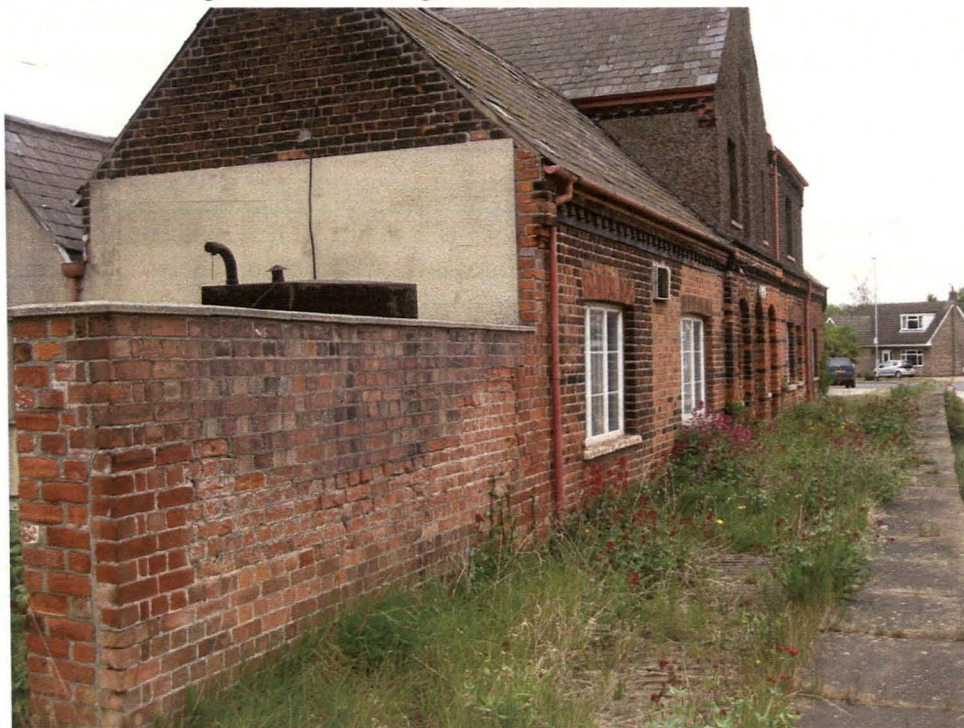
return (0.5m long) to the north (Fig. 5; Plate 3).

Plate 3
Southern
façade of
station house,
and western
gable end of
Block 1, with
boundary wall
in foreground,
looking
northeast

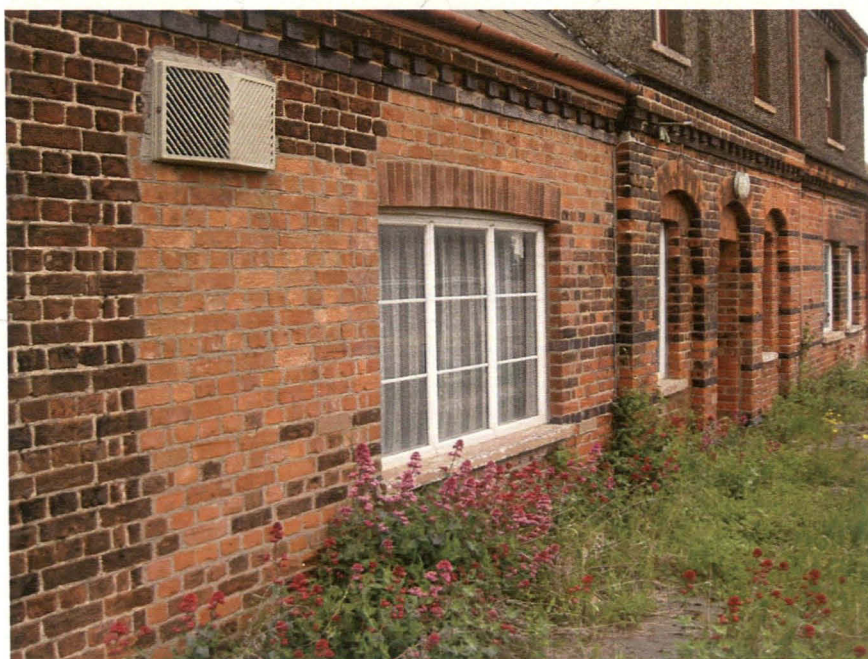
The western single storey room (Room 1) is butted against the remainder of the complex (Blocks 2-4), as evidenced by mis-alignment of the brick and dentilation courses (Plate 4). Within the southern elevation are two windows, both with modern double glazing, concrete sills and gauged arches of brick rubbers, the arch on the eastern window being of machine-made brick. Much of the wall around the eastern window is of light orange brick, in contrast to the much darker brick used for most of the rest of the elevation (Plate 4). This lighter brick terminates to the west, between the two windows, in a vertical ragged join. This area of lighter brick appears to constitute a patch, perhaps created when the window was installed. To the east of this window are two string courses of blue brick.

Plate 4
Block 1
(foreground),
showing brick
patching and
inserted window,
looking northeast

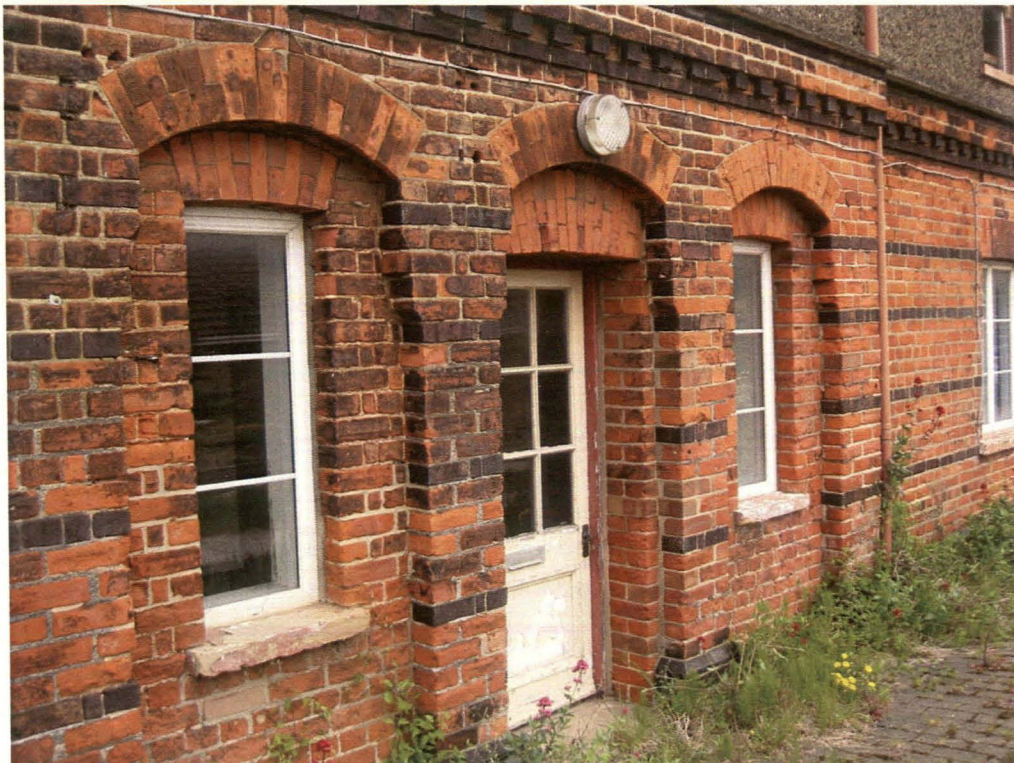
To the immediate east of Block 1 is Block 2, containing Rooms 2 and 8 on the ground floor and 12-16 on the upper storey. The southern façade is two storeys high and gabled (Plate 3). At ground floor level (Room 2) there are four plinths that surround the central door and two flanking windows (Plate 5). Each of these openings has gauged arches of brick rubbers and, above these, further brick arches. The windows are modern double glazing set in original mid-19th century openings, and the door is original. Crossing the ground floor section of the elevation are four string courses of blue brick. Above the ground floor windows is a dentillation course of blue brick.

Plate 5
Block 2,
southern
entrance,
looking
northeast

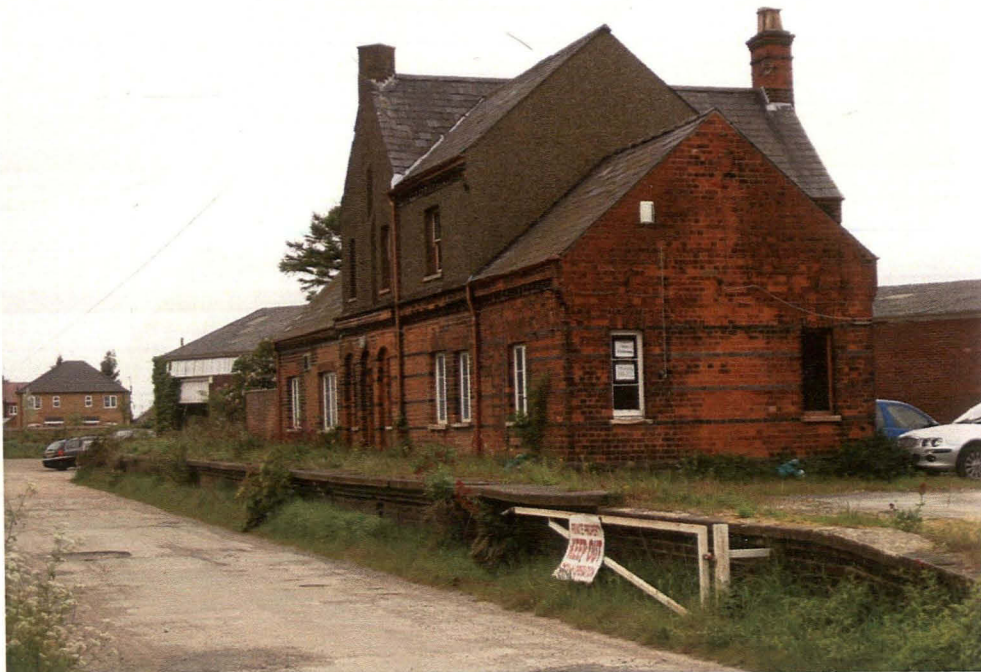
The upper part of the southern gable is pebble-dashed. There are two original sash windows to the room (Room 14). These are set either side of a rectangular projecting chimney. At the top of the gable is a square chimney stack that is not set square to the roof apex, but rather at 45° (Plate 6).

Plate 6
General view
of southern and
eastern sides of
station house,
looking
northwest

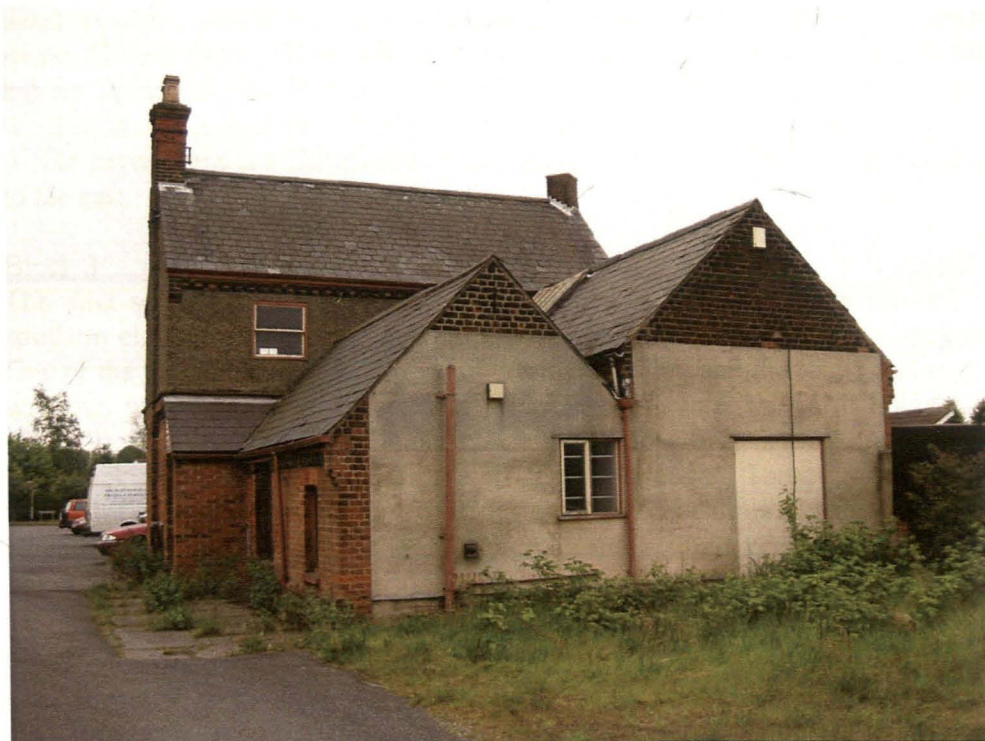
Most of the western elevation is covered by Blocks 1 and 5. However, the upper storey, which is pebble-dashed, contains two windows, both in original openings though the glazing in the northern window is a later replacement. Dentilation occurs at the eaves (Plate 7).

Plate 7
General view of
western
elevations of
station house:
Block 1 right
foreground;
Block 5 left
foreground;
Upper part of
Block 2 to rear,
looking east

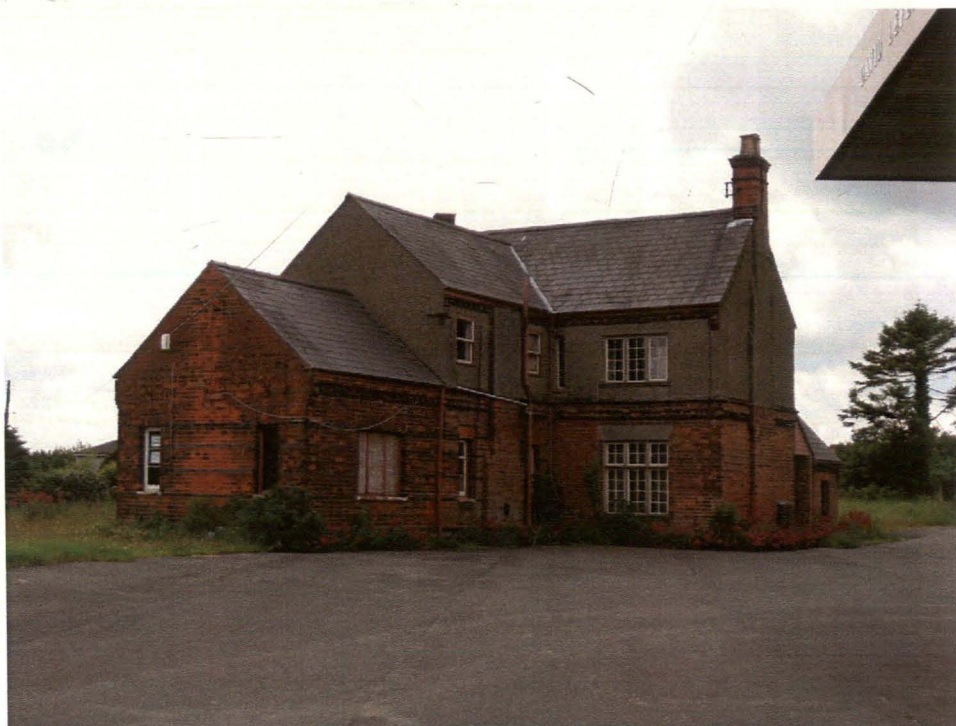
the upper storey is pebble-dashed (Plate 8).

Plate 8
General view
of north side of
station house,
looking
southwest

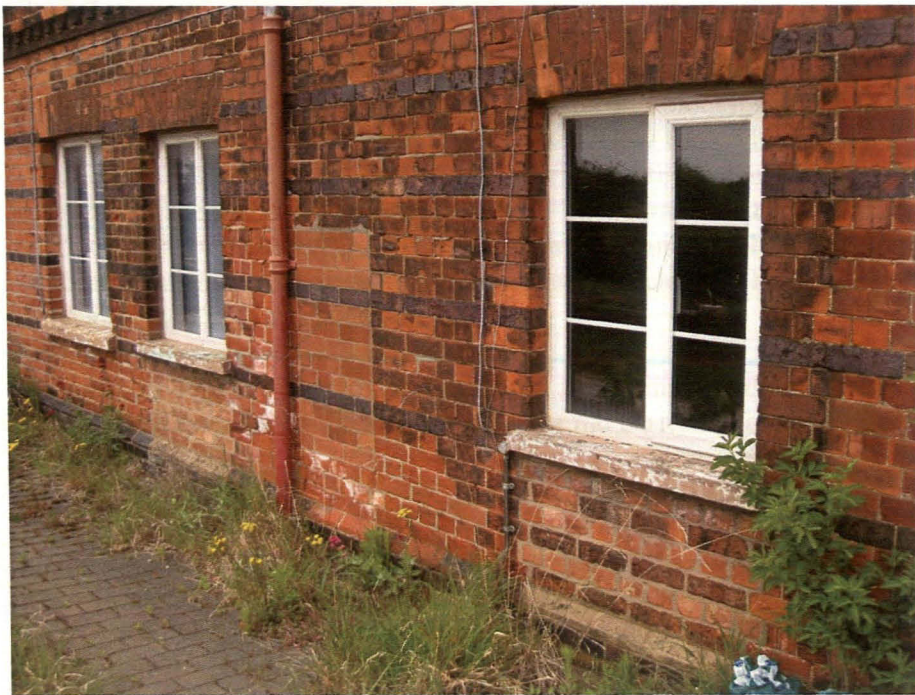
Plate 9
Blocks 3 (left) and 4
(right), southern
elevation, showing
windows inserted
into blocked
doorways, and
infilled niche,
looking northwest

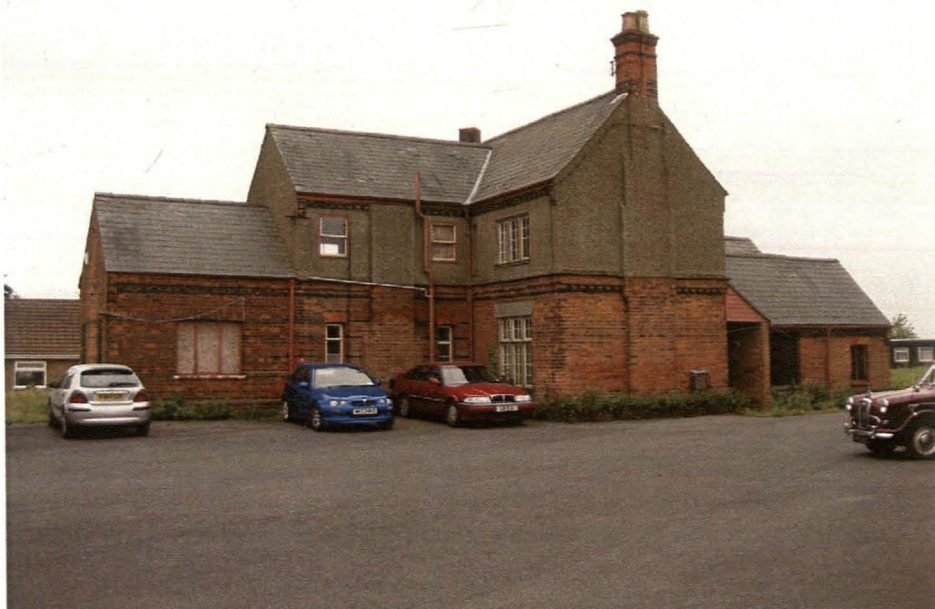
At ground floor level the northern elevation contains two original narrow sash windows, one each on either side of a projecting chimney block. The string and dentilation courses, which continue through to Block 4 to the east, are interrupted by this chimney block, which also breaks the dentilation course on the upper storey. There is no stack to this chimney. The upper storey (Room 13) is pebble dashed and contains original sash windows, one on each side of the chimney (Plate 10).

Plate 10
General view of
northern elevation
of station house,
looking southwest

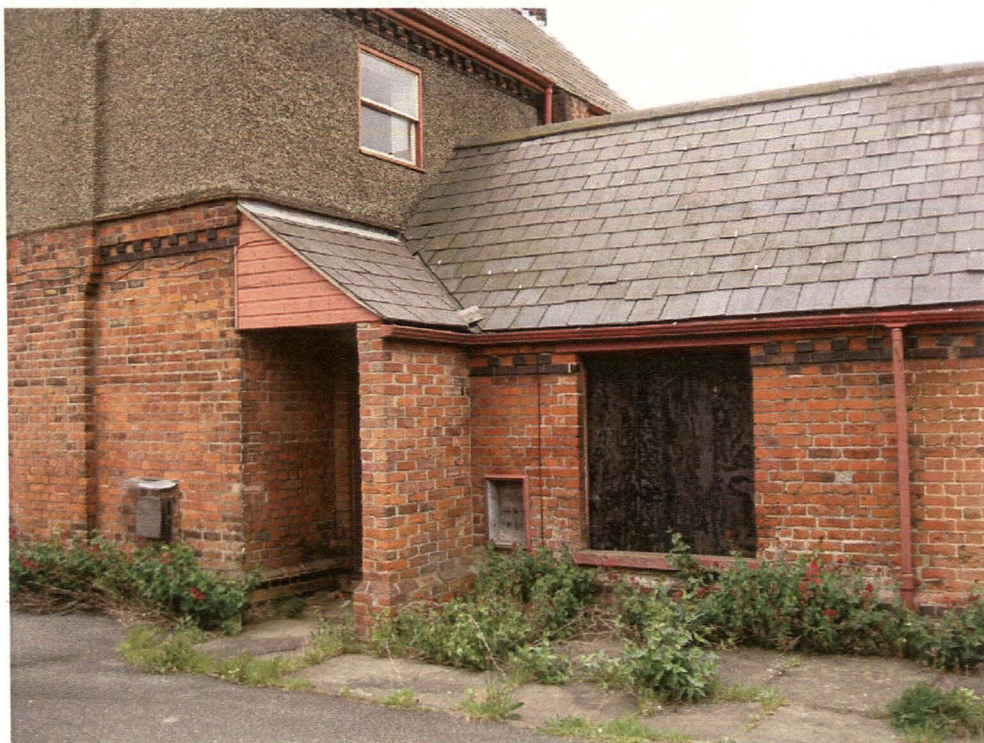
Set back (to the south) slightly from, and on the western side of, the northern part of Block 2, is single storey Block 5 (Plate 7). In the north wall of this block, at its eastern end, is a modern door within an original opening. This doorway is covered with a porch formed from a mono-pitched roof running from the western side of Block 2 to a short north-south wall to the west of the door (Plate 11). This wall is butted up against the northern elevation of Block 5.

Plate 11
Porch over
doorway at
junction of
Blocks 2 (left)
and 5 (right),
looking
southeast

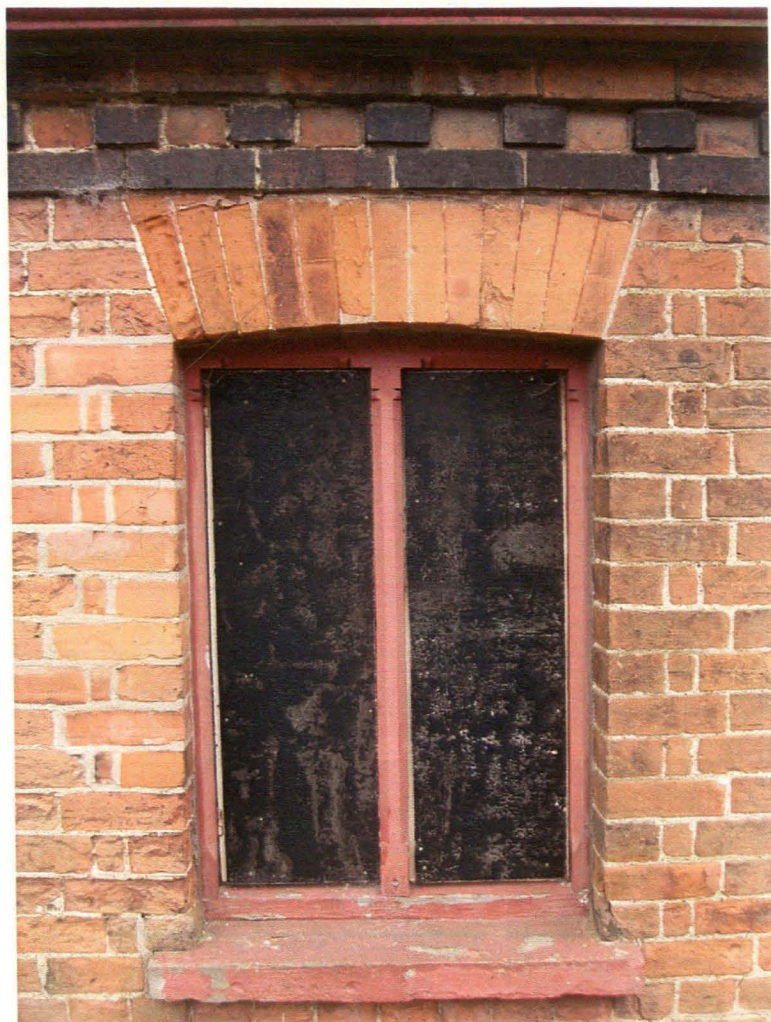
Plate 12
Carved window glazing
bar, Block 5, northern
elevation, looking south

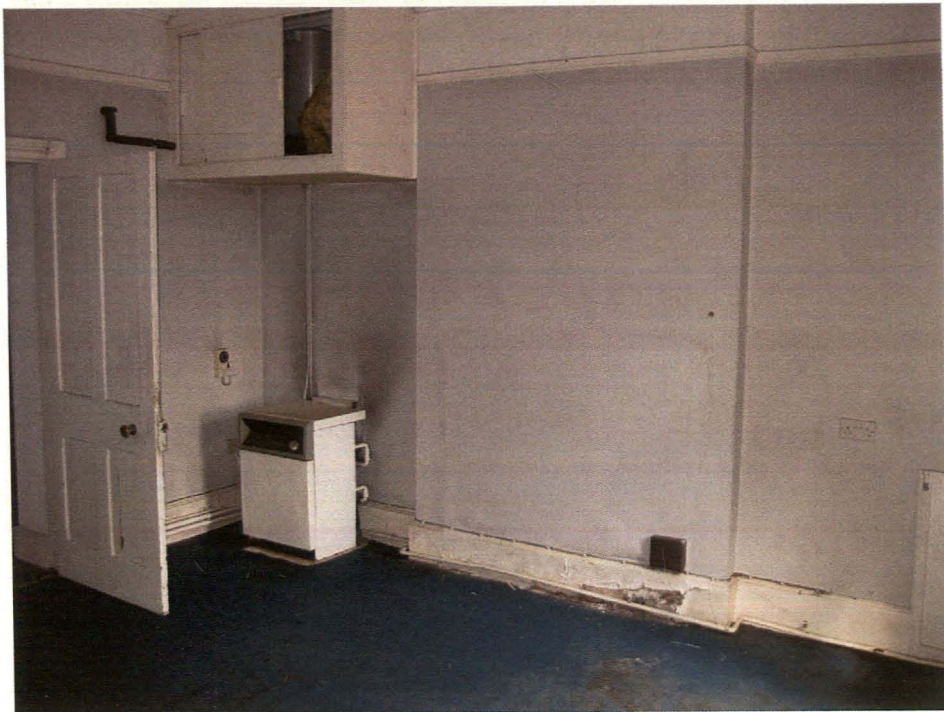
The northern room (Room 8) has an original doorway and contains a blocked fireplace on the north side (Plate 13) and the original concrete-mullioned window on the east (Plate 14). There is an opening in the southeastern corner to a passage leading south, beneath the stairs.

Plate 13
Room 8,
showing
blocked
fireplace and
original door,
looking
northwest

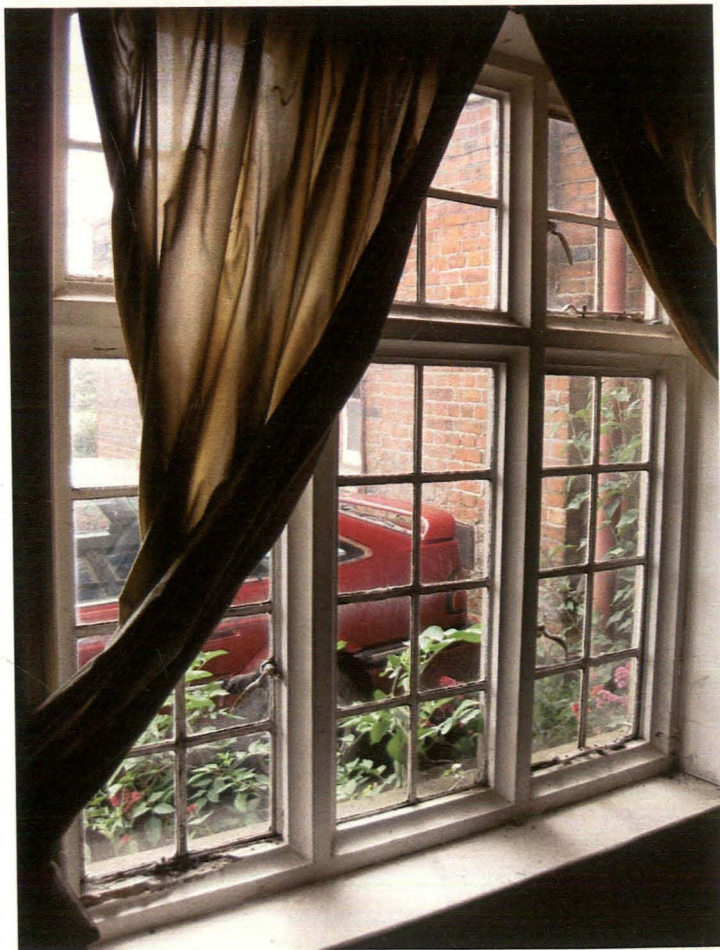
Plate 14
Room 8, detail of mullioned
and transomed window,
looking east

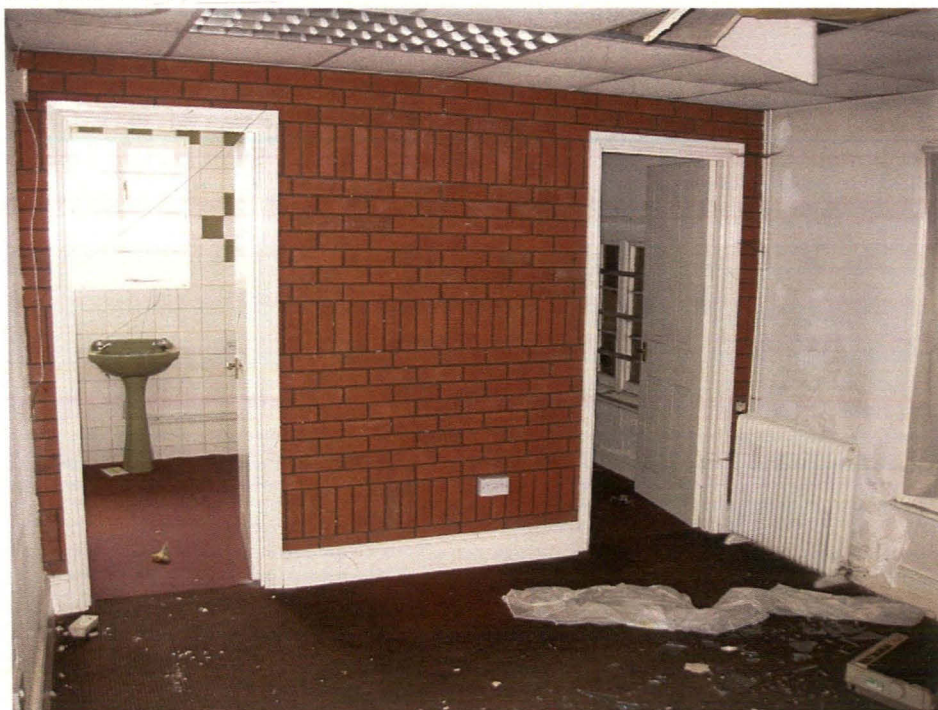
The room (Room 9) to the west of the corridor has an original window in the north elevation and a suspended ceiling. There is a modern (1980s+) inserted partition wall on the west side with doors leading to a utility room (Room 10) and a bathroom (Room 11). The utility room has a small original window in the north side, while the bathroom has an inserted window in the west wall.

Plate 15
Room 9, view
towards inserted
partition and
Rooms 10 (right)
and 11(left),
looking west

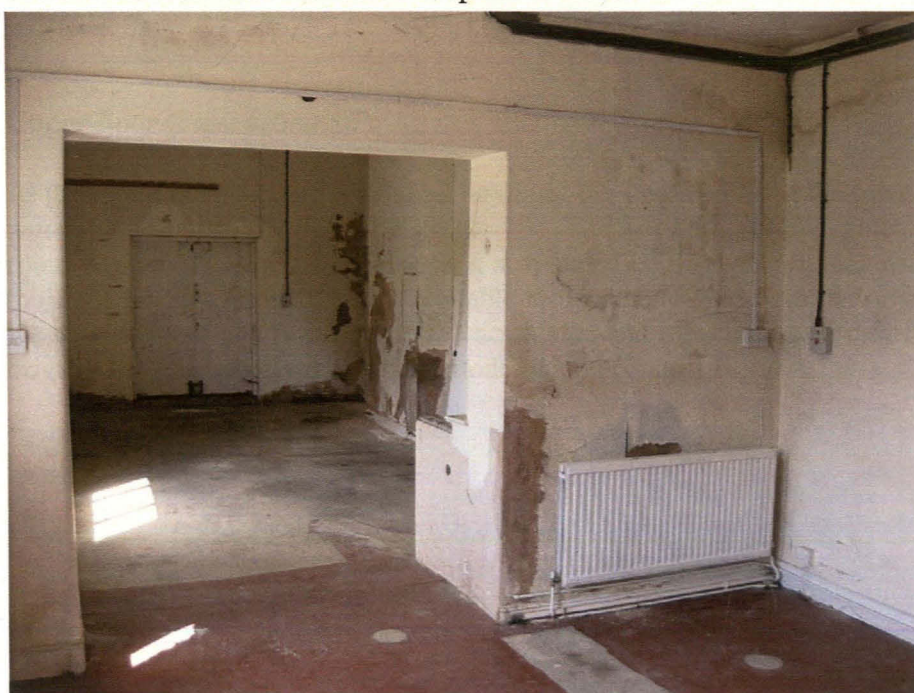
Leading from the southwestern corner of Room 8 (see above), the passage provides access to Room 2 (Block 2). In the south wall of this are the southern door to the complex and flanking windows. A wide opening on the west side of the room gives access to Room 1 (Block 1). There is a low and short partition leading west from the north side of the entry, and the floor slopes down. There are the modern double glazed windows in the south wall and double doors in the west side. A blocked fireplace is located on the north wall.

Plate 16
View from Room 2
to Room 1, looking
west

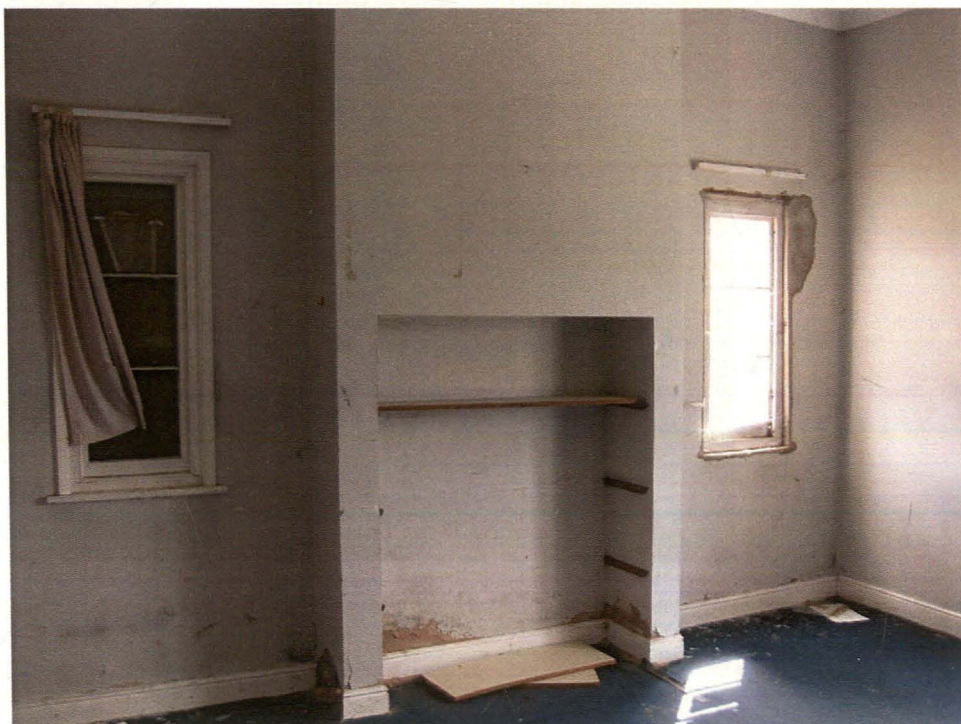
A doorway in the east wall of Room 5 leads to Room 7 (Block 4) at the eastern end of the complex. In the east wall of this room is an empty disused fireplace (now containing shelves) flanked by two small original windows (Plate 17). There is a modern double glazed window in the south wall and an original window in the north side.

Plate 17
Room 7,
showing former
fireplace and
windows,
looking east

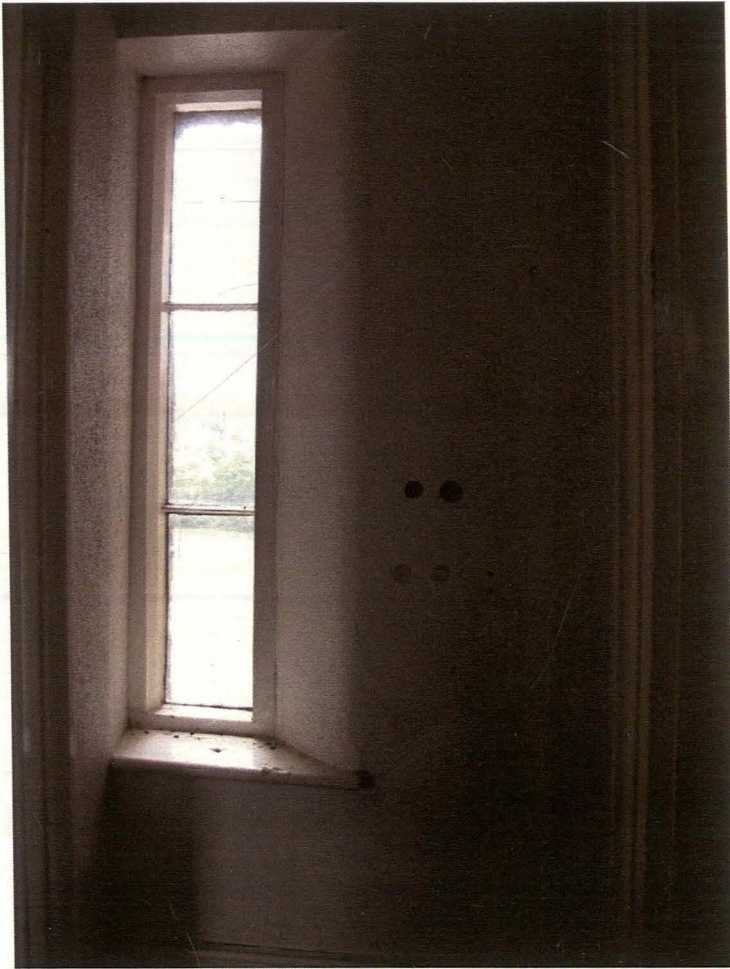
At the top of the stairs are two small landings, the one directly at the top of the stairs having a narrow window in the east wall (Plate 18). The northern landing gives access to the north room (Room 12, Block 2). This has a suspended ceiling, an original window with concrete mullions in the east wall, and a probable replacement window in an original opening on the west side. There is a fireplace on the north side and this contains a cast iron hearth, possibly original but more likely reused or a modern copy (Plate 19).

Plate 18
Narrow window on landing
at top of stairs, looking
northeast

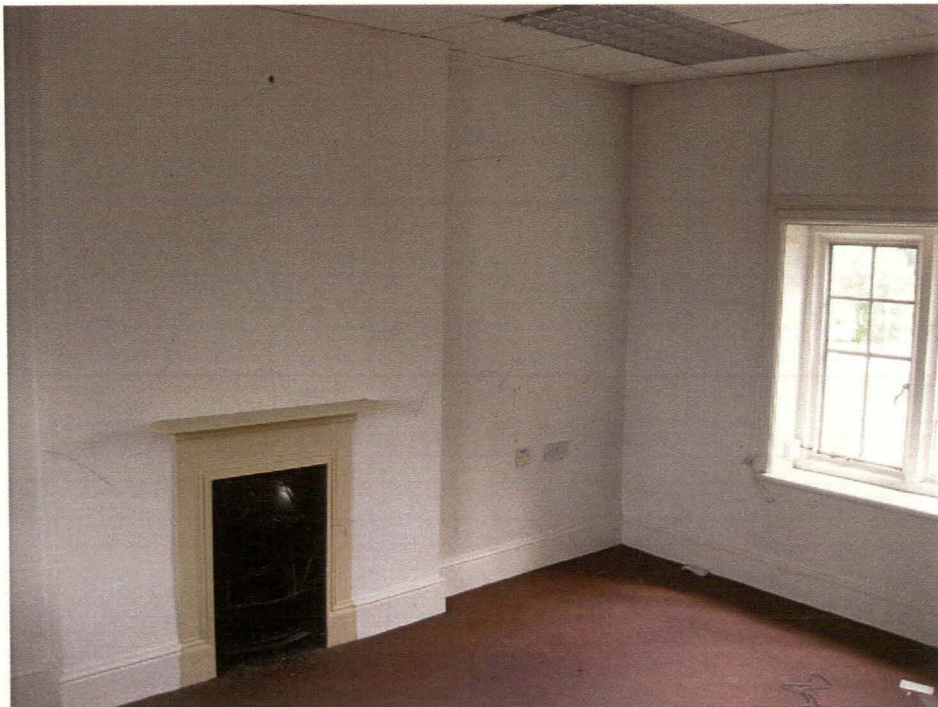
Plate 19
Room 12, showing
fireplace and
mullioned
window, looking
northeast

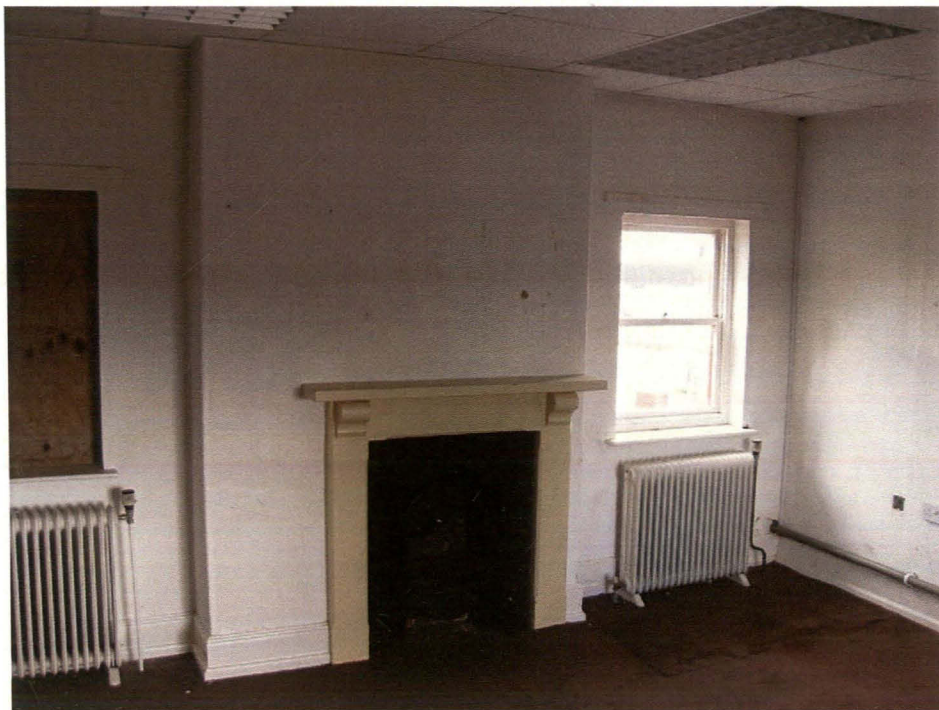
The southern landing provides access to three further rooms. There is an original doorway to the eastern room (Room 13, Block 3). This room has an original window on the south side and a fireplace flanked by windows on the north side.

Plate 20
Room 13,
looking north

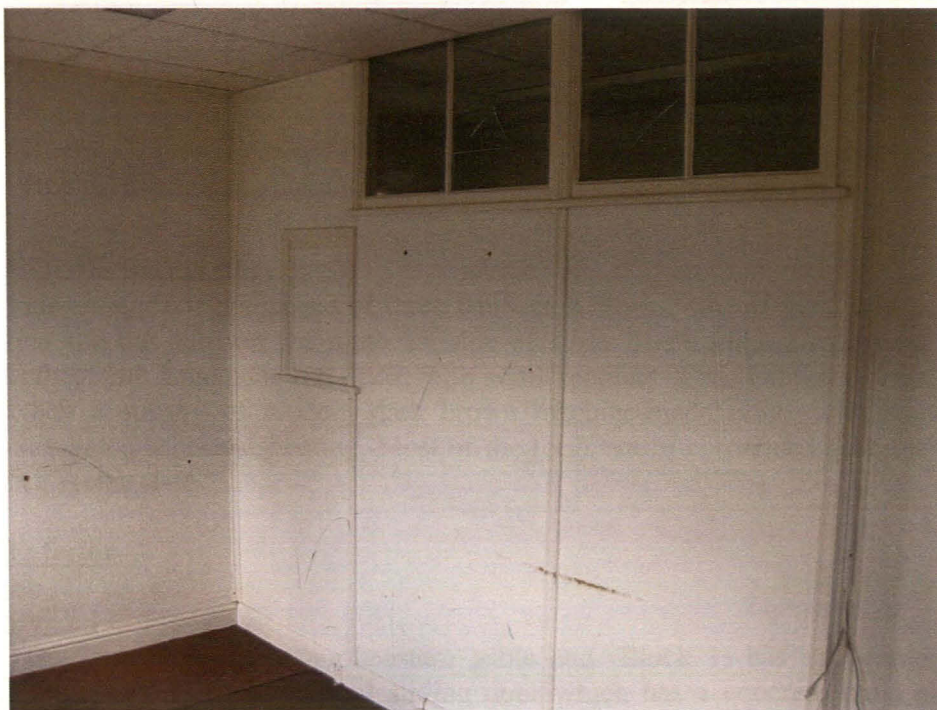
Off the south side of the landing is Room 14 (Block 2). In the south wall of this room is a fireplace flanked by two windows, all original. The fireplace contains a cast iron hearth that is probably a modern or reused insertion, but may be original.

Plate 21
Room 14,
showing
inserted
partition
separating it
from Room 15,
looking
northwest

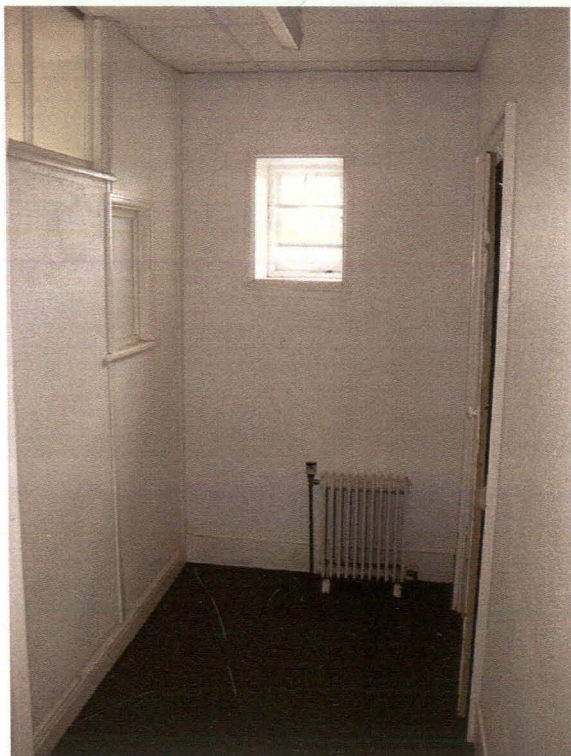
A wooden partition with glazing along the top forms the north wall of Room 14, separating from Room 15 (Block 2). There is a blocked window towards the western end of this partition (Plate 21). Room 15 is narrow and contains a deeply recessed small window in the west end wall (Plate 22). At the western end of the north wall is an original door that gives access to a small storage area (Room 16). This appears to have a blocked exit on the north side, suggesting this small room originally served as a passage to, or common store with, Room 12 to the north (Plate 23). However, there are no indications of this possible exit within Room 12. All the upper floor rooms have modern suspended ceilings.

Plate 22
Room 15, showing door to storage area,
Room 16, on right, looking west

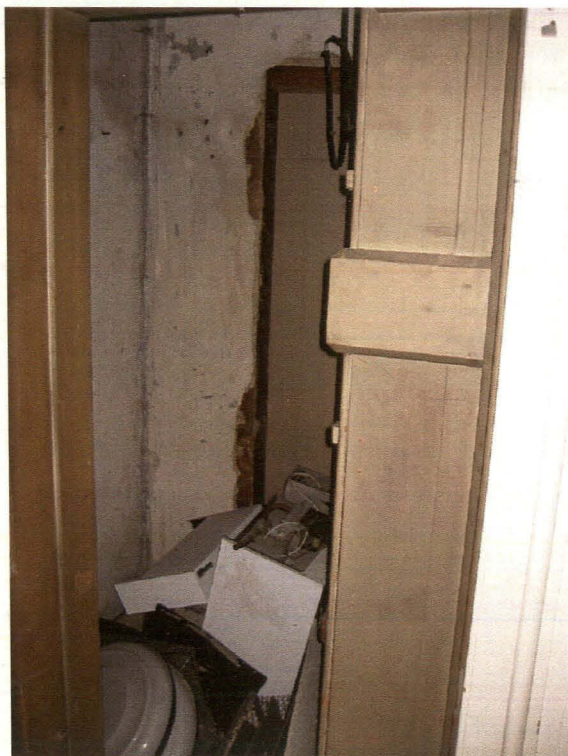
Plate 23
Room 16, storage area, showing
blocked opening at rear, looking north

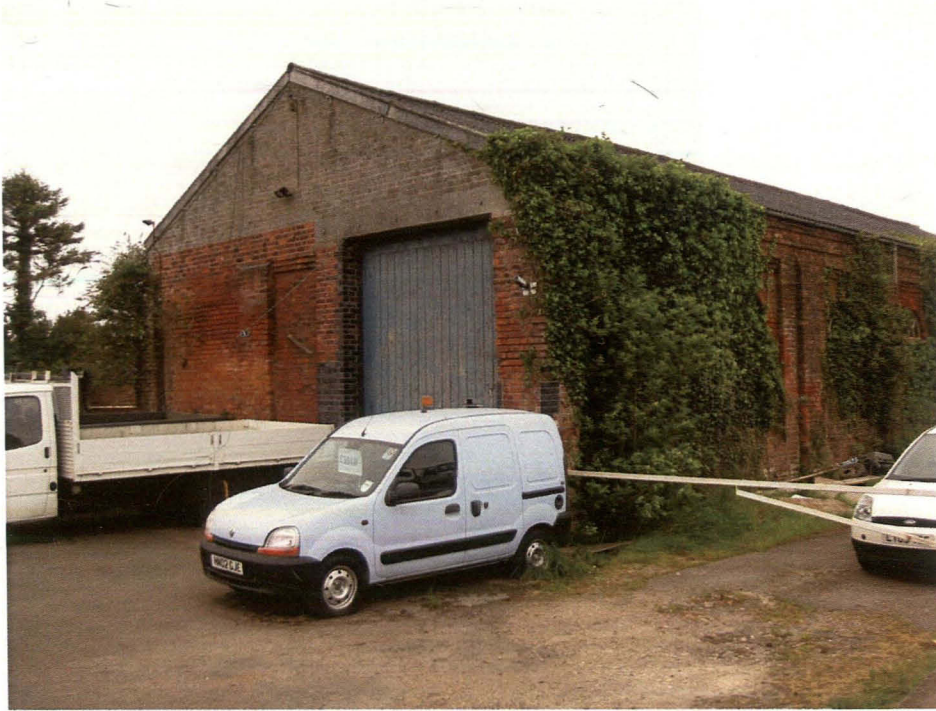
Plate 24
Goods shed,
northeastern and
northwestern
elevations, looking
south

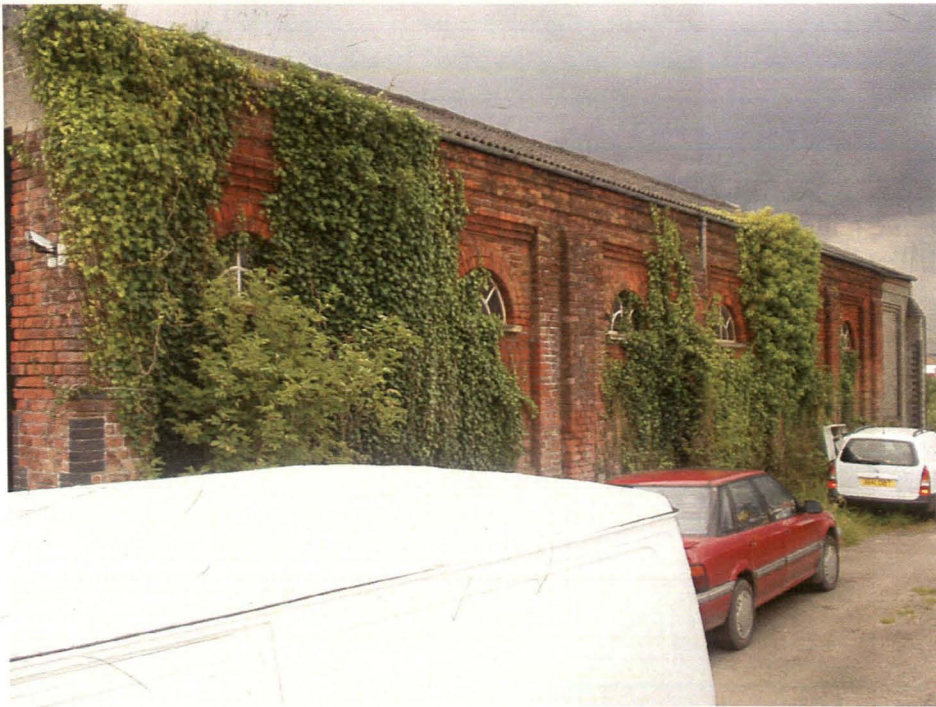
Plate 25
Goods shed,
northwestern
elevation, looking
south

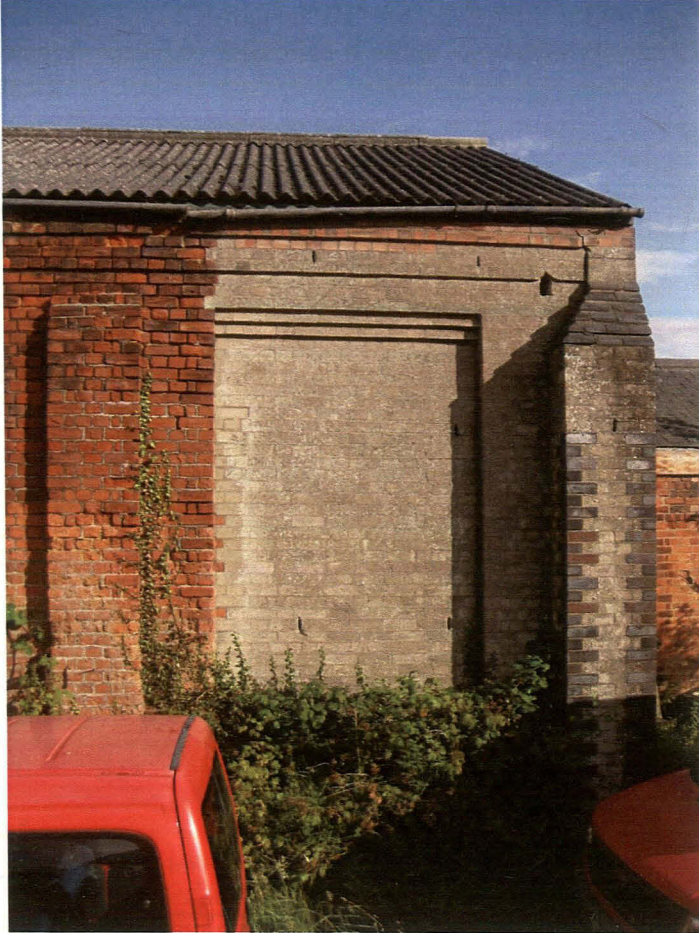
elevation is a corner buttress of grey brick with edging of blue, black and brown brick.

Plate 26
Western end of northwestern
elevation, showing repair,
looking southeast

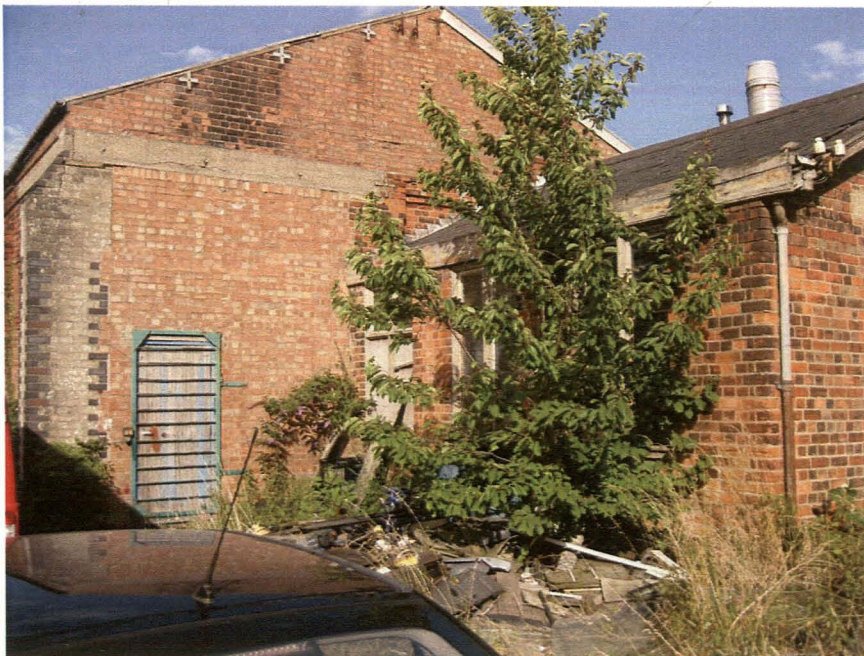
The southwestern elevation is partially obscured by attached Block 2. The northern half of the elevation, almost up to eaves level, is a large patch of modern machine-made brick topped by a large concrete lintel. This probably represents a blocked loading door. This patch contains a modern door (Plate 27).

Plate 27
Southwestern elevation
of goods shed, and
attached Block 2,
looking east

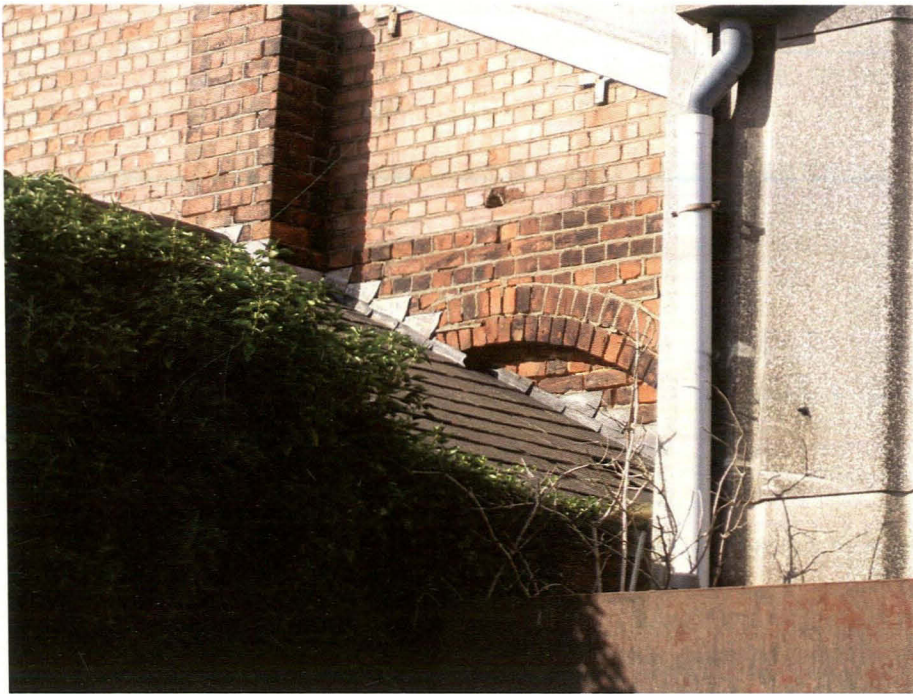
South of the blocked loading door the walling is of handmade brick and contains two recesses, one flat-topped and the other with a D-shaped arch (Plate 28). Two little of these were revealed to determine if either were ever glazed. The gable is of modern machine-made brick.

Plate 28
Southwestern
elevation of goods
shed, showing
arched recess
crossed by roof of
adjacent Block 2,
looking northeast

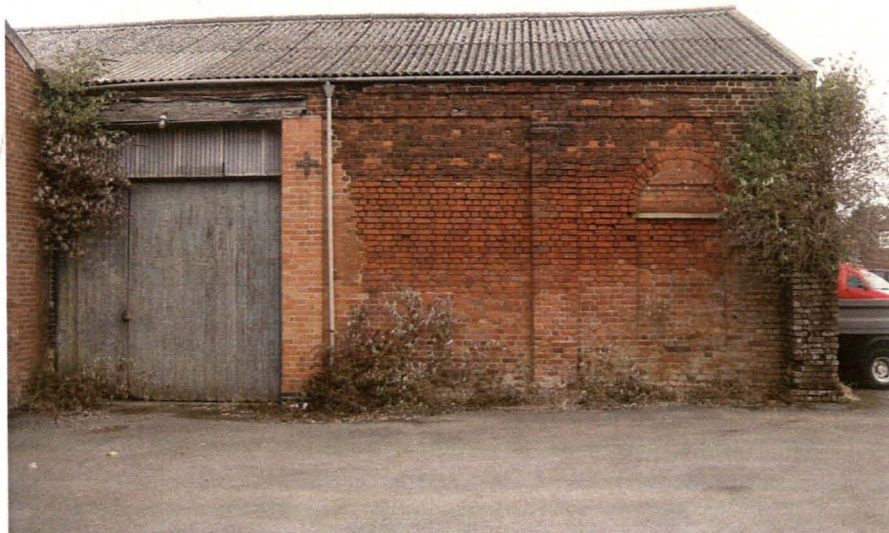
Most of the southeastern elevation is covered by Block 3. Immediately east of Block 3 the elevation contains a tall wide wooden sliding door. The entry is topped with a timber lintel just below the eaves. On the east side of this entry is a ragged join and patch of modern machine-made brick. There are two plinths further to the east, one at the corner of the elevation. Between the plinths is a tall recessed panel with a blocked D-shaped window at the top (Plate 29).

Plate 29
Eastern end of
southeastern
elevation of goods
shed, looking
northwest

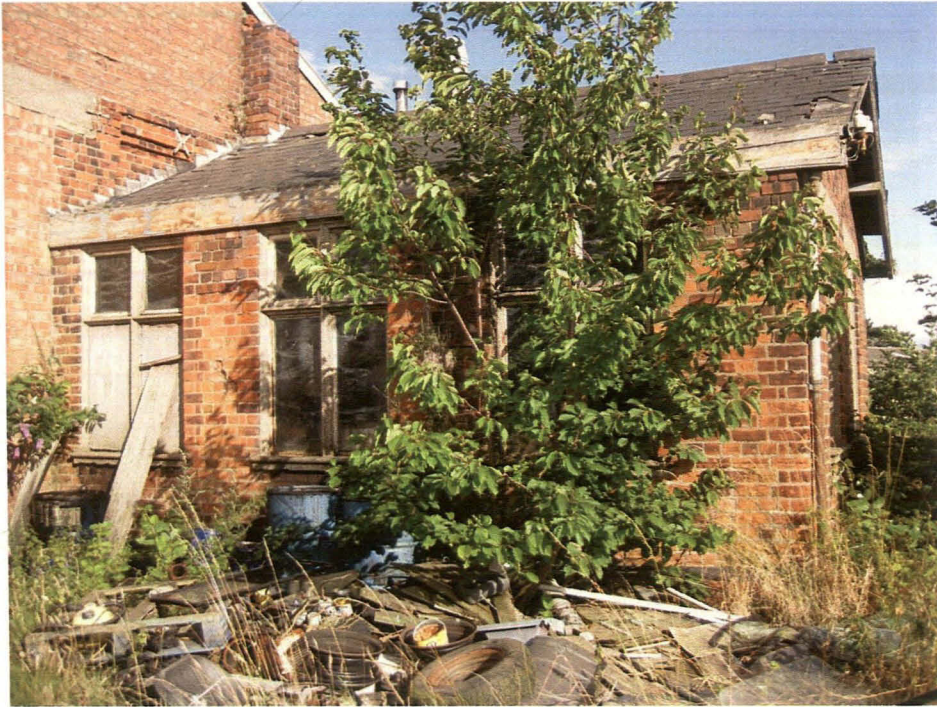
This single storey section is located at the southwestern end of, and set slightly back from, Block 1. It is built of late handmade brick and has a slate roof. There is a brick chimney rising from the eastern end of the roof apex, and attached to the wall of Block 1. The northern elevation contains three windows with concrete frames, mullions and transoms (Plate 30). The western gable end contains two further concrete framed windows with mullions, transoms and lintels all of concrete. Although mostly obscured by vegetation and dumped materials the southern elevation appears to be plain (Plate 31).

Plate 30
Northern
elevation of
Block 2. Note
recessed panel in
wall of Block 1
(on left) crossed
by roof line,
looking
southeast

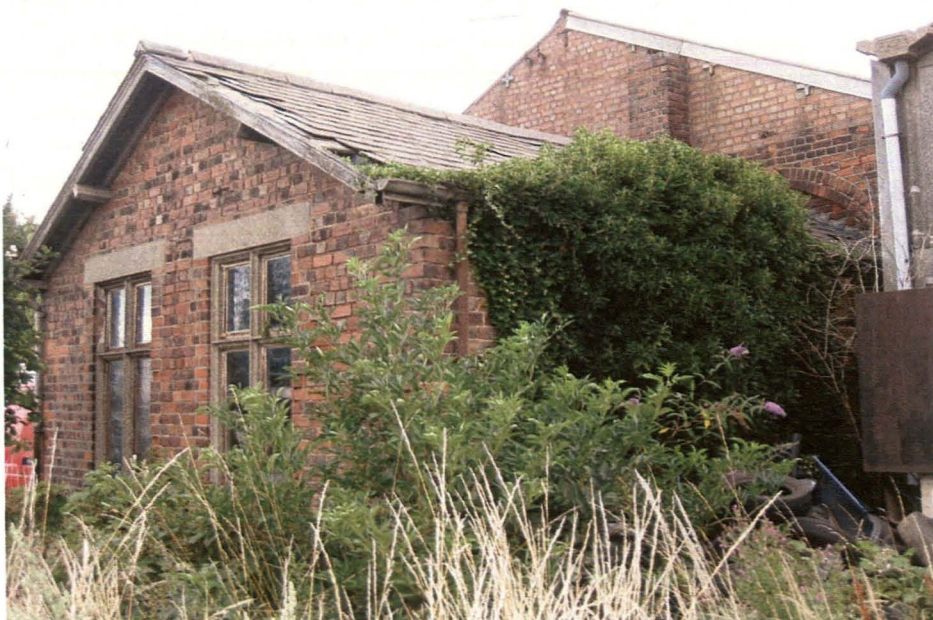
Plate 31
Western and
southern
elevations of
Block 2, looking
north
