**HISTORIC BUILDING SURVEY
OF THE
FORMER STATION HOUSE AND GOODS SHED,
AT THE FORMER RAILWAY STATION,
STATION ROAD,
HOLBEACH,
LINCOLNSHIRE
(HOSR09)**

Report Compiled by
Gary Taylor BA (Hons) MA MSc

APS Report No. 73/09

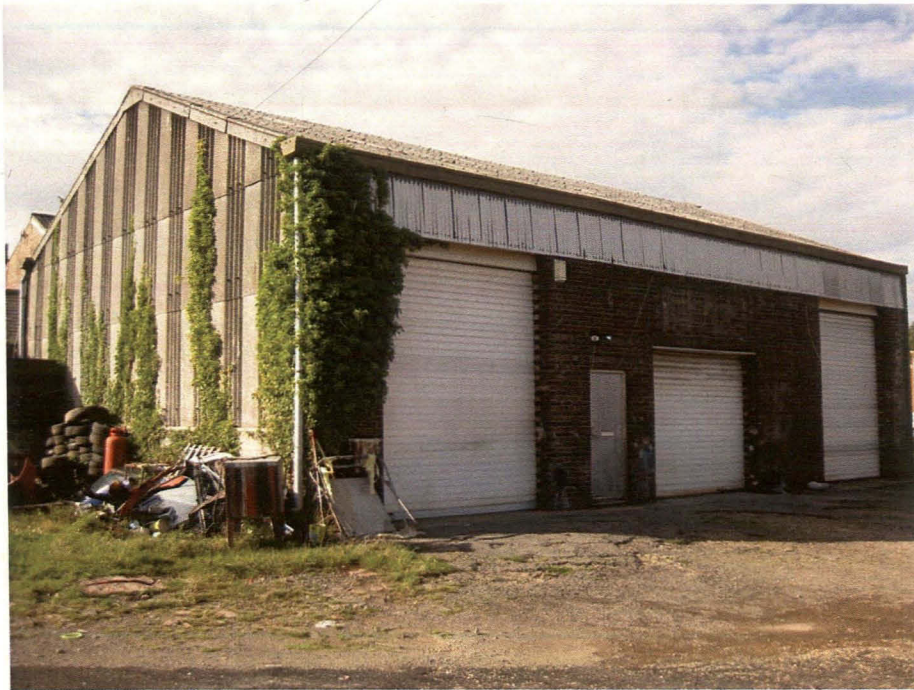
Of dark brown machine-made brick, the southern façade contains three modern metal roller doors, two (located towards either end of the wall) being almost the full height of the elevation, the third being half as tall. There is also a normal sized wooden door between the western and central roller doors. The eastern gable end is plain.

Plate 32
Western and
southern sides of
Block 3, looking
north

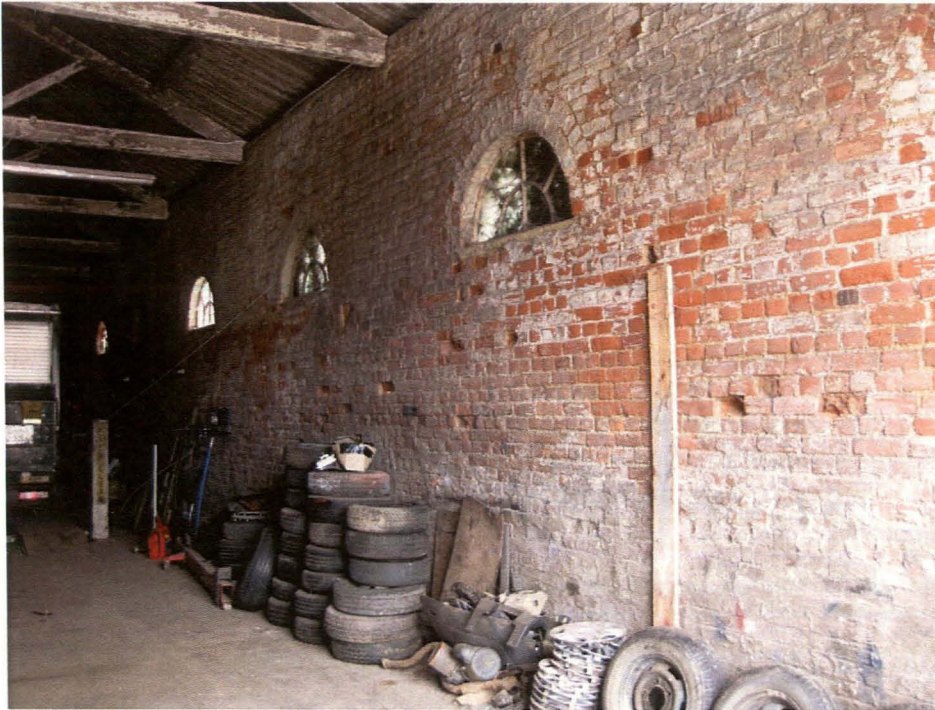
Room 1 has a concrete floor and a series of roof trusses which also go over inaccessible Room 2 to the south. The D-shaped windows are evident in the north wall but there are no indications of the recessed panels beneath, as seen on the exterior. There is a series of plinths in the eastern gable that support roof joists. In the southeastern corner of the room is a single story office of breeze block with a modern glazed door in the north side (Room 3).

Plate 33
Goods shed
Room 1, north
side, looking
west

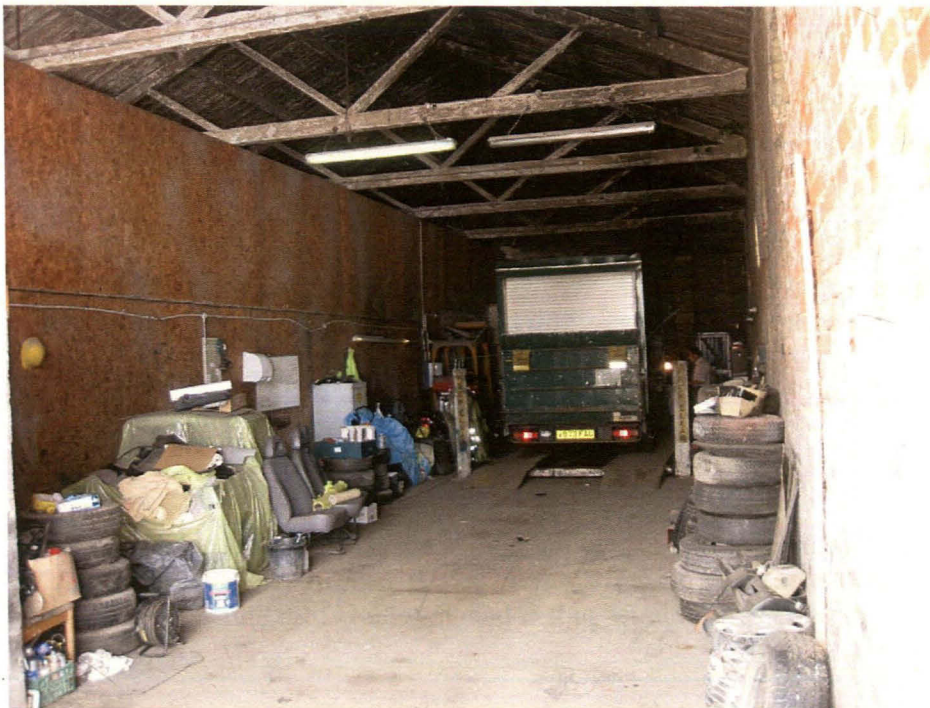
Plate 34
Goods shed
Room 1,
showing roof
trusses and
inserted
partition, looking
west

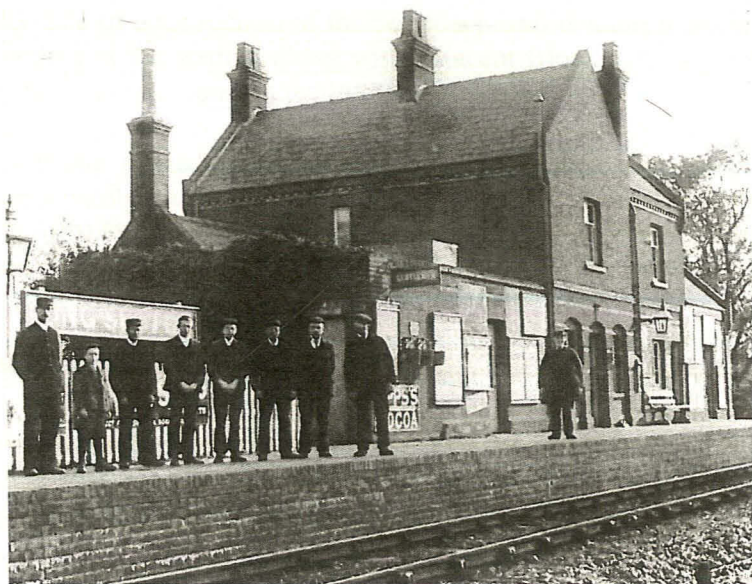
Plate 37
Long Sutton station house,
c. 1900

Historical evidence shows that the station house was built according to a plan that was used with minor adaptations at other stations on this line. In particular, the station house at Long Sutton was very similar to Holbeach, and that at Moulton was also closely comparable (plates 37-39).

In consideration of the similar station houses at Long Sutton and Moulton (see Plates 37 and 38, above), and the suggestion that, originally, there was a central doorway in the southern elevation (see Plate 4, above), this block might have initially been a toilet block, perhaps unroofed or with a flat roof. If so, the building seems to have been altered soon after its construction and a new toilet block, represented by the boundary wall, erected alongside.

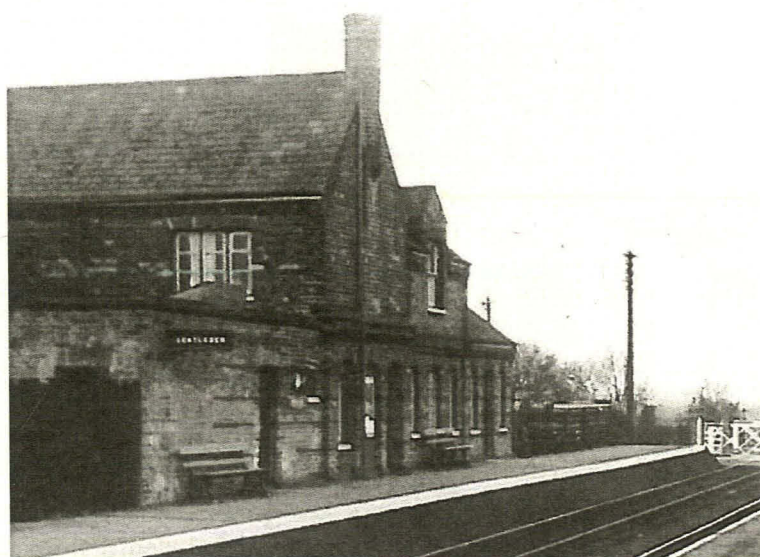
Plate 38
Moulton station house, 1958

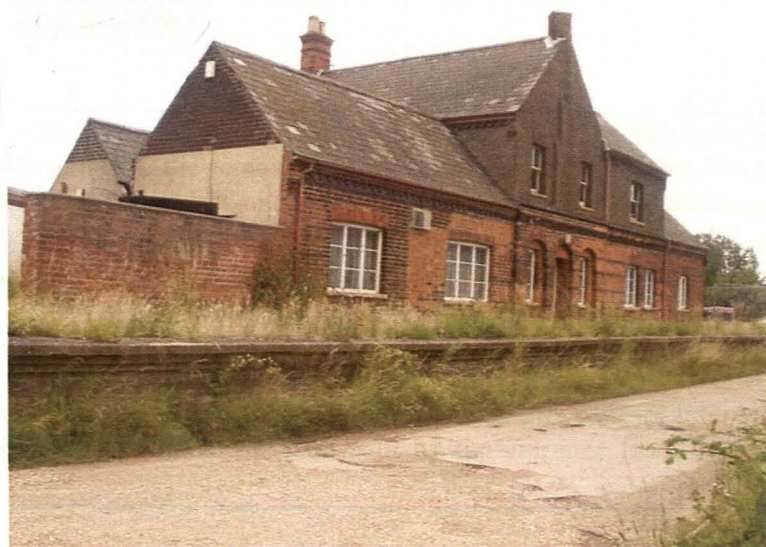
Plate 39
Holbeach station house,
2009, showing similarity to
Long Sutton and Moulton

This block was probably also built as part of the unified station house plan in *c.* 1858. Initially, it may have been one large room, but was more probably two, though there are no surviving architectural indications of a dividing wall. However, a historic photograph, taken in 1961 (Plate 39, above), shows a centrally-located chimney stack rising through the roof, and also suggests an alteration in the roof line where the chimney is located. This photographic evidence implies this block was divided into two rooms, perhaps with back-to-

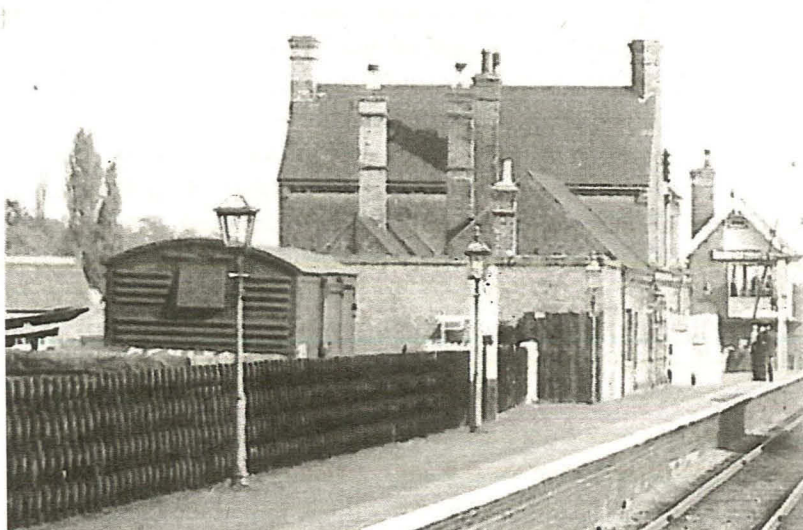
Plate 40
Holbeach station house,
1961

The boundary wall relates to rendering across the west sides of Blocks 1 and 5. Historic photographs, taken between *c.* 1906 and 1961, show the boundary wall forming part of a flat-roofed extension to the station house complex. This extension was probably a toilet block, though the 1961 photograph shows that the building had a chimney. Comparable flat-topped toilet blocks, in broadly the same relative position to this one at Holbeach, are recorded at the closely similar station houses at Long Sutton and Moulton.

Originally, the building was one storey high, with the top at about the level of the eaves of adjacent Block 1. However, when the toilet block was demolished the wall was lowered to about half its original height. The date of demolition of this building is unknown, but was clearly after 1961.
