**LADY ANNE'S HOTEL, ST MARTINS,
STAMFORD**

HISTORIC BUILDING RECORDING

ARCHAEOLOGICAL SOLUTIONS LTD**LADY ANNE'S HOTEL, STAMFORD,
LINCOLNSHIRE****HISTORIC BUILDING RECORDING**

LADY ANNE'S HOTEL, STAMFORD, LINCOLNSHIRE AN HISTORIC BUILDING RECORDING

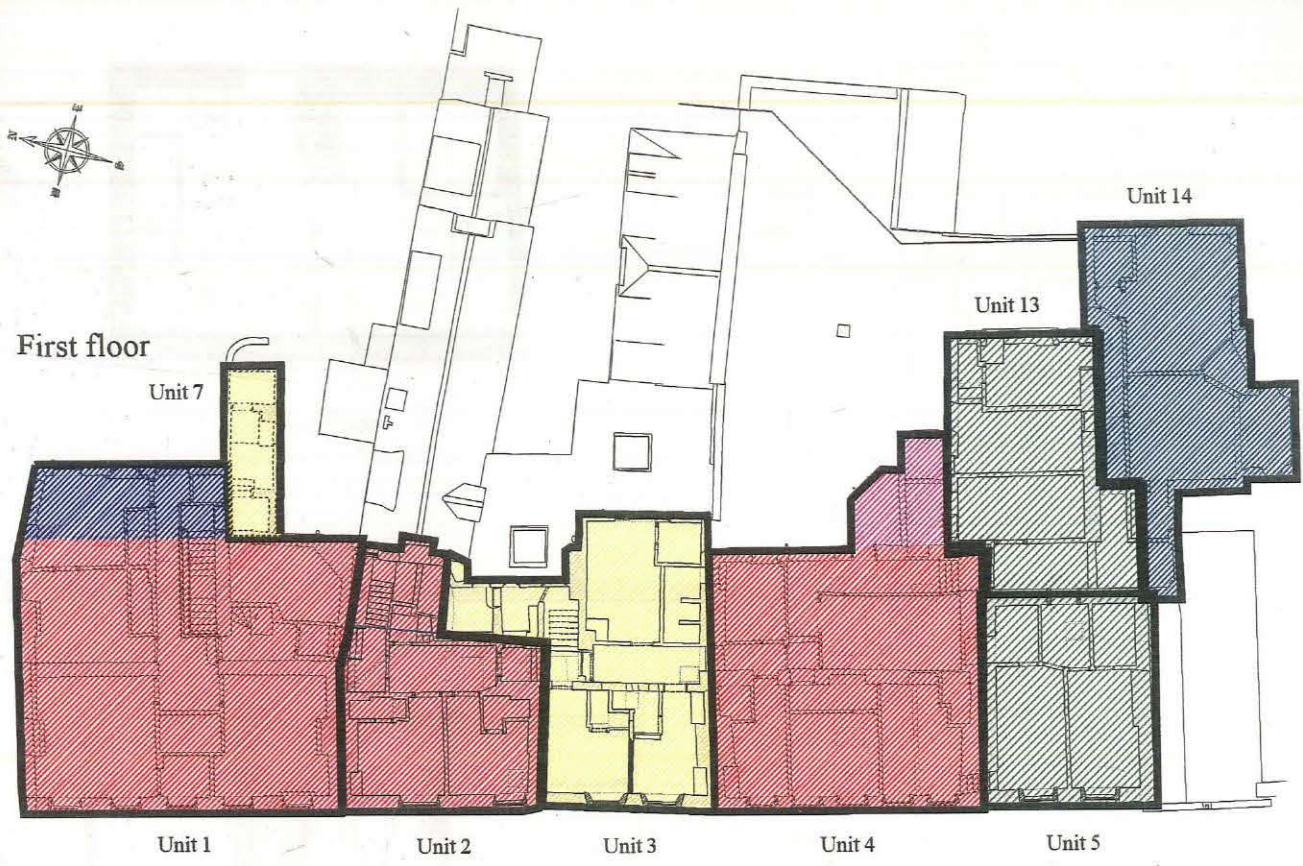
Fig. 18 Phase plans

- Phase 1 (later 18th century)
- Phase 2 (late 18th/early 19th century)
- Phase 3 (earlier 19th century)
- Phase 4 (mid 19th century)
- Phase 5 (late 19th century)
- Phase 6 (earlier 20th century)
- Phase 7 (later 20th century)
