**SURVEY OF BUILDINGS AT
MEADS FARM,
KIRTON DROVE,
BROTHERTOFT,
LINCOLNSHIRE
(BMF05)**

November 2005

A.P.S. Report No. 174/05

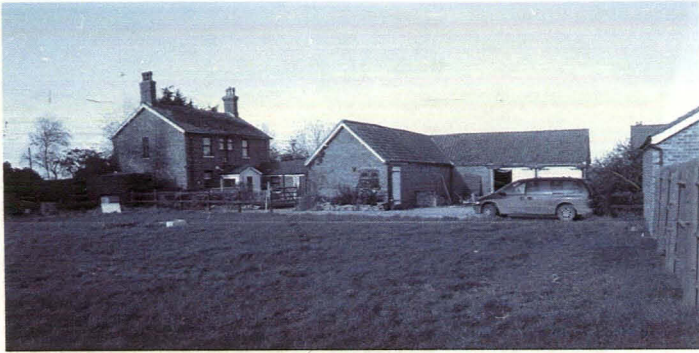
Plate 1 General Site View, showing recorded buildings (right) and house (left), looking west

The recorded structures form an L-shaped arrangement of outbuildings located immediately to the east of the farmhouse (Figs. 3 and 4; Plate 1).

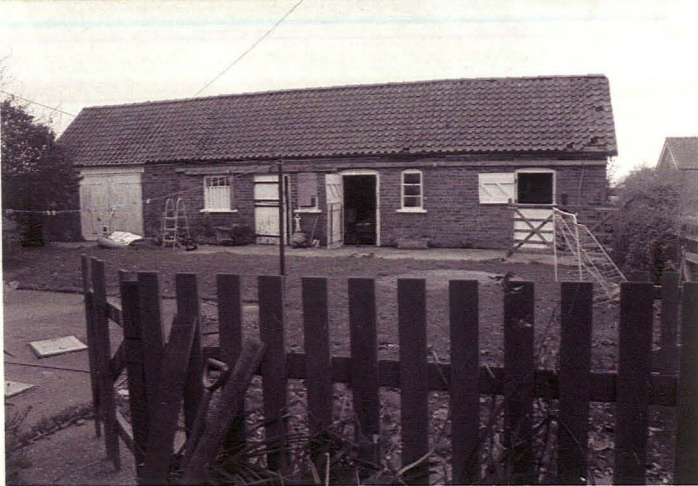
Plate 2 NW-SE Range, SW elevation, looking northeast

The range consists of four rooms, accessed by four separate doors in the southwestern elevation (Plate 2). Each room is open to

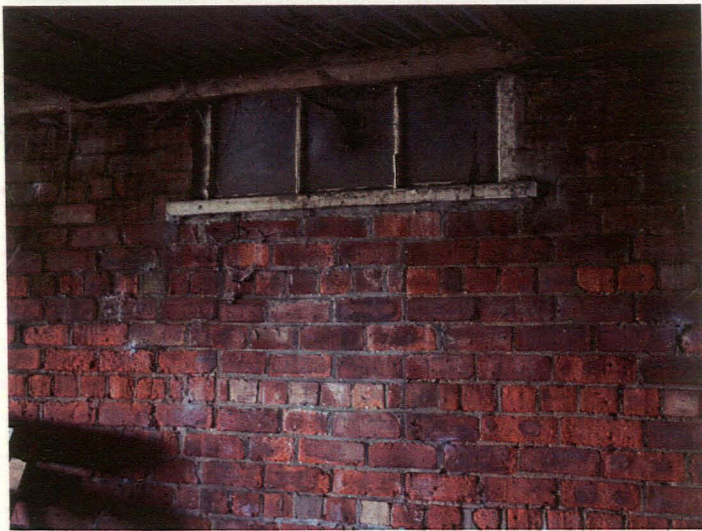
Plate 3 NW-SE Range, northwest external wall, showing straight joins of blocked window, looking southeast

At the northern end is the largest room with entry via planked double doors. This room has a brick floor and a window in the northwestern wall. On the interior of the room there is a ragged joint below the window. On the exterior of this wall are two straight joins (Plate 3), one in line with the ragged joint internally. Also on the exterior, the window is partially overlapped by the roofline of the timber lean-to, described below.

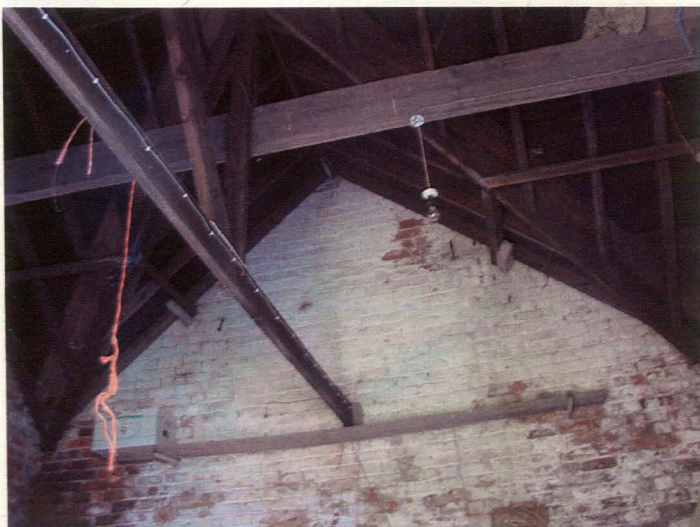
Plate 4 NW-SE Range, northwest room, showing roof timbering, looking northeast

Two beams cross the room, from NW-SE and NE-SW, the former overflying the latter. To the east of the NW-SE beam are two valleys in the roof, rising from the north and south corners to meet above the beam crossing point over the centre of the room (Plate 4).

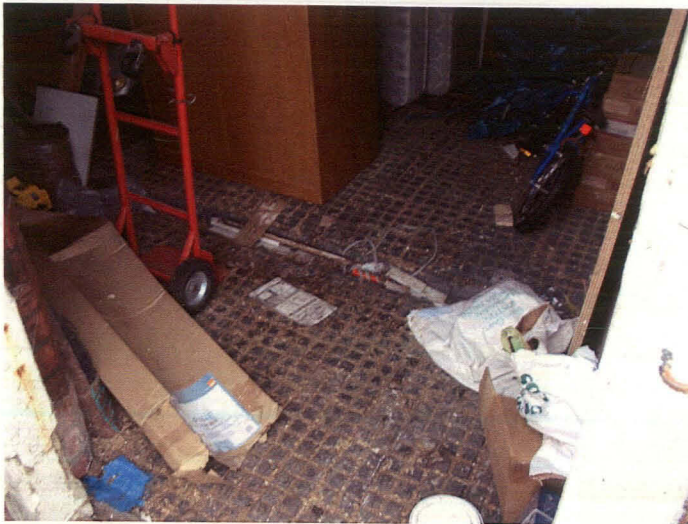
Plate 5 NW-SE Range, 2nd room from north, showing blue pavers and drain, looking north

The next room to the southeast is entered by a Dutch door. There are rebates on the door jambs, mostly to accommodate the strengthening planks on the insides of the doors, though there is also one low down on the inside of the jamb on the lock side of the doorway. North of the doorway is a window with a wooden slat ventilator below. There is a manger alongside the rear, eastern, wall. Above the manger the wall chamfers and thins. The floor is of 8-panel blue pavers and contains a drain channel (Plate 5) about 2m from the manger. Two tie-beams cross the room NE-SW, the more southerly supported on a brick plinth located just inside the doorway. High in the southeastern wall are ventilator holes where bricks have been removed.

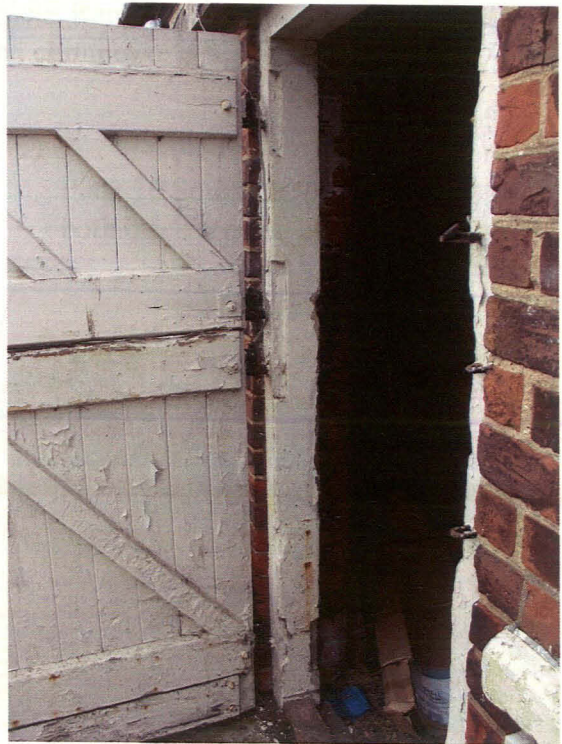
Plate 6 NW-SE Range, detail of door jamb rebates, looking north

The third room from the northwestern end of the range is accessed by a central Dutch door. Rebates are also present on the jambs of this doorway, including low down on the insides of both posts (Plate 6). There are small windows in the southwestern

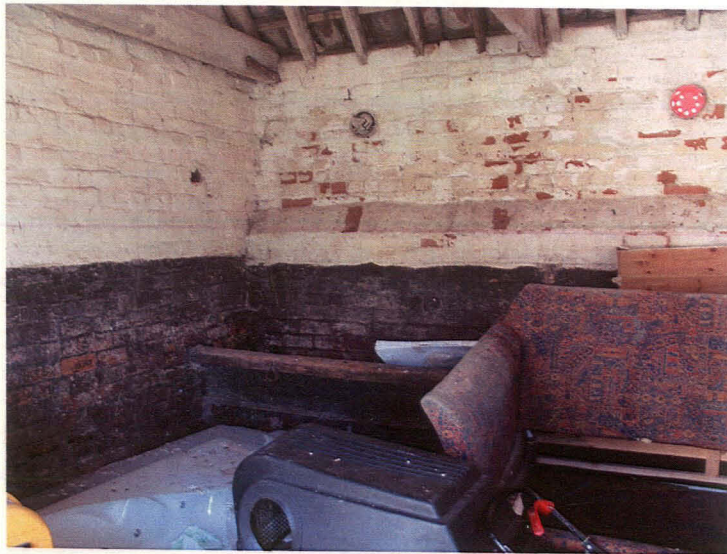
Plate 7 NW-SE Range, manger and chamfered wall, looking north

elevation at the northern and southern limits of the room. Internally, there is a manger against the far, eastern, wall and the wall chamfers and thins above (Plate 7). Toward the eastern side of the northwestern wall and a little above the chamfering of the eastern wall is a small socket. Additionally, high in this wall are several ventilator holes formed by removed bricks (Plate 8). Two tie-beams cross the room NE-SW. Much of the floor is of brick though a large part of the central and northern section is concrete. A drain channel is evident in brick flooring on the northern side of the room, though this drain did not continue in the brick paving on the south side. There is a small cavity in the northwestern wall directly above the drain.

This northwest-southeast range was purpose-built as stables and retains some of the original fittings, most notably the mangers and slatted ventilator windows. It is possible that the chamfering of the walls above the mangers provided the bases of hay racks and a socket in the wall near the chamfering may have originally held the top front bar of such a rack (Plate 7).

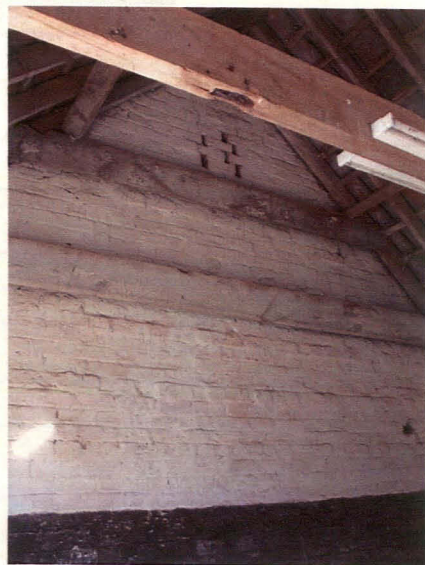
Plate 8 NW-SE Range, NW wall of 3rd room from north showing ventilator holes, looking north

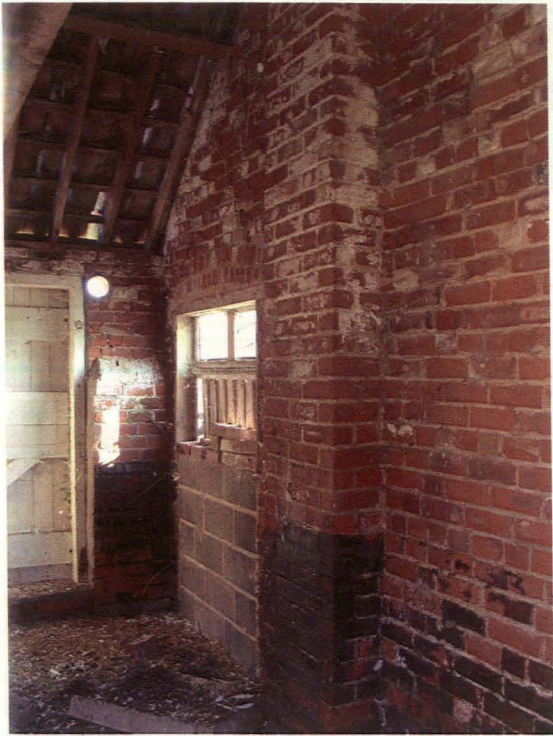
Plate 9 NW-SE Range, SE room, showing former fireplace and chimney and blocked door, looking northeast

A Dutch door provides entry to the room at the south end of the range. This has a brick floor and has two tie-beams, both NE-SW, above. On the southeastern wall is a brick plinth that appears to be a small blocked fireplace and chimney (Plate 9). However, this chimney does not exit the roof (Plate 10). On the east side of the chimney, in the southeastern gable, is a blocked doorway with a wooden slat ventilator and window in the upper half. This is also seen from the outside (Plates 10 and 11). However, the blocking of the lower half is breeze block on the interior and brick on the exterior. High in the exterior gable is a perforated ventilator brick.

Alterations to this stable block occurred with the closure of the fireplace and the conversion of a doorway at the southeastern end to a ventilator window.

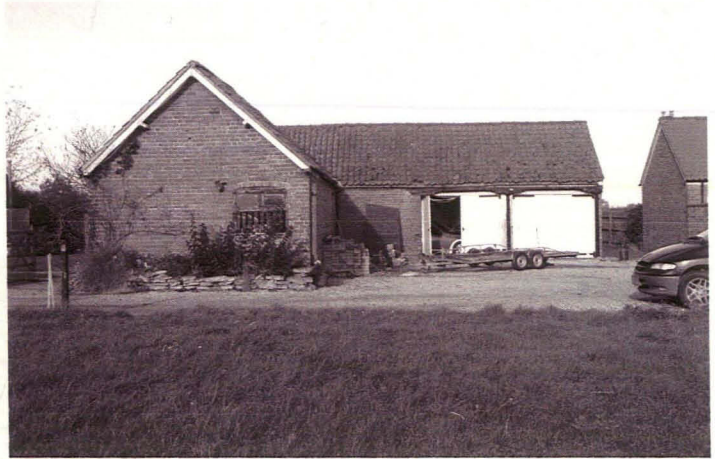
Plate 10 Southwestern elevations of both brick ranges, looking northwest

elevation are two wooden double doors that provide the main access to the range (Plate 10). To the west of the doors the elevation is of brick. Between the two sets of doors is a small section of wooden walling. Directly in front of this is a cast iron stanchion (Plate 13). Another iron stanchion is located at the northeastern end of this wall and is partially built in to it. Above these stanchions, and also over the western end of the west doorway, are ornate timber pads that support beams used as lintels to the entries. Both beams are chamfered with simple straight-cut stops.

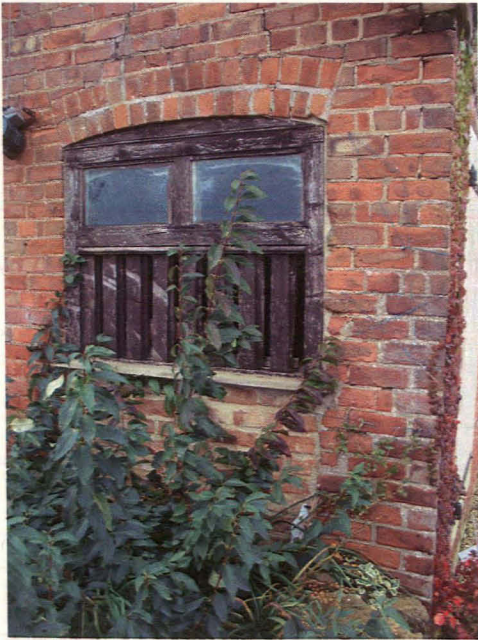
Plate 11 NW-SE Range, SE room, showing ventilator window in blocked door, looking west

These mangers were only present in the central two rooms of the range and there were no indications of comparable feeding troughs in either of the two end rooms. At the southeastern end of the range is a room with another ventilator window and what appears to be a blocked fireplace. It is possible that this compartment served as a loose box, which would house a sick or

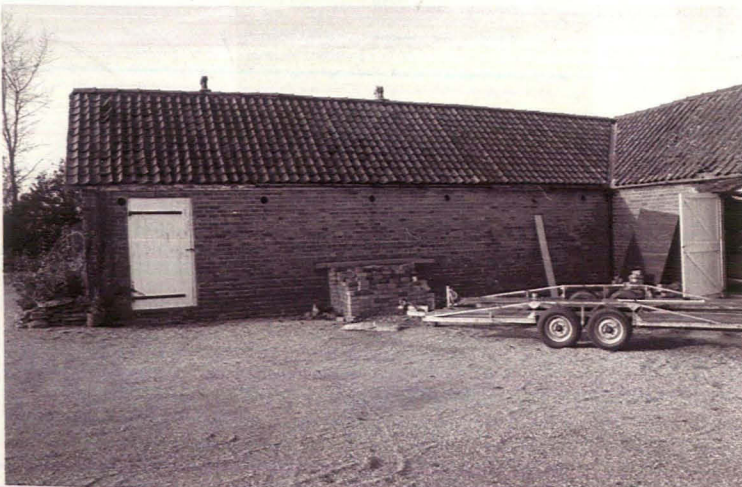
Plate 12 NW-SE Range, NE elevation, looking southwest

Most of the northeastern exterior elevation of the range is plain, except for the door near its southern end. The base of this doorway is set above ground level (Plate 12).

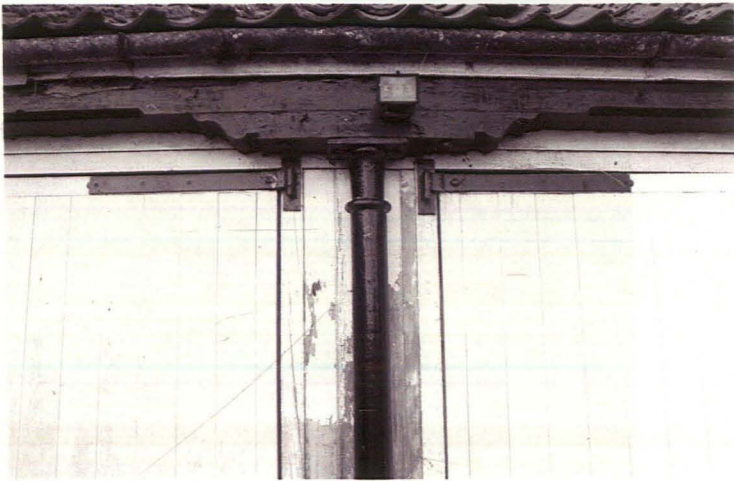
Plate 13 NE-SW Range, iron stanchion, pad and chamfered beams, looking northwest

This open front was broken by several cast iron stanchions that supported the front of the roof. Two of these stanchions remain, though it is possible that there were 3 or 4

originally. These stanchions were topped by ornately-carved timber pads that, in turn, supported wooden beams over the openings. These beams are chamfered with simple straight-cut stops. Such chamfer stops are characteristic of the late 16th-mid 17th centuries (Jones and Smith 1971, 14; Alcock and Hall 1994, 36), which may suggest that these beams are reused. However, rural areas like the region around Holland Fen frequently have conservative building techniques and these beams may be an example of such conservatism.

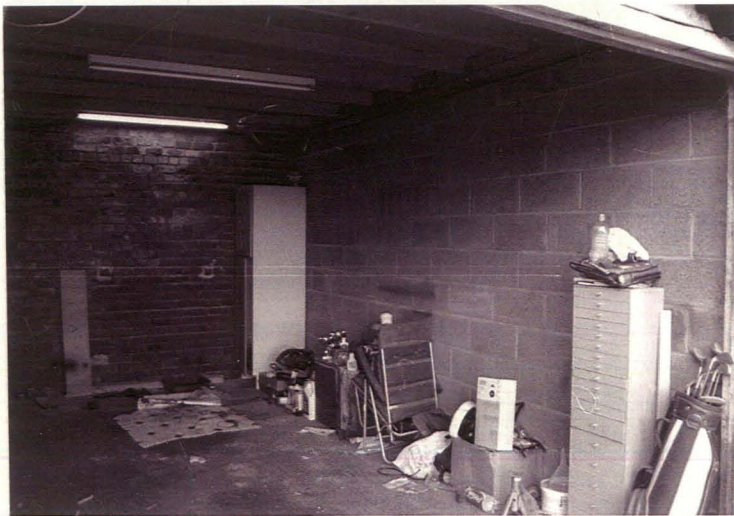
Plate 14 NE-SW Range, interior showing breeze block wall, looking north

The northeastern wall of the range is of breeze block internally (Plate 14), faced with brick on the exterior, and provides a plain gable end (Plate 15).

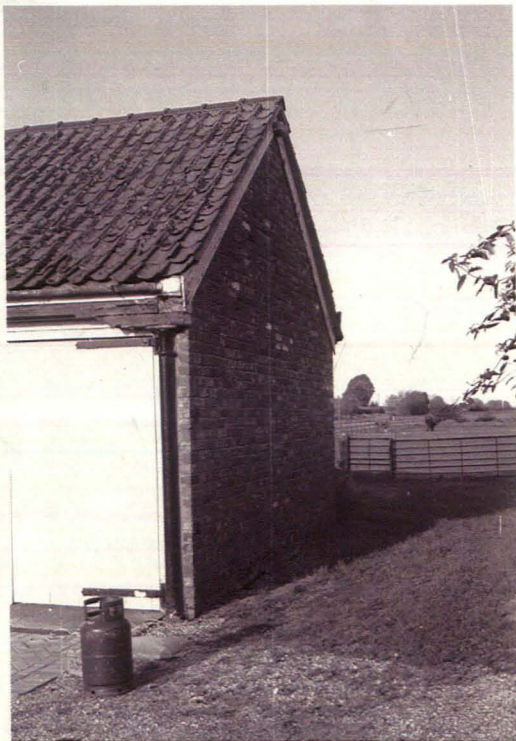
Plate 15 NE-SW Range, northeastern elevation, looking west

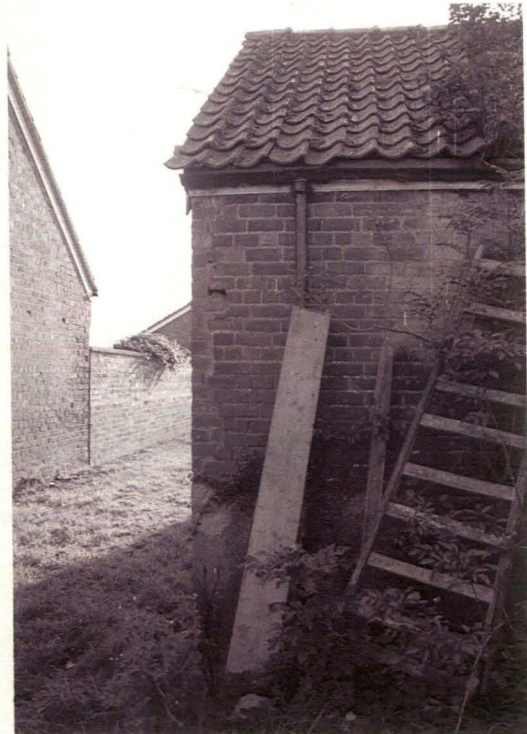
Plate 16 NE-SW Range, northwest elevation, north end, showing ragged joint, looking east

At the eastern end of the northwestern exterior elevation is a ragged join (Plate 16). About 3.5m to the west the elevation is met by the timber lean-to, described below. In the middle of the elevation, effectively within the lean-to, is a Dutch door. At the western end of the elevation, where the wall meets that of the NW-SE range, is a straight join that extends the full height of the wall (Plate 17).

A ragged join close to the northern end of the northwest wall of the range denotes an alteration of the structure at this point. This is emphasised by the construction of the northeast wall, which is of two skins, breeze block internally with an exterior brick face. These combined features indicate that the northeastern wall is an alteration to the range. This is confirmed by cartographic evidence that shows that this range originally extended further to the northeast and linked to buildings in that direction. It is likely that the original U-shaped arrangement of buildings was broken into the two separate L-shaped ranges, and the new end wall constructed, no earlier than the mid 20th century.

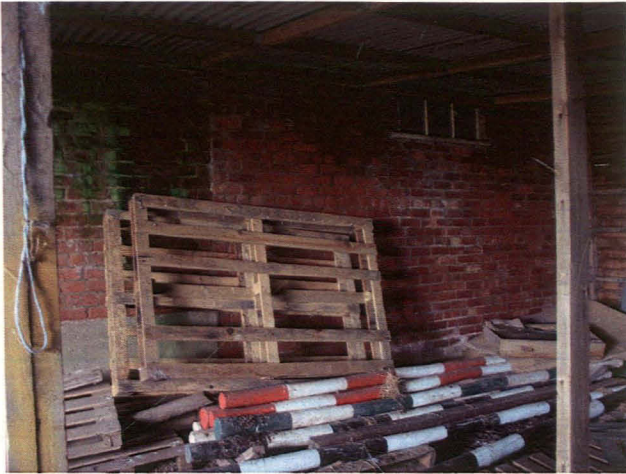
Plate 17 Interior of timber lean-to, showing straight join junction between NW-SE range (on right) and NE-SW range (to left), looking south

A straight join reveals that a second range, aligned northeast-southwest, was constructed against the back of the stable block. This new phase of building probably followed soon after the initial erection of the stables and the combined structures, together with others, were in existence by the early 1890s when they appeared on maps of the area (OS 1891).

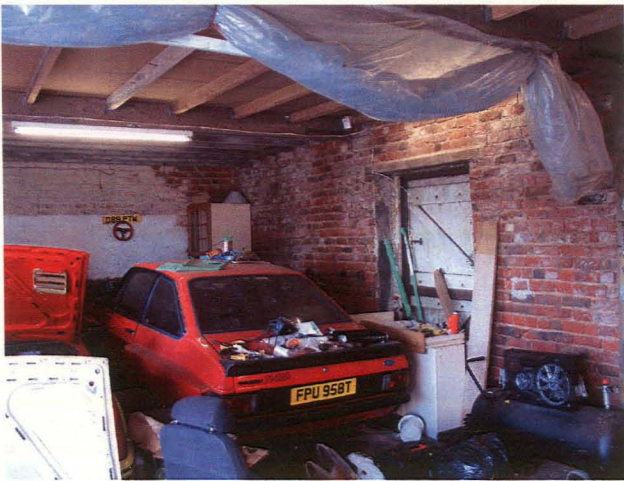
Plate 18 NE-SW Range, interior view, looking southwest

Internally, the range is crossed by a tie-beam, oriented NW-SE. The roof joists change direction part way across the ceiling. In the northeastern two-thirds they are aligned NE-SW, while in the southwestern third they run NW-SE (Plate 18).

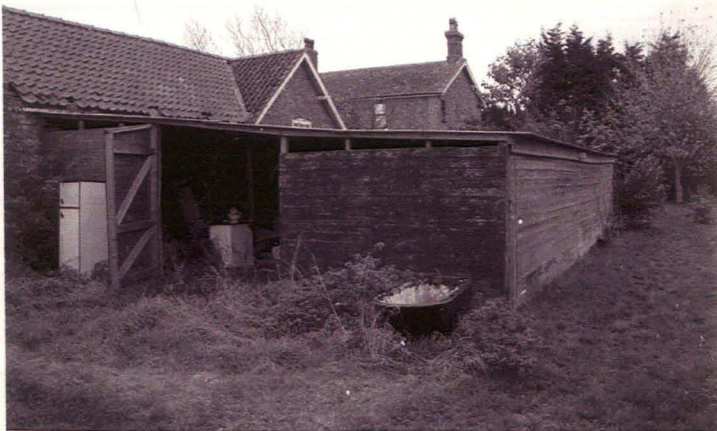
Plate 19 Timber Lean-to, northeastern elevation, looking south

Located on the northwestern edge of the complex and built against that face of the two brick ranges, this has plain exteriors on its southwestern and northwestern sides. Its northeastern elevation is broken by a double entry, though only one of the doors remains (Plate 19).

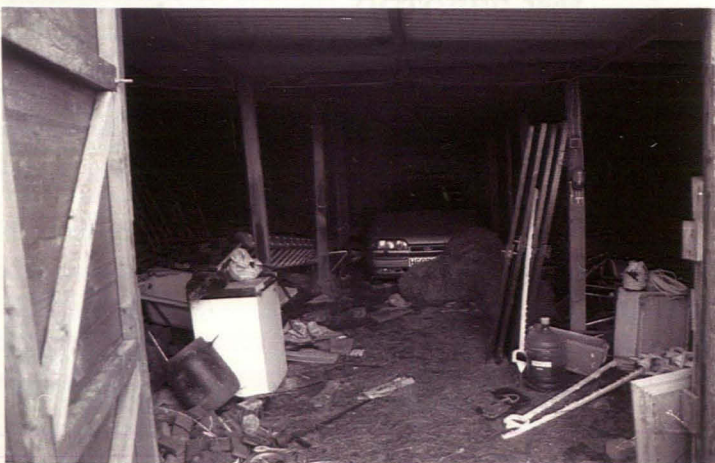
Plate 20 Timber Lean-to, interior, showing aisles, looking southwest

rows of slight timber stanchions dividing the room in to three aisles (Plate 20). There is a floor of earth and brick. The southeastern side of the lean-to is provided by the brick walls of the northwestern sides of the other two ranges, described above.
