NEWPORT ARCH AND BASTION
RECORDING OF REMAINS PRIOR
TO CONSERVATION

CLAU ARCHAEOLOGICAL REPORT NO: 222

Report to
Lincoln City Council

December 1995

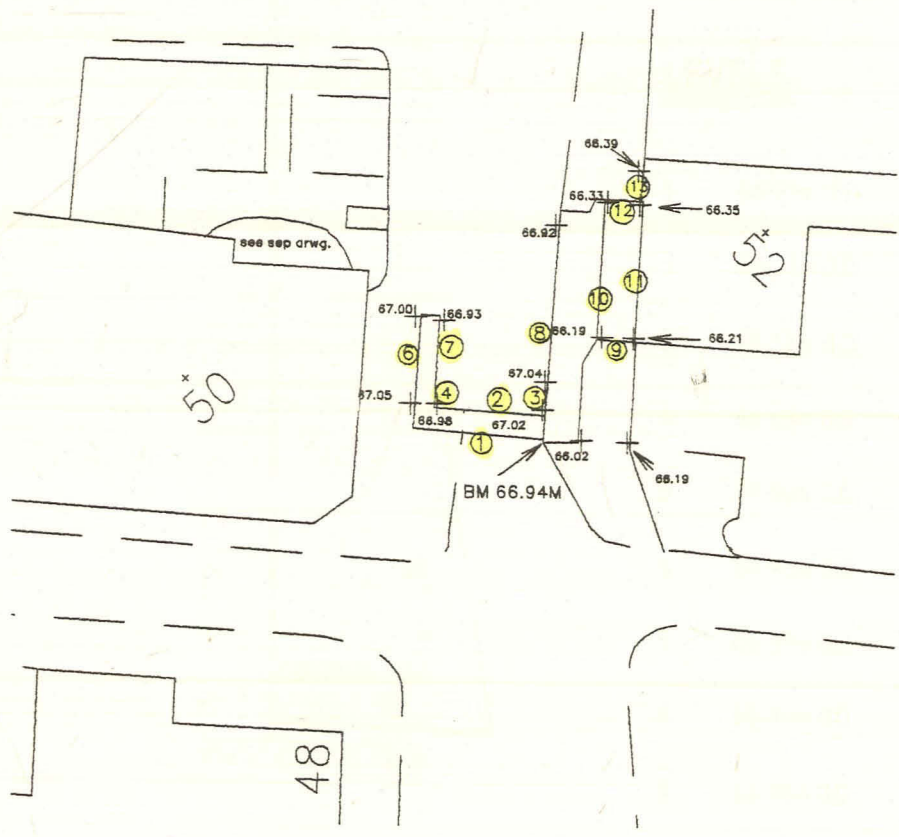
Fig.1

NEWPORT ARCH - LOCATION OF ELEVATIONS

CITY OF LINCOLN ARCHAEOLOGY UNIT	
SITE CODE: NAAGS	PLAN/BLDG/ISSUE NO: 1
CLIENT: LINCOLN CITY COUNCIL	
DESCRIPTION: PLAN OF MONUMENT	
SHOWS LOCATION OF ELEVATIONS	
+ LEVELS shown with values of ground/pathway surface.	
SCALE: NOT TO SCALE	ARCHIVE NO:
DRAWN BY: LJO	CHECKED: X
SURVEY ACCESSION NO:

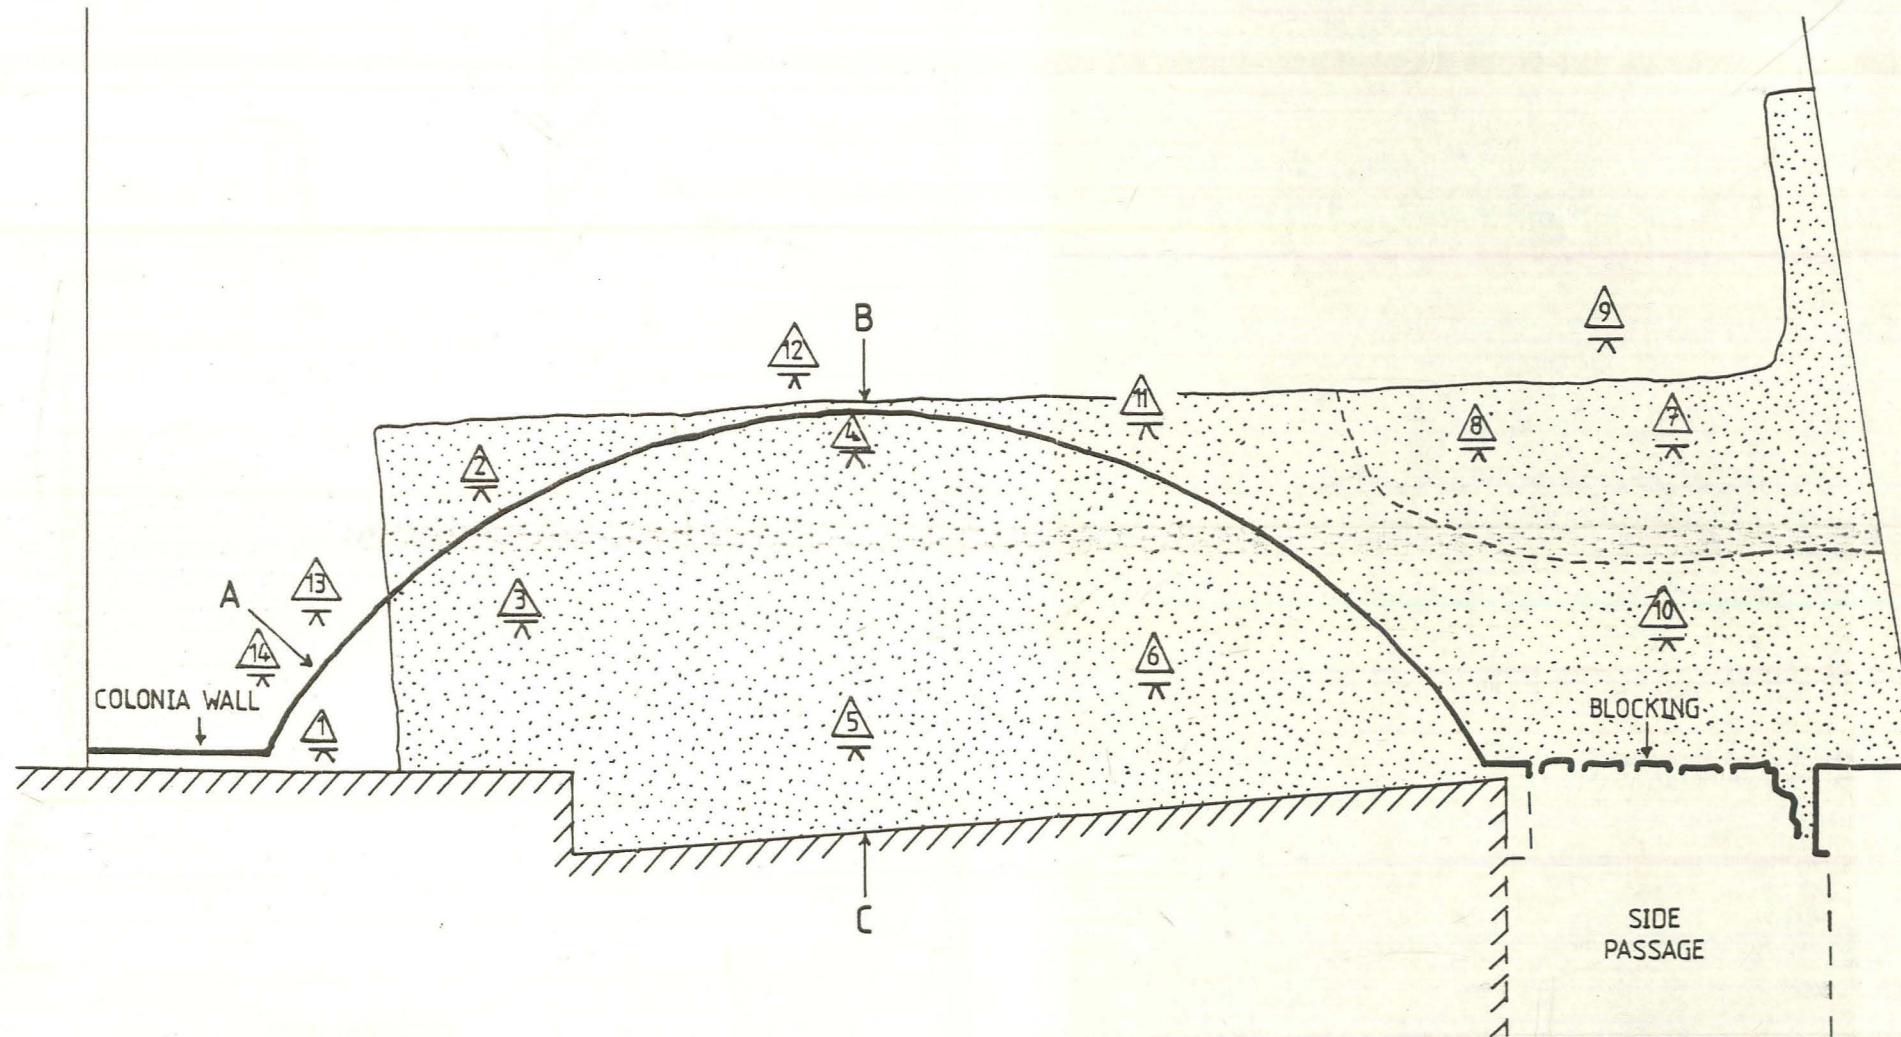
CITY OF LINCOLN ARCHAEOLOGY UNIT		
SITE CODE: NA 93	PLAN/ELEV/SECTION NO:	
CLIENT: LINCOLN CITY COUNCIL		
DESCRIPTION: GROUND PLAN OF BASTION		
SCALE: 1:50	ARCHIVE NO:	
DRAWN BY:	CHECKED:	DATE: 08/09/93

1	66.71m O.D.
2	66.33m O.D.
3	67.12m O.D.
4	66.93m O.D.
5	67.14m O.D.
6	66.95m O.D.
7	66.37m O.D.
8	65.89m O.D.
9	64.78m O.D.
10	64.89m O.D.
11	64.75m O.D.
12	64.74m O.D.
13	64.76m O.D.
14	64.79m O.D.

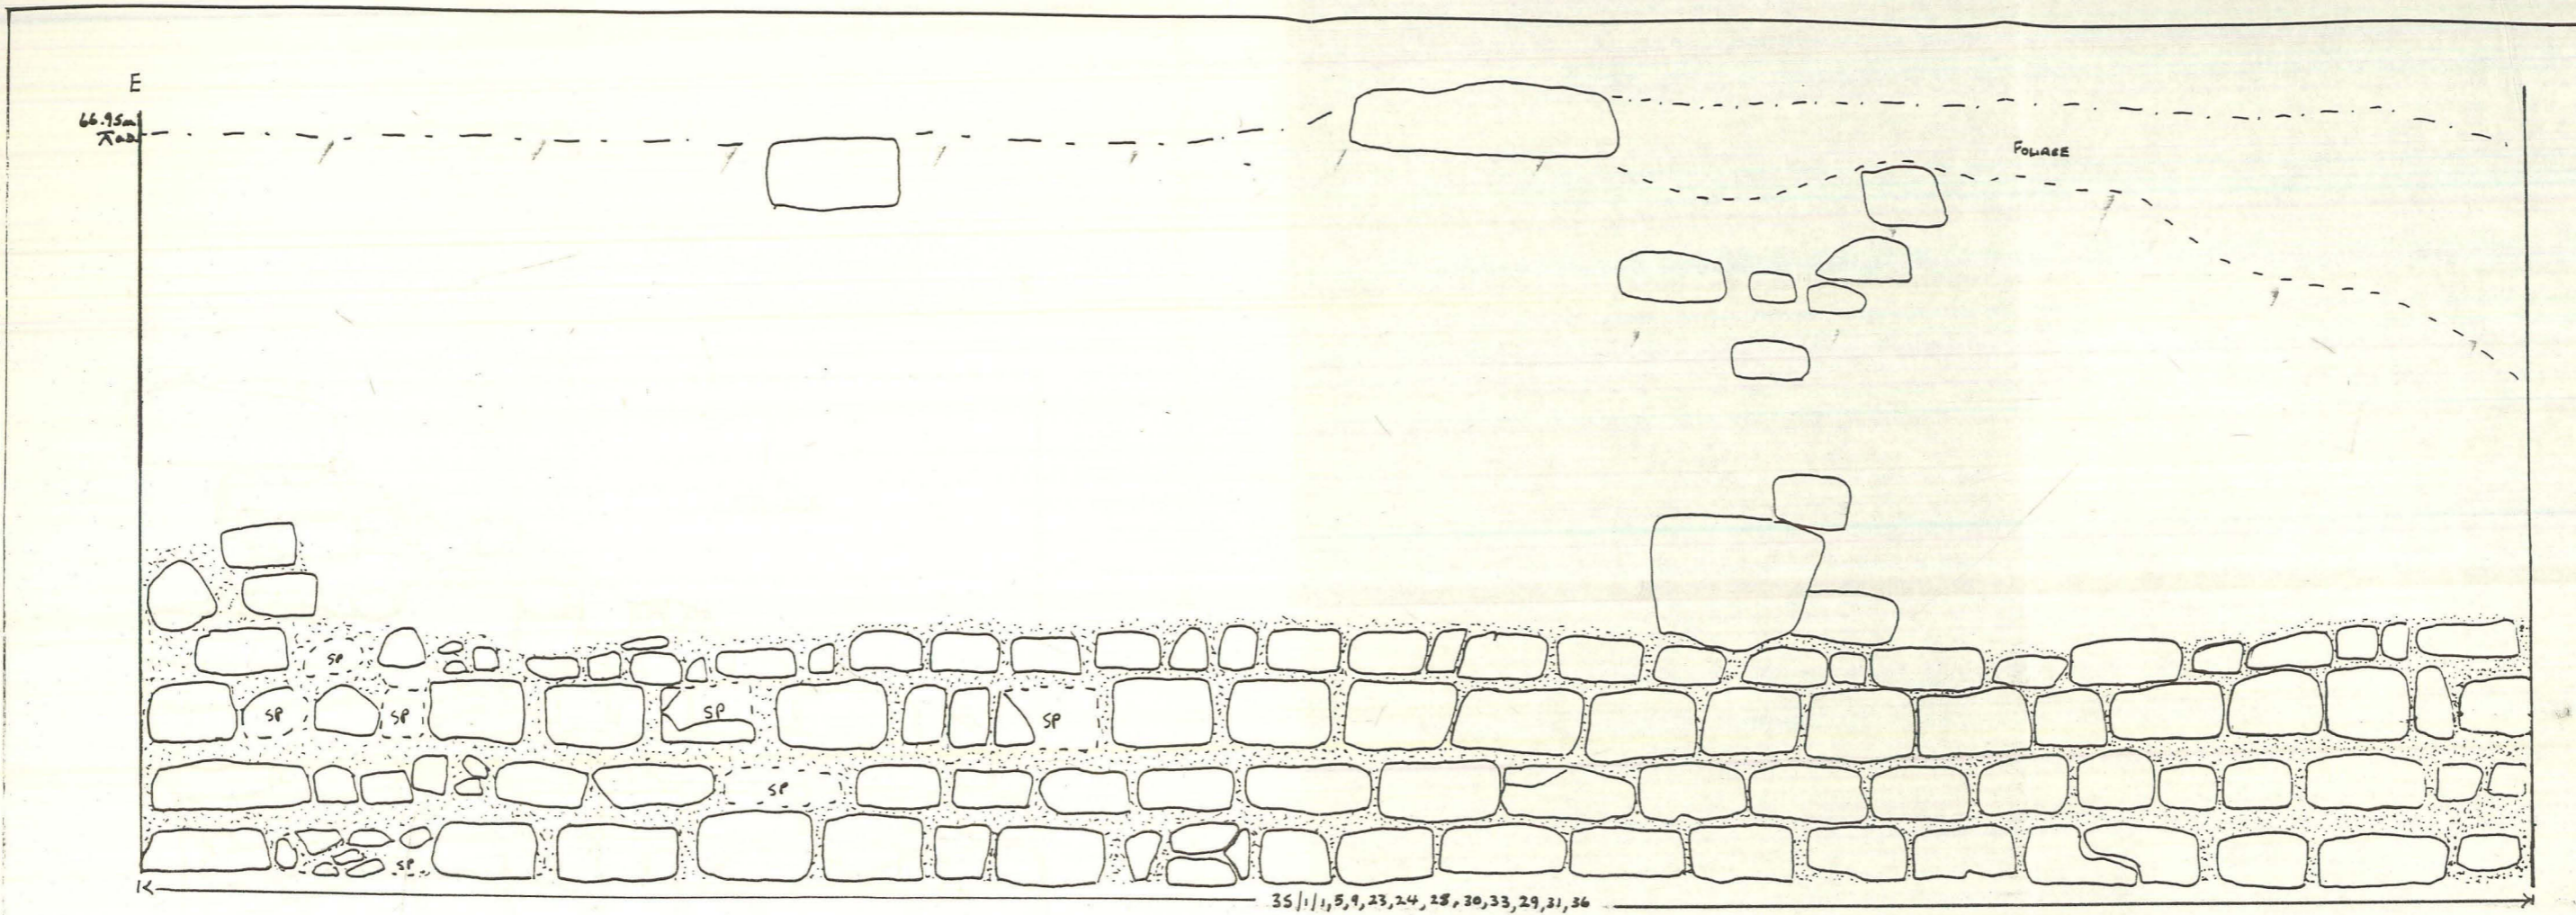
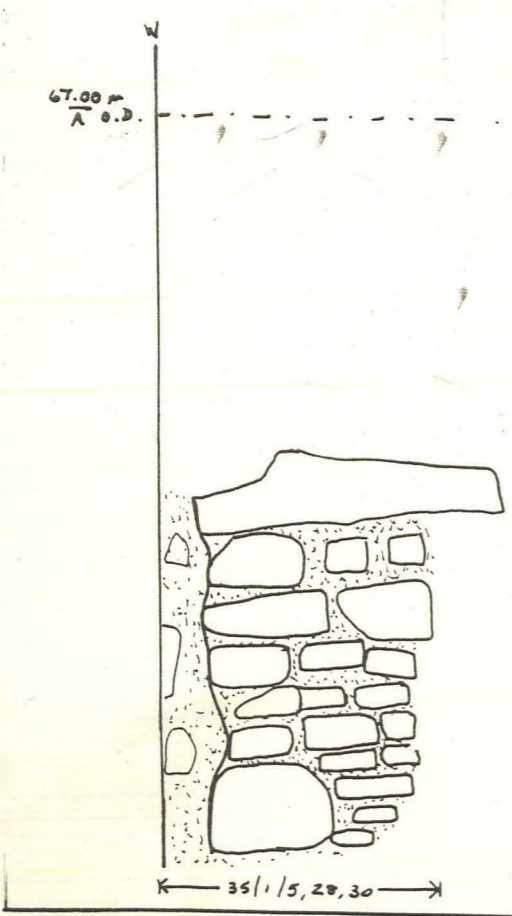
Fig.4

CITY OF LINCOLN ARCHAEOLOGY UNIT		
SITE CODE: NA93	PLAN/ELEV/SECTION NO:	
CLIENT: Lincoln City Council		
DESCRIPTION: East-West Elevation		
SCALE: 1:20	ARCHIVE NO:	
DRAWN BY: LGD	CHECKED:	DATE: 07/09/93

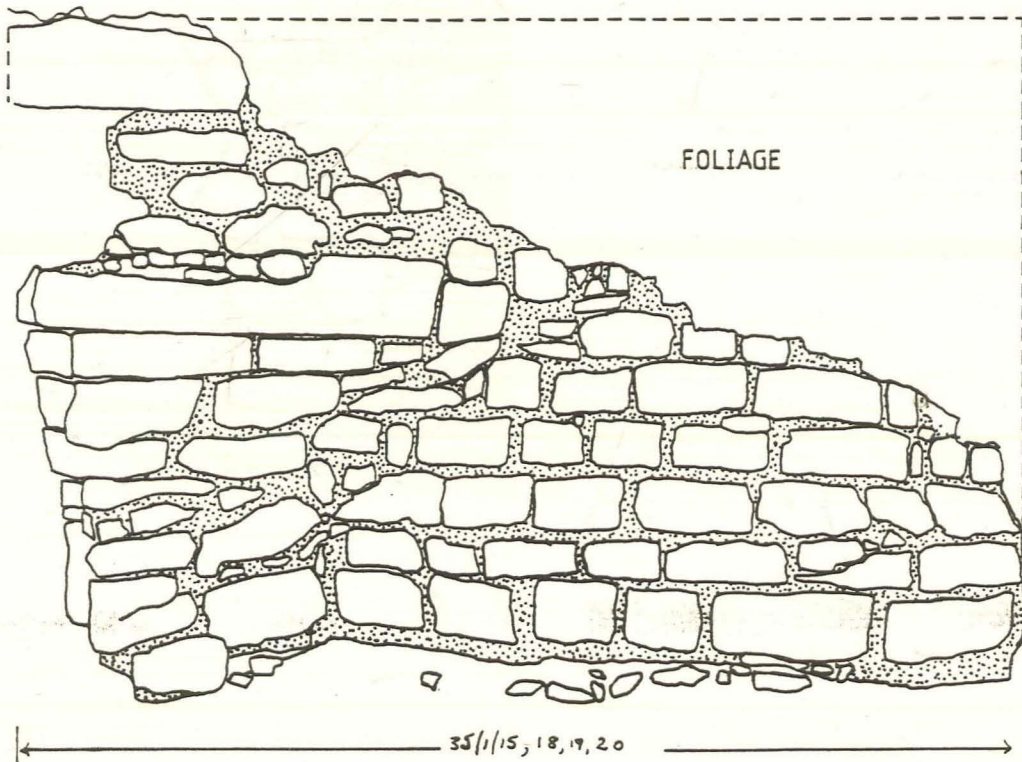
Fig.5

CITY OF LINCOLN ARCHAEOLOGY UNIT		
SITE CODE: NA93	PLAN/ELEV/SECTION NO:	
CLIENT: Lincoln City Council		
DESCRIPTION: North-South Elevation		
SCALE: 1:20	ARCHIVE NO:	
DRAWN BY:	CHECKED:	DATE: 12/09/93

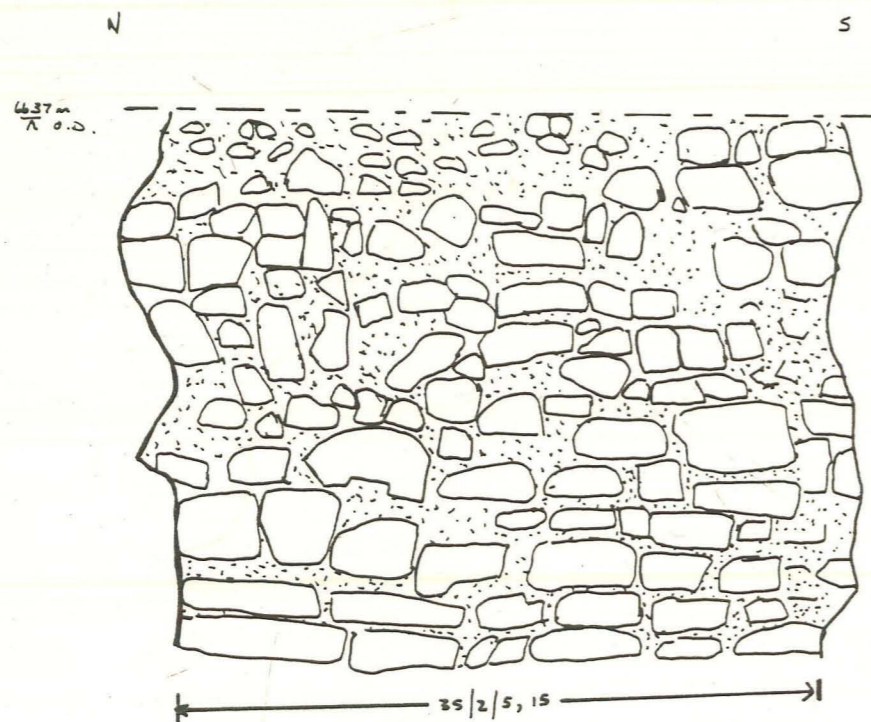
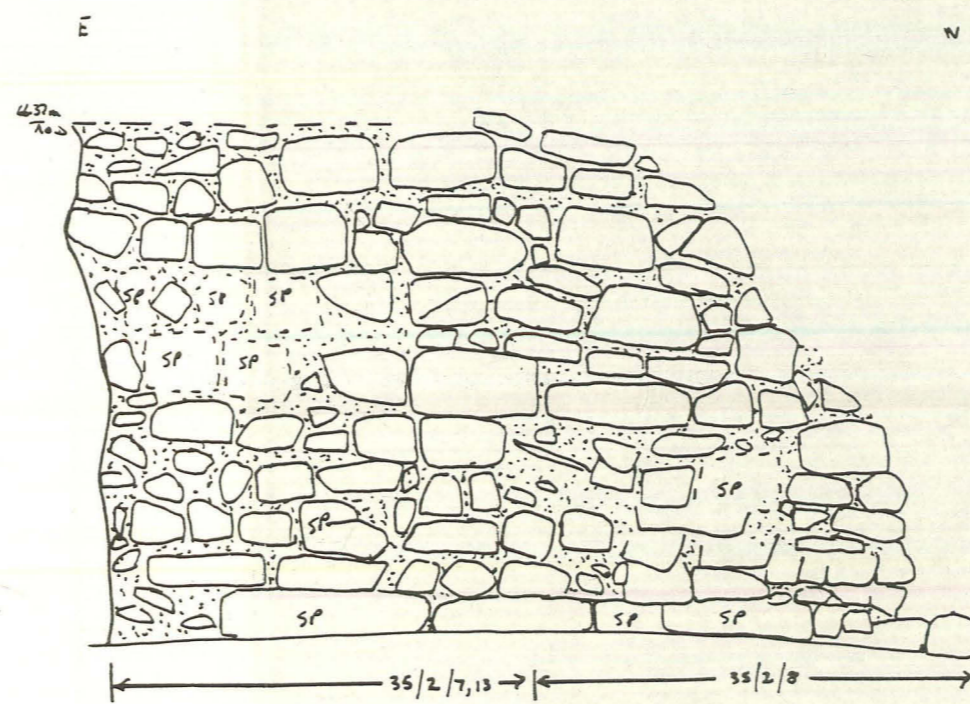
Fig.6

CITY OF LINCOLN ARCHAEOLOGY UNIT		
SITE CODE: NA93	PLAN/ELEV/SECTION NO:	
CLIENT: Lincoln City Council		
DESCRIPTION: North-South Elevation East-West Elevation		
SCALE: 1:20	ARCHIVE NO:	
DRAWN BY: LGD	CHECKED:	DATE: 07/09/93

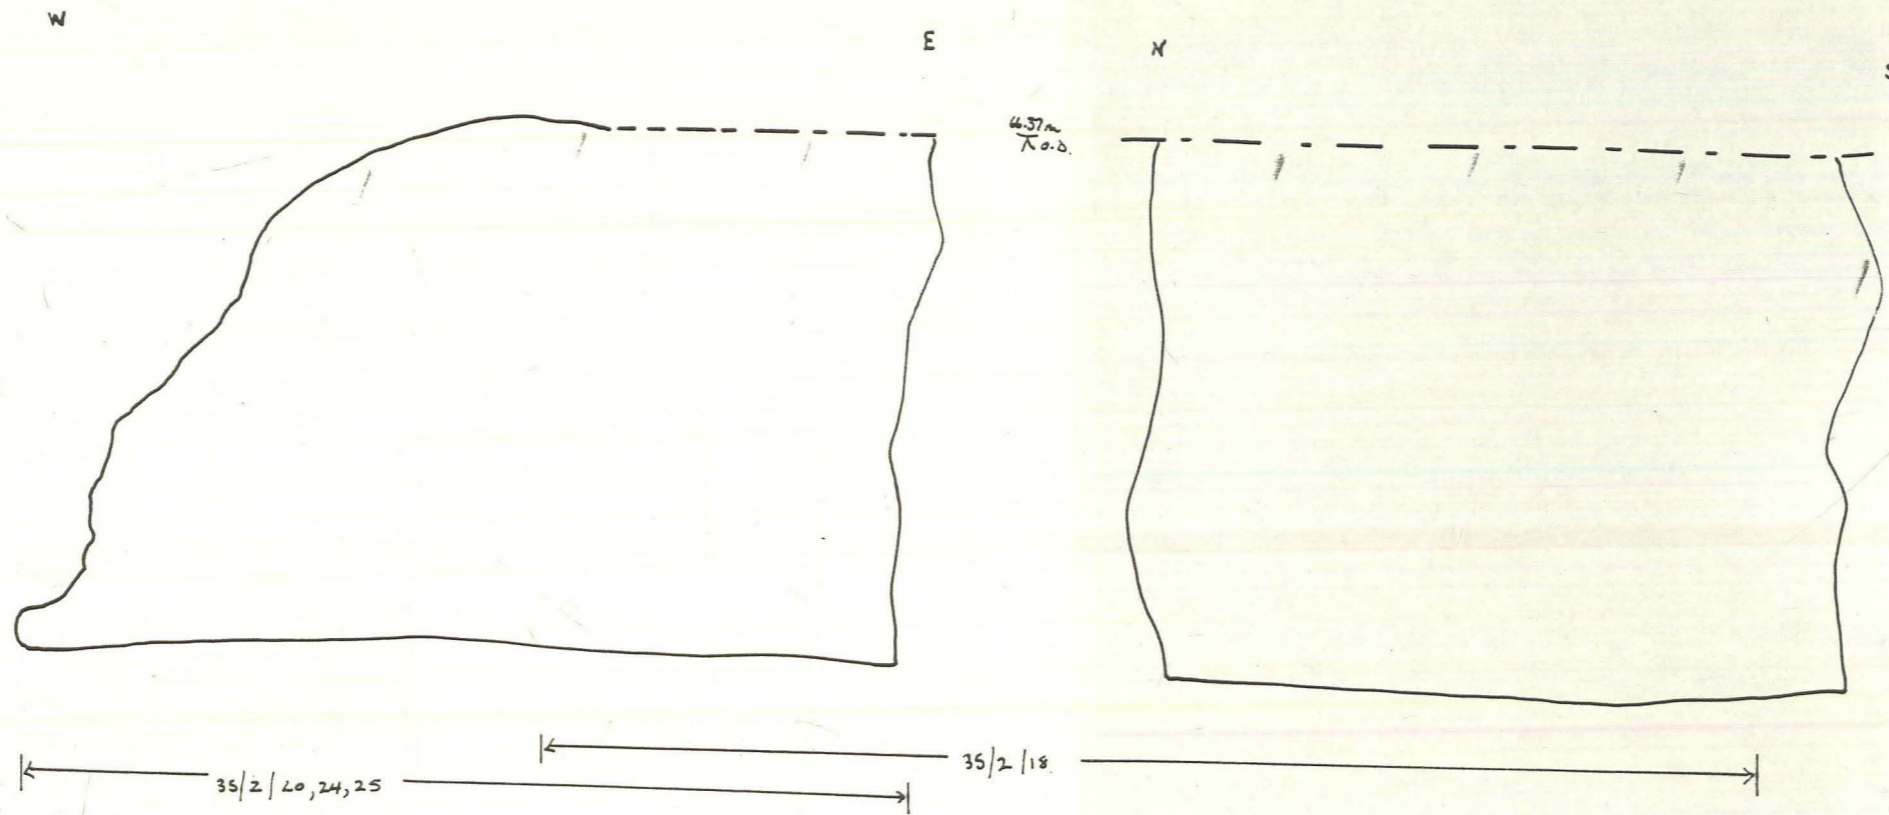
Fig.7

CITY OF LINCOLN ARCHAEOLOGY UNIT		
SITE CODE: NA93	PLAN/ELEV/SECTION NO:	
CLIENT: Lincoln City Council		
DESCRIPTION: North-South Profile West-East Profile		
SCALE: 1:20	ARCHIVE NO:	
DRAWN BY: LGD	CHECKED:	DATE: 07/09/93

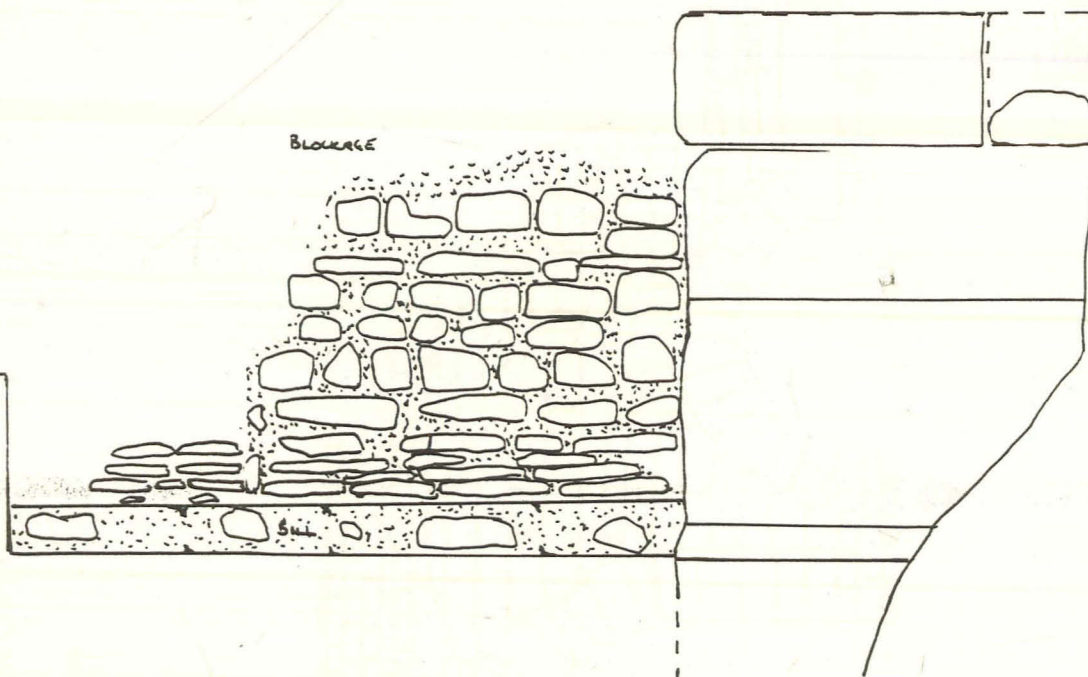
Fig.8

CITY OF LINCOLN ARCHAEOLOGY UNIT		
SITE CODE: NA93	PLAN/ELEV/SECTION NO:	
CLIENT: Lincoln City Council		
DESCRIPTION: East-West Elevation		
SCALE: 1:20	ARCHIVE NO:	
DRAWN BY: LGD	CHECKED:	DATE: 12/09/93

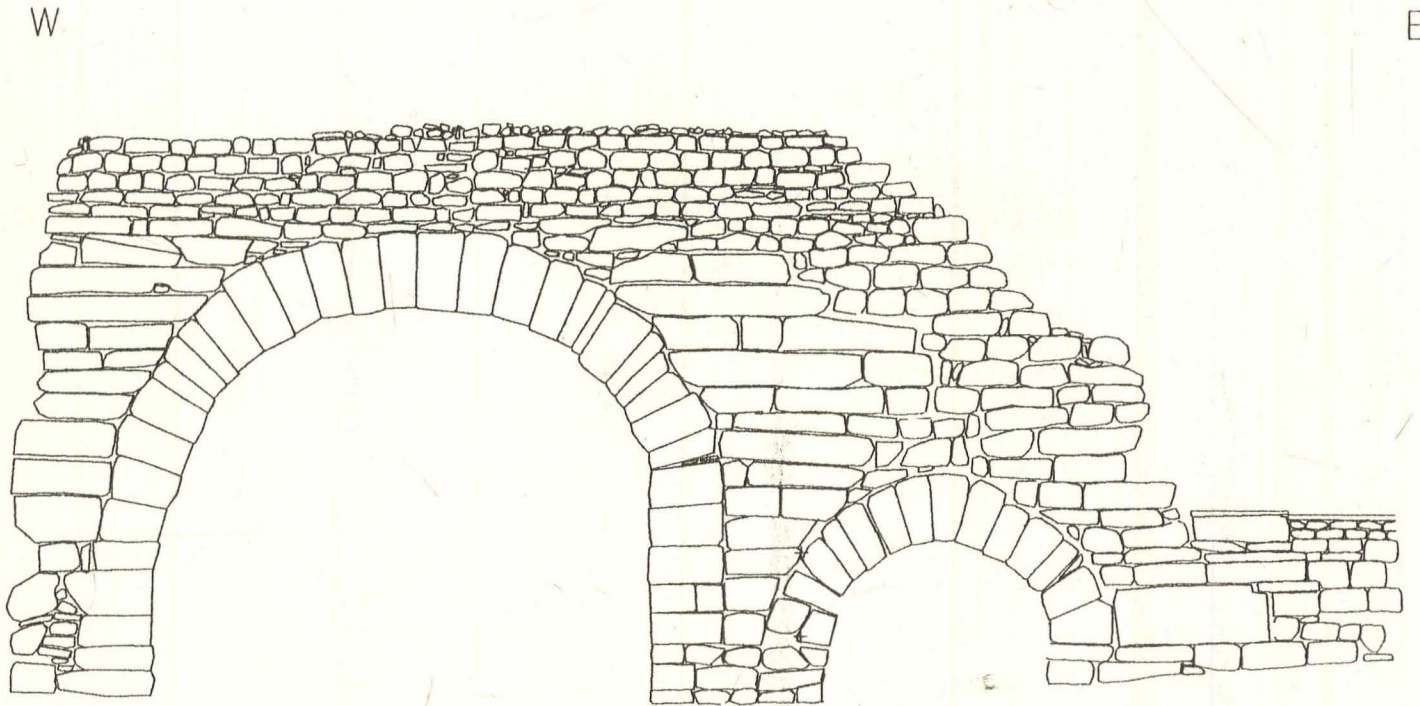
SOUTH FACING ELEVATION

CITY OF LINCOLN ARCHAEOLOGY UNIT	
SITE CODE: NAAB5	PLAN/ELEV/SECT No: 1
CLIENT: LINCOLN CITY COUNCIL	
DESCRIPTION: NEWPORT ARCH	
SOUTH FACING ELEVATION	
SCALE:	ARCHIVE NO:
DRAWN BY: LGD	CHECKED: X
MUSEUM ACCESSION NO:

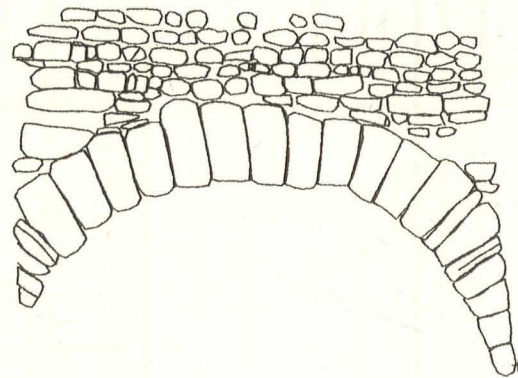
Fig.10

CITY OF LINCOLN ARCHAEOLOGY UNIT	
SITE CODE: NAAB5	PLAN/ELEV/SECTION: 2
CLIENT: LINCOLN CITY COUNCIL	
DESCRIPTION: NEWPORT ARCH N FACING ELEVATIONS	
SCALE:	ARCHIVE NO:
DRAWN BY: LGD	CHECKED: X
MUSEUM ACCESSION NO:

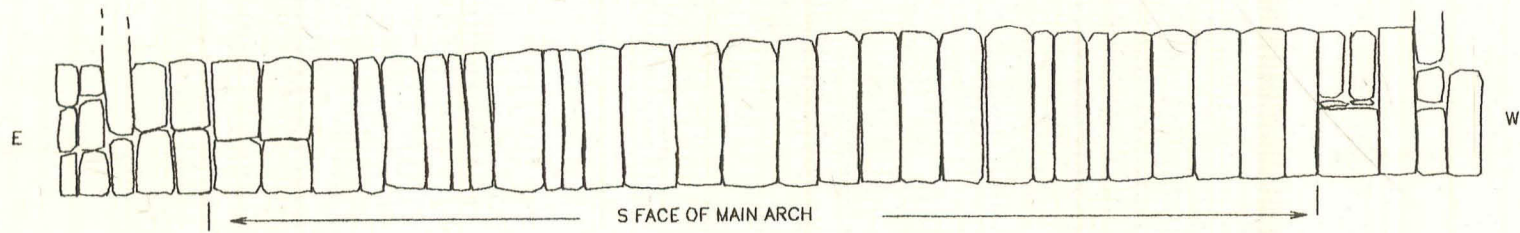
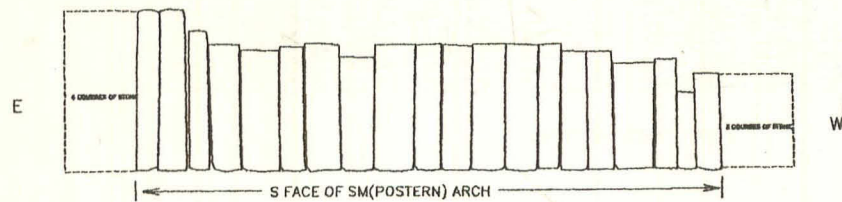
Fig.11

CITY OF LINCOLN ARCHAEOLOGY UNIT	
SITE CODE: NAA95	PLAN/ELEV/DEPTH: 5
CLIENT: LINCOLN CITY COUNCIL	
DESCRIPTION: NEWPORT ARCH	
S FACING ARCHES UNFOLDED	
SCALE:	ARCHIVE NO:
DRAWN BY: LGD	CHECKED: X
MUSEUM ACCESSION NO:

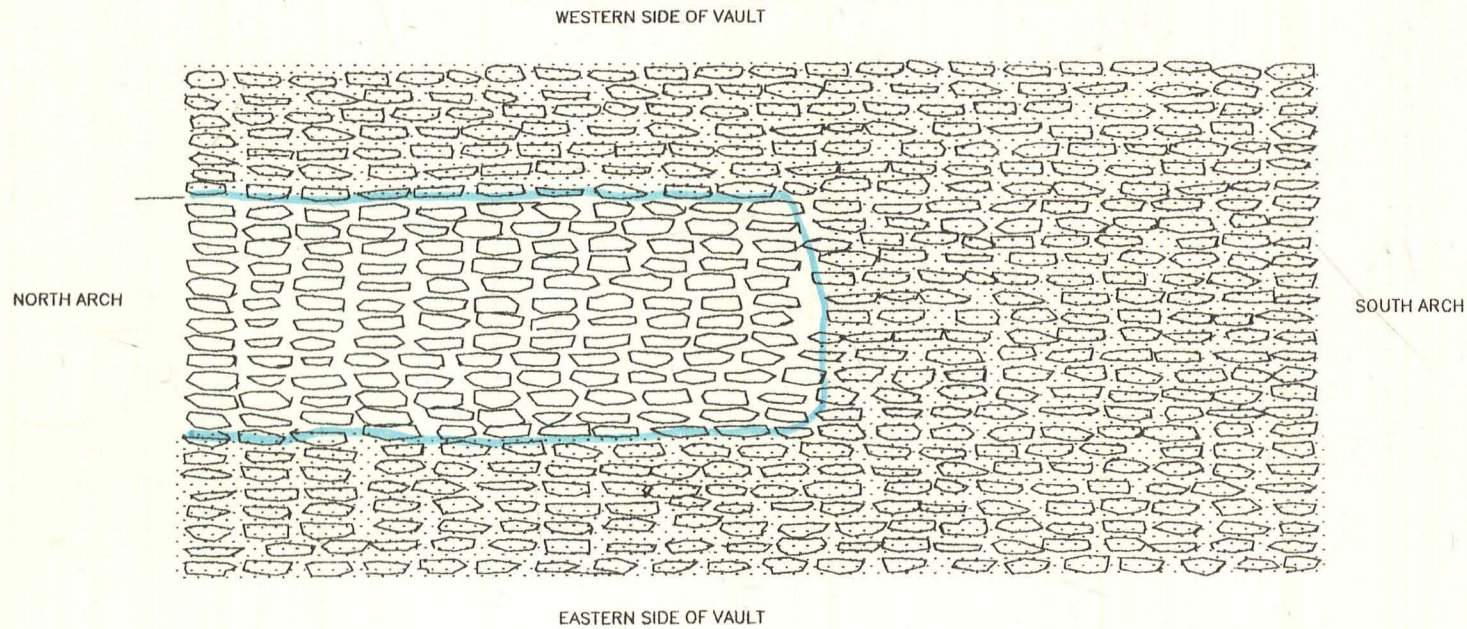
Fig.12

REPRESENTS AREA COVERED IN MORTAR AND BLACK MUCK
 INDIVIDUAL STONES BASED PARTLY ON MEASUREMENT, PARTLY GUESSTIMATE

CITY OF LINCOLN ARCHAEOLOGY UNIT	
SITE CODE: NAA95	PLAN/ELEV/SECT NO: 15
CLIENT: LINCOLN CITY COUNCIL	
DESCRIPTION: NEWPORT ARCH - N-S VAULTED ROOF OF TUNNEL	
SCALE:	ARCHIVE NO:
DRAWN BY: LGD	CHECKED: X
MUSEUM ACCESSION NO:

The monument requires a certain amount of conservation work, primarily centred around repointing and replacing of loose stonework. We would suggest that this work should have an archaeological record made of the repair work. The record would take the form of annotation of the existing drawings and a comprehensive photographic record of the monument. The information gained could then be used as a basis for any further conservation work on the monument.

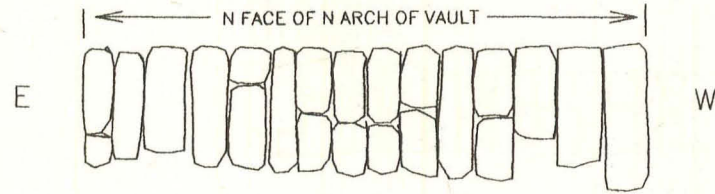
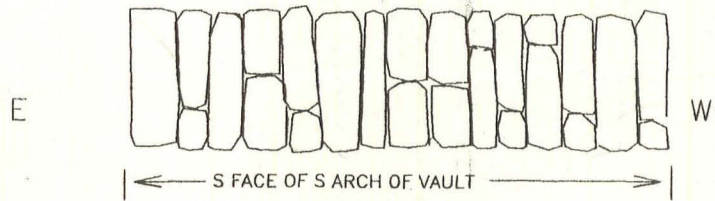
Fig. 13

NEWPORT ARCH – VAULT ARCHES UNFOLDED

CITY OF LINCOLN ARCHAEOLOGY UNIT	
SITE CODE	MA95
CURATOR	LINCOLN CITY COUNCIL
DESCRIPTION	NEWPORT ARCH SMALL ARCHES UNFOLDED
SCALE	AS SHOWN
DRAWN BY	LGD
CHECKED BY	X
MUSEUM ACQUISITION NO.

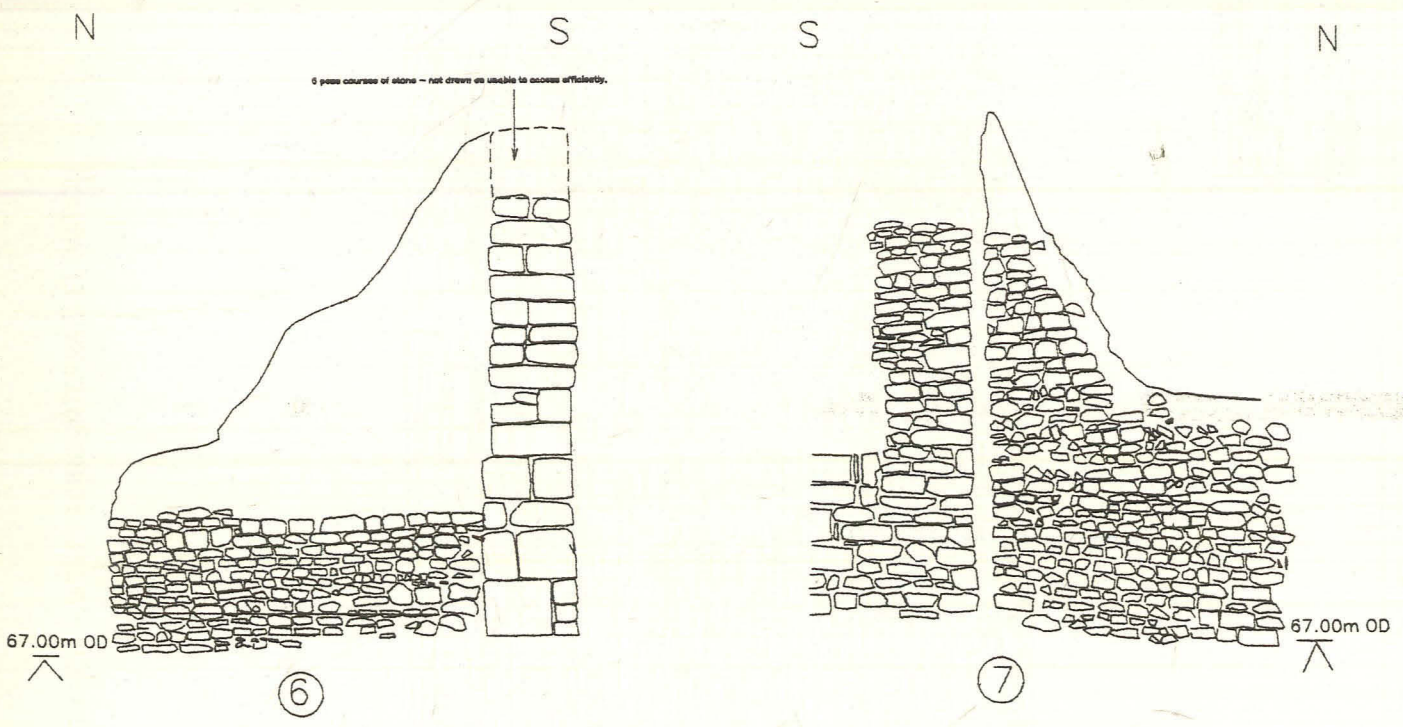
Figs.14 & 15

CITY OF LINCOLN ARCHAEOLOGY UNIT	
SITE CODE: NA95	PLAN/LEV/S&E Nos: 6 & 7
CLIENT: LINCOLN CITY COUNCIL	
DESCRIPTION: NEWPORT ARCH - WEST WALL INTERNAL AND EXTERNAL VIEWS	
SCALE:	ARCHIVE NO:
DRAWN BY: LCD	CHECKED: X
MUSEUM ACCESSION NO:

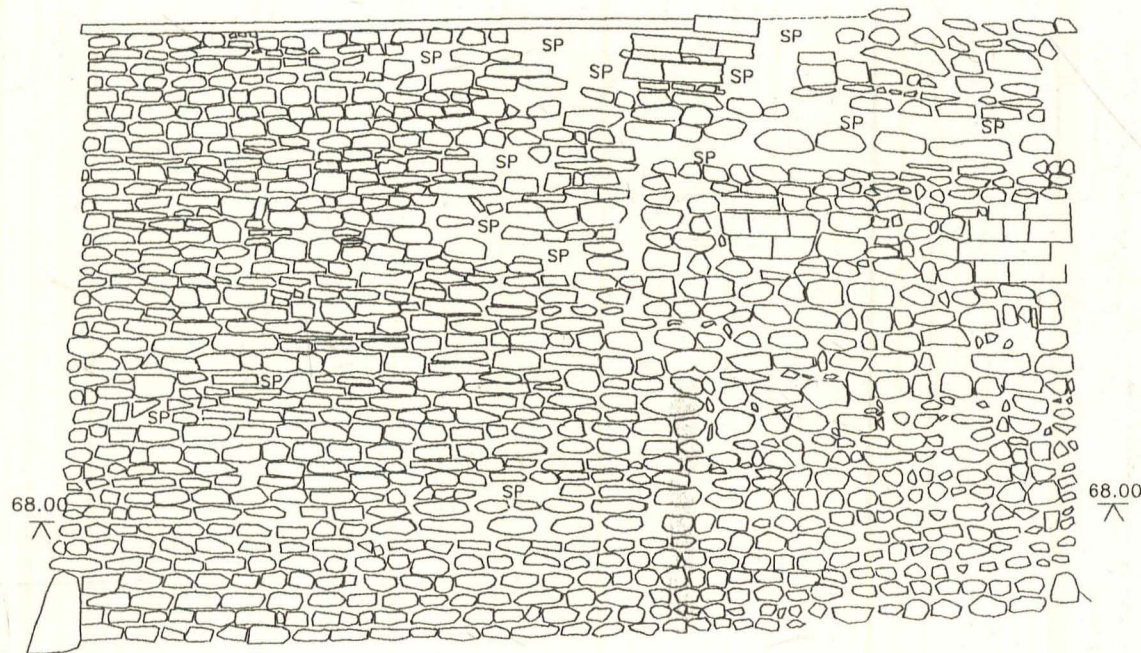
CITY OF LINCOLN ARCHAEOLOGY UNIT	
SITE CODE: NAAB5	PLAN/REV/NOY 100- 8
CLIENT: LINCOLN CITY COUNCIL	
DESCRIPTION: NEWPORT ARCH – W FACING INNER WALL	
SCALE:	ARCHIT. NO:
DRAWN BY: LGO	CHECKED: X
MANUAL ACCESSION NO:

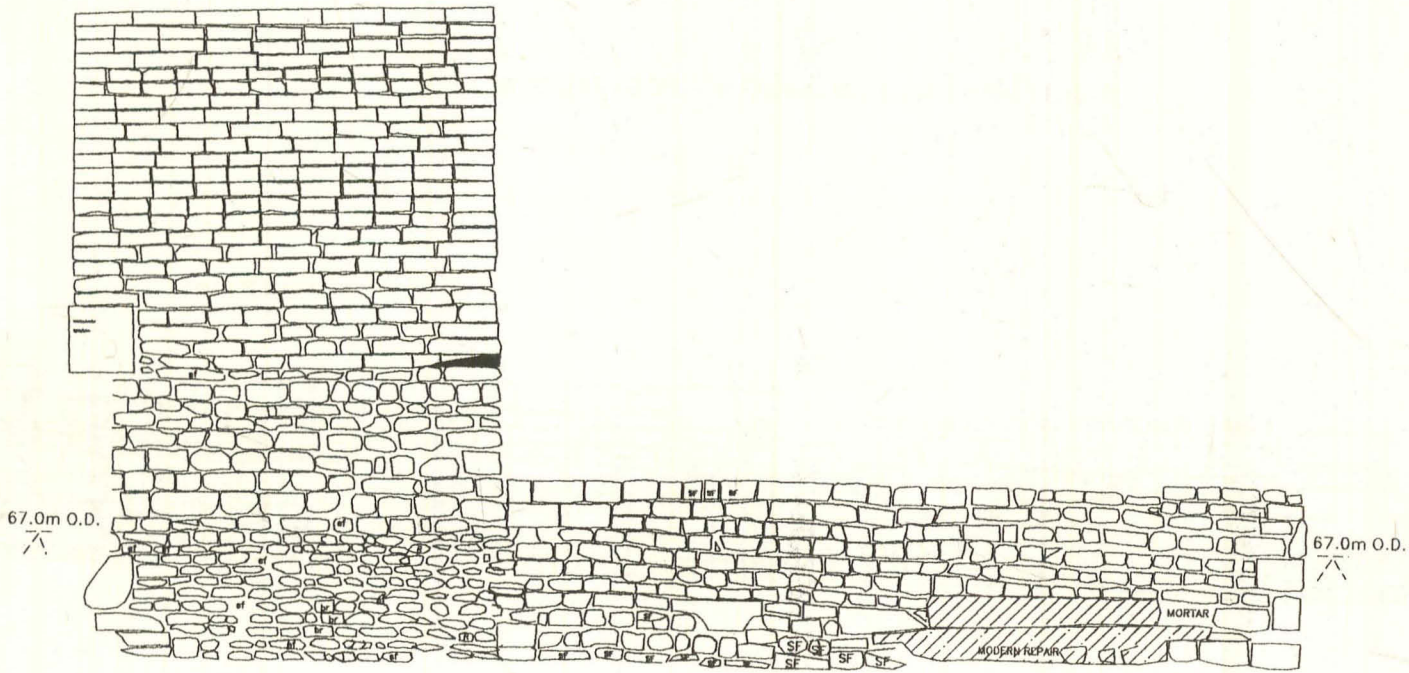
Fig.18

NEWPORT ARCH – W FACING WALL (INTERNAL) E GATE

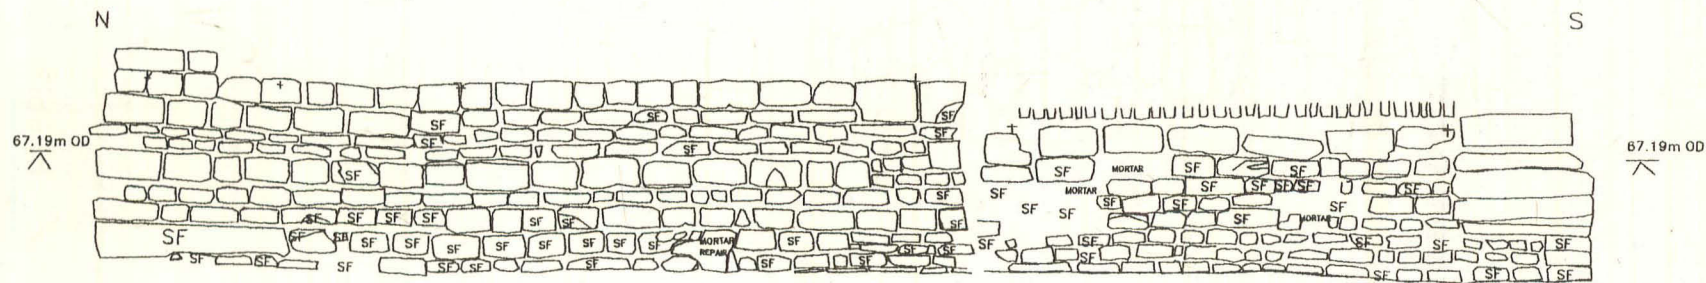
CITY OF LINCOLN ARCHAEOLOGY UNIT	
SITE CODE: NA415	Draw/Photo/Map Ref: 11
CLIENT: LINCOLN CITY COUNCIL	
DESCRIPTION: NEWPORT ARCH - W FACING WALL (INTERNAL) E GATE	
PROJECT:	ARCHIVE NO:
CONTRACT NO: 100	DATE: 11
SEARCH NUMBER 101

The inside of the eastern walkway and tunnel show serious evidence of decay with considerable loss of mortar and degradation of stone. There is also some evidence of earlier repair which is also now showing

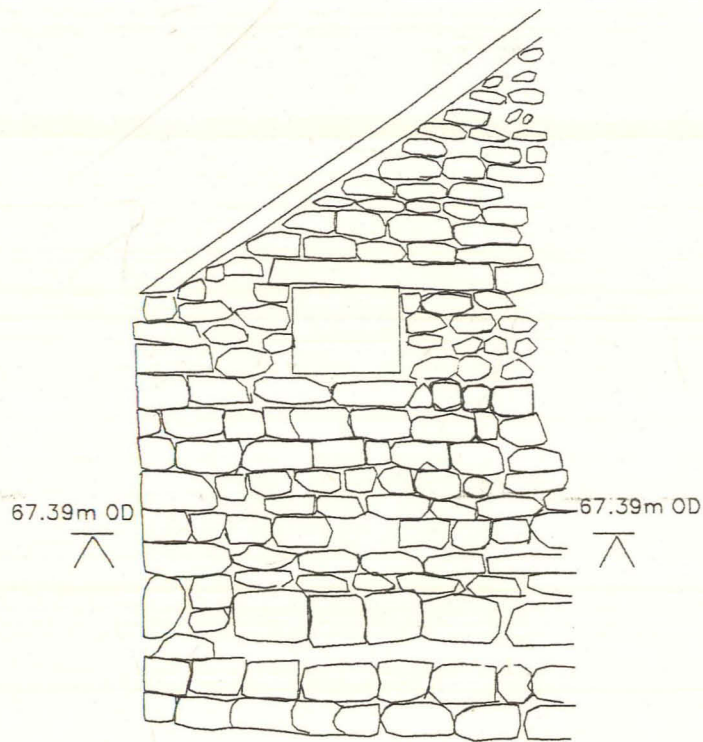
Fig. 21

CITY OF LINCOLN ARCHAEOLOGY UNIT	
SITE CODE: NAAG/S	PLAN/ELEV/SECTION- 13
CLIENT: LINCOLN CITY COUNCIL	
DESCRIPTION NEWPORT ARCH - W FACING (EXT) ELEVATION AT SOUTHERN END OF E PATH	
SCALE:	ARCHIVE NO:
DRAWN BY: LGD	CHECKED: X
MUSEUM ACCESSION NO:

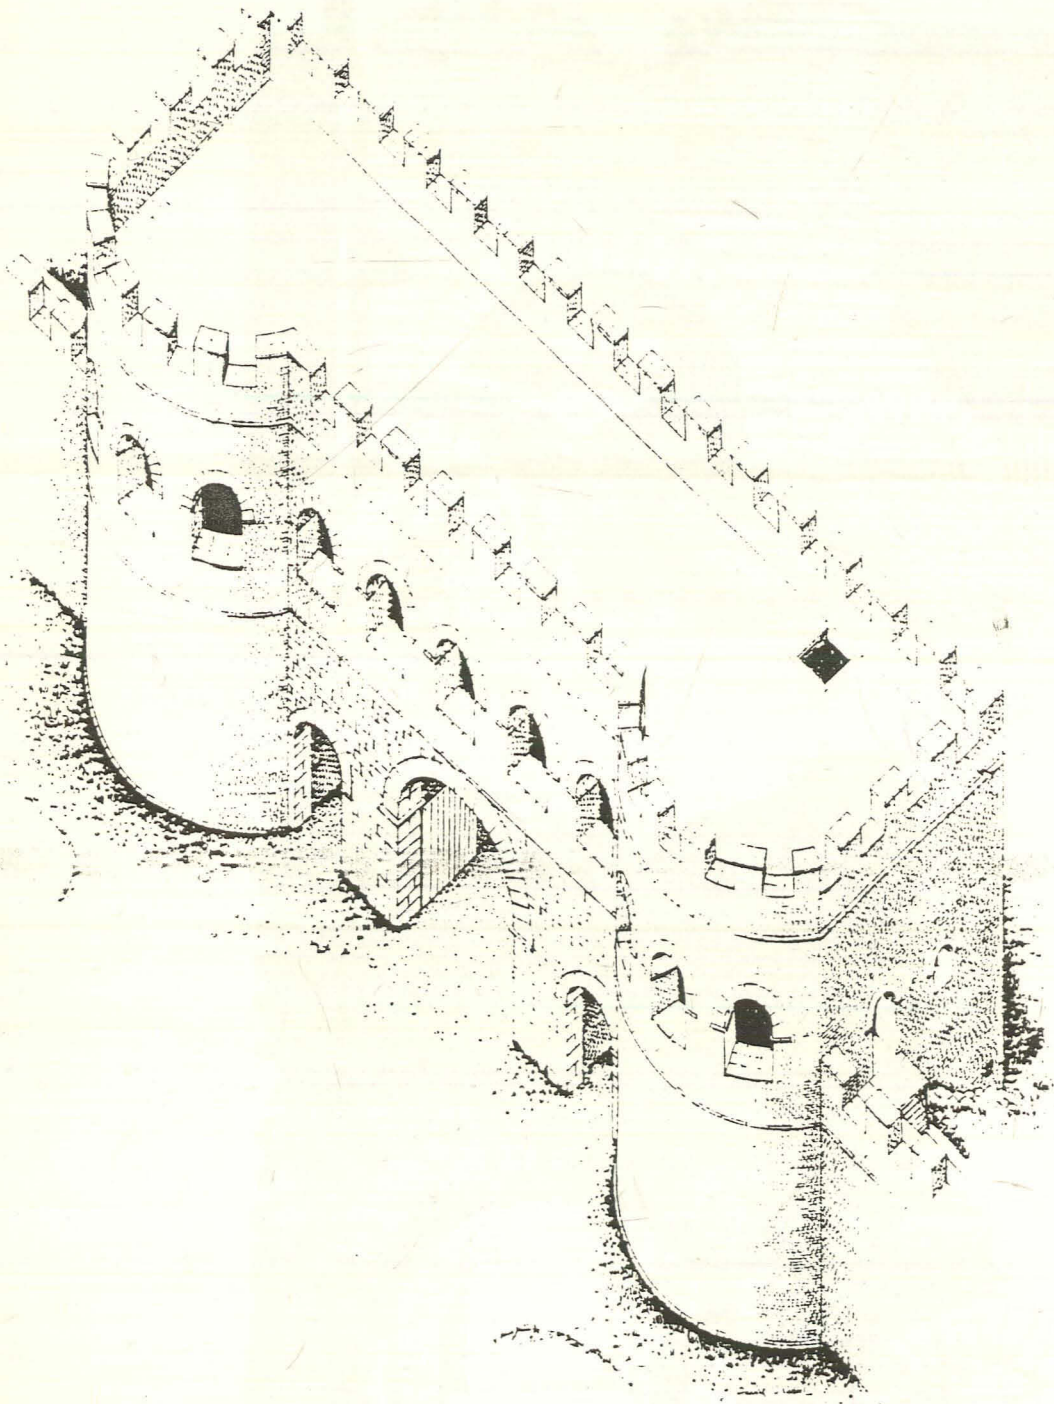
FIG. 23. Lincoln: suggested appearance of north gate of *colonia* in its final form.

It is possible to arrive at the general plan of the Roman north gate in its final form by combining the results of the 1954 excavation with the evidence provided by the surviving structural remains and earlier records (fig. 22). The same sources have also been used for a tentative impression of the front elevation, once again from the skilful pen of Mr. David Neal (fig. 23). As noted above (p. 186), the basic plan is of a single central carriage-way, 16 ft. wide, flanked by side-passages, 7 ft. wide, with 6-foot piers between. The length of the gate from north to south is now known to be 24 ft., and it has already been argued (above, p. 186) that the three passages were barrel-vaulted, implying an upper storey.

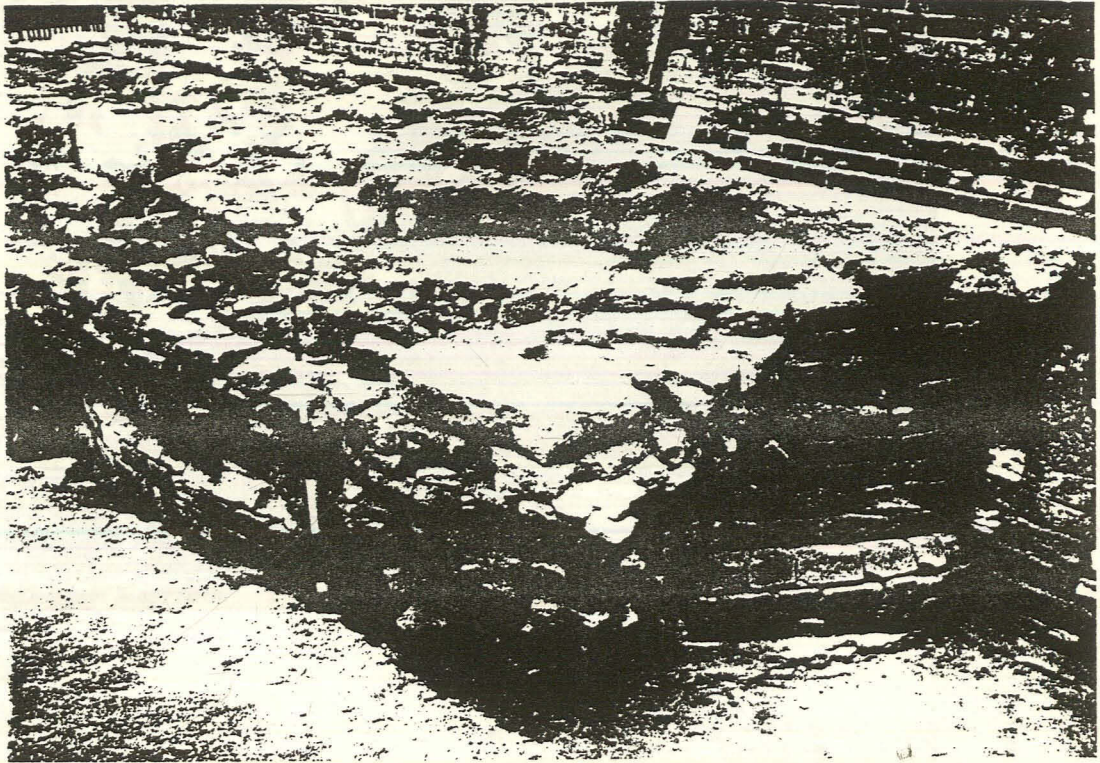
a. North-west angle of medieval foundation with Roman west tower behind

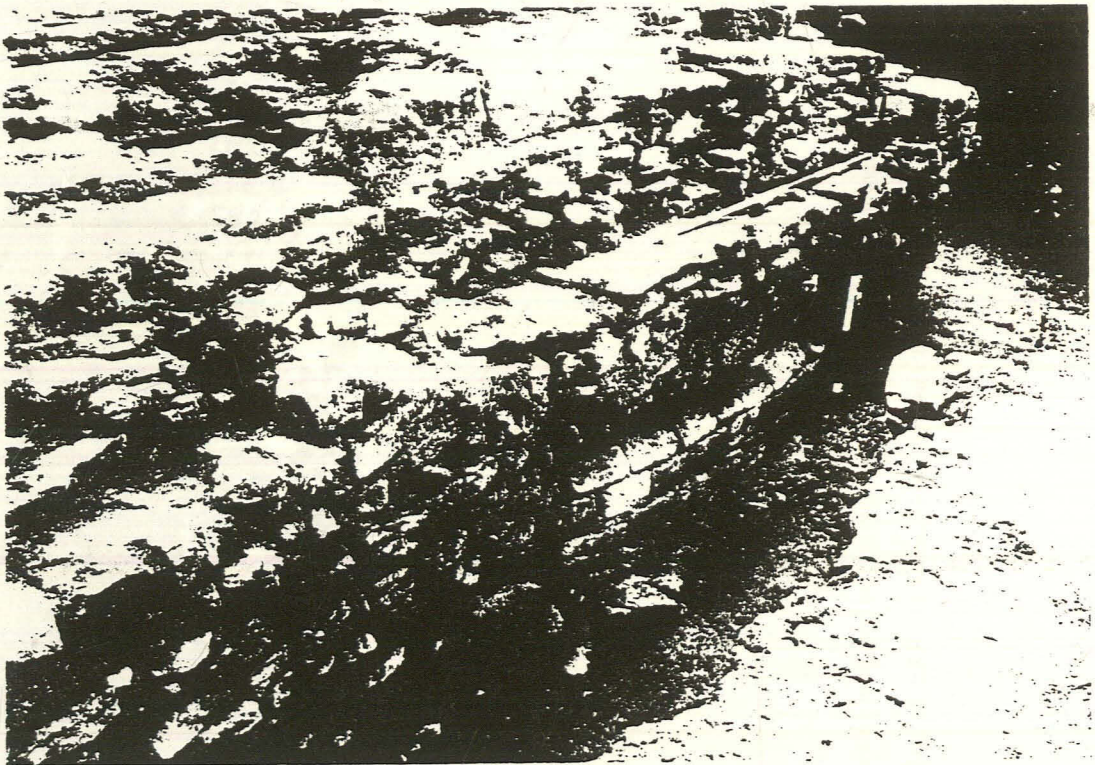
b. Curved front of Roman west tower beneath medieval face (looking west)

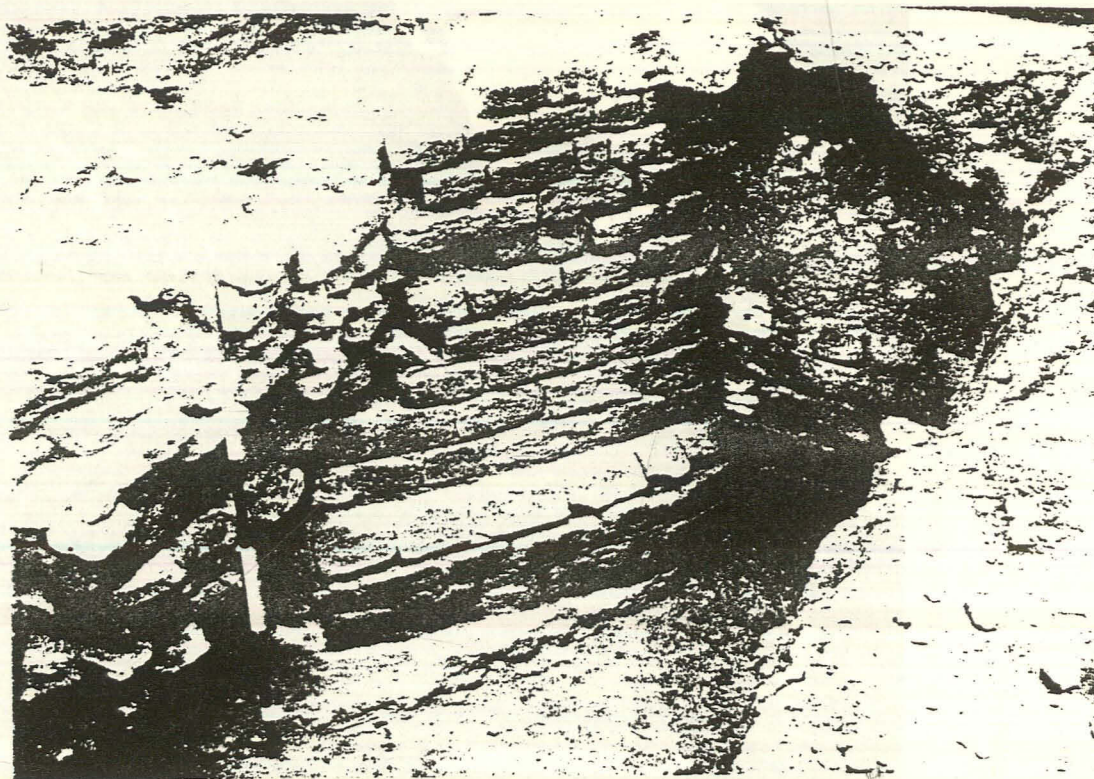
a. Junction of west tower and *colonia* wall (from north-west)

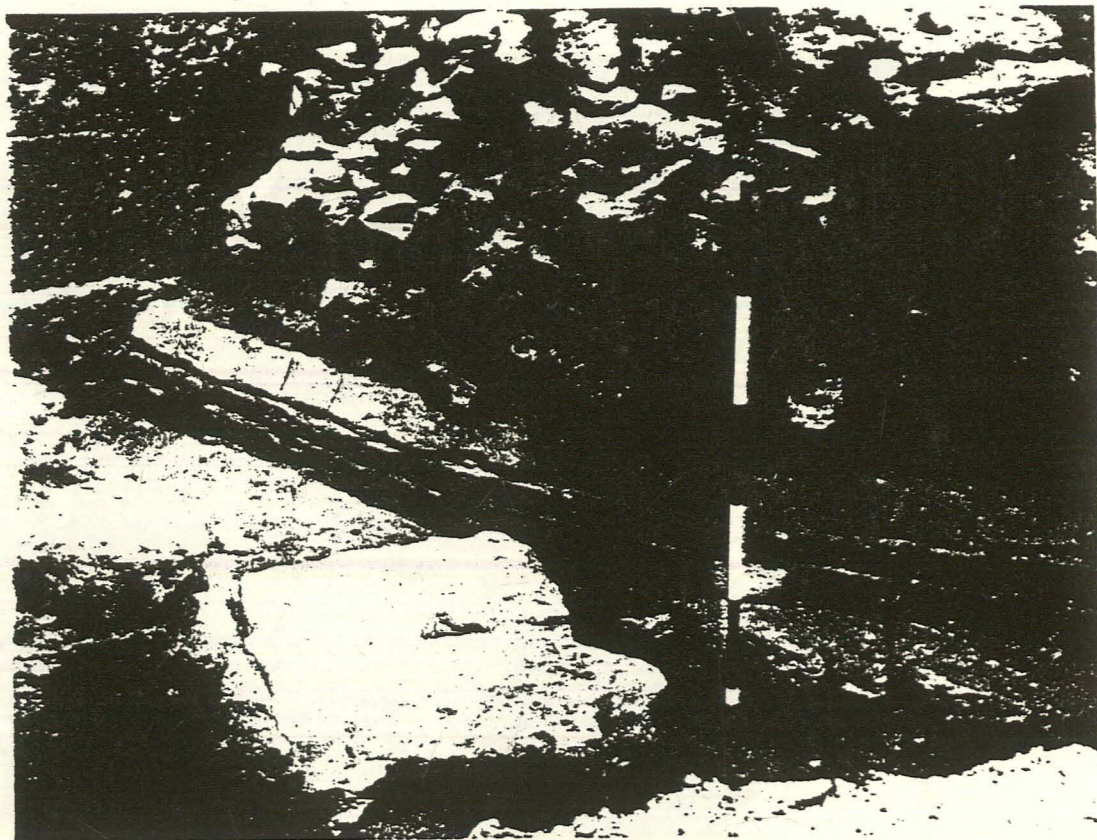
b. Roman west tower exposed beneath medieval foundation to east
