NEWPORT ARCH AND BASTION
RECORDING OF REMAINS PRIOR
TO CONSERVATION

CLAU ARCHAEOLOGICAL REPORT NO: 222

Report to
Lincoln City Council

December 1995

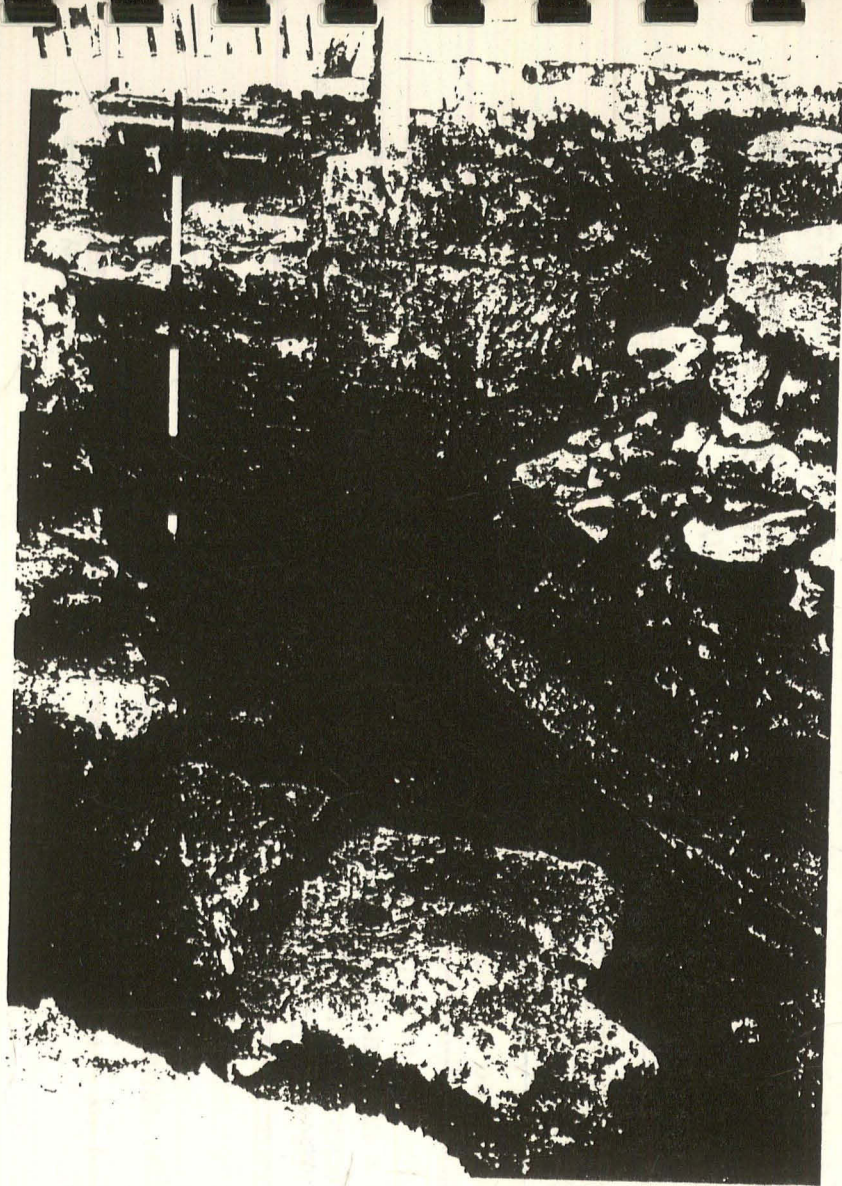
a. Junction of west tower with west jamb of side-passage (from north)

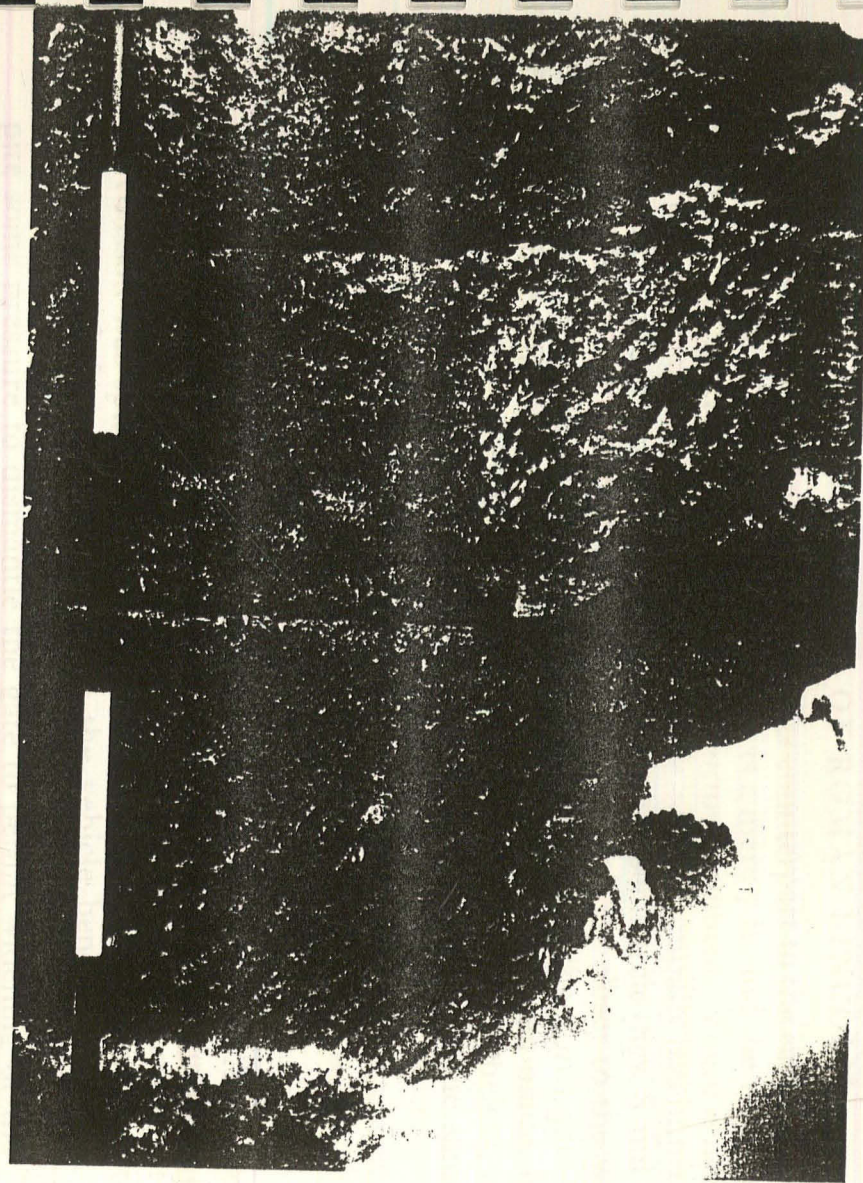
b. Detail of masonry of west jamb of side-passage

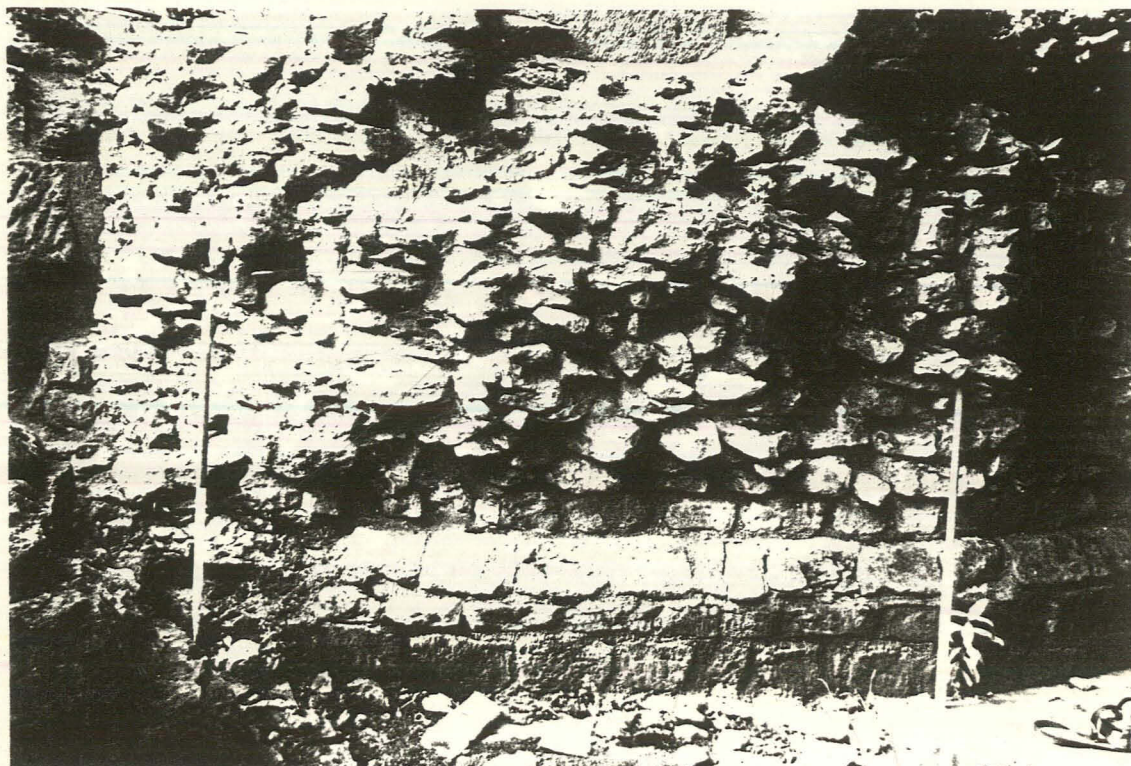
Site code : NA 93

Direction: LOOKING SW

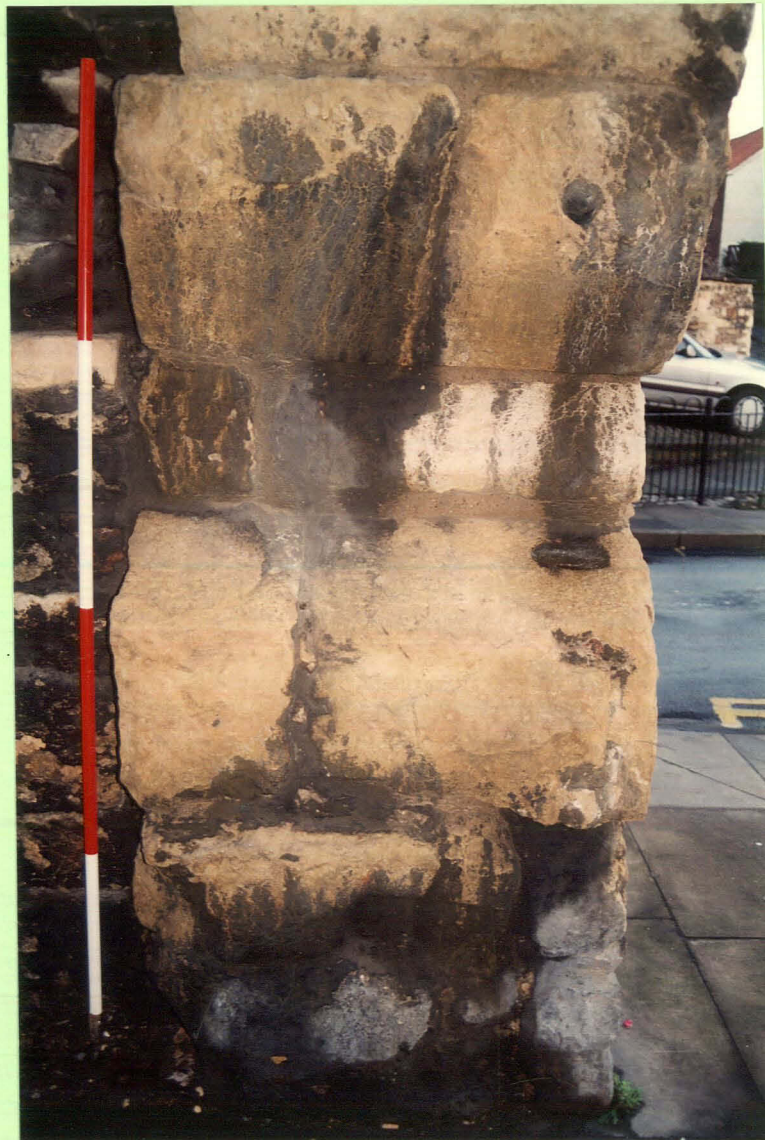
Address:	Subject: • NA - E. FACING INTERNAL WALL	File Reference: CLAU REPORT 222
Date Photograph Taken: 9.1.96	Time Photograph Taken: PM

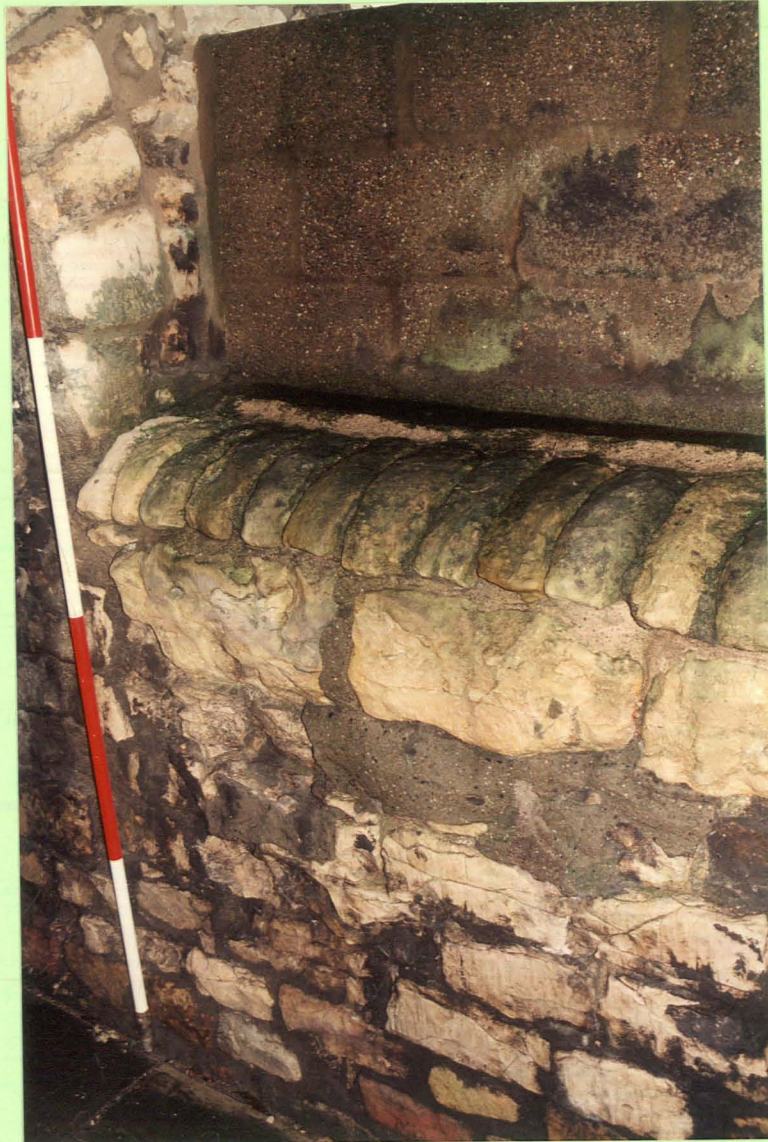
Address:	Subject: • NA PATH - W. FACITG WALL DETAIL	File Reference: CLAU REPORT 222
Date Photograph Taken: 9.1.96	Time Photograph Taken: PM
